## **In-Line Ditch BMP Installations**

### ***SE Petrovitsky Road***

The in-line ditch best management practices (BMPs) for SE Petrovitsky Road were installed on Tuesday, June 30, 2009 in a long section of roadside ditch located on the south side of SE Petrovitsky Road between SE 192<sup>nd</sup> Drive and 170<sup>th</sup> Avenue SE and 172<sup>nd</sup> Avenue SE. The BMPs use a flow control treatment design that are comprised of a series of modified rock check dams that contain washed, coarse sand encased in geotextile fabric. A total of five BMPs were installed at this location following engineering designs prepared by King County Roads Maintenance Section (KCRMS) and approved by the Washington Department of Ecology (Ecology) under Stormwater Management Implementation Grant Number G0900039. The installation was completed by a KCRMS crew from the Summit Maintenance Facility (Division 4).

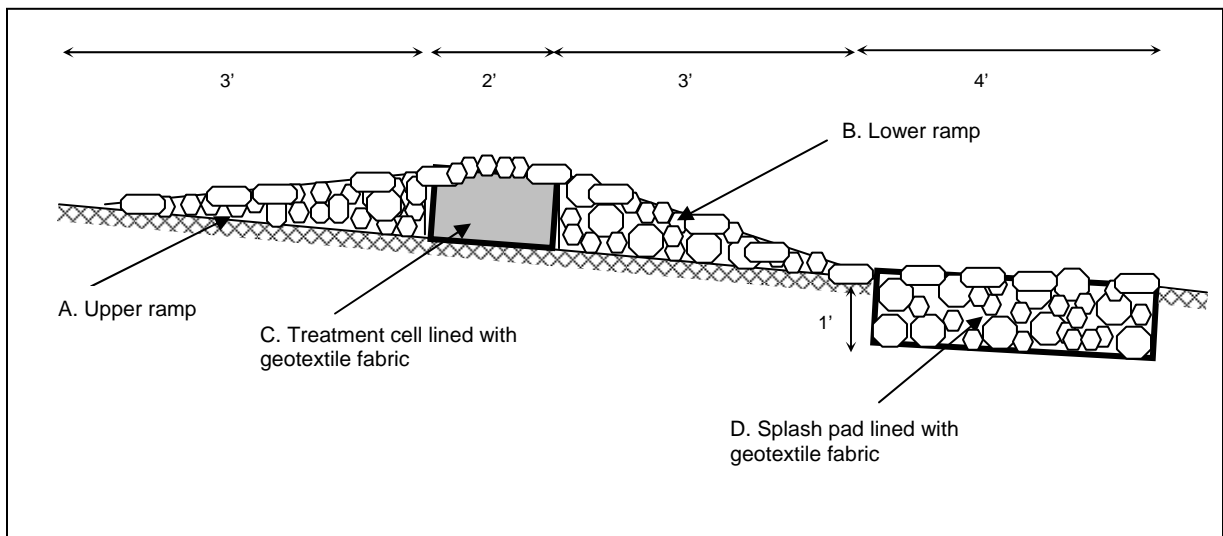
**Figure 1. In-Line Ditch Modified Rock Check Dam BMP**

The BMPs are based on a modified angular rock check dam design (see Figures 1 and 2) that encase a media filled “treatment cell” (in this case washed coarse sand) wrapped<sup>1</sup> in a highly permeable, non-woven geotextile (Figure 1, C). The BMPs are used to provide stormwater retention and energy dissipation while providing some filtration through the treatment cells. The BMPs are designed to allow higher flows to bypass over the top of the check dam.

The rock check dams consist of two ramps built from a mix of 2”-4” and 4”-8” angular rock (Figure 1, A and B). Larger rock (> 4”) was primarily used for the BMPs at the SE Petrovitsky Road site due to larger seasonal volumes and flow rates documented during pre-construction flow monitoring. The check dam ramps are installed with a 3 to 1 slope; each ramp is three-feet long, sloping up to a peak height of one foot above the floor of the ditch. The treatment cell is placed in a two-foot gap left between the upper and lower ramps.

A “splash-pad” consisting of a four-foot long by one-foot deep trench that is lined with geotextile fabric and filled with 2”-8” angular rock is located just downstream of each check dam (Figure 1, D). The splash pads provide permanent energy dissipation, BMP erosion control, and stormwater storage and infiltration areas. The complete footprint of each BMP, including the splash-pad, is approximately 12-feet in length.

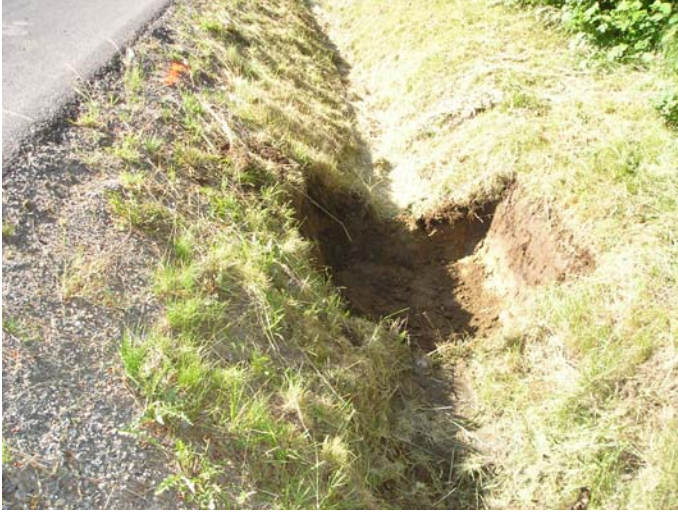
As described above in the BMP Design Description, the splash pad trenches were excavated four-feet long by one-foot deep as shown below in Figure 3.

*Figure 3. Ditch section prepped for BMP placement with excavations for spill pads. Lower end of ditch looking east.*

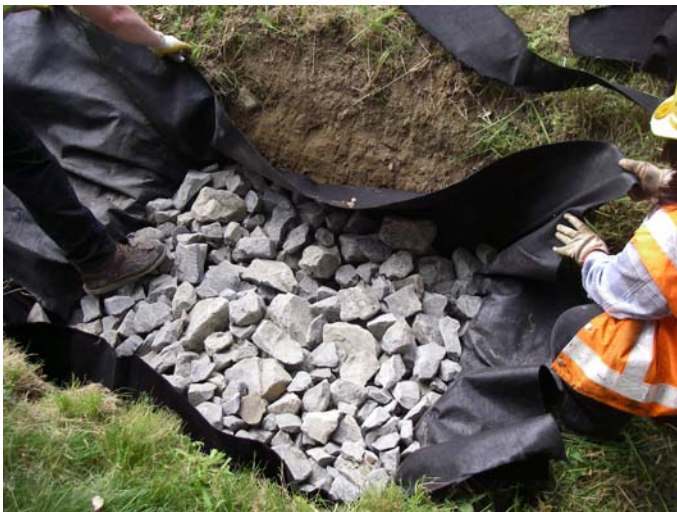
The splash pad trenches were lined with geotextile fabric and filled with the angular rock mixture. The ends of the fabric were partially wrapped inward over the splash pads and secured with additional rock as shown in Figure 4.

*Figure 4. Splash pad trench lined with geotextile fabric, filled with angular rock mixture, and wrapped inward over the splash pad edges, which is then secured with angular rock.*

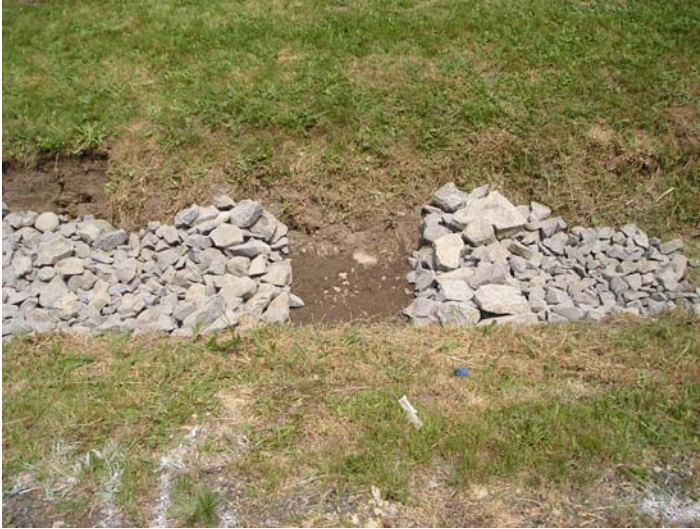
When each splash pad was completed, the backhoe placed mixed rock immediately upslope from the pad. This rock was positioned by hand to form the lower ramp. Additional rock was placed two feet above the lower ramp to form the upper ramp while leaving an open space for the treatment cell as shown below in Figure 5.

*Figure 5. Lower rock ramp and upper rock ramp installation with 2-foot long gap left to allow for treatment cell installation.*

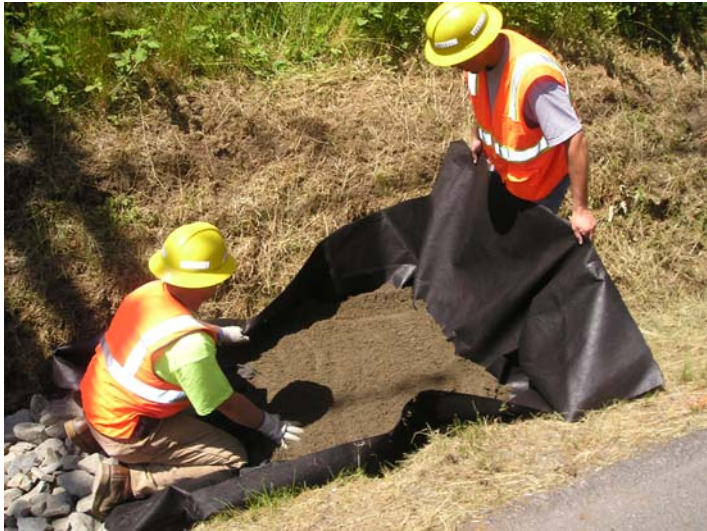
A pre-cut piece of geotextile was laid over the area of the treatment cell in the gap between the two check dam ramps. The fabric covered cell was then filled with washed, coarse sand as shown below in Figure 6. Approximately 0.6 yards of sand was used to fill each treatment cell.

*Figure 6. Crews fill the treatment cell with washed, coarse sand.*

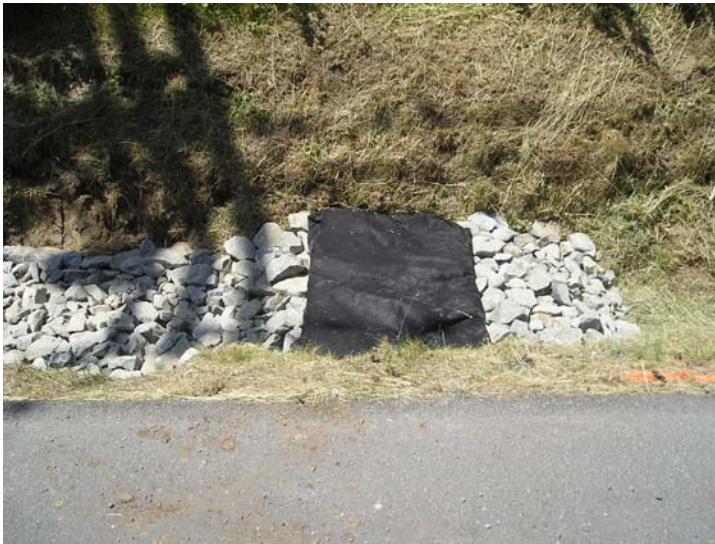
**Figure 7. Treatment cell geotextile fabric filled with washed, coarse sand and wrapped.**

The fabric was folded over the sand (Figure 7) and was then secured with rock to complete the BMP (Figure 8).

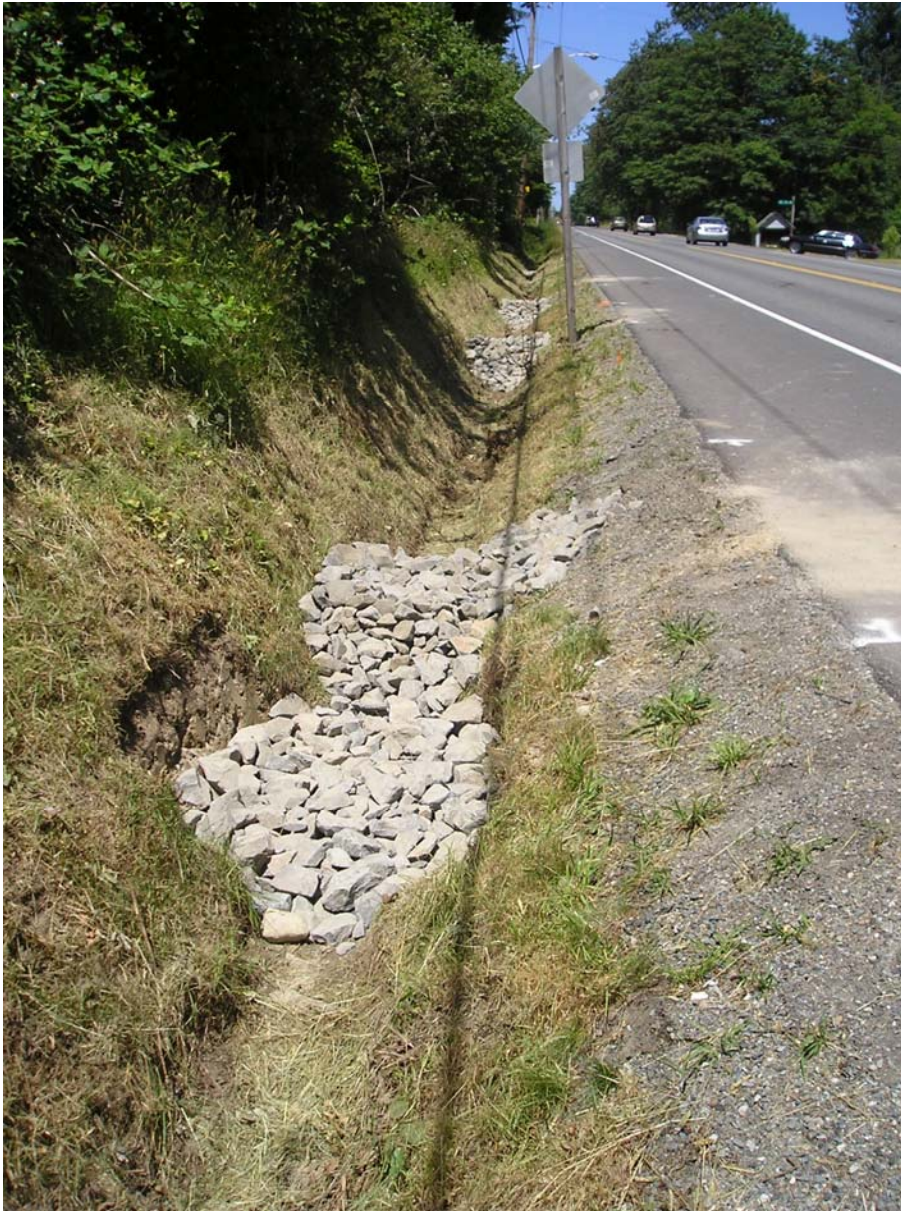
Figure 9 shows three of the five flow control BMPs installed along the south side of SE Petrovitsky Rd.

**Figure 9. In-line  
Ditch BMPs  
looking  
upstream (west)  
along SE  
Petrovitsky Rd.**
