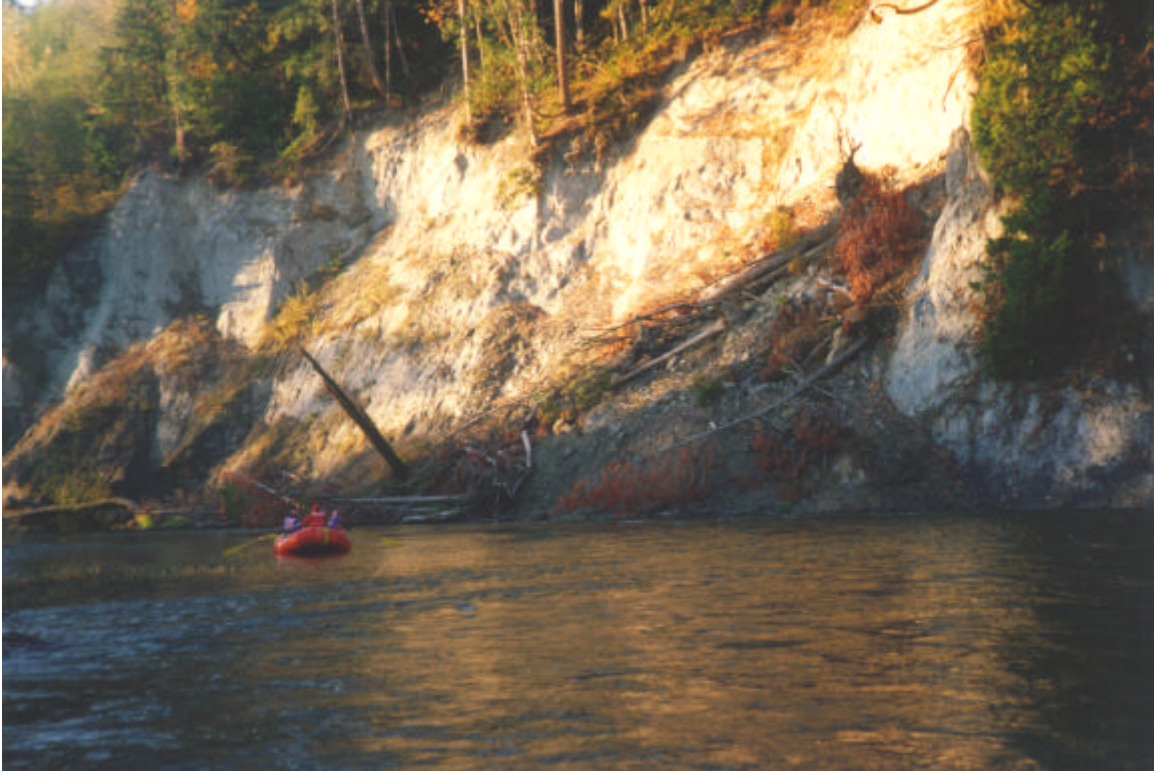
Figure Sed-6a. Eroding valley wall composed of unconsolidated glacial sediments near RM 32 on the mainstem Green River.

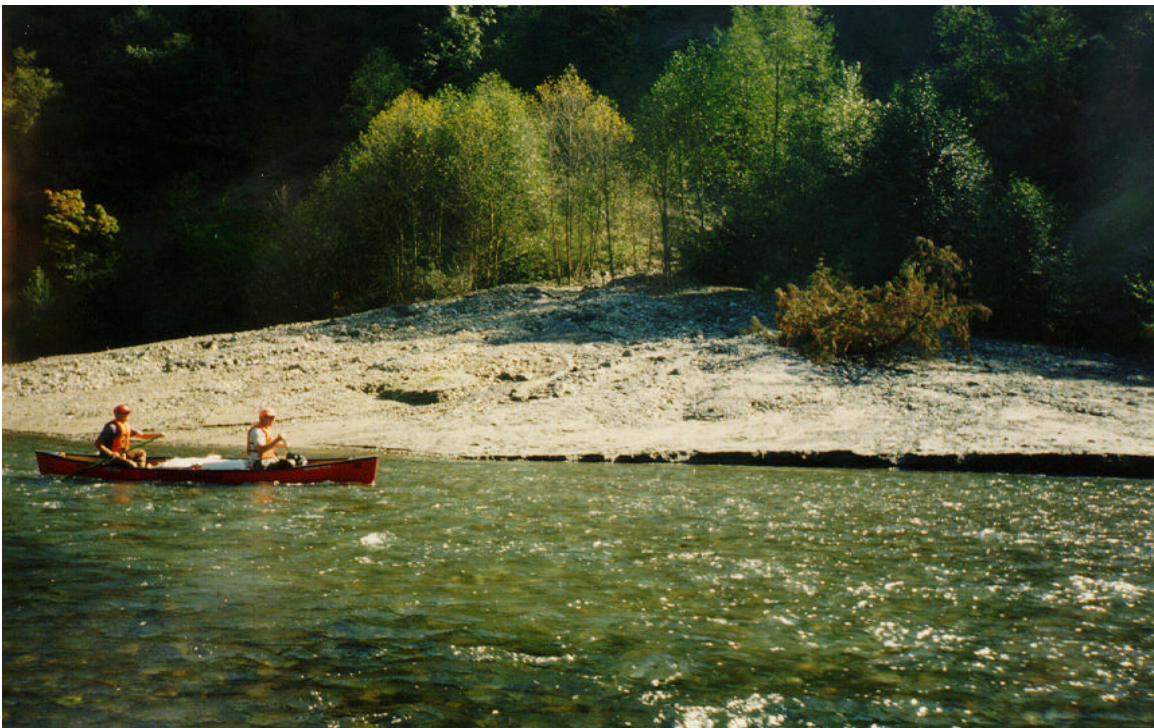
Figure Sed-6b. Deposit of fine sediment at the base of landslide in mainstem Green River near RM 42.8.
