# Wetland 79 Natural Area Site Management Guidelines

*December 2004*

**King County**

**Water and Land Resources Division**

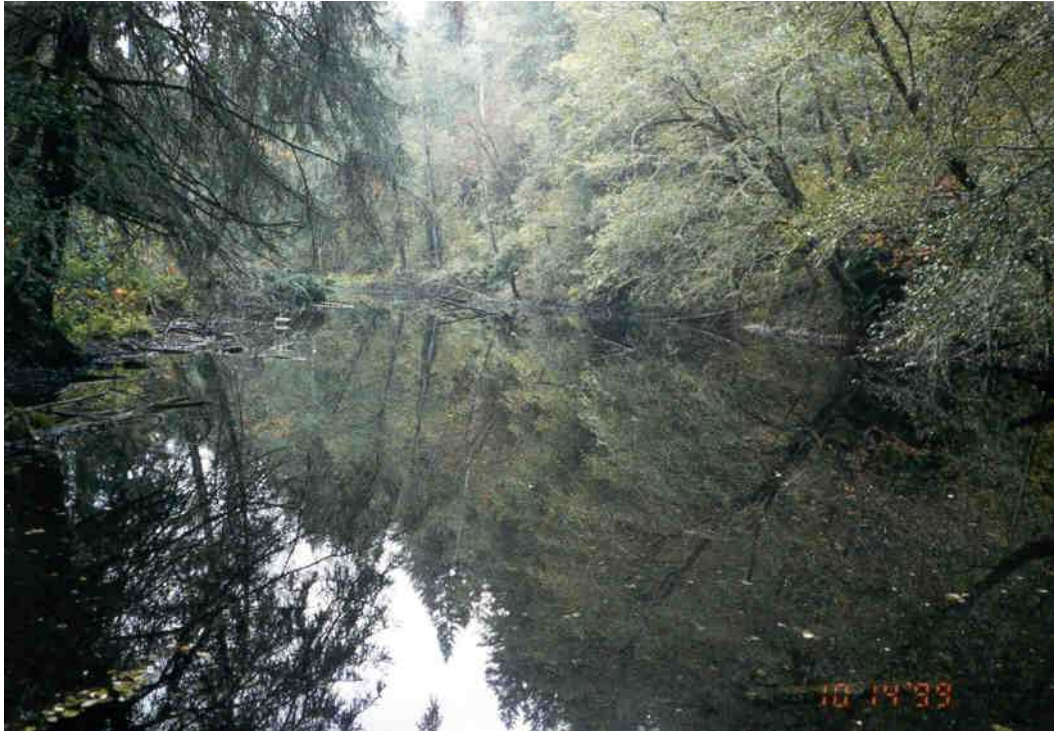
**Figure 4: View of oxbow taken in 1999.**  
 (Image obtained from CD in King County CPOSA project files.)

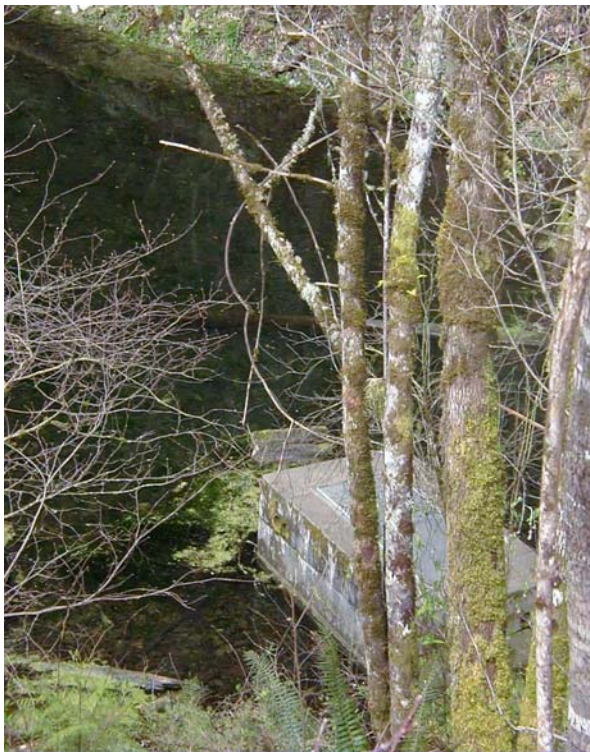
**Figure 5: View of culvert at Wetland 79 outlet from Cedar River Trail.**  
 Photo taken in Spring 2003

The fish culverts installed at the site area were reported to be periodically blocked by debris and sediments in the monitoring report. The report recommended regular monitoring of culvert openings, including regular clearing prior to spawning season. Improvements to the culverts were suggested in the 1999 monitoring report:

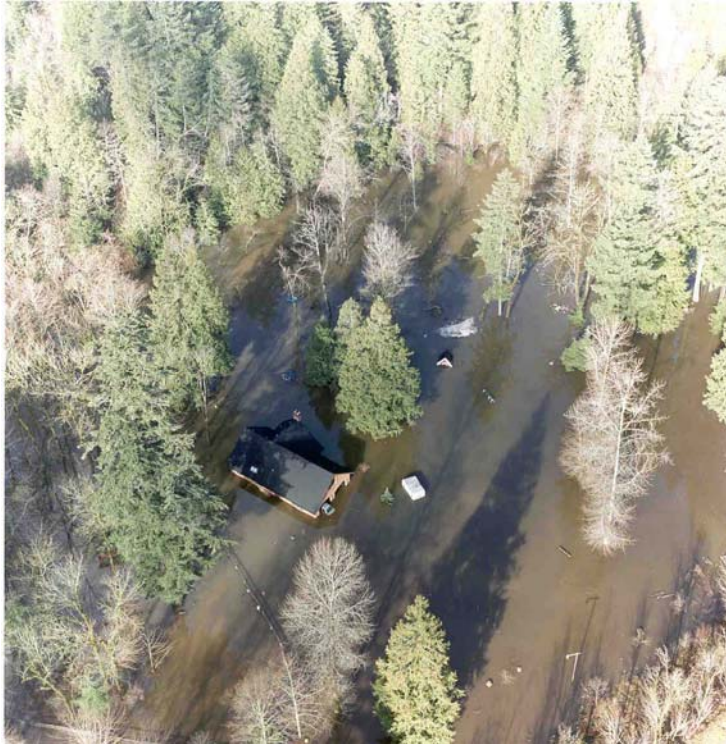
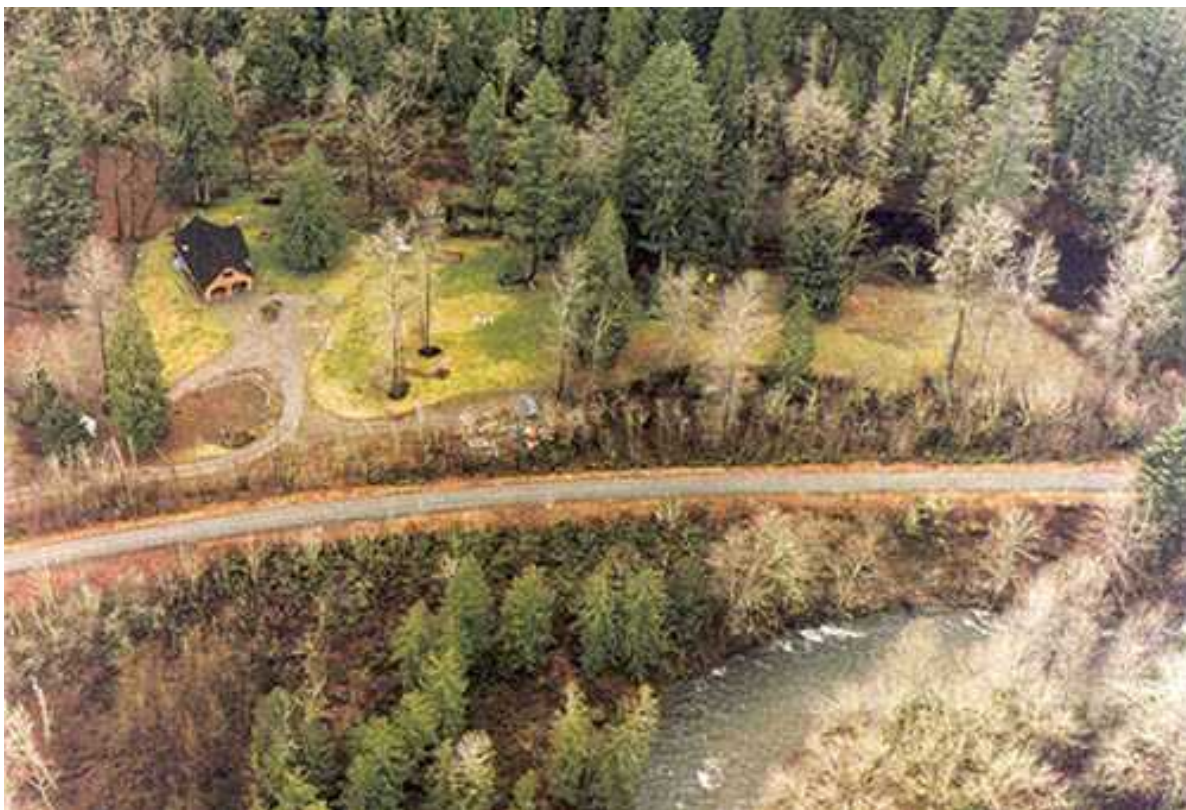
**Figure 6. Flooding at site before acquisition.**

Top photograph depicts flooding at site during early 1996. For purposes of orientation, same structure is visible in aerial view below taken when water has subsided, which provides view of site from air facing west. (Images obtained from CD in King County CPOSA project files.)

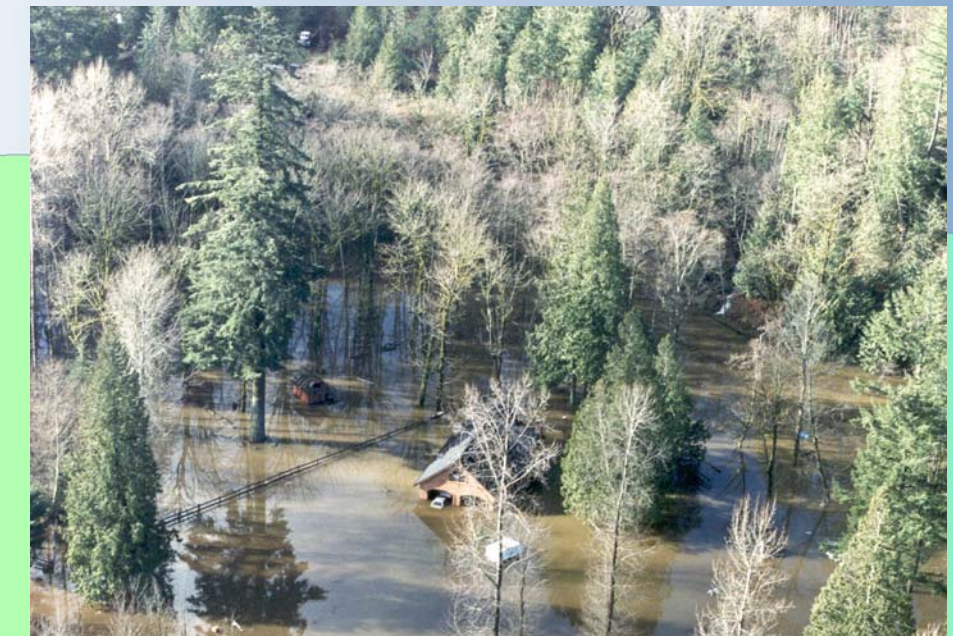
In July of 1999 a repeatedly flood damaged home was purchased and removed.

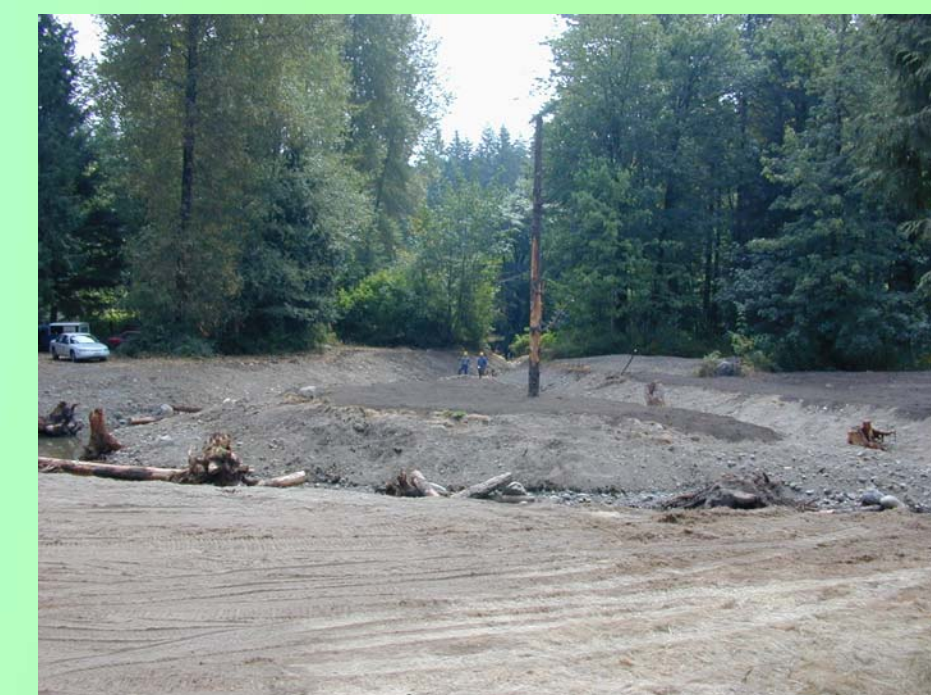
Then a plan to restore the wetland was created. In August of 2000, restoration of the wetland began.

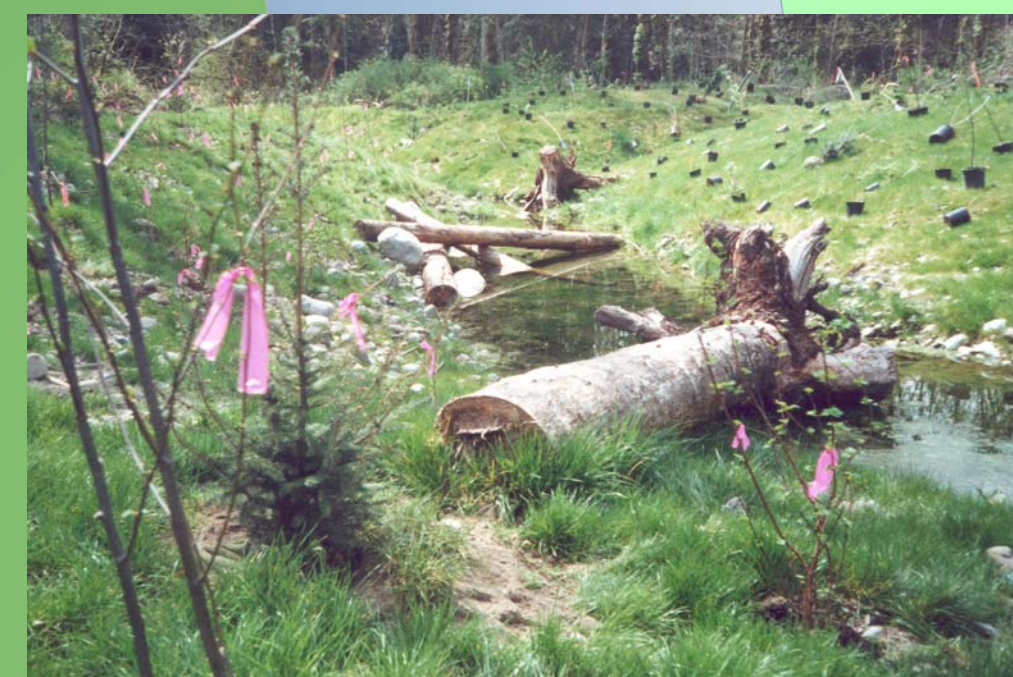
During the Fall of 2000 almost two thousand trees and twentyfive hundred shrubs were planted to help restore this oxbow ecosystem.
