PNNL-15678-5

Fifth Annual Report: 2008 Pre- Construction Eelgrass Monitoring and Propagation for King County Outfall Mitigation

Prepared for
King County Department of Natural Resources and Parks
Wastewater Treatment Division, Brightwater Project
Under a Related Services Agreement
With the U.S. Department of Energy
Contract DE-AC05-76RL01830

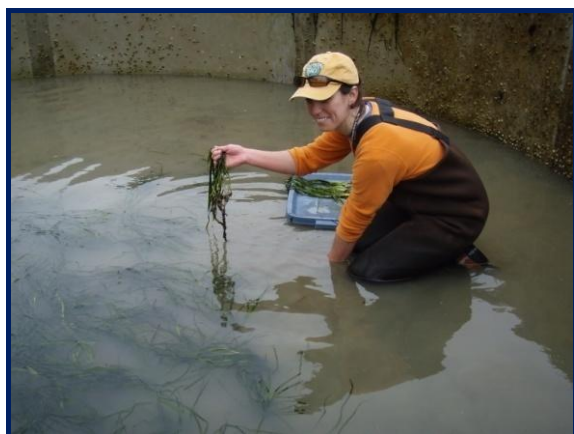
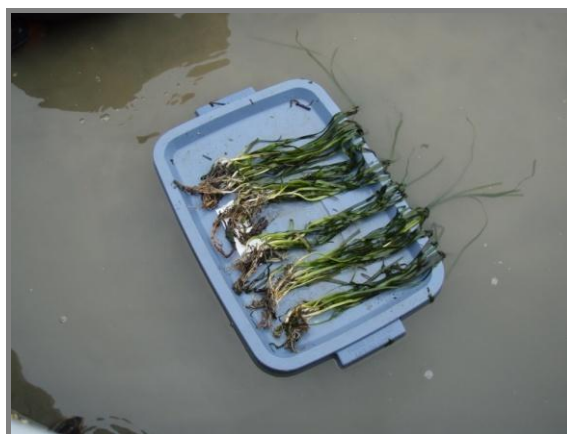
Figure 7. Transplanting eelgrass into MSL propagation tanks in May 2008 (left), and bundled eelgrass shoots ready for transplanting (right).

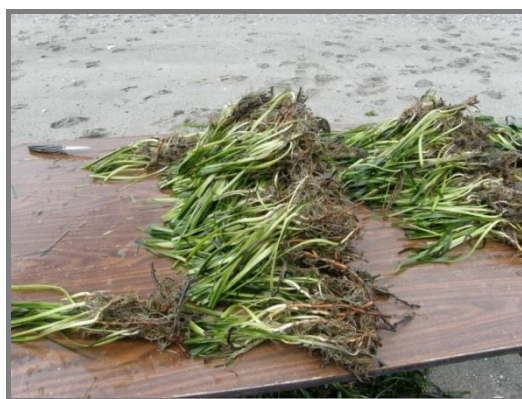
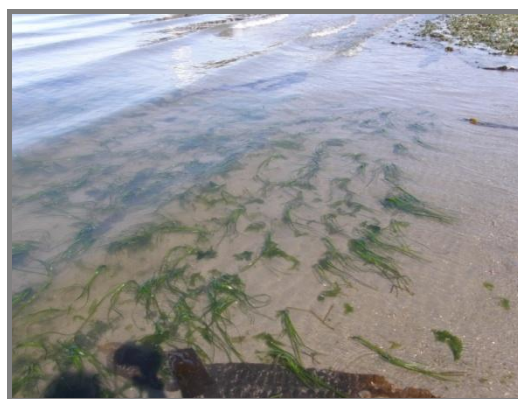
Figure 8. Eelgrass ready for transplant at Marine Outfall Corridor, May 2009 (left), and recently transplanted in the Outfall Corridor, June 2009 (right).

Between July 2008 and mid-October 2008, construction activities below mean high water in the Marine Outfall Corridor, included the following components; shoring, trenching, placing the outfall pipes, backfilling the trenched area, and removal of shoring. To replicate pre-construction habitat conditions as closely as possible, the uppermost layer of substrate in the corridor was stockpiled separately during construction and returned after construction to the site. Eelgrass plants were returned to the site approximately seven months after construction early in the growing season to allow establishment of a healthy root system and to store energy for the following winter. On May 18th, 2009, approximately 16,000 eelgrass shoots were harvested using the bare-root method described above from the MSL propagation tanks. The leaves were trimmed to approximately 30 cm to facilitate handling and planting (Figure 8). Shoots were packed in coolers filled with seawater and transported to the outfall site where they were transplanted by Grette Associates divers. A portion of the shoots will remain at the MSL in reserve during the first year, and used as needed to fulfill the restoration guidelines outlined in the *Implementation Plan* (King County, 2008).
