The WRIA 9 Marine Shoreline Monitoring and Compliance Project Phase 2 Final Report

January 2019

King County

Department of Natural Resources and Parks
Water and Land Resources Division

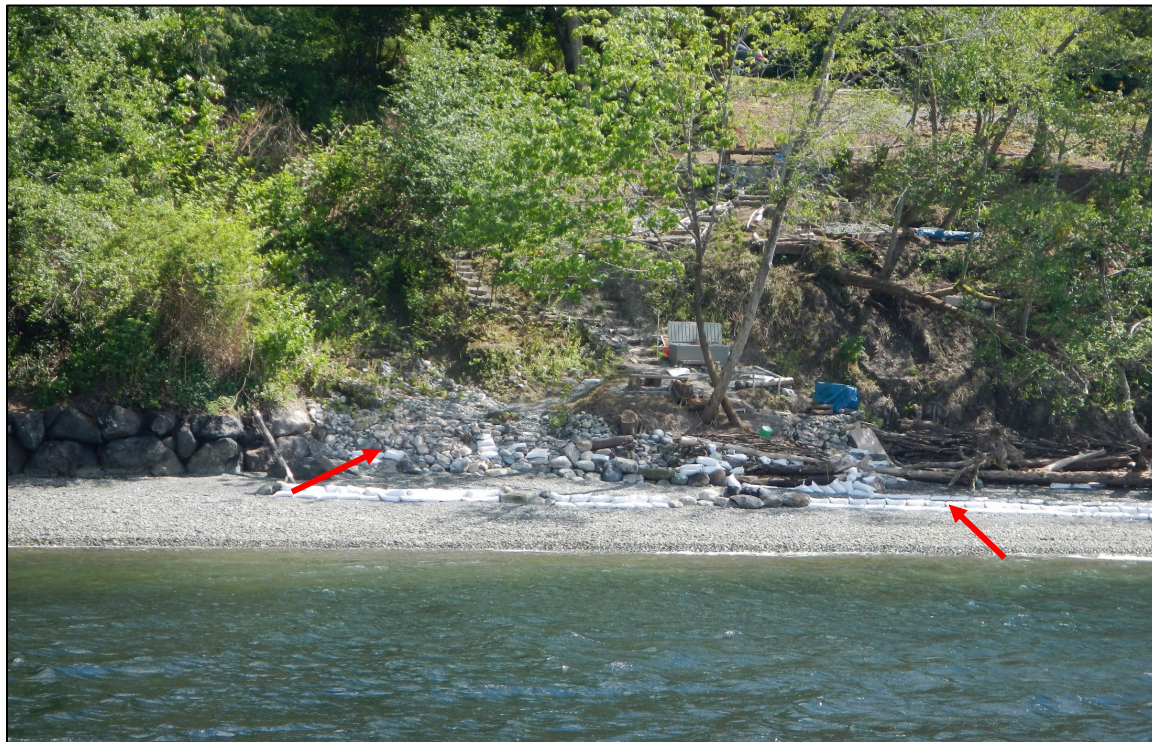
Figure 4. Vegetation clearing and two different bulkheads in the process of construction, arrows indicate one at the toe of slope and the other made of sandbags built in upper intertidal.

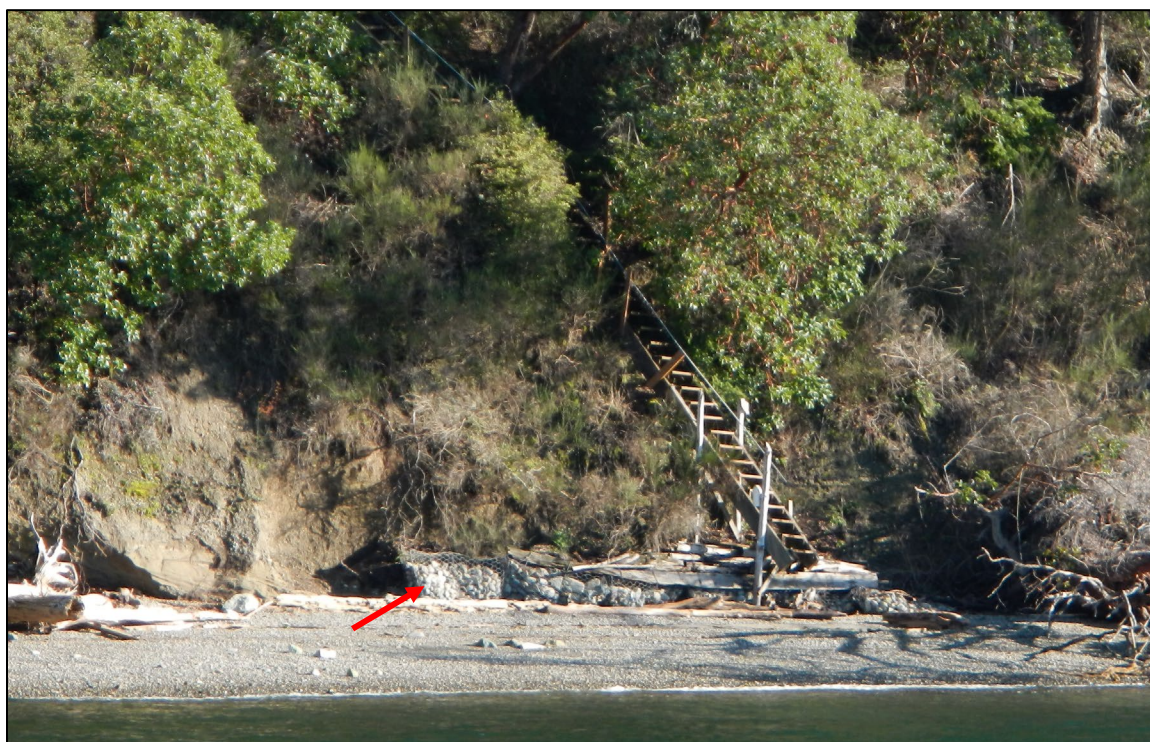
Two of the other new bulkheads will likely affect the amount of sediment reaching the beach over the long term, but not necessarily in the short term. This assumption is based

on the fact that these bulkheads were installed in front of transition zone shoreforms in unincorporated King County (Table 4 and Figure 5). Transition zone shoreforms are characterized as relatively stable bluffs that appear to be in equilibrium with the beach environment and do not currently contribute much sediment to the beach system (Johannessen et al. 2005). With the predicted rates of sea level rise in Central Puget Sound (Miller et al. 2018), it is expected that transition zone shoreforms will eventually become active feeder bluffs, thus the new bulkheads would likely affect the long-term sediment contributions to the beach. There was no documented forage fish spawning habitat on the beaches at these two locations, though as is typical in many parts of King County, forage fish spawner surveys have not been comprehensive and have been relatively sporadic in time and space over the last 30 years.

Figure 5. A new small rock filled gabion basket bulkhead associated with stairs in front of a transition zone shoreform indicated by the arrow.

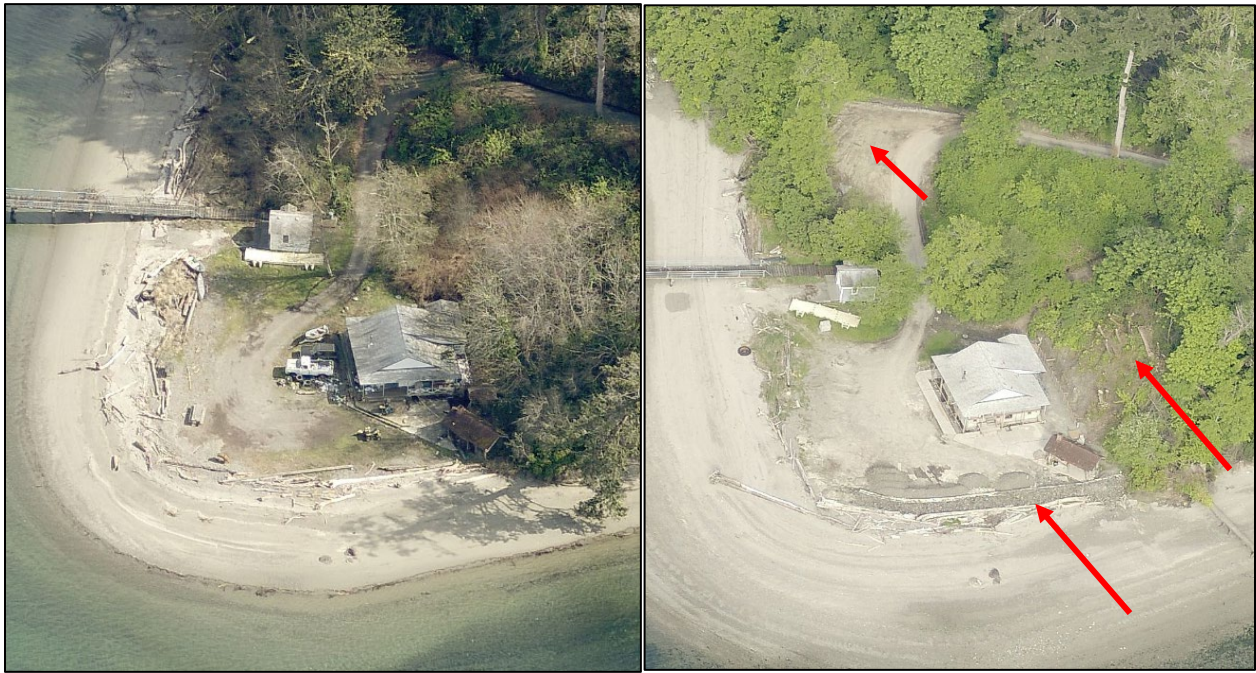
The remaining two new bulkheads were built on accretion shoreforms. These are generally areas where beach sediment is accumulating (Table 4 and Figure 6). Neither of these two locations were known to have forage fish spawning occurring on the beach, though as previously noted, spawner surveys have not been comprehensive within King County.

Figure 6. Aerial photographs of 2015 condition on the left and on the right new shoreline armoring in construction in the foreground (indicated by lowest arrow) on an accretion shoreform and vegetation clearing in 2017 right, indicated by the two upper arrows.

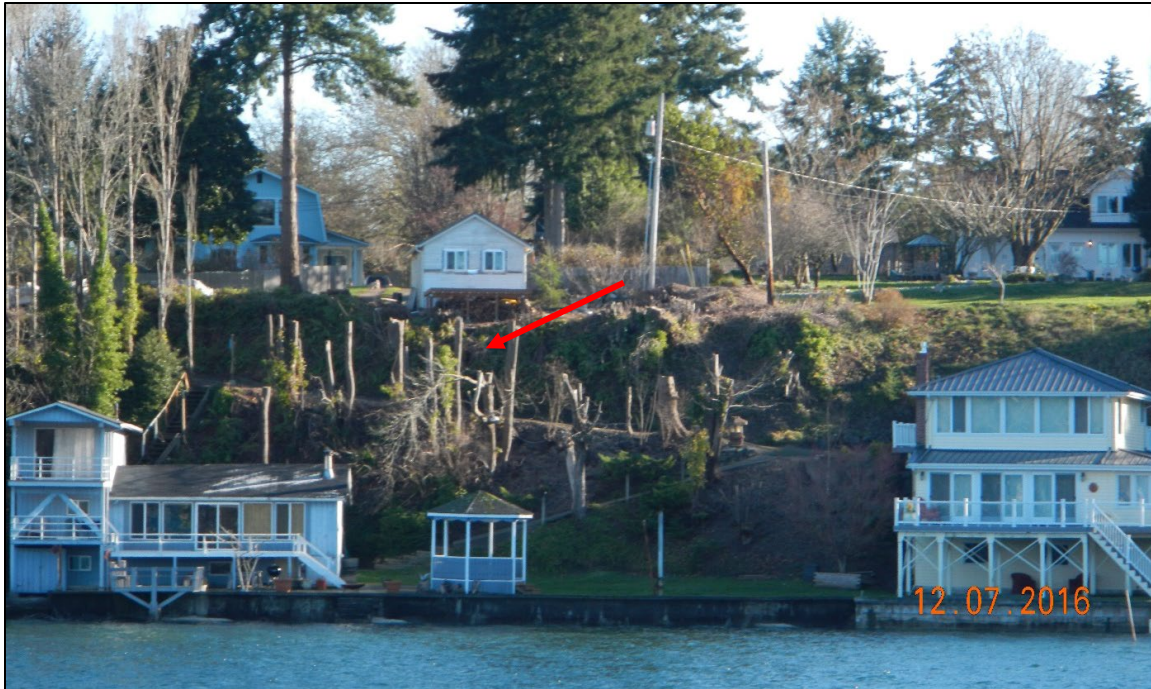
Figure 7. Clearing that took place in a King County road right of way, indicated by arrow.

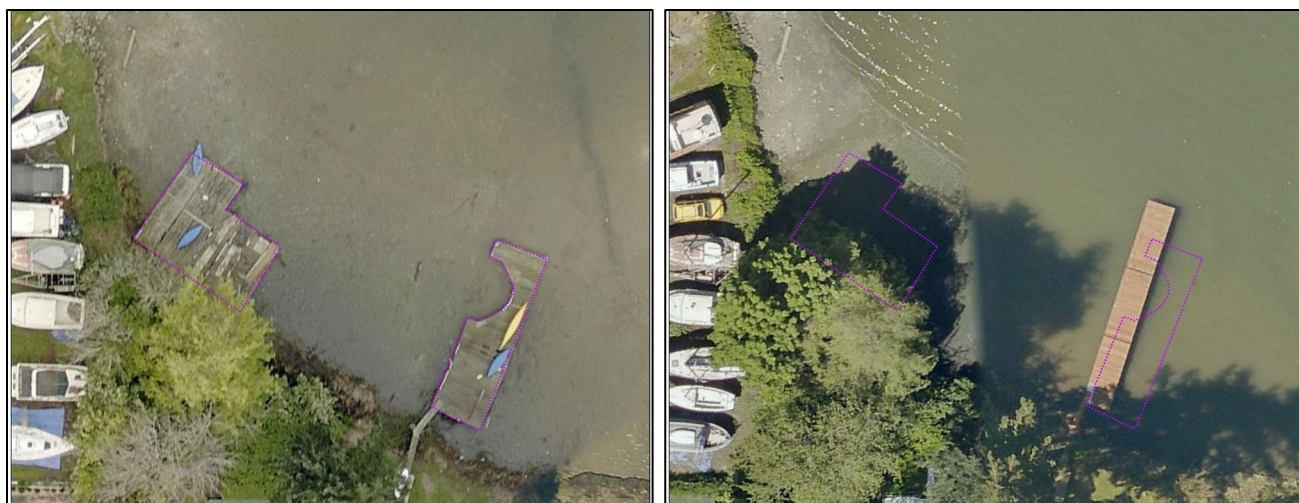
Docks and overwater structures primarily affect changes in light transmission and wave energy, but can have many of the same effects of bulkheads if they are not already associated with existing shoreline armoring. In 2016, there were two changes associated with overwater structures and both were encountered in unincorporated King County and were relatively small in size (Table 2). The changes were very minor modifications that barely extended out into the intertidal zone, so that they are unlikely to have a large negative ecological effect. In both cases, structures appeared to have been created on top of derelict pilings that had not had an overwater structure present for a long time. In 2018, there was an increase in the number of changes associated with overwater structures, with nine changes encountered (Table 2), all on Vashon and Maury Islands. The changes were a mixture of relatively minor repairs or reconfigurations of the docks along with several small new overwater structures (Figure 8).

Figure 8. Largest change in docks during the study period. On the left is the 2015 condition with the docks traced in purple. On the right is the modified condition in the 2017 with the purple tracing showing the location of the docks in 2015.
