Stressor Identification and Recommended Actions for Restoring and Protecting Select Puget Lowland Stream Basins

December 2019

King County

Department of Natural Resources and Parks
Water and Land Resources Division

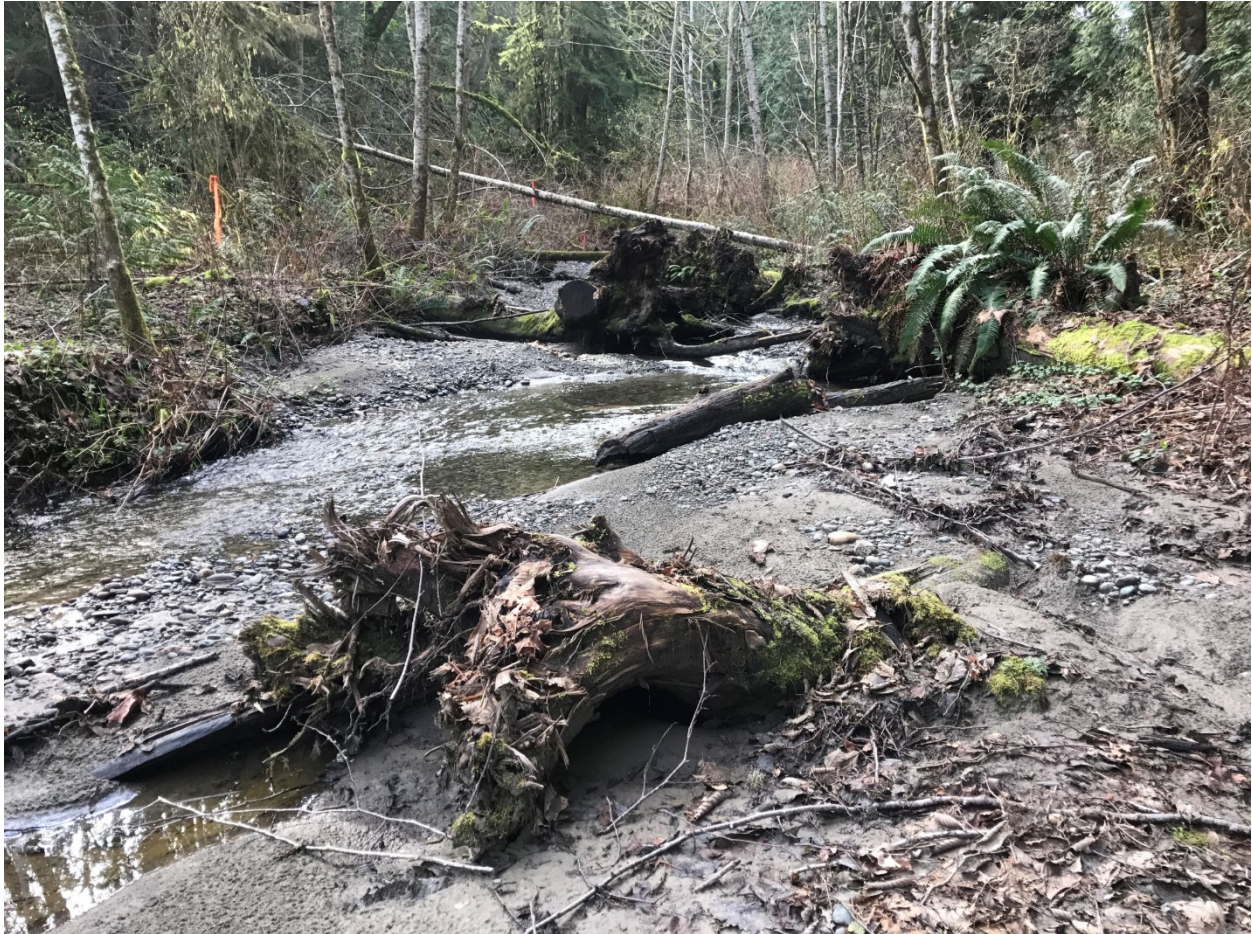
Figure 11. Gravel and sand deposits embedding placed logs in Illahee Creek (2/13/2018).

Despite these efforts, habitat conditions remained unstable. Landowners adjacent to the B-IBI site report that large storms in 2007 mobilized huge volumes of sediment and nearly filled the new culvert, threatening to block fish passage. Placed logs were embedded by gravel and sand (Figure 11), and the floodplain aggraded nearly one meter according to the landowner (J. Krigsman, personal communication).
