**Duwamish/Diagonal CSO/SD Sediment Remediation Project
Closure Report**

**Prepared for:
King County Department of Natural Resources and Parks
Elliott Bay/Duwamish Restoration Program Panel**

**Prepared by:
The EcoChem Team
EcoChem, Inc.
Anchor Environmental, L.L.C.**

Panel Publication 39

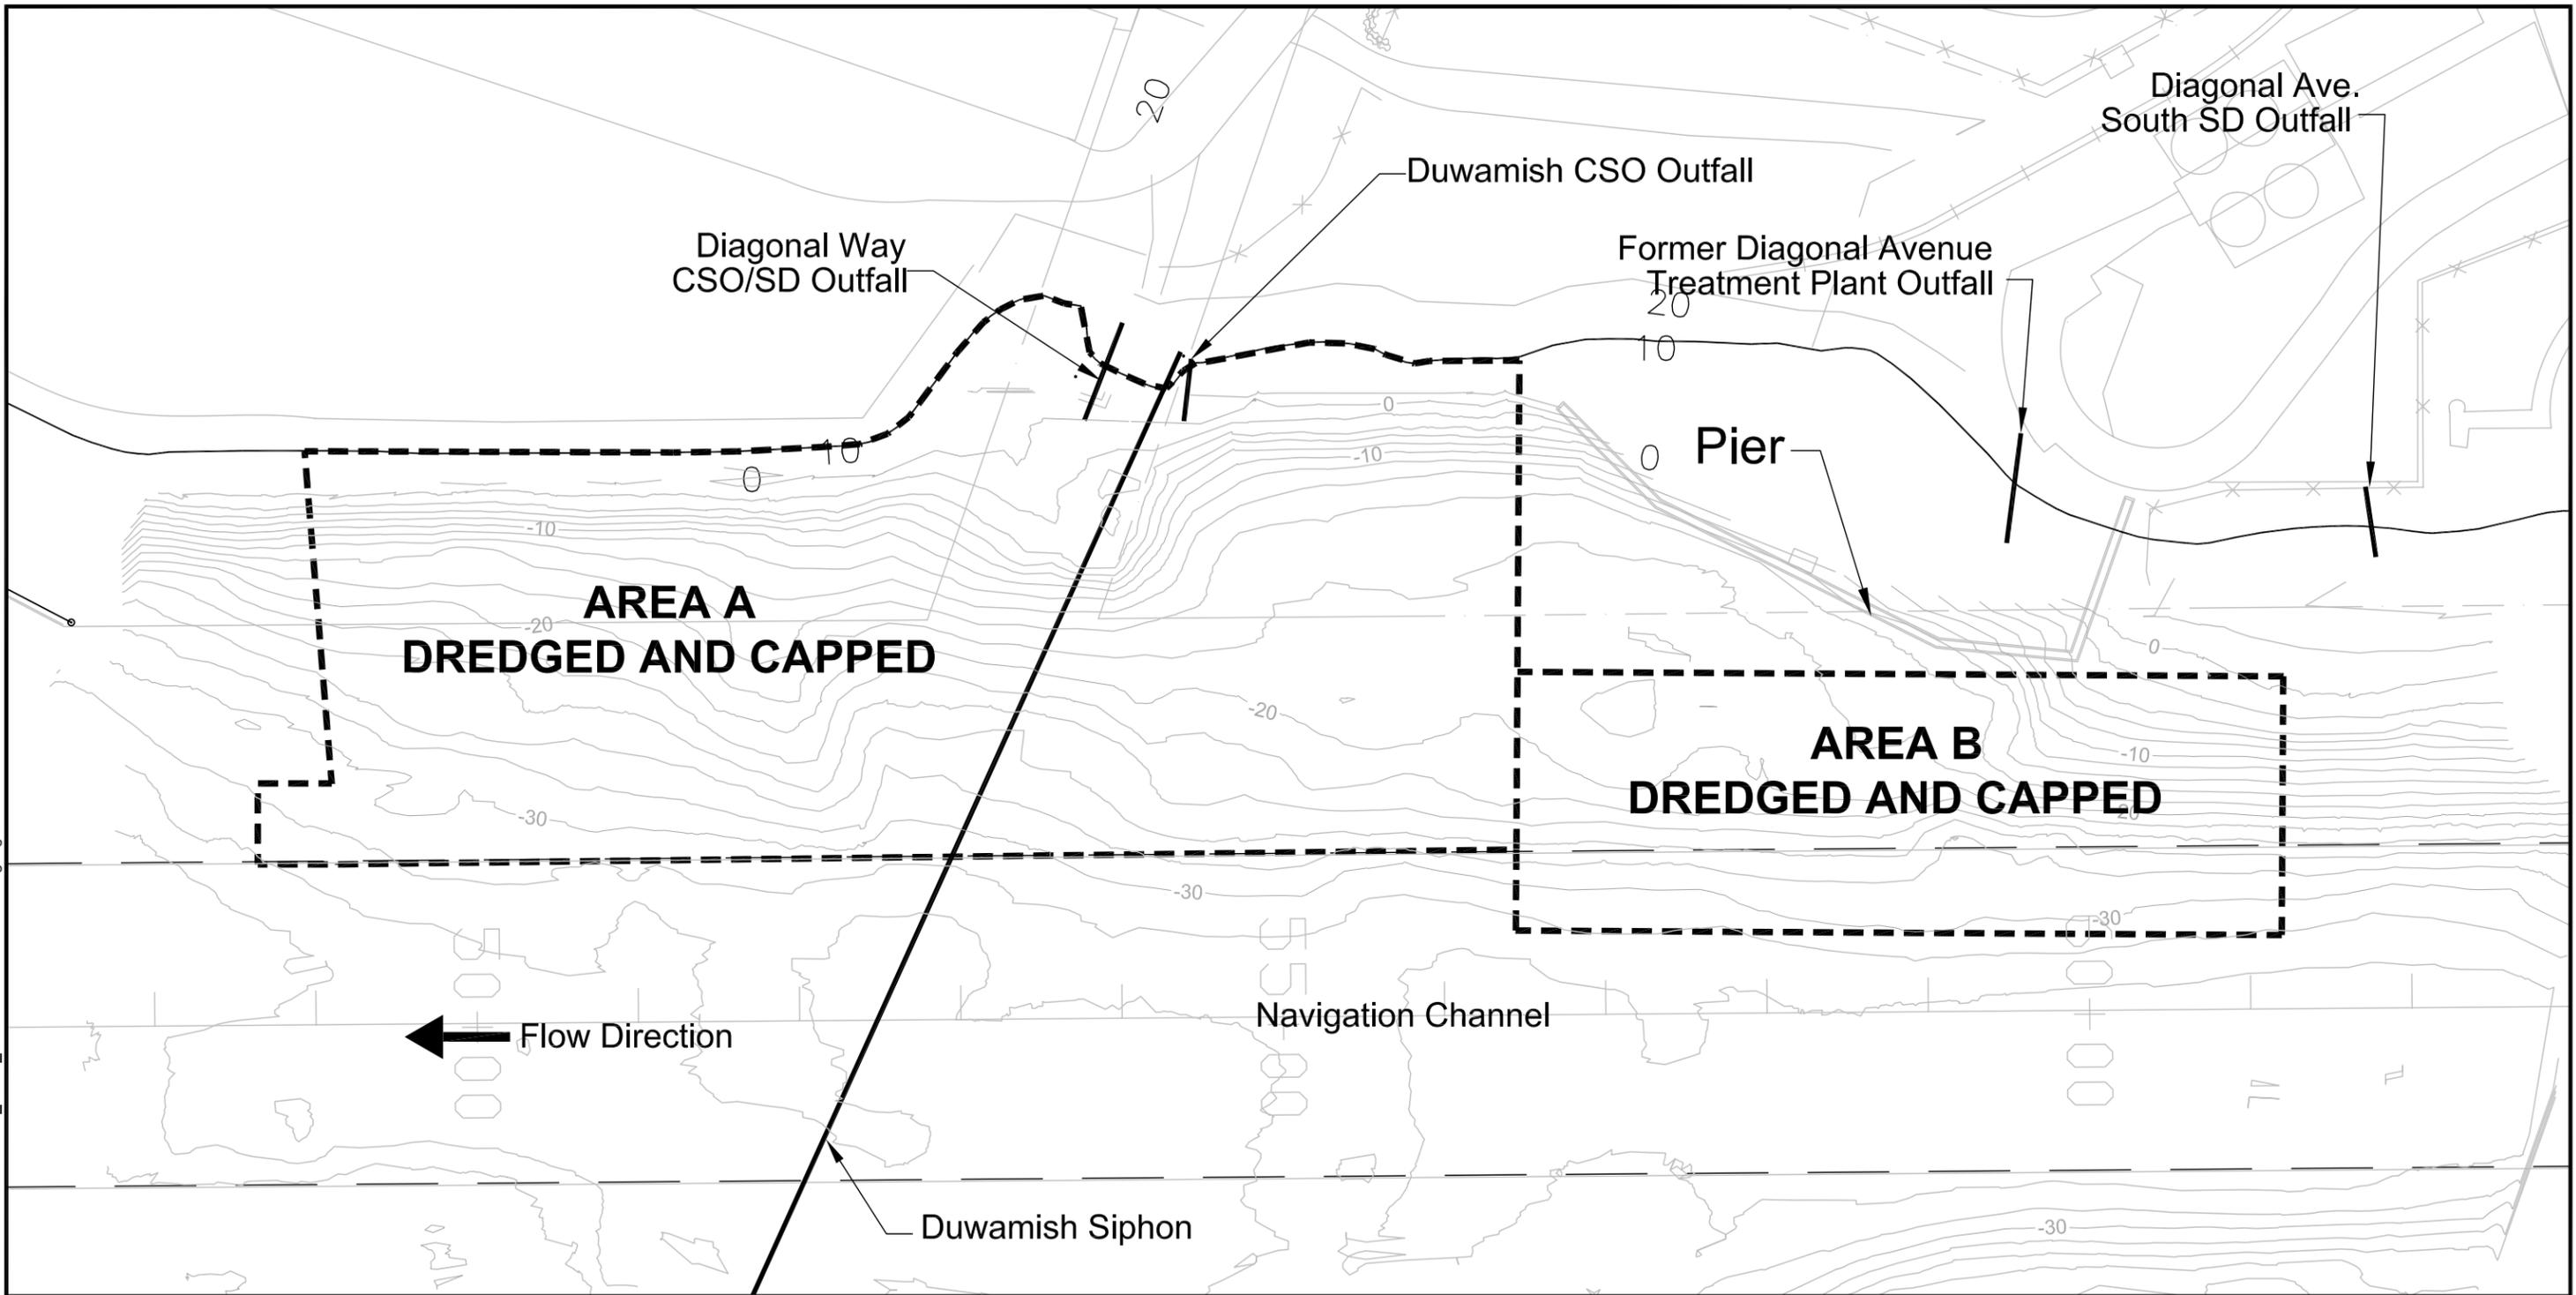
Figure 2

The objective of the project was to remediate contaminated sediment in a 5-acre rectangle (Area A) and a 2-acre rectangle (Area B), as shown in Figure 2. The extent of contaminated sediment removal for the two primary COCs, bis(2-ethylhexyl)phthalate (BEHP) and PCBs, is shown in Figures 3 and 4, respectively. Area A was the original proposed cleanup area designed to address chemicals associated with discharges from the Duwamish/Diagonal CSO/SD and remediates about 5 acres of the highest BEHP values in surface sediments. The upstream and downstream boundaries of Area A were set based on bioassay testing results, and the offshore boundary was set at the edge of the navigation channel. The 2-acre Area B addresses a historic chemical “hot spot” associated with discharges from a historic sewage treatment plant. High PCB values in these sediments represent a significant risk of recontamination to cleanup Area A if sediments in Area B were dredged at a later time. The offshore boundary of Area B extends 50 feet into the navigation channel in order to remove all of the chemical “hot spot” where PCB values exceed the Cleanup Screening Level (CSL). Areas A and B do not include all sediments above the Sediment Quality Standards (SQS) for PCBs, but all sediments that are near the Duwamish/Diagonal CSO/SD site and exceed the SQS for PCBs will be evaluated as part of the Lower Duwamish Superfund Study.

Cleanup Areas A and B Dredged and Capped

The cleanup action for Areas A and B involved first removing sufficient contaminated sediment from both cleanup areas to make room for an effective layer of cap material. Then the remaining contaminated sediments within each cleanup area were covered with a minimum of 3 feet of capping material to isolate the remaining chemicals from the environment and return the site to approximately the bottom elevations that existed prior to dredging.

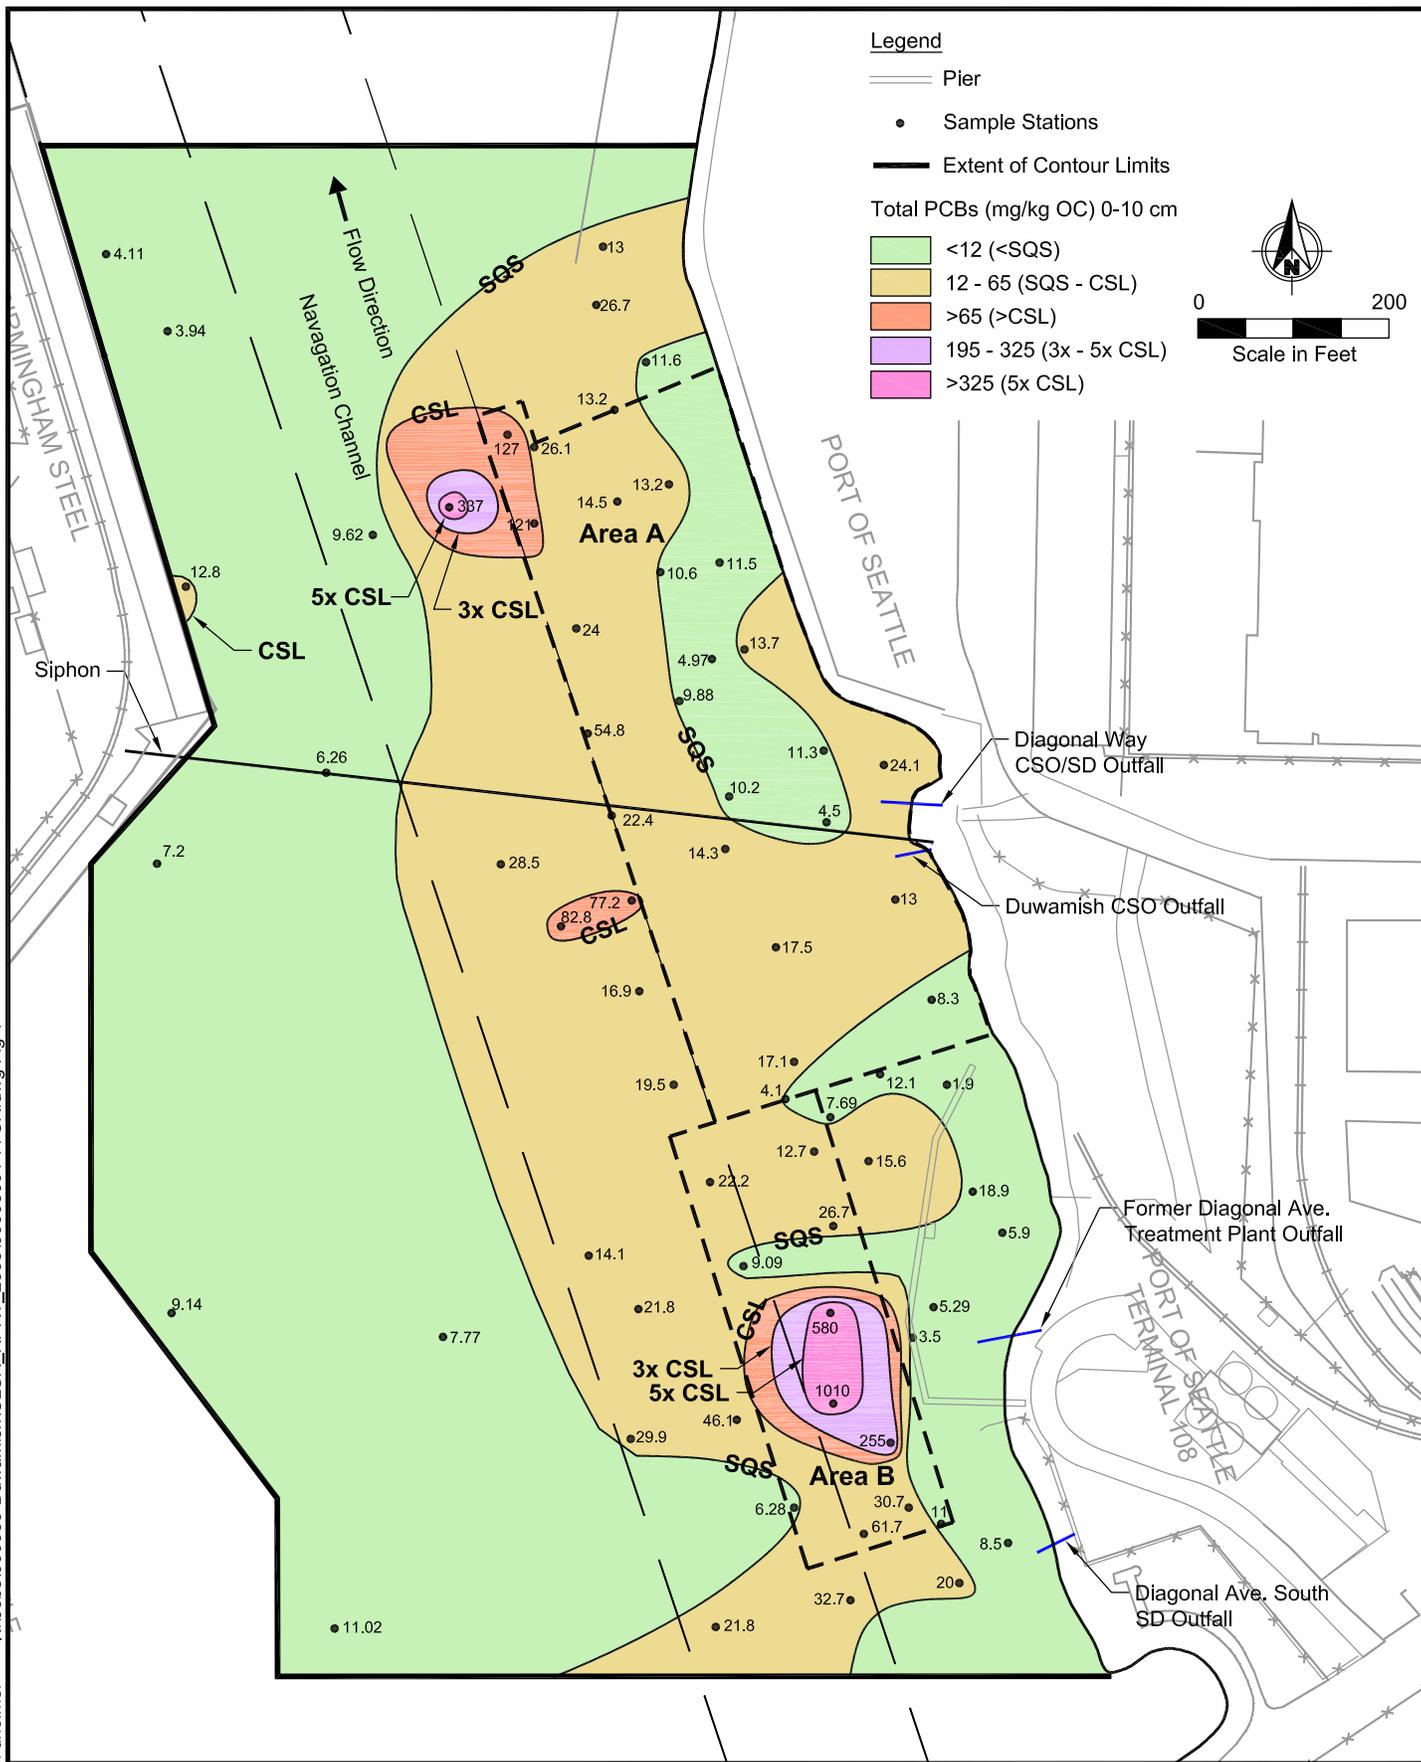
Figure 4

Total PCBs Distribution in Surface Sediment (0-10 cm)

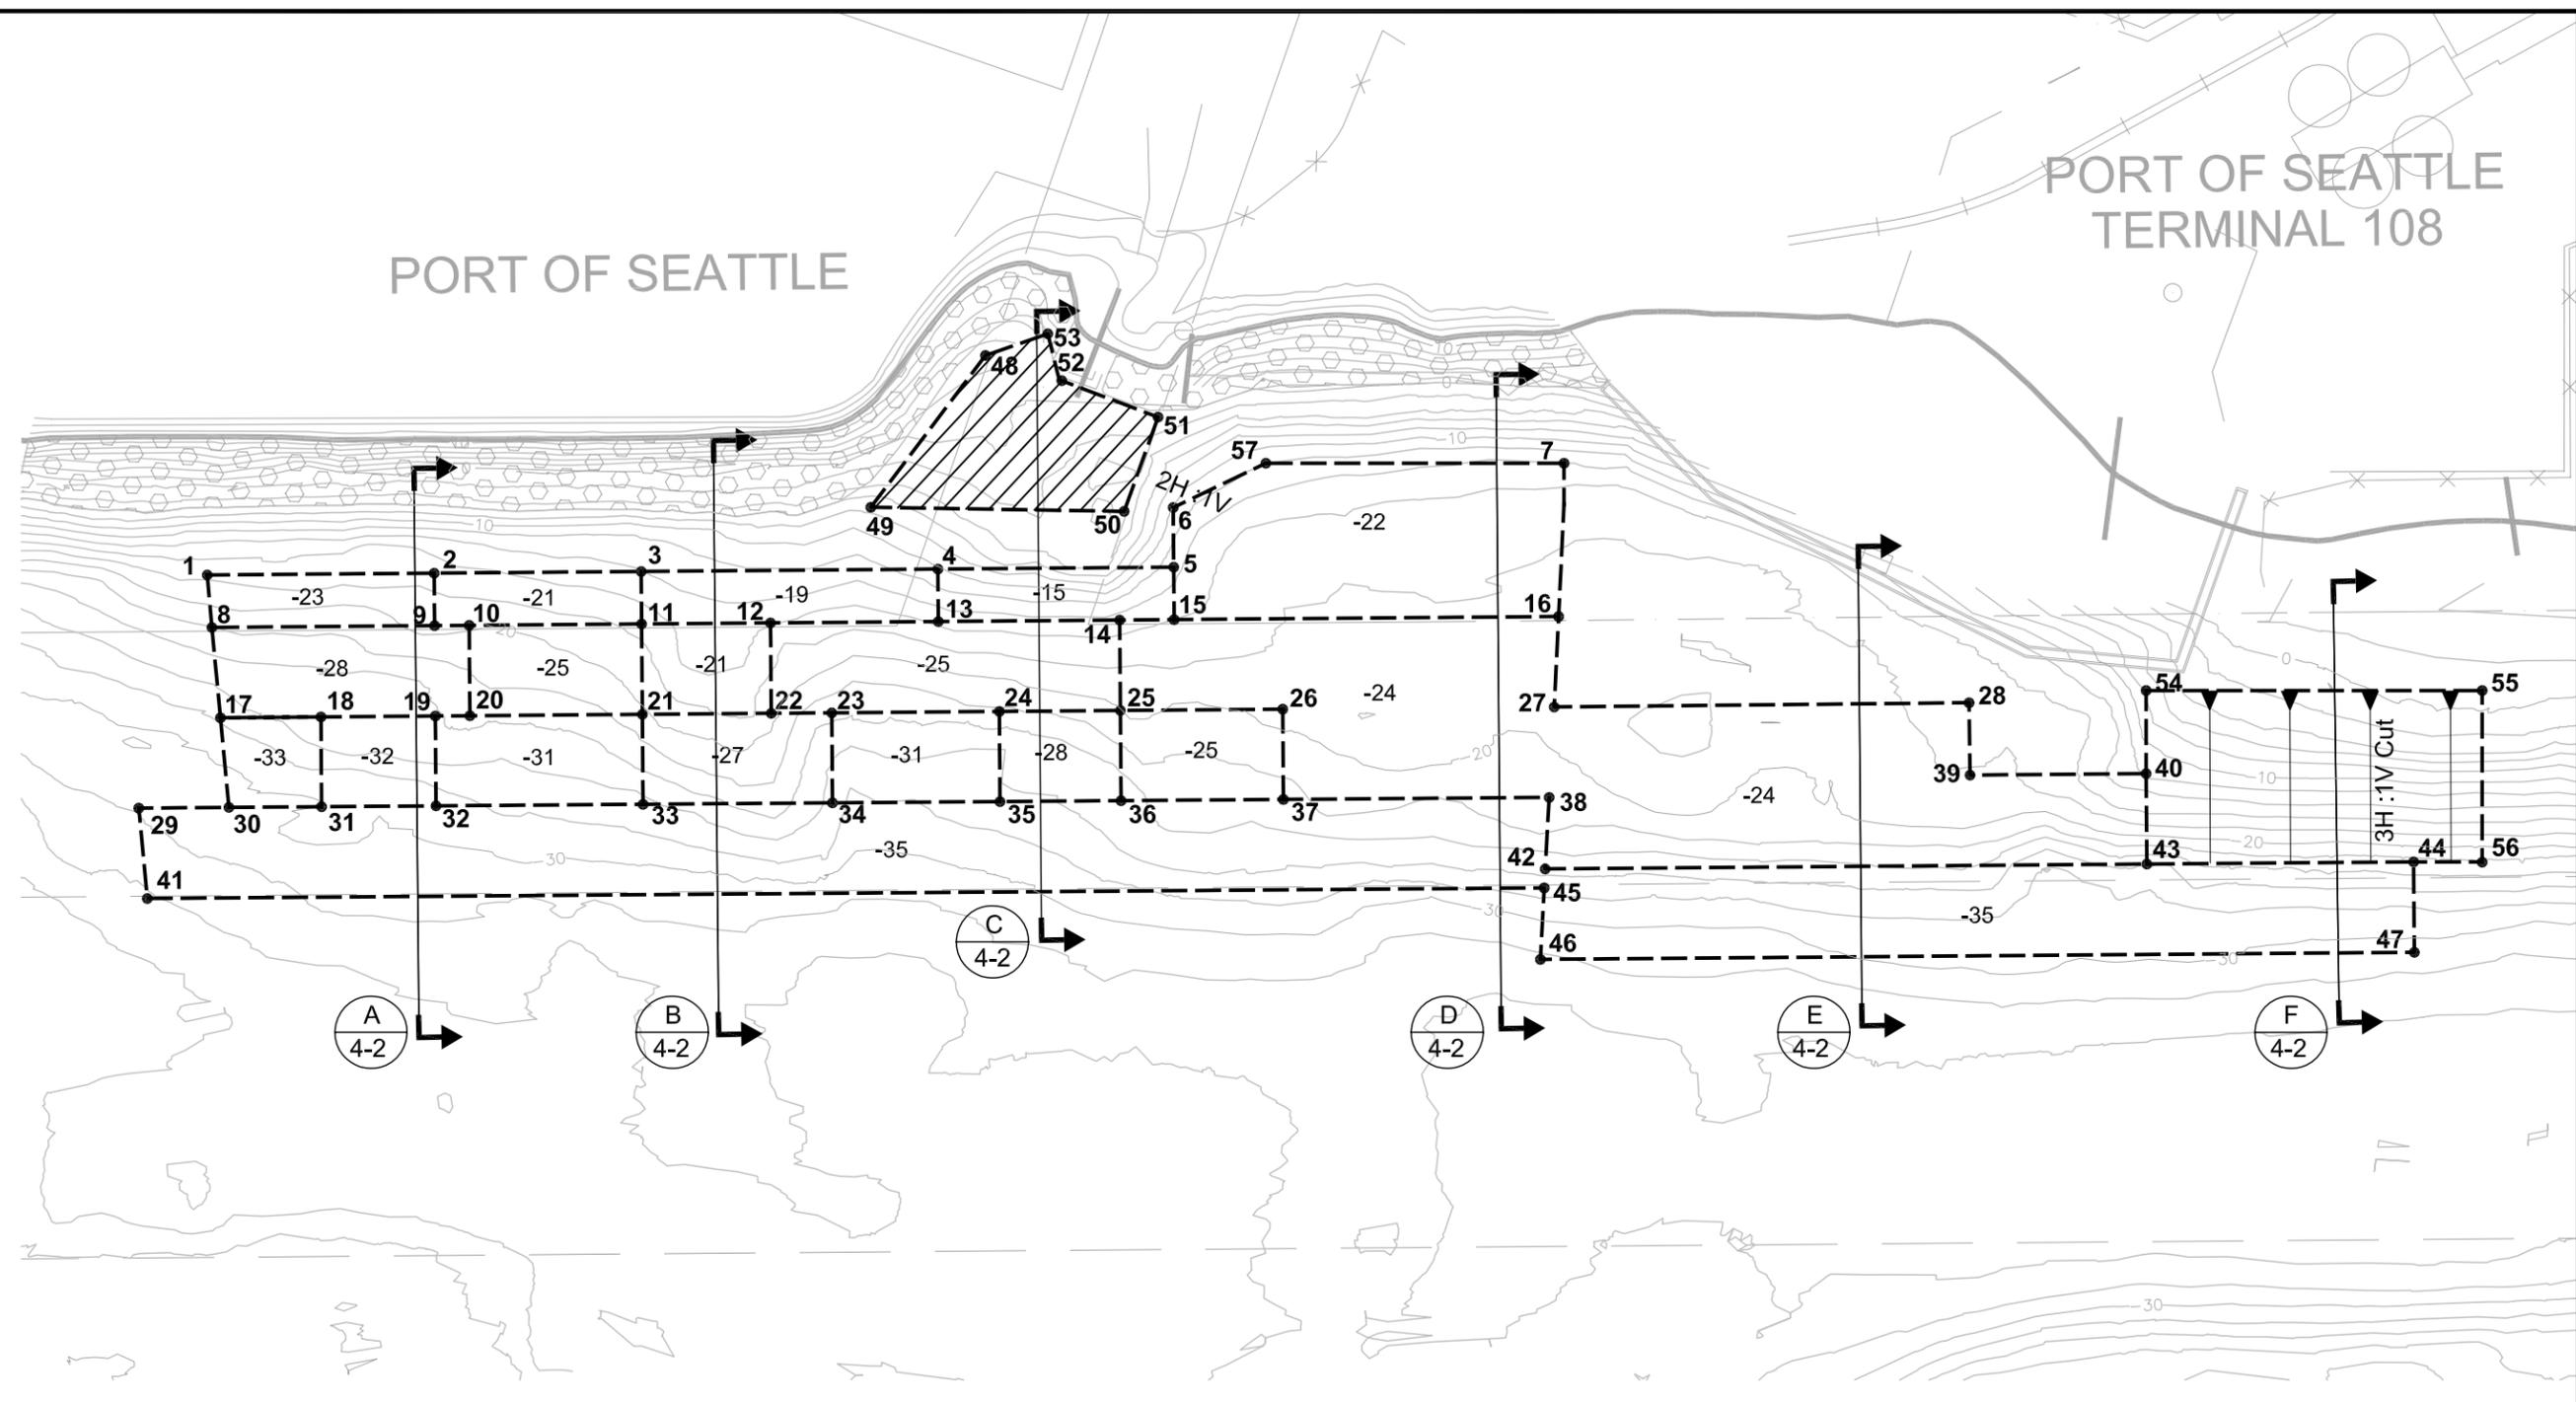
Figure 5

The dredge cut plan is shown in Figure 5. At about 2 a.m. on November 14, 2003, the contractor began dredging in Area B at the inshore part of the dredge area. Because most of the dredge area was on the side slope created when the navigation channel was dredged, the contractor worked from the shallower inshore area to the deeper offshore area to maintain slope stability. After completing the 50-foot-wide strip of Area B located within the navigation channel, dredging in Area B was substantially complete. Dredging began in Area A on December 3, 2003, and the same general procedures of working from the top of the slope to the bottom were used in Area A. The confirmatory surveys by King County's surveyor showed some high spots in Area B, so the contractor moved equipment back to the location and made the required changes. The contractor's surveys identified high spots in Area A, so equipment was moved to those locations and the required changes were performed. All dredging in Areas A and B was completed on January 20, 2004.

Dredge Cut Plan

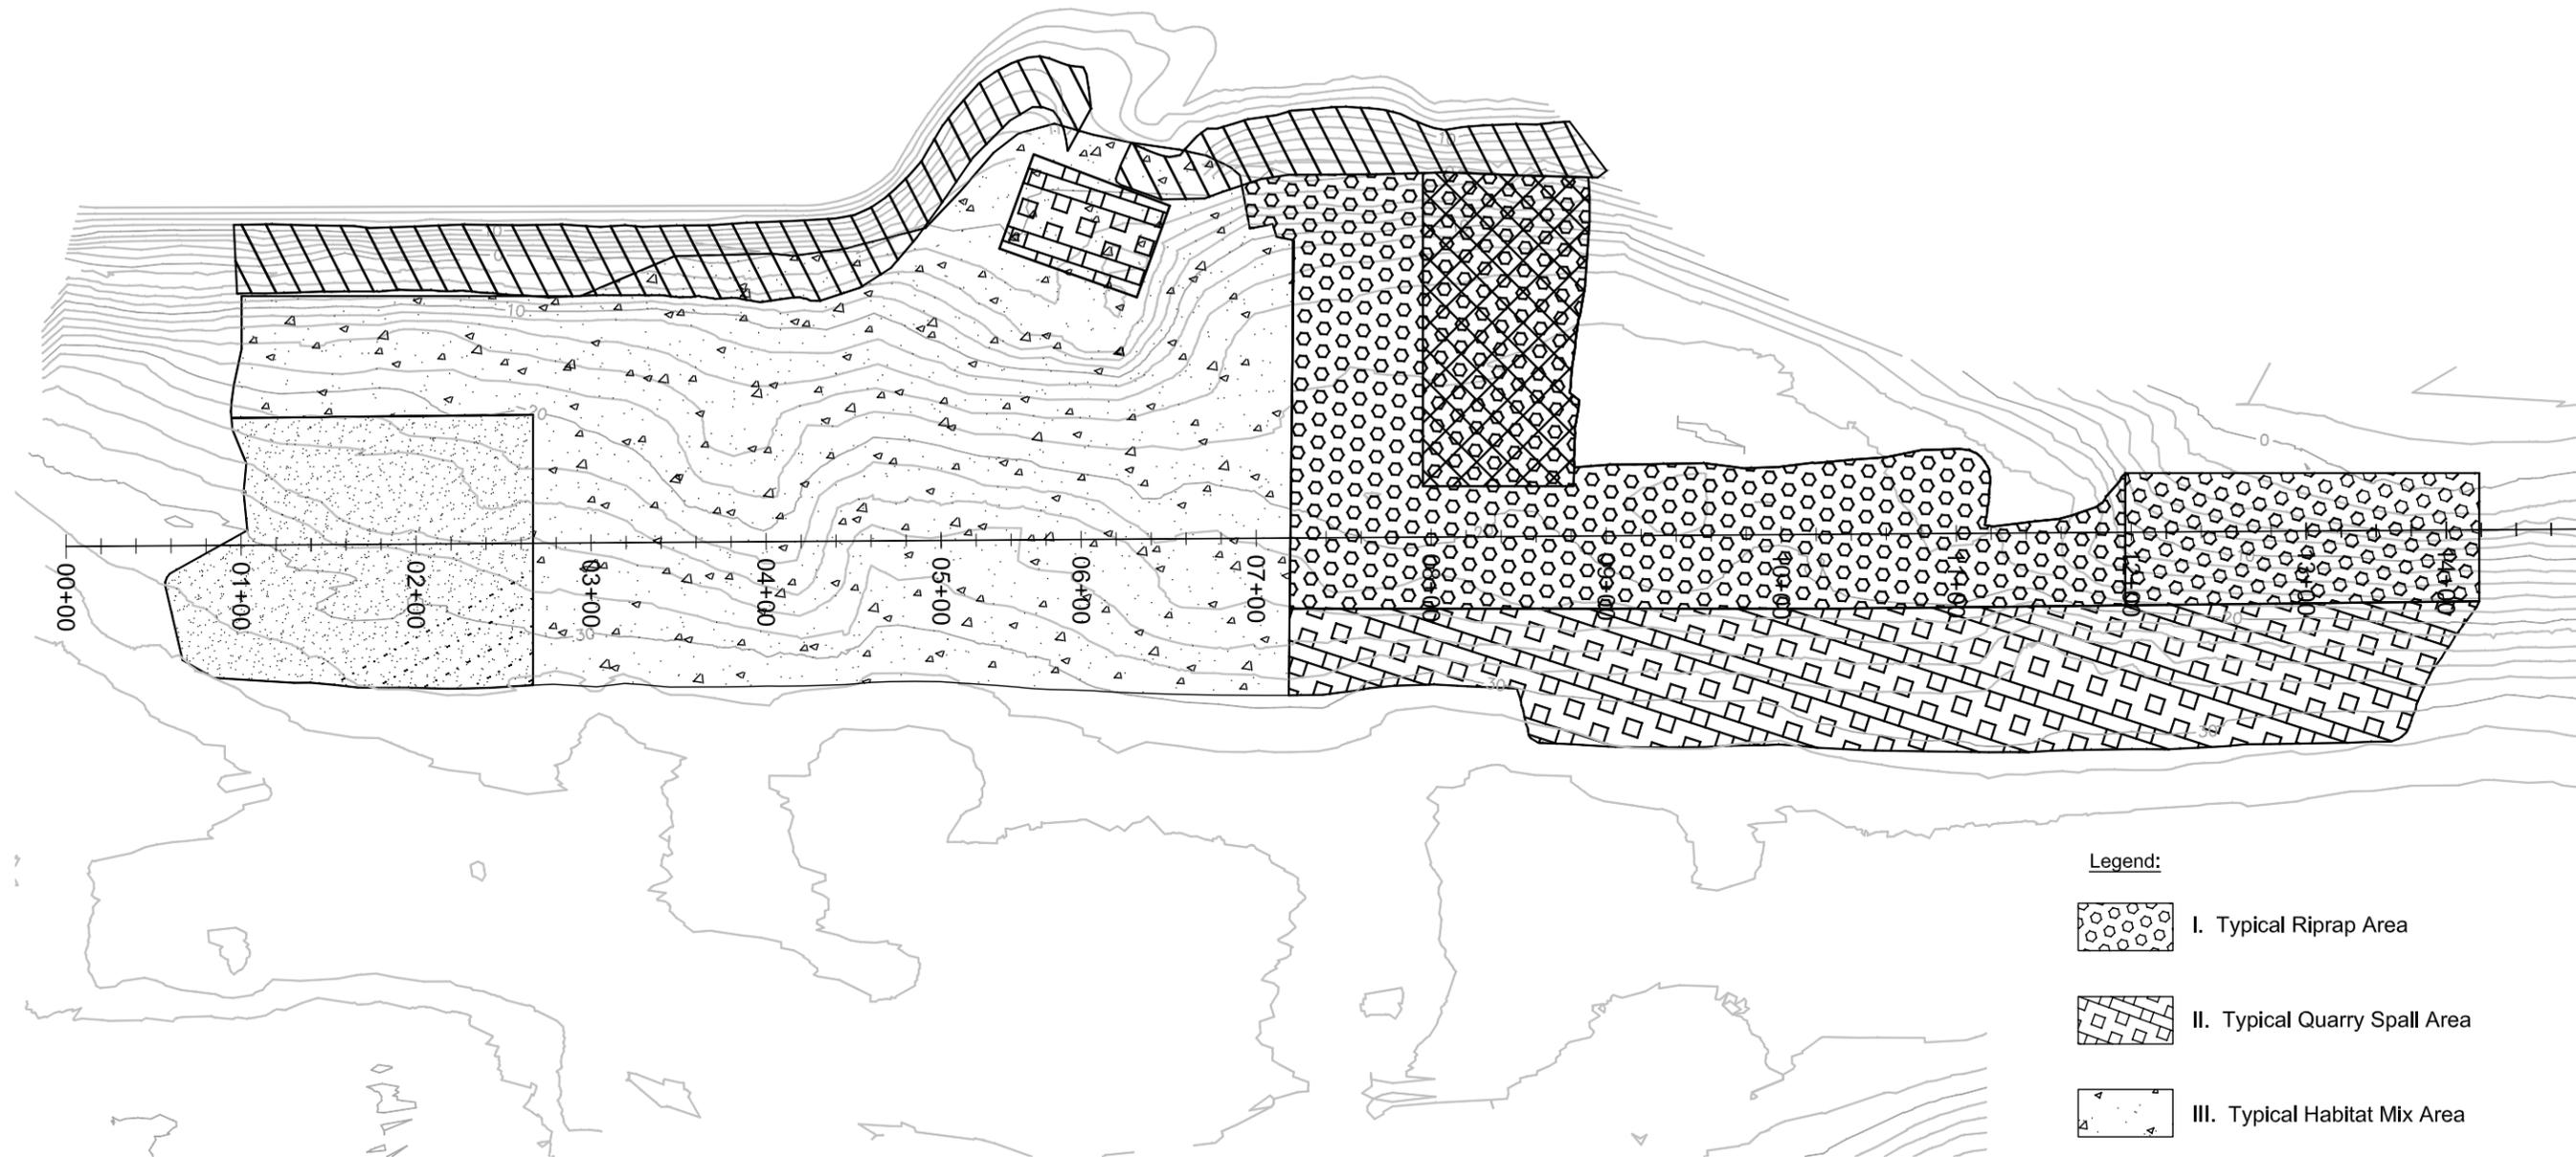
K:\Jobs\00008601-Duwamish\CLSR_RPRT_2005\00008601-79CR.dwg Fig 7
Jul 01, 2005 11:30am cdauidson

After all the dredging was complete and elevations were confirmed by the post-dredge survey, capping operations were allowed to begin. The capping plan showing armoring material is shown in Figure 7. Capping material was obtained from Canadian quarries and transported to the site by flat deck haul barges. Base cap and habitat mix materials were obtained from Lehigh Northwest – Producer’s Pit in Victoria, British Columbia (BC) and the quarry spall and riprap were obtained from Pitt River Quarries in Coquitlam, BC.

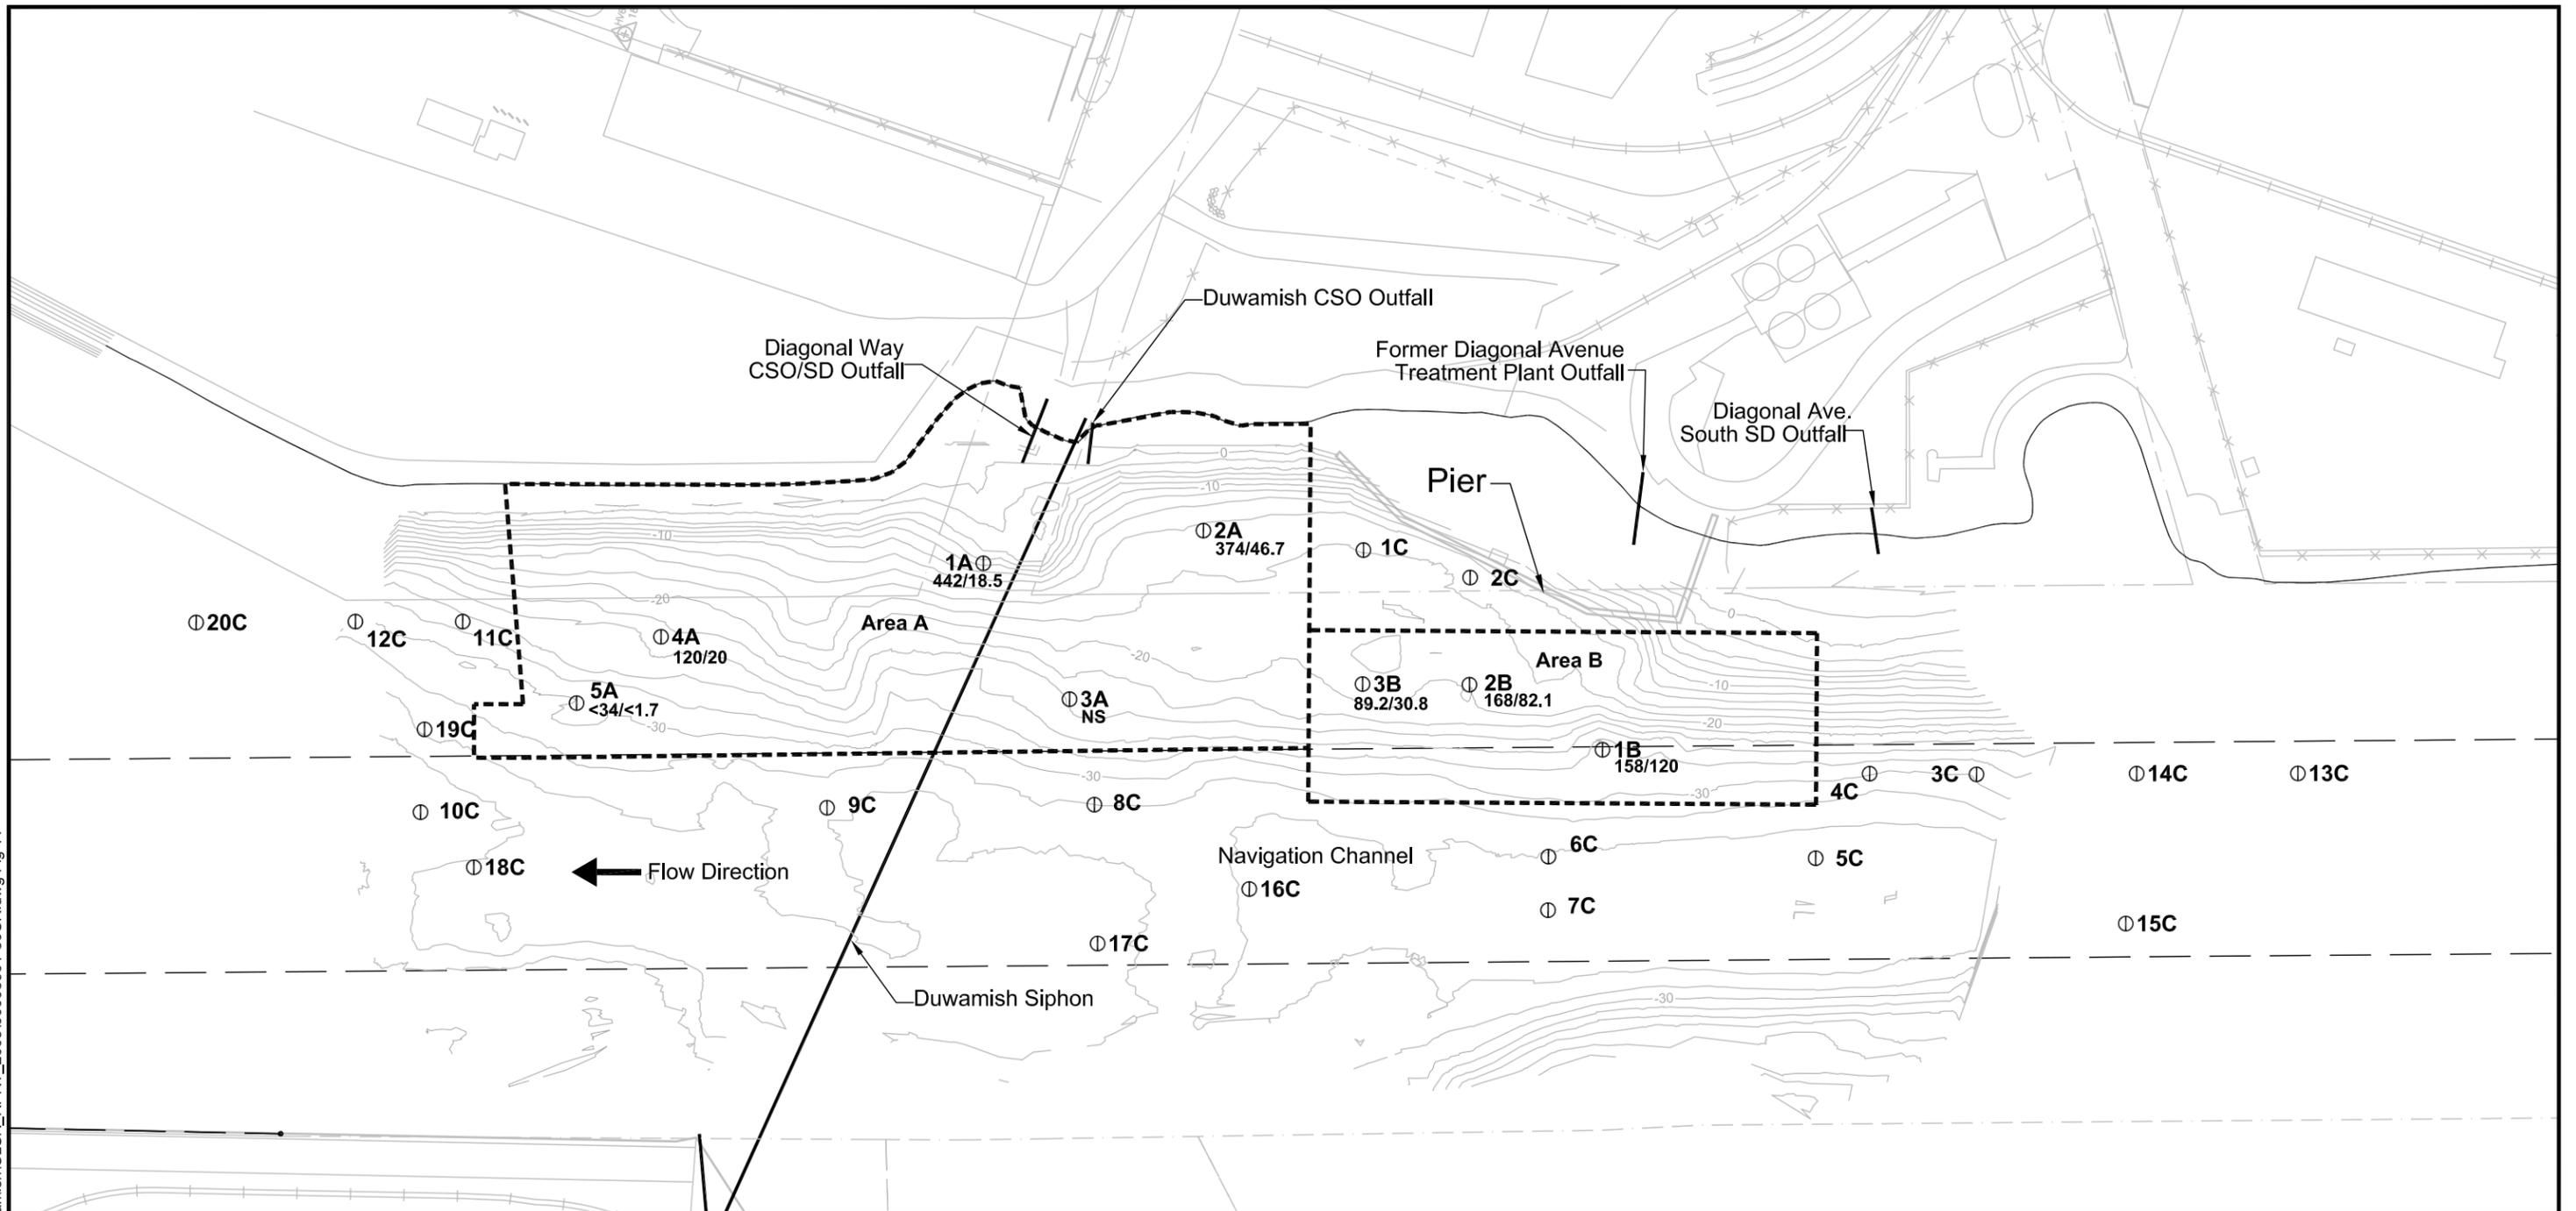
K:\Jobs\000086-Duwamish\CLSR_RPRT_2005\00008601-8OCR.dwg Fig 11
Jul 28, 2005 10:14am dholmer

Legend:
 ⊕ Sample Location
 442/18.5 Baseline Chemistry Values for Bis(2ethylhexyl)phthalate and PCBs in ppb DW
 NS No Sample Possible

Baseline samples for the cap were collected June 1, 2004, which was about 2 months after the Duwamish/Diagonal project was completed. There is no way to know whether the presence of higher baseline BEHP values in Area A and higher PCB values in Area B reflect the conditions immediately after the cap was placed or whether these values were influenced by potential input sources during the 2 months before the baseline samples were collected. The highest baseline BEHP values were at stations 1A and 2A located closest to the Diagonal CSO/SD outfall, which is suspected to be the primary input source for BEHP to the cap. The highest baseline PCB value occurred at station 1B (120 ppb), which is located approximately 100 feet inshore from where the highest post-construction PCB values were found beyond the site boundary (3,160 and 3,390 ppb in replicate samples at station 6C). Potential recontamination during the two months before collecting the baseline samples should be easier to determine when the results for the 1-year post-construction cap samples are available.¹
