**Duwamish/Diagonal Sediment Remediation Project
4-Acre Residuals Interim Action Closure Report**

**Prepared for:
King County Department of Natural Resources and Parks
Elliott Bay/Duwamish Restoration Program**

**Prepared by:
Anchor Environmental, L.L.C.**

May 2007

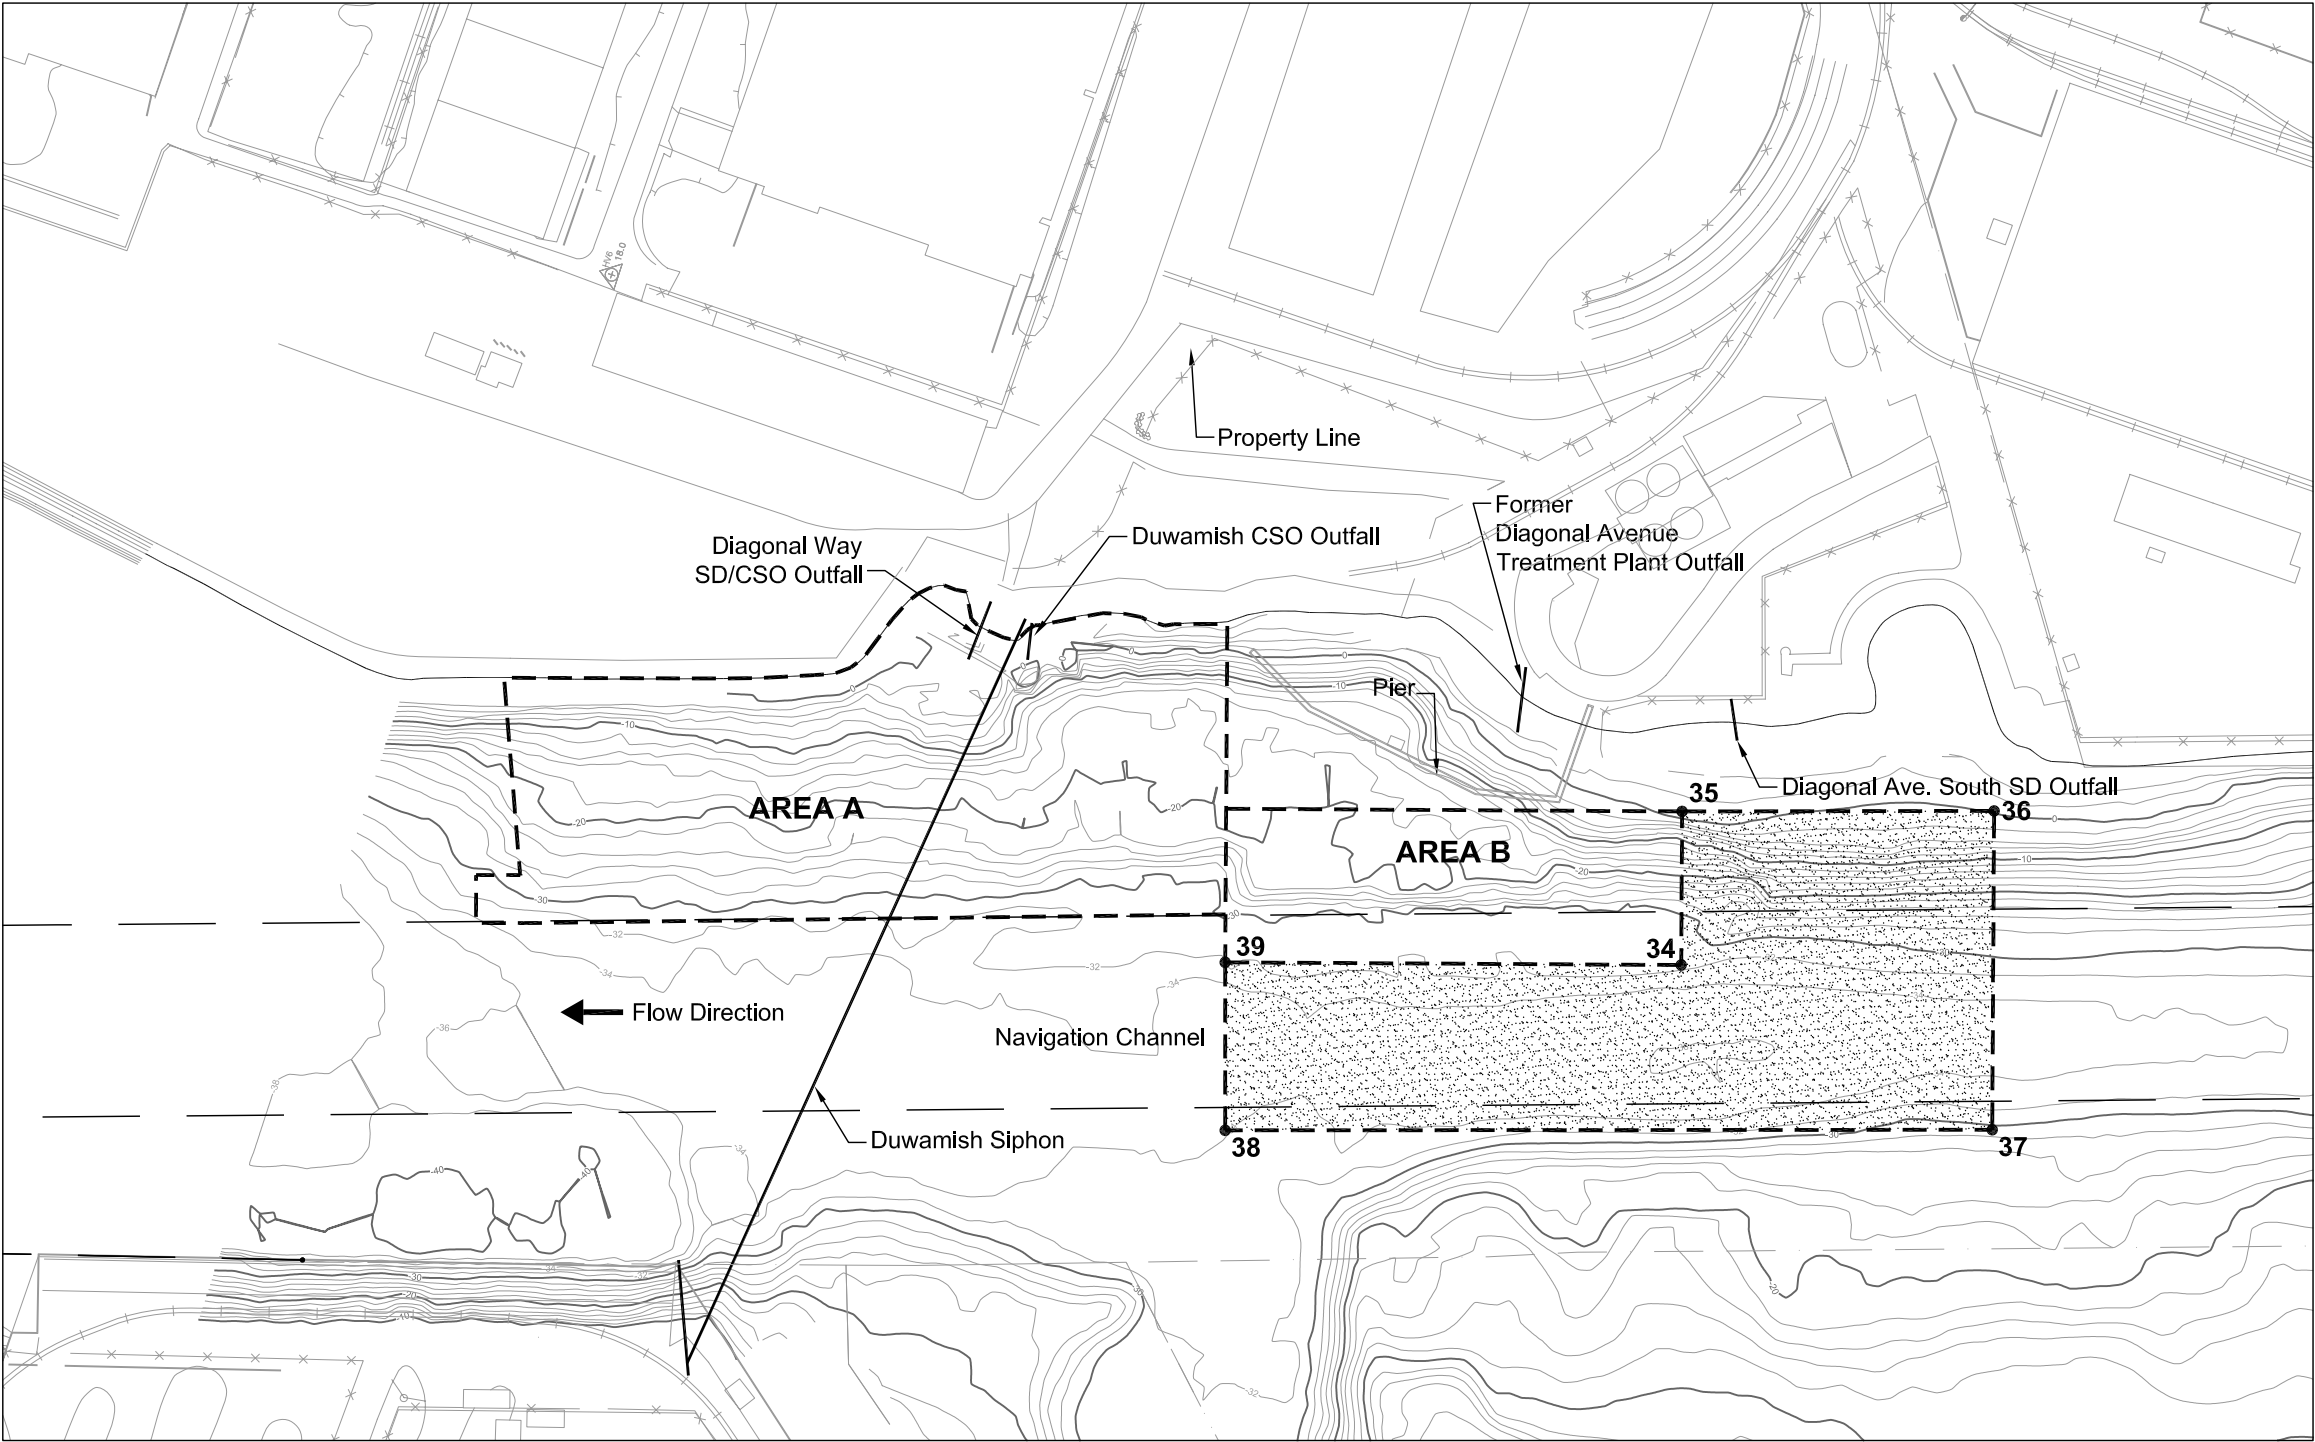
K:\Jobs\020067-KING_CO_SED_MANAG\02006701\Capping 100-Percent\02006701-PLACE02.dwg SHEET C-1
Dec 10, 2004 3:05pm dholmer

Figure 2 (Sheet C-1) defines the proposed project boundaries for the Enhanced Natural Recovery. The intent is to cover the bottom of the navigation channel to the west of “Area B” and 25 feet up the side slope in order to cover the residuals that spread cross-current and to cover the area upstream to the extent that the residual levels are found at concentrations above those around Area A. It is anticipated that those areas further upstream of the cap boundaries should naturally recover at the same time scale as the margins around “Area A”. This upstream area will be monitored together with the margins of “Area A” to determine if natural recovery is occurring at an acceptable pace or additional action would be warranted.

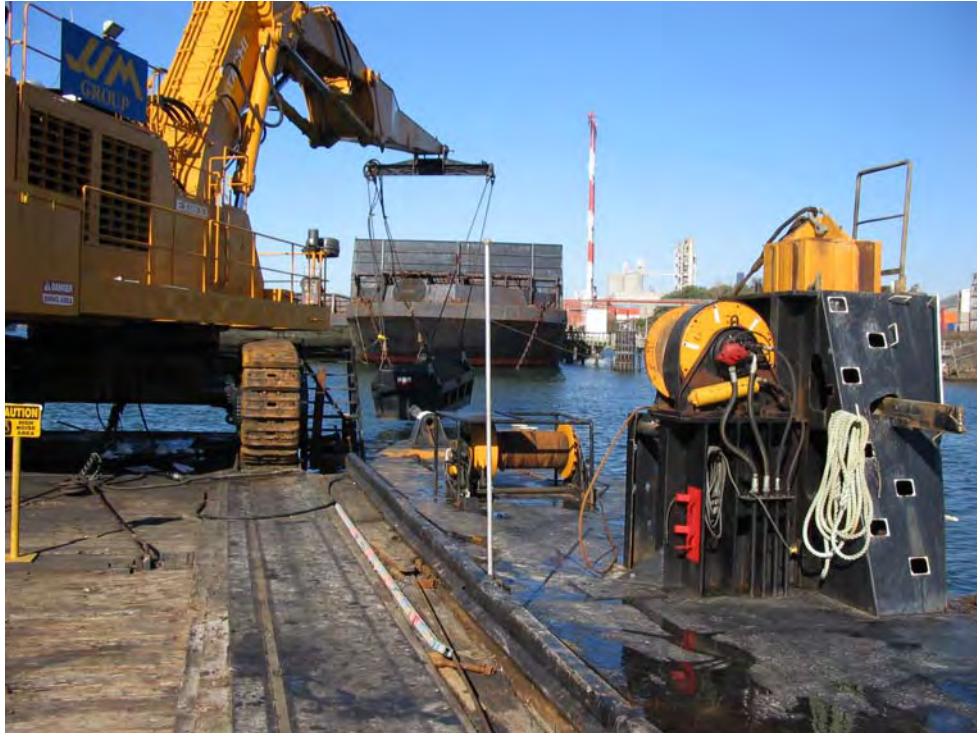
Photo 2
EX1800 hydraulic excavator with 16 CY skip box

The contractor began placing ENR material on Saturday, February 19, 2005. They used a 16 cubic yard (CY) skip box on an EX1800 hydraulic excavator to place the material. The skip box was opened slightly so that the load of sand would be placed while the skip box was swung over the 50-foot-long cell. The skip box was located just above the water surface during the swing. Appendix D includes photographs of the ENR sand placement activities. The contractor expected to place three skip boxes in each cell (approximately 42 CY) by cracking open the skip box and swinging it over the cell. Each skip box load would cover an area 10-feet-wide over a 50-foot radial distance.
