**DRAFT
SUPPLEMENTAL
ENVIRONMENTAL
IMPACT STATEMENT**

**Brightwater
Regional Wastewater
Treatment System**

Surface-Fault-Rupture Hazard Evaluation

**Surface-Fault-Rupture Hazard Evaluation
Brightwater Project SR-9 Site
King County Department of
Natural Resources, Washington**

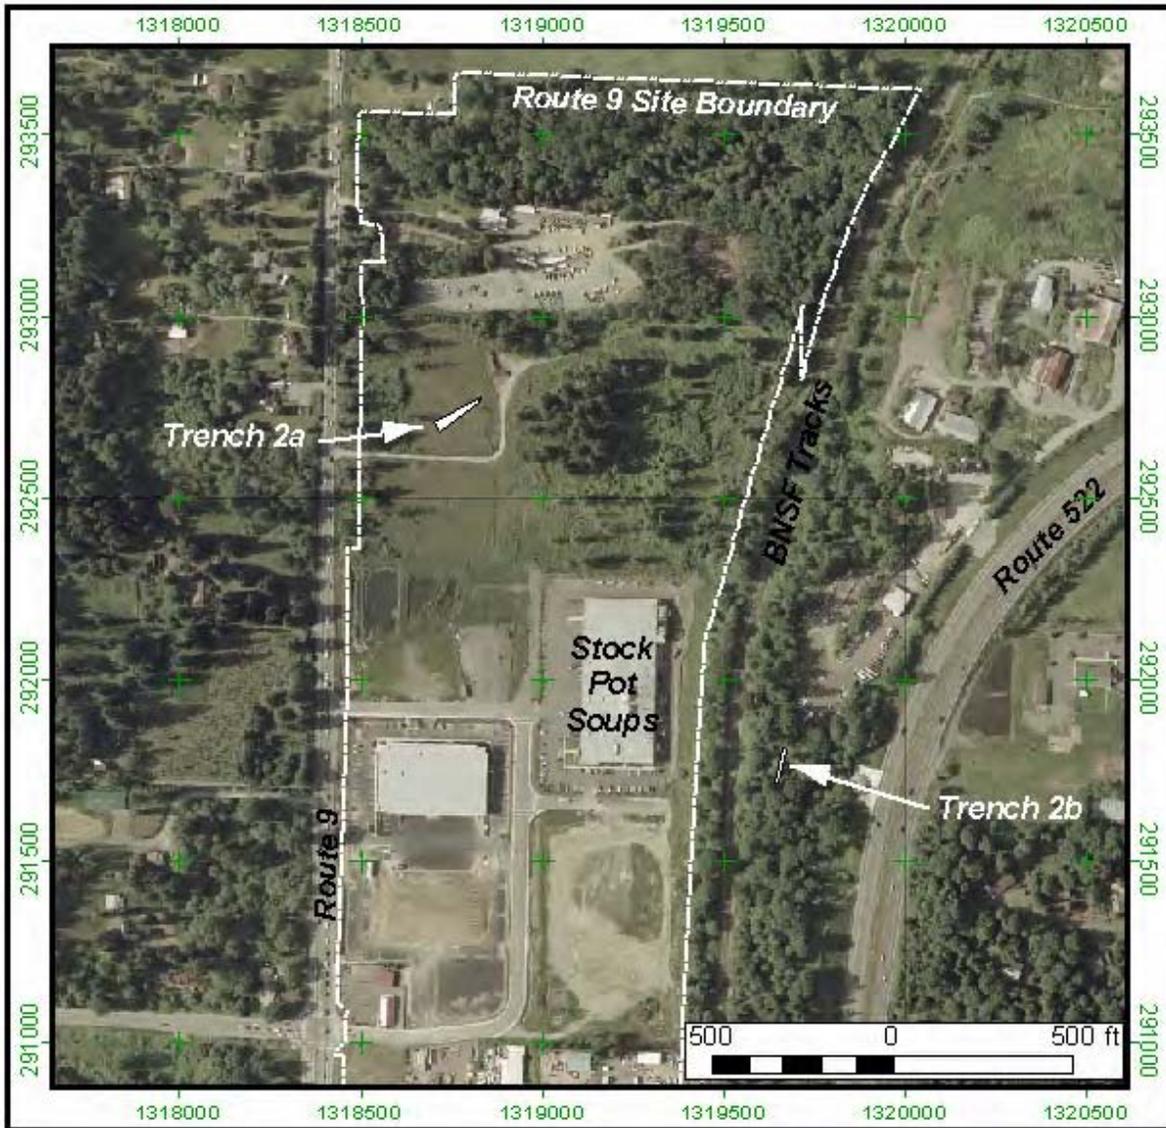
Figure 11. Aerial photograph showing site land use as of 2000(?) and trench locations. Note: Trench 1 does not exist. Washington State Plane North Zone coordinates in feet.

Two trenches were excavated across Lineament 4 at the Brightwater Route 9 site in September 2004 (Figure 11). A detailed discussion of these trenches is presented in Appendix A.A. Trench 2a in the North Mitigation Area exposed glacial outwash deposits, post-glacial wetland deposits, and modern fill sediments. Trench 2b east of the StockPot Soups building exposed glacial till and lacustrine deposits that are compact, indicating that they have been overridden by ice. Hence, the deposits exposed in Trench 2b are older than recessional deposits of the Vashon Stade of the Fraser glaciation. Deformation features were observed in both trenches, but the deformation in each trench has completely different character. Exposures in Trench 2b do not yield useful information for paleoseismology interpretations of Lineament 4, other than deformation is younger than deposits that were overridden by Vashon Stade ice but older than the Vashon ice that compressed tectonically deformed sediments.

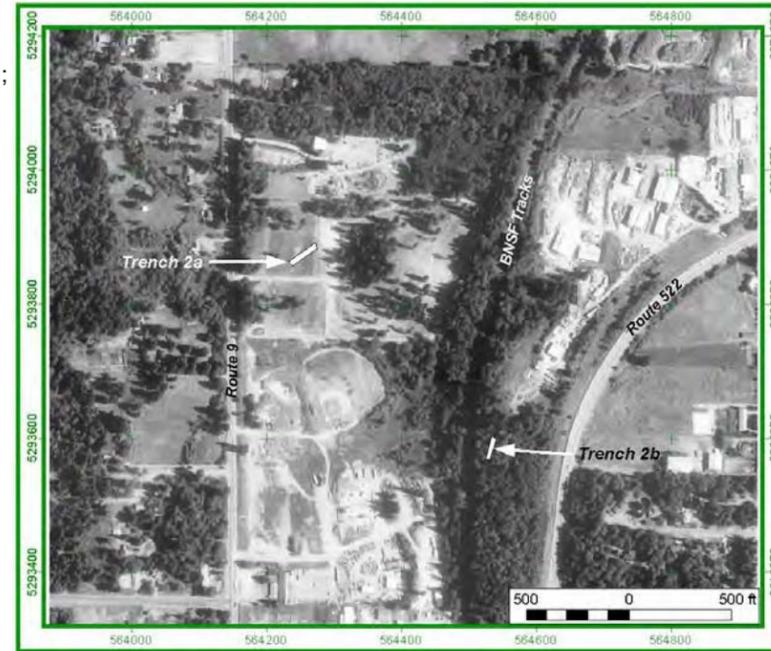
Figure A-1c. Aerial photograph showing site land use as of 1990. Digital ortho-quarter-quad; UTM Zone 10 coordinates.

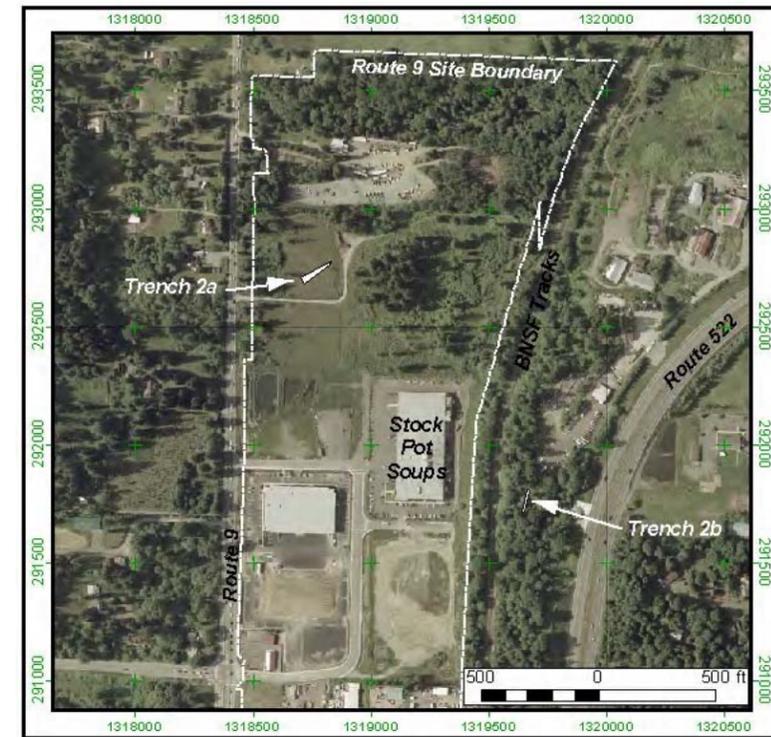
Figure A-1d. Aerial photograph showing site land use as of 2000(?) and trench locations. Washington State Plane North Zone coordinates.

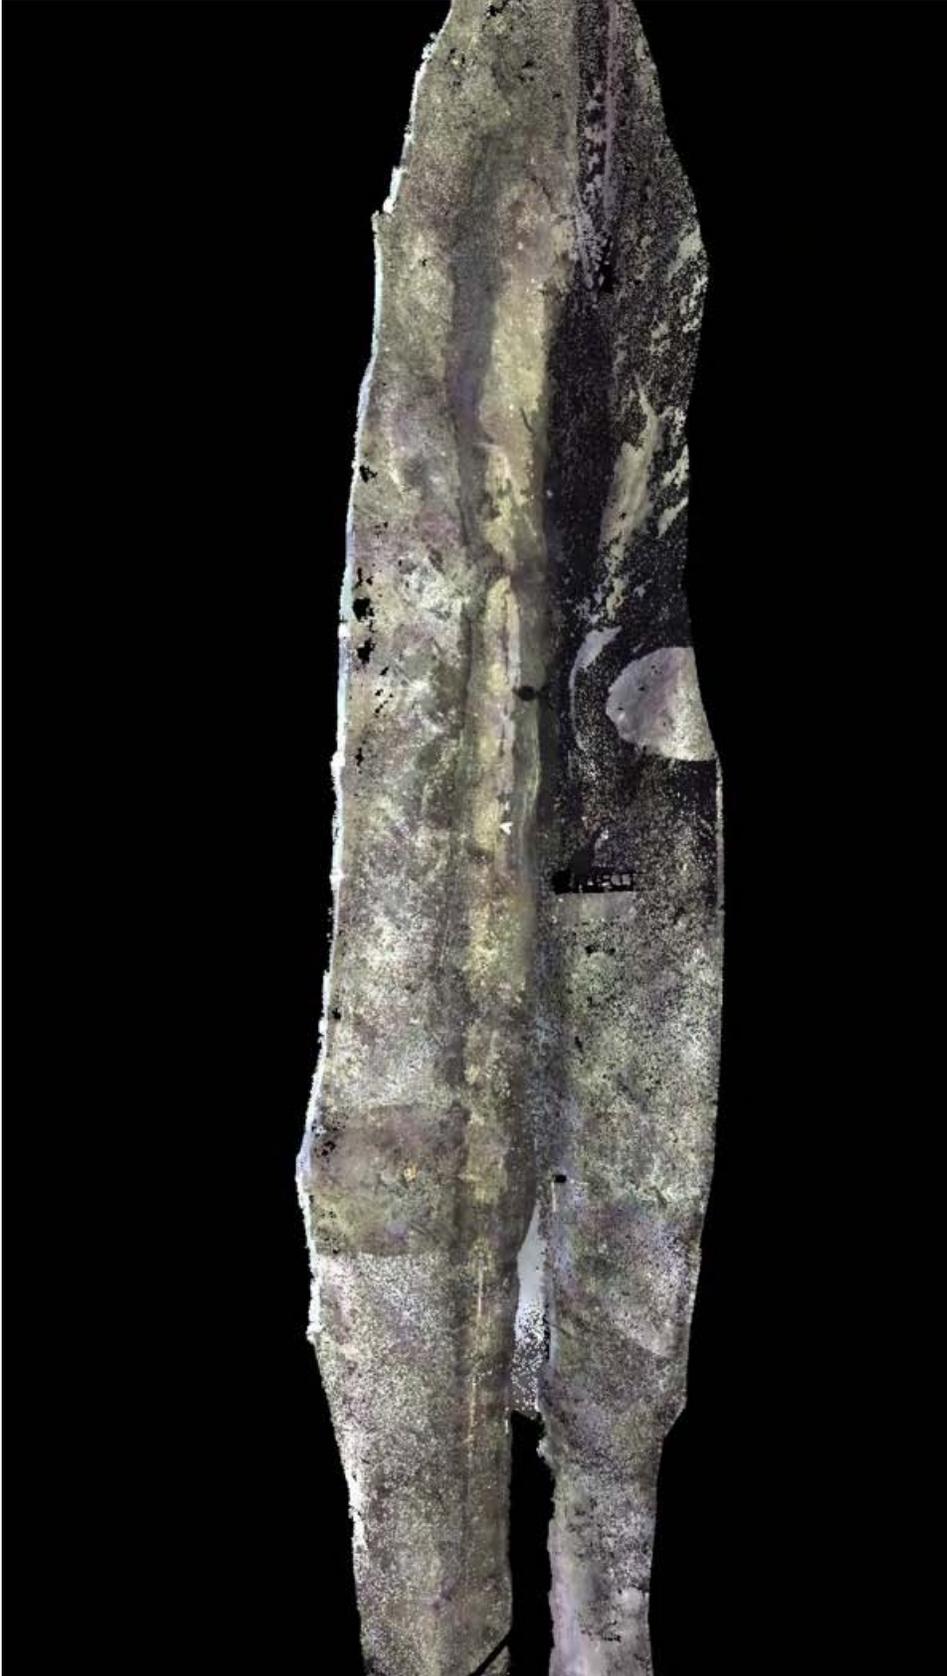
Figure A-6. View produced by 3-D laser scan survey looking vertically down at Trench 2a.

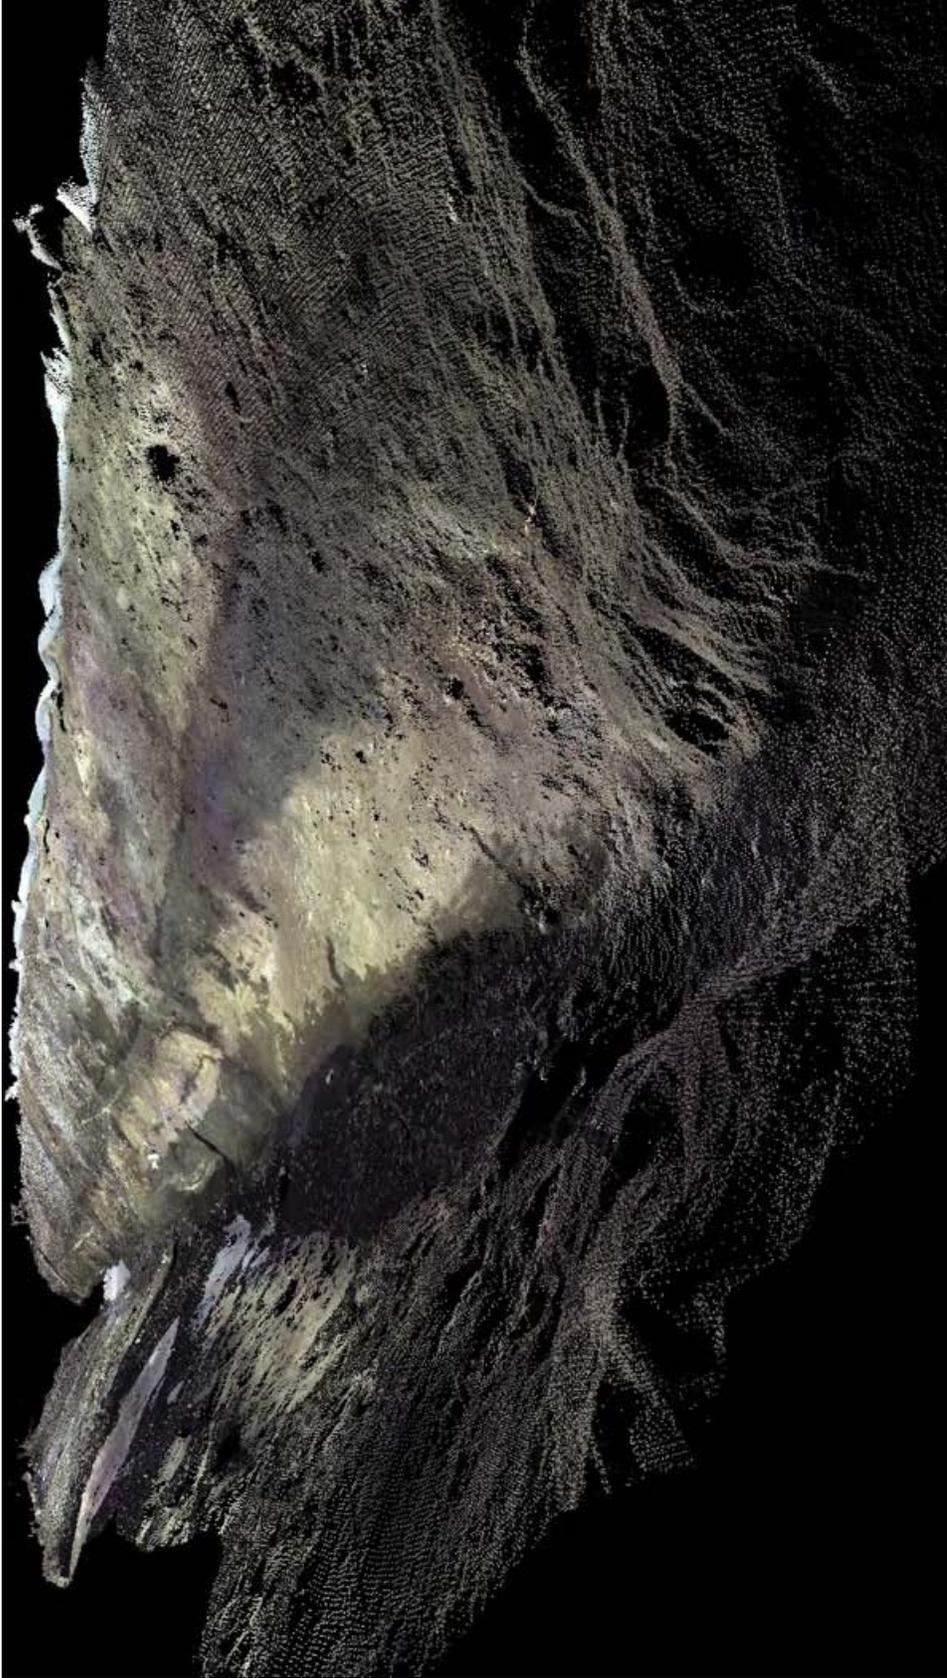
Figure A-7. View produced by 3-D laser scan survey looking west at northern sidewall of Trench 2a.

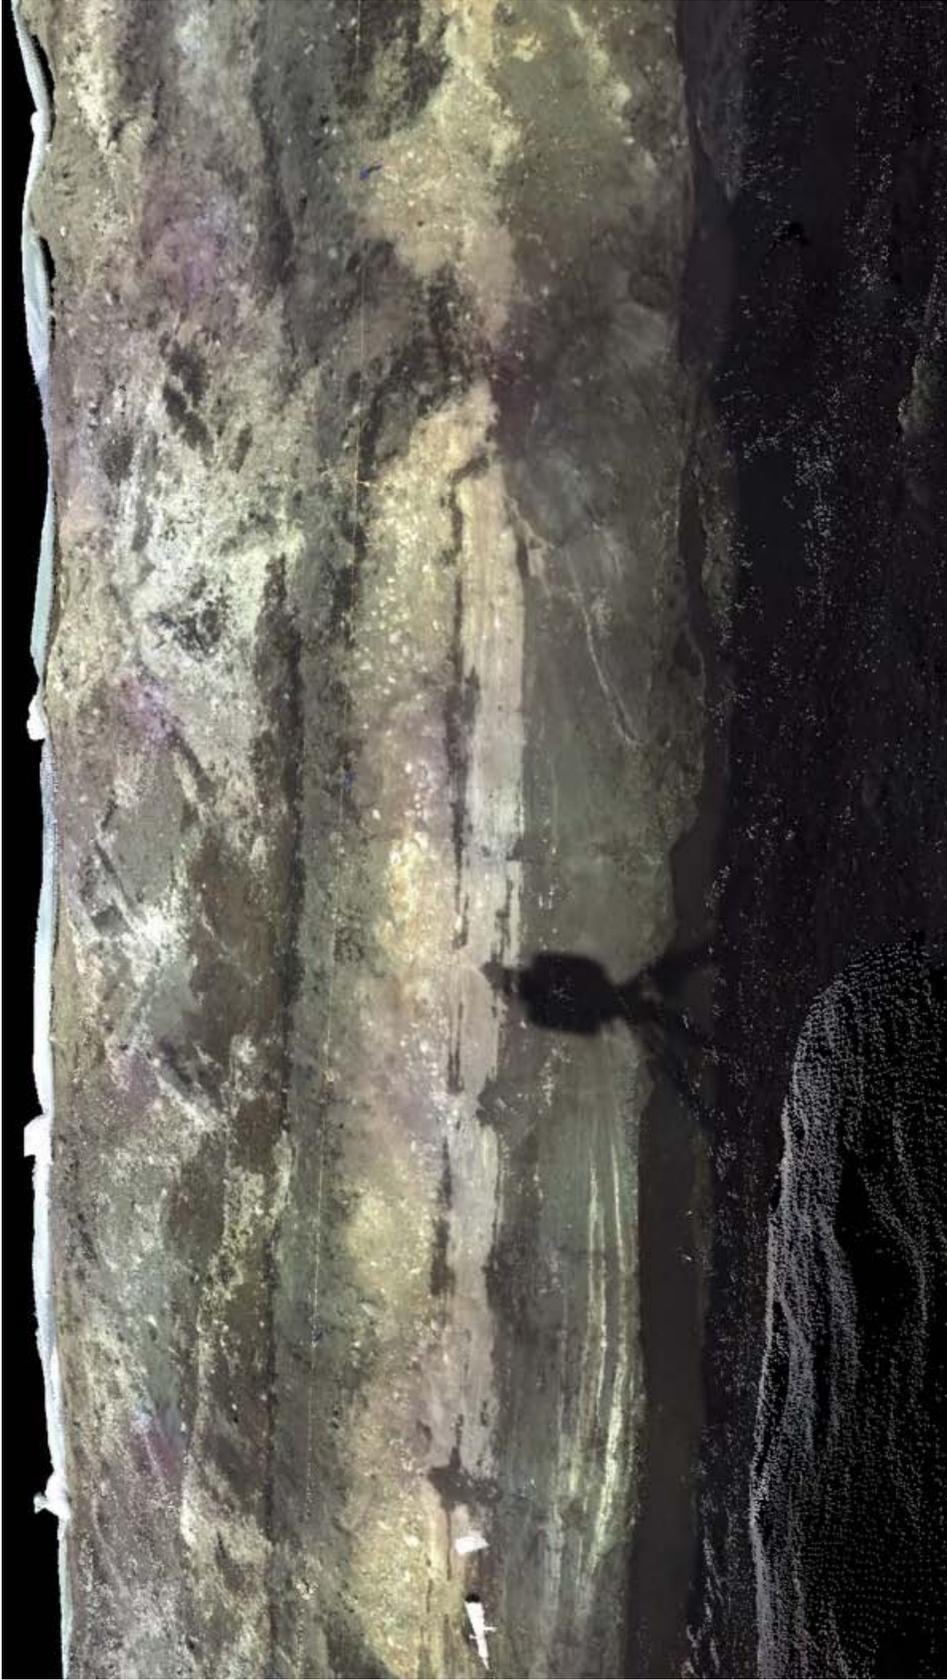
Figure A-9. View looking at northern sidewall of Trench 2a showing angular unconformity.

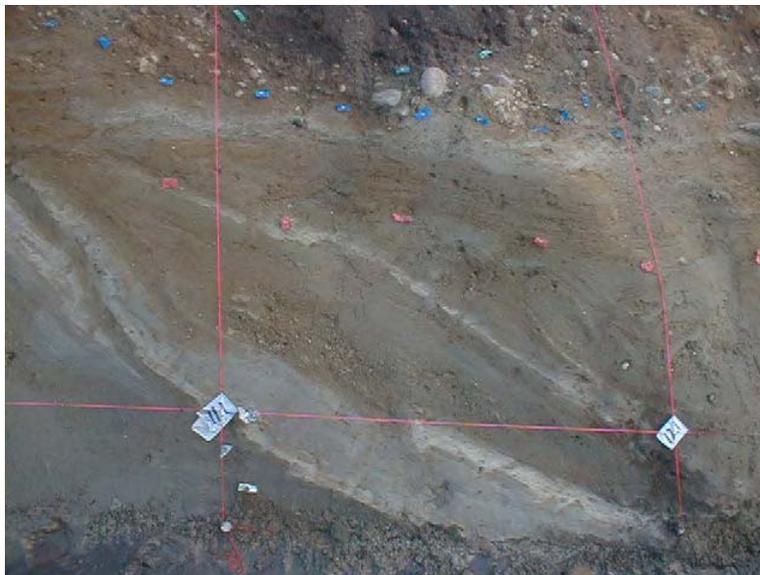
Figure A-11. The same angular unconformity as Figure A-10 exposed in the southern sidewall of Trench 2a. View between the U.S.G.S. survey grid lines is from station 1+03 and 1+06. Unconformity is delineated by white tags at base of sandy gravel subunit 3b. (PIC00027)

A similarly appearing monoclinial flexure was exposed in the southern sidewall (Plate 2), where delineation of the stratigraphy and structure was hindered by sand intrusions and krotovina (i.e., small-animal burrows in-filled with soil). The hinge point (i.e., angular change or inflection in dip from subhorizontal to moderately dipping) of the monoclinial flexure was observed at about station 1+04 along the base of the southern sidewall and station 1+02 along the northern sidewall. A trend of approximately N. 25° W (155° azimuth) was measured along the hinge axis by sighting the two hinge points on either sidewall. Only one bedding attitude was measured along the southern sidewall. A

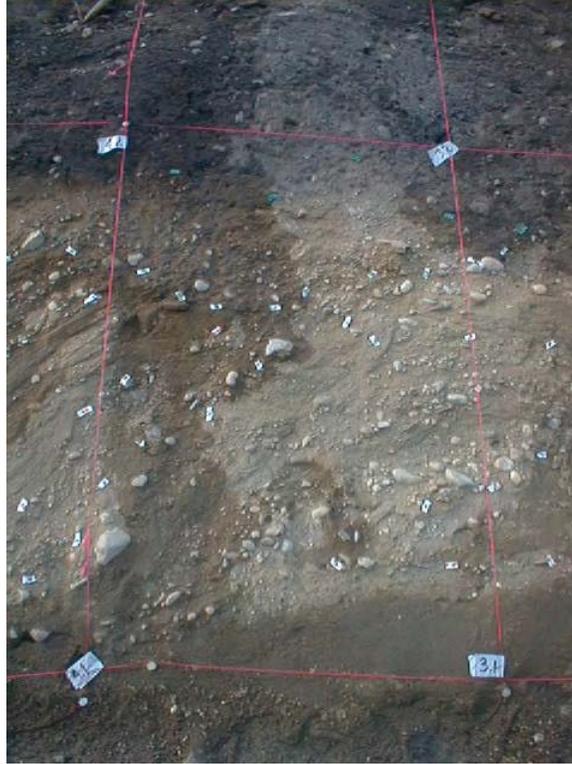
Figure A-12. Angular unconformity exposed in northern sidewall of Trench 2a between station 1+16 and 1+23. At this location, unconformity marks boundary between tilted outwash strata (subunits 3d3, 3e, and 3f) that are erosionally truncated in the up-dip direction by gently dipping subunit 3a2. Tilted beds are dipping westward at about 30 to 35 degrees. (PIC00014)

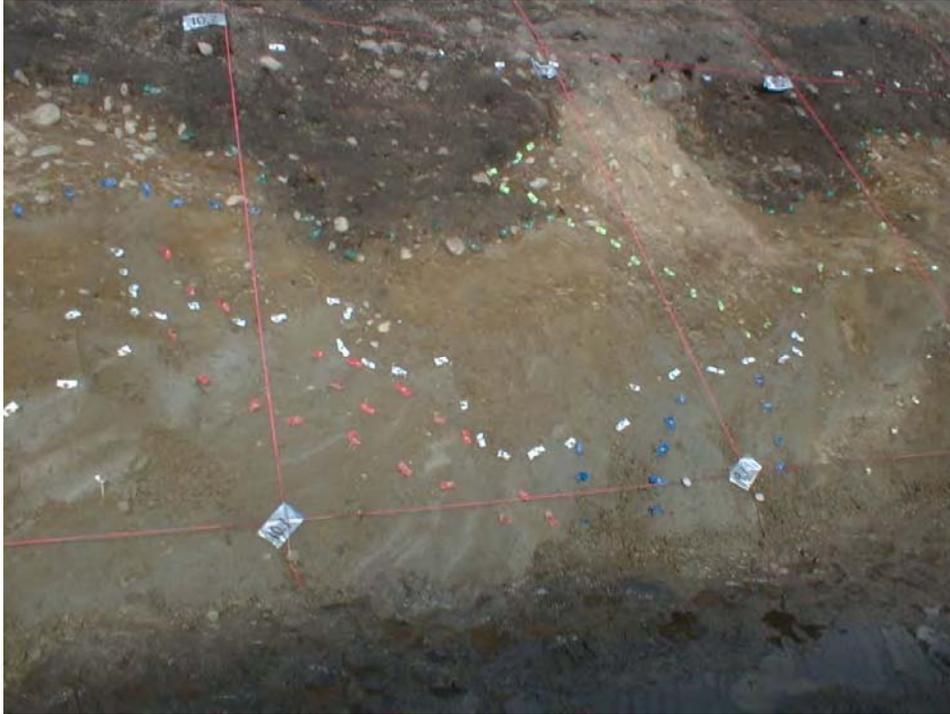
Figure A-13. Faults with apparent minor offset of tilted strata exposed in northern sidewall of Trench 2a between station 1+12 and 1+13. Offsets delineated by red tags in lower half of view. (PIC00033)

The tilted strata are offset by four closely spaced faults with variable displacement. The faults are exposed in the northern sidewall between station 1+11 and 1+12. A fault trend of approximately N. 65° W was determined by aligning a brunton compass over the trace of the faults in the inclined sidewall. No piercing points were observed which precluded determination of fault slip. The sense of offset based on displaced silty clay and silt layers appeared to be east side up (apparent reverse separation) in each instance. However, a component of lateral slip would appear to be required across one of the faults due to significant differing thickness of strata on either side of the fault. The vertical offset appeared to range from about an inch to at least 6-inches. No gouge was observed along either of the faults. The projected trace of these faults across the trench to the southern sidewall intersects a portion of the southern sidewall that has been obscured by sand intrusion and burrowing rodent activity.

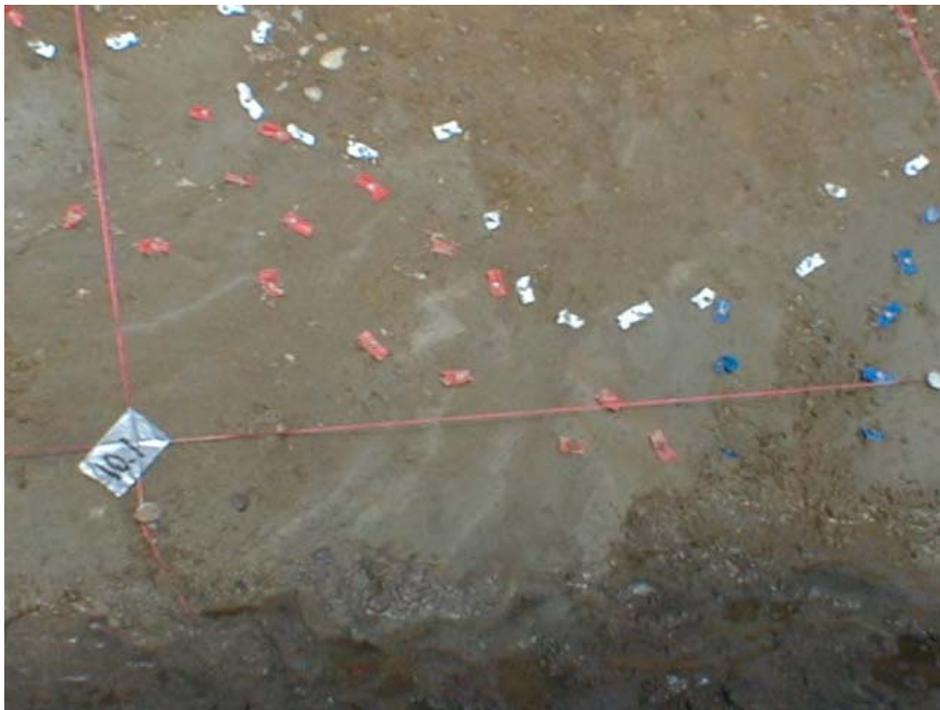
Figure A-14. Close up view of part of Figure A-13 photograph showing fault offsets. (PIC00034)
