SUMMARY OF SEDIMENT TRENDS

Lower White River: RM 4.44 to RM 10.60

King County
River and Floodplain Management Section
Department of Natural Resources and Parks

Herrera Environmental Consultants
2200 Sixth Avenue, Suite 1100
Seattle, Washington 98121
Telephone: 206.441.9080

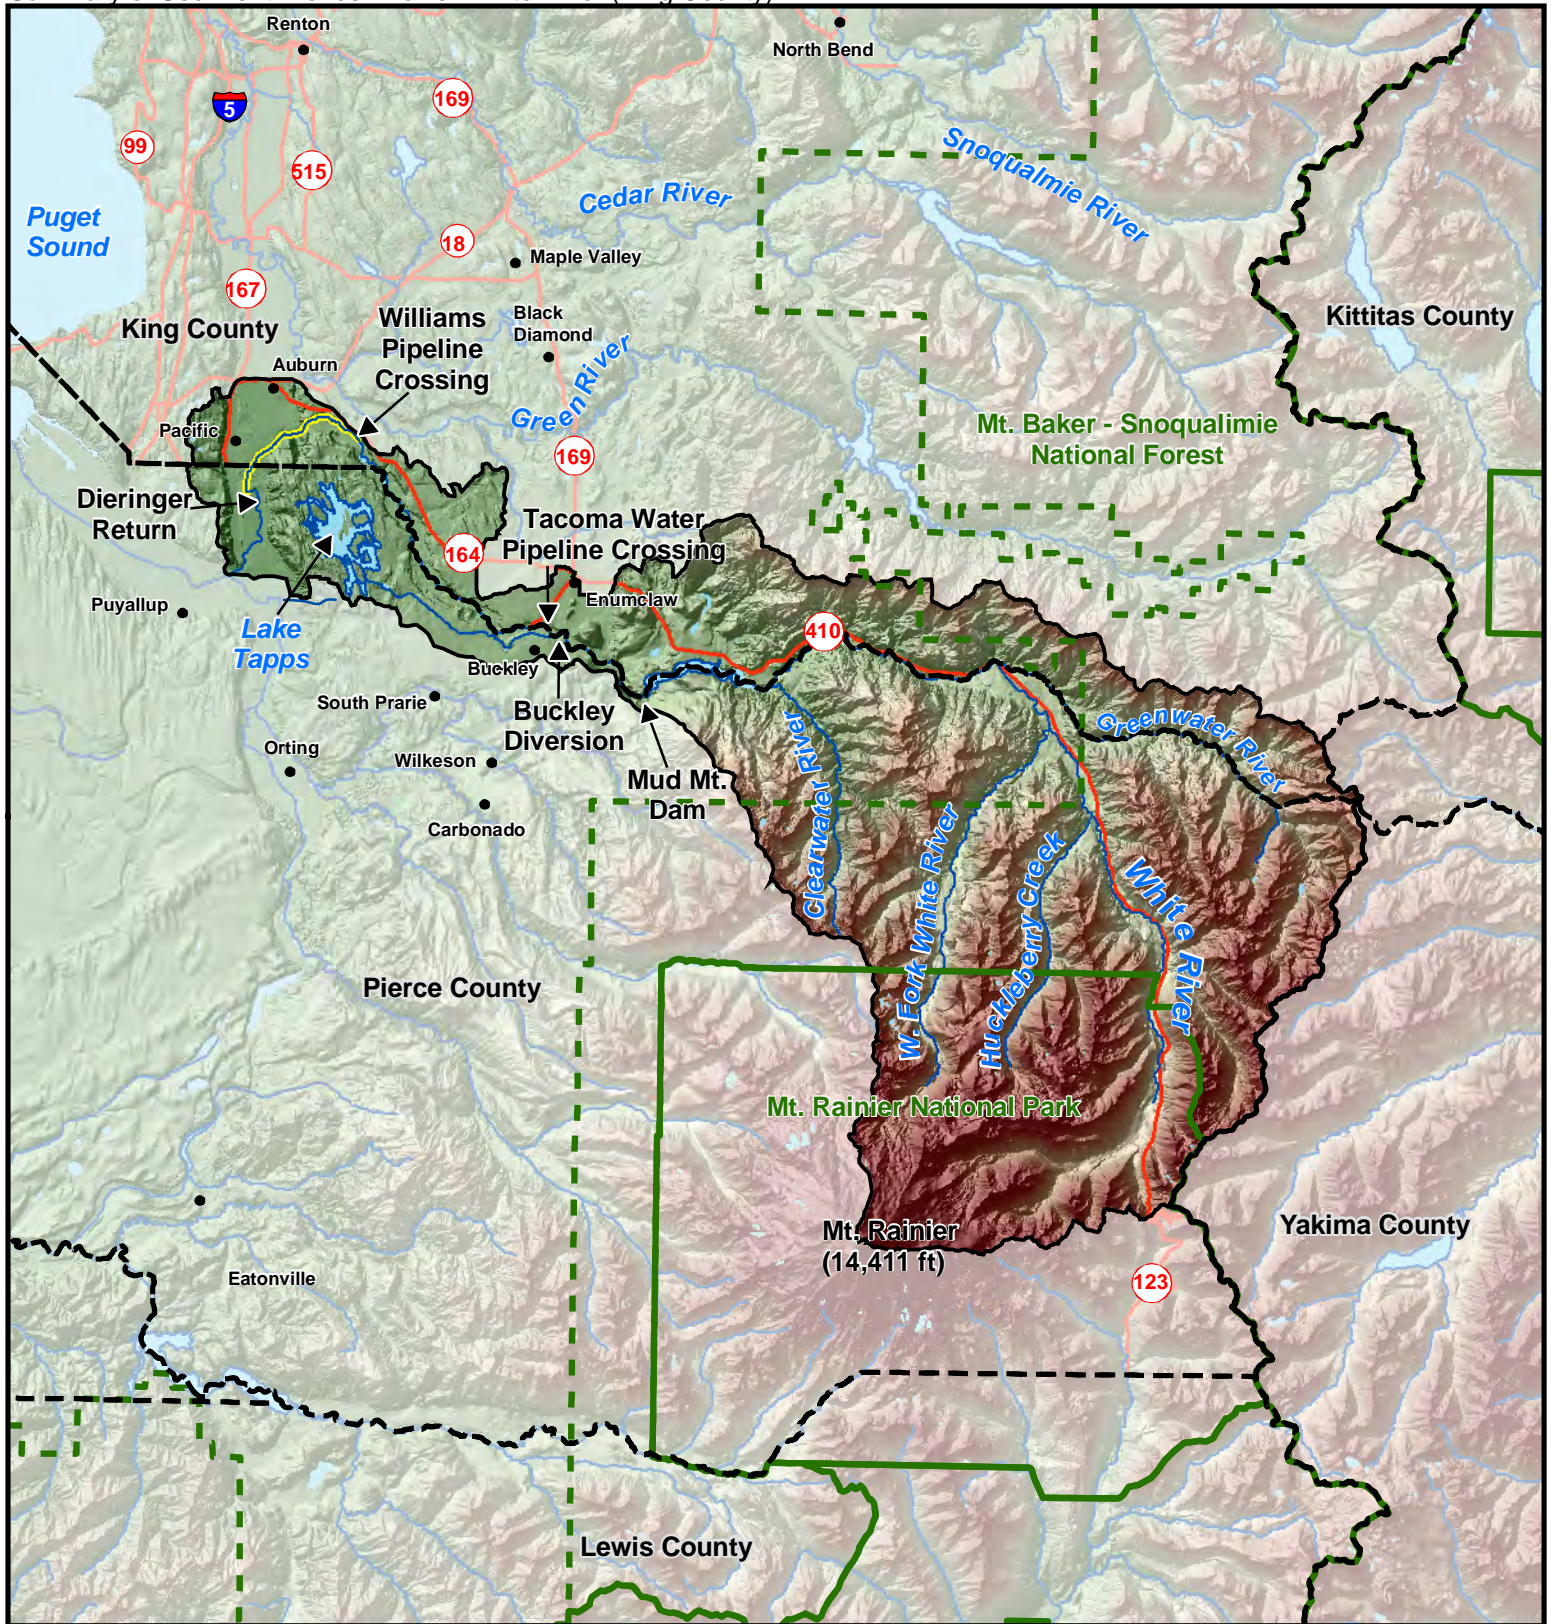
Figure 2. Map of the White River watershed in King and Pierce Counties, Washington.

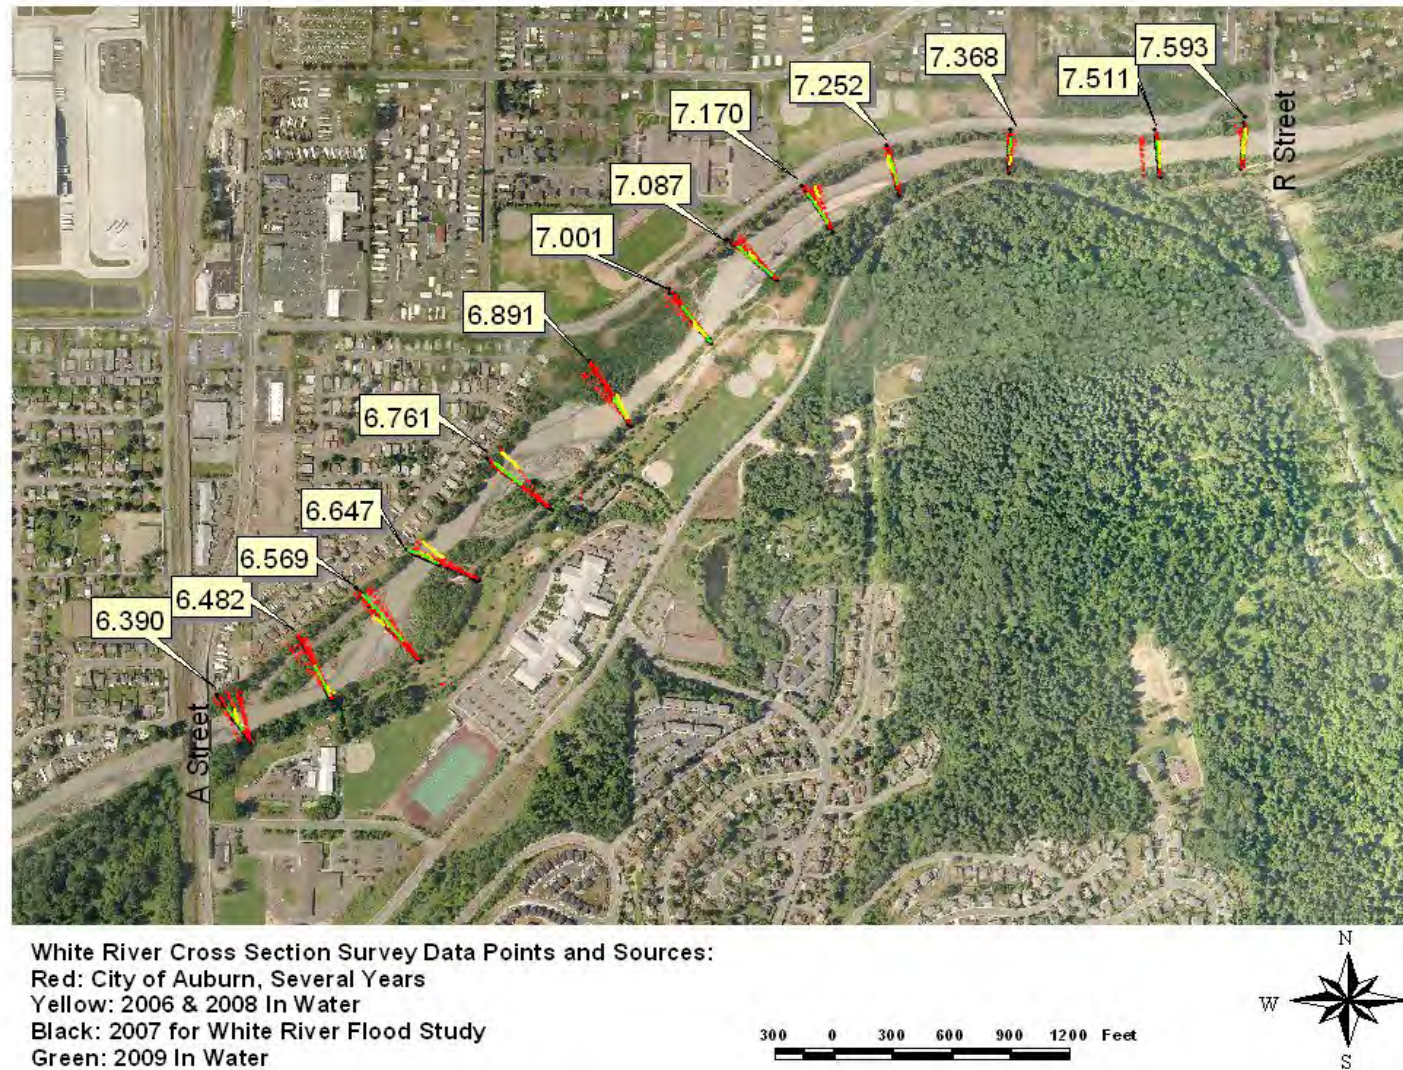
Figure 2: Plan view of 1996 through 2009 data points surveyed at 13 Auburn cross sections
