Year 5 (2014) Monitoring and Maintenance Report

| Project Name: | Chinook Bend Floodplain Reconnection Project |

King County. 2017. Chinook Bend Floodplain Reconnection Project Effectiveness Monitoring Report: Year 5 (2014). Prepared by J.J. Latterell and D. Eastman, King County Water and Land Resources Division. Seattle, WA.

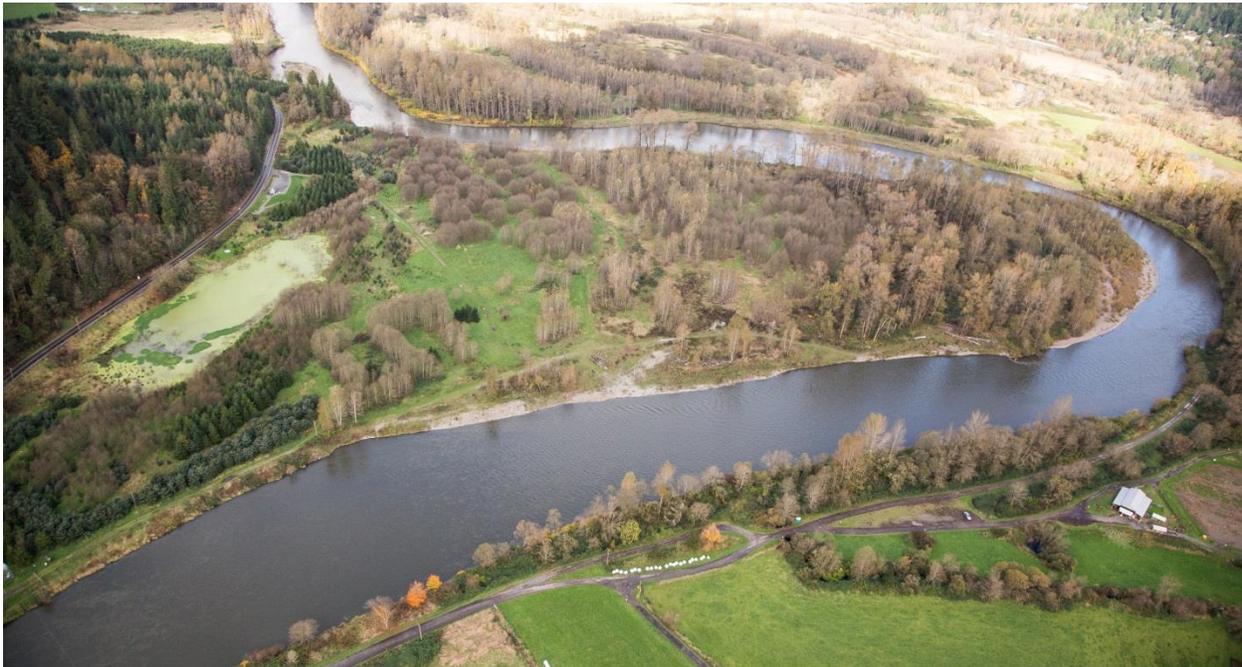
Figure 1. Chinook Bend project site, looking downstream. Photo from October 29, 2014. Discharge at USGS 12149000 was 7,500 cfs (212 cms).

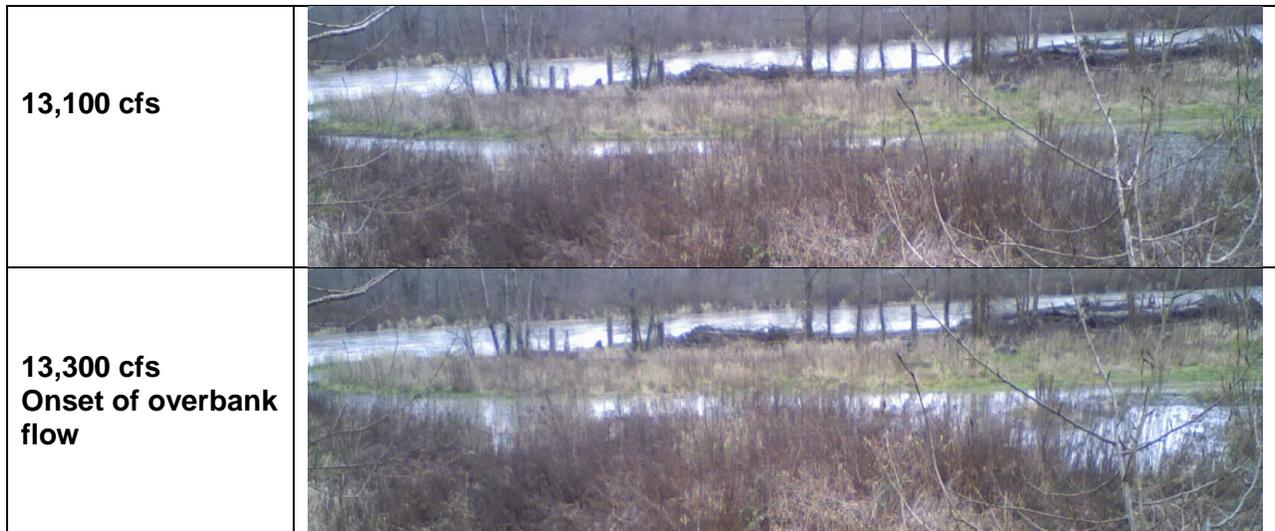
Overbank flooding in the project site was abruptly increased by levee removal, as expected. Prior to levee removal, the site was backwatered from downstream during floods, beginning at approximately 20,000-23,000 cfs (at USGS 12149000; Snoqualmie at Carnation). This discharge level is a 1.25 to 1.50-year flood. The levee overtopped between 30,000 and 40,000 cfs, slightly less than a five-year flood. After the levee was removed, backwatering was unchanged, but water began flowing overbank into the low swale at downstream across the low swale at 13,300 cfs (a 1.01 to <1.25-year RI event), as verified by time-lapse video from the swale (Figure 21). Maximum daily discharge has exceeded 13,300 cfs on approximately 3% of the all days since October 1, 2009. On January 5th, 2015, water was flowing through the swale at depths >1-2 ft during discharge levels of approximately 17,400 cfs.

Figure 21. Time-lapse images of the onset of overbank flow after levee removal. Footage is from March 13, 2013 on the ascending limb of a high-water event.

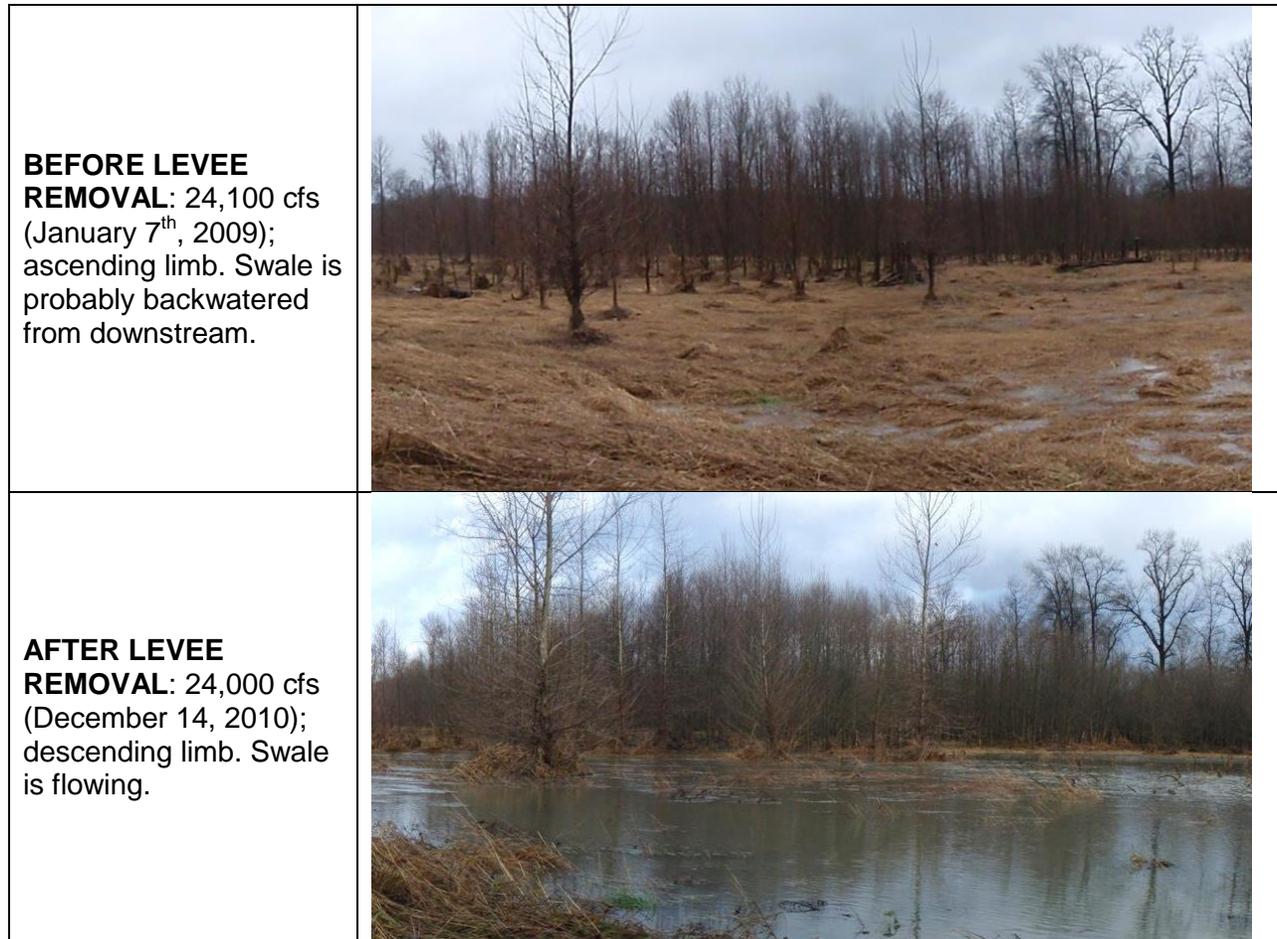
Once discharge reaches a 1.5-year flood level (24,000-25,000 cfs; Figure 23), floodwaters are flowing across the swale, and inundating a large portion of the floodplain. Photopoint comparisons illustrate how this alteration increased the extent and depth of floodwaters in the swale during frequently-experienced discharges (Figure 22 and Figure 24).

Figure 22. Comparison of floodplain connectivity before and after levee removal. Photopoint 6.

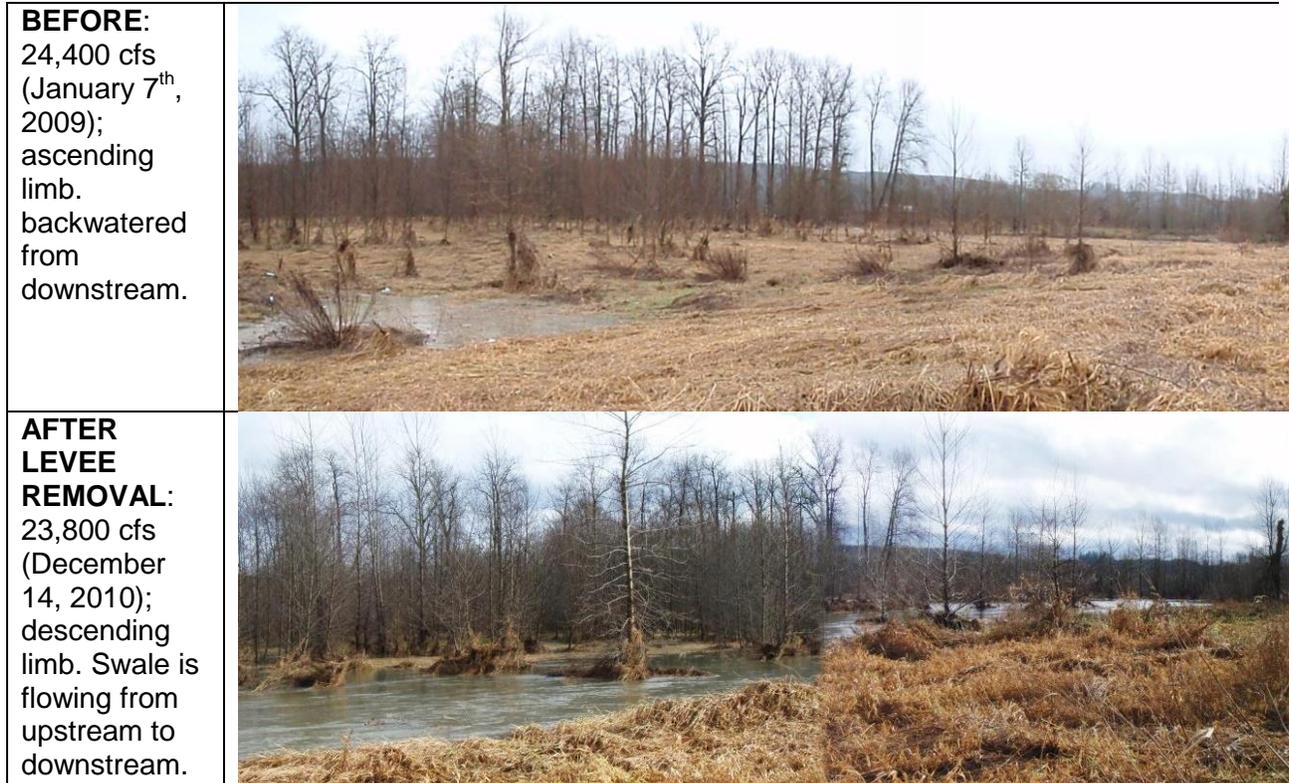
Figure 24. Comparison of floodplain connectivity before and after levee removal. Photopoint 7 Southeast.

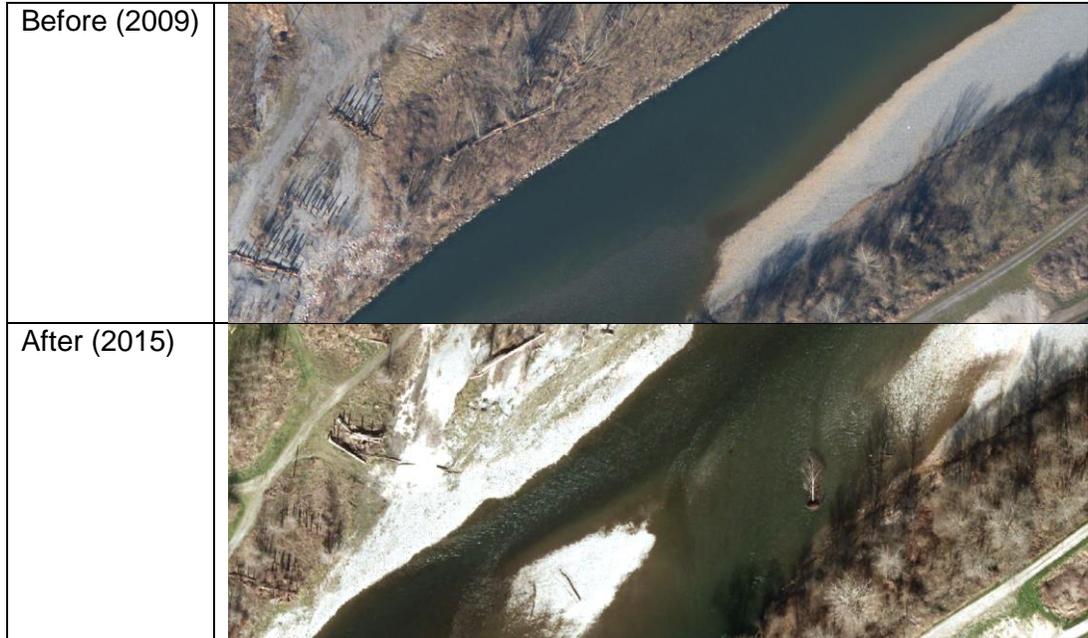
Safely navigation of the project reach is facilitated by multiple channels with few obstructions (Figure 31). Two wood accumulations have formed near the apex of the meander (Figure 30). A small wood accumulation was present on the left bank, prior to the project. By 2015, a new, larger wood accumulation formed along that bank. Even so, river users could navigate through an 80-foot-wide opening, or choose to float the north channel split.

Figure 31. Comparison of large wood accumulations before and after the Chinook Bend Project.
