Memorandum

To	Scott White Confluence Environmental Company	File no	5915178990
From	Jason B. Cooper, M.A., RPA Amec Foster Wheeler Environment & Infrastructure, Inc. Connie Walker Gray, Senior Architectural Historian, Confluence Environmental Company	cc	Dan Meatte, WA State Parks Jennifer Vanderhoof, King County Laura Murphy, Muckleshoot Indian Tribe Brandon Reynon, Puyallup Tribe of Indians Rob Whitlam, DAHP
Date	November 10, 2015		
Subject	Archaeological Resources/Built Environment Assessment and Monitoring Results from the Geotechnical Exploration at Saltwater State Park, King County, Washington

King County, in collaboration with Washington State Parks (Parks), is in the early stages of planning the McSorley Creek Pocket Restoration Project (Project). The Project proposes to remove 150 feet of rock armoring along both banks of McSorley Creek to restore one acre of intertidal habitat at the creek delta and remove as much of the 2,500 feet of marine shoreline armoring as possible to maximize habitat benefits while maintaining protection of known cultural resources. The mouth of McSorley Creek is currently bulk-headed with rip-rap and no longer flows in its original channel. Remov

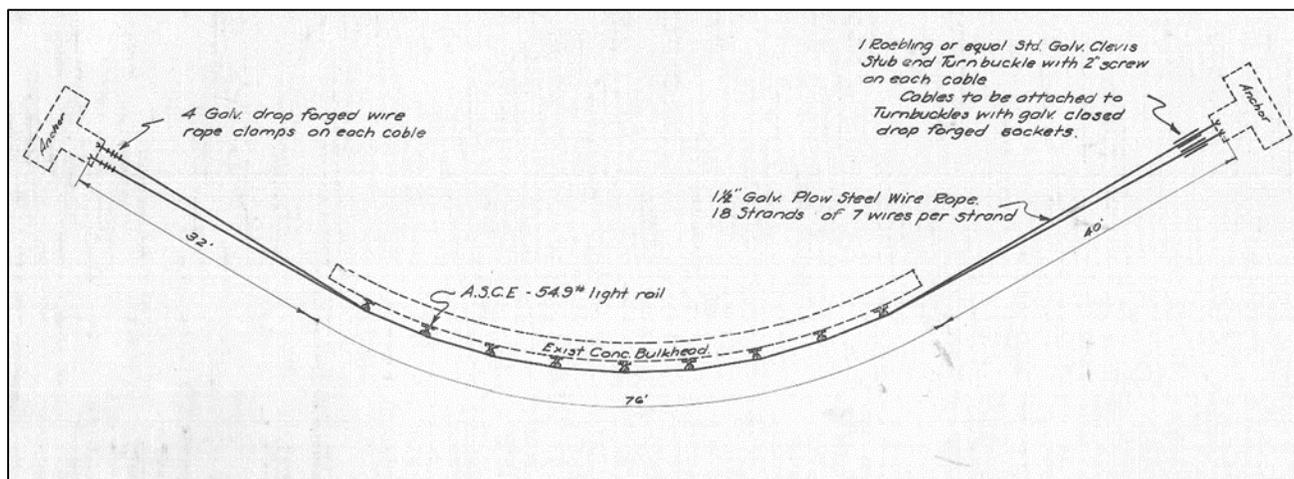
Exhibit 1. Bulkhead Reinforcement Schematic for Saltwater State Park (Source: King County Map Vault, #20150915-7049).

In TP #3 (**Figure 2**), a thick steel wire rope, measuring 1-1/2" in diameter, was identified in the test pit at approximately 1.2 to 1.8-meters (4 to 6-feet) below the surface (**Photograph 4**). Immediately above the coiled rope, a large bent piece of steel in the shape of a hook, approximately 1.5-feet in length was pulled from the test pit (**Photograph 5**). The steel wire rope, which was heavily corroded with rust, was damaged during the geotechnical exploration. Researching the King County Map Vault on-line database, a map from the King County Engineering's Office from the late-1930s shows a bulkhead reinforcement schematic for Saltwater State Park. This drawing depicts 1-1/2" galvanized plow steel wire rope, affixed with galvanized drop forged wire rope clamps (**Exhibit 1**).

Unfortunately, the map does not depict the placement of the subsurface structure in relationship to the former course of McSorley Creek or the modern-day bulkhead. Still, it is believed that we encountered the partial remains of Saltwater State Park's former bulkhead anchoring system. It is unclear if the anchoring system is still connected in any way to the remaining bulkhead or if it was abandoned in place after the partial removal of the bulkhead near TP #3. **Figure 3** shows a linear bulkhead tracking south toward the former course of McSorley Creek. This portion of the bulkhead no longer exists, having been removed at some point during the latter half of the 20th century. Additional research on the park's bulkhead is necessary before further attributing the find in TP #3 to the anchoring system. Further documentation, including an archaeological site inventory form for the wire rope and wire clamp, will be completed during the full cultural resources assessment of the Project's APE.

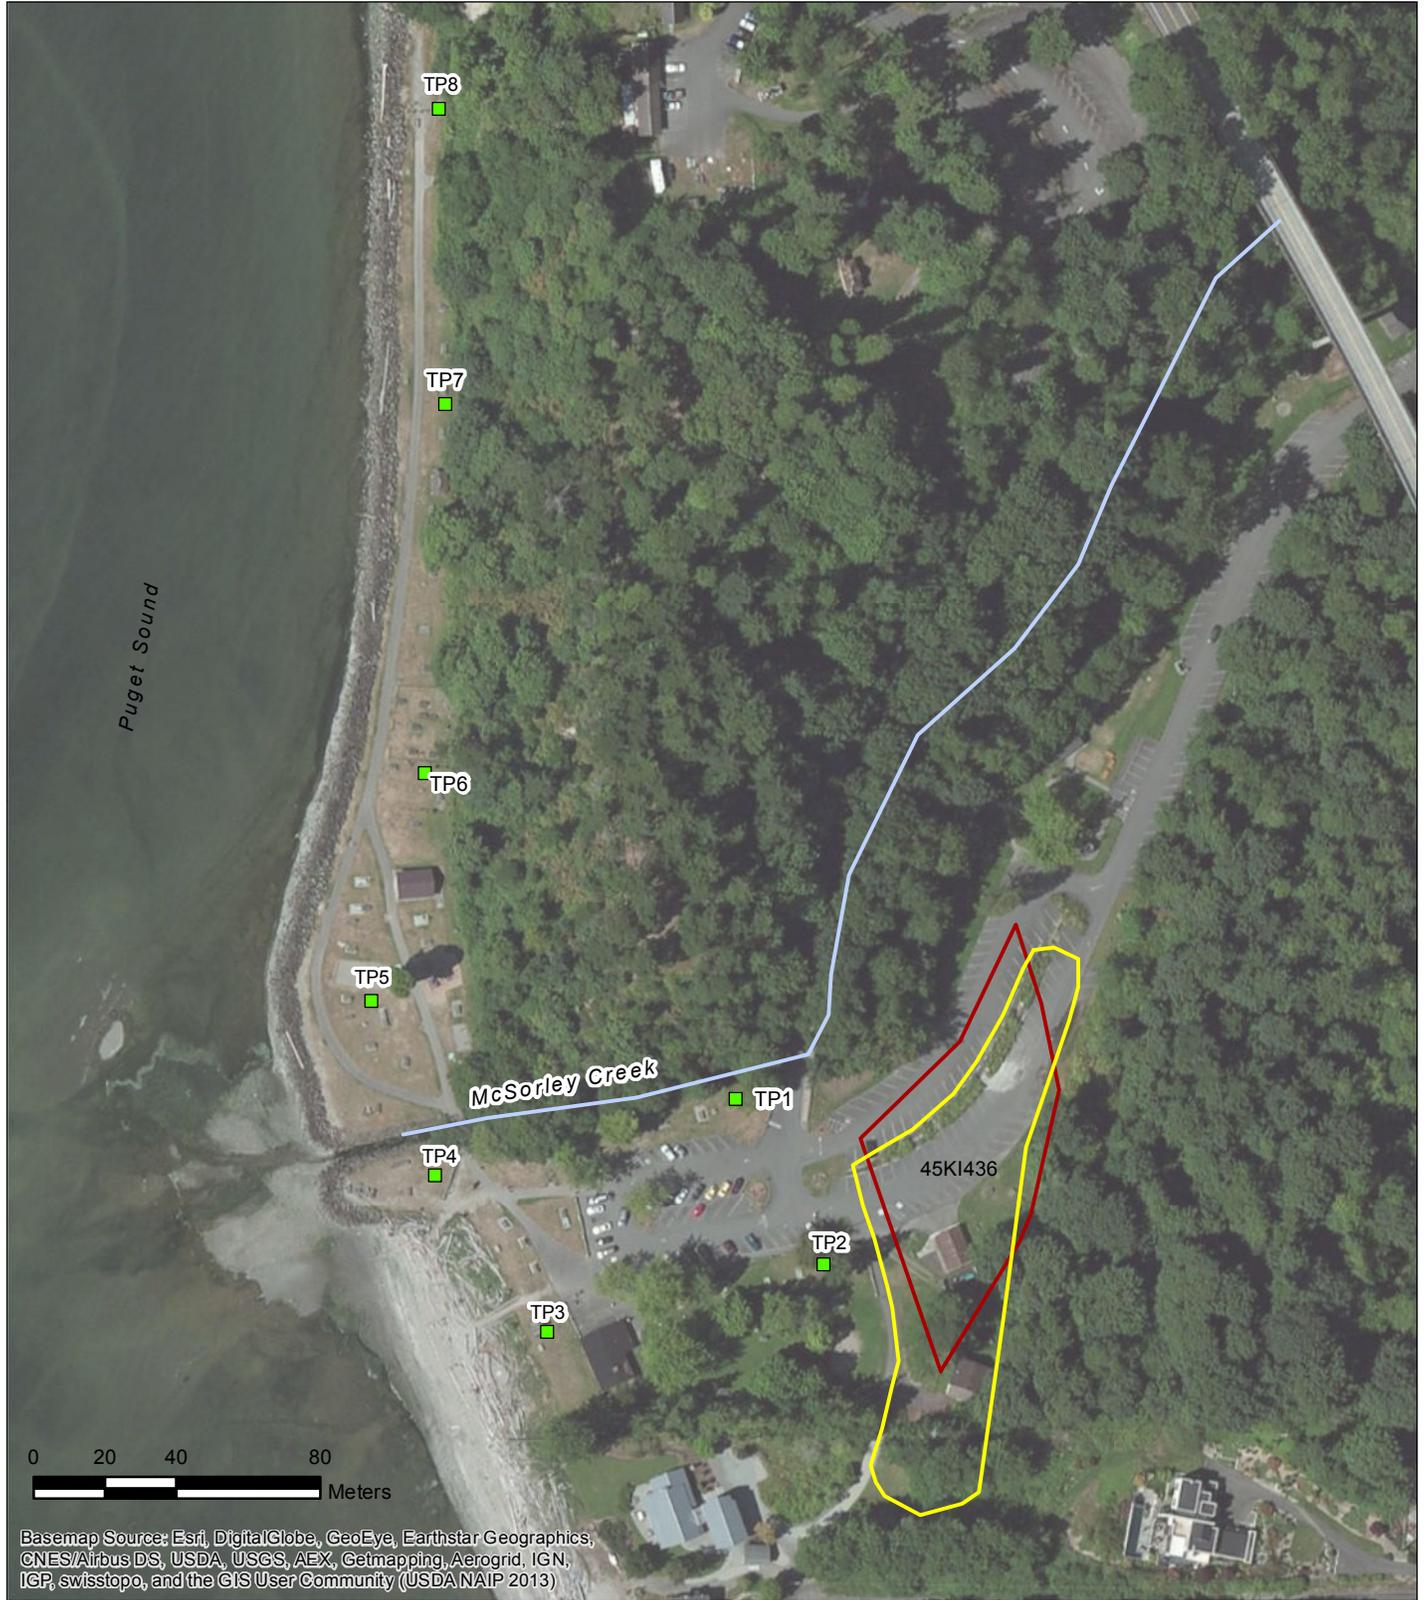
Figure 2

Amec Foster Wheeler archaeologist Jason B. Cooper (M.A., RPA) conducted the archaeological monitoring of eight geotechnical test pits over two days in Saltwater State Park. The test pits were numbered 1 through 8 (**Figure 2**). In general, the test pits were 4-feet wide by 8-feet long at the surface (**Photograph 2**). The depths of the test pits varied from 6 to 10 feet below the surface, depending on the water table, compaction of soil, and concentration of subsurface rocks and boulders.

On September 15, 2015, Test Pits (TPs) #2, 3, 7, and 8 were excavated, and on September 16, 2015, TPs #1, 4, 5, and 6 were excavated (**Figure 2**). Shell material was found in all but two of the test pits, TP #1 and #5. The observed shell was not in association with a cultural midden, and did not contain organically-stained sediment, fire-modified rock (FMR), lithics, and/or bone. Shell identified in TPs #3, 4, and 6, and lesser degree TPs #7 and 8, were all associated with a deeply buried beach deposit

Test Pit Locations

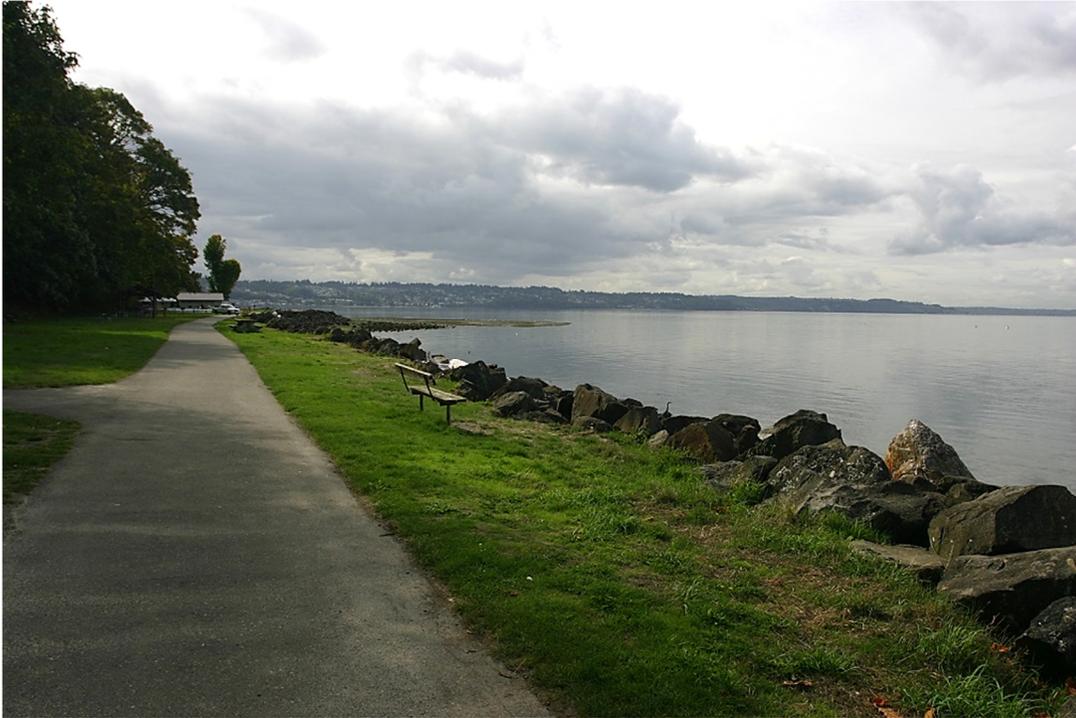
This memorandum provides a brief synopsis of the archeological and built environment resources at Saltwater State Park, as well as the results from the archaeological monitoring by Amec Foster Wheeler Environment & Infrastructure, Inc. (Amec Foster Wheeler) of eight geotechnical test pits that were excavated within Saltwater State Park on September 15-16, 2015 (**Photograph 1**). The

Photograph 1. Saltwater State Park, view is south from Test Pit #8.

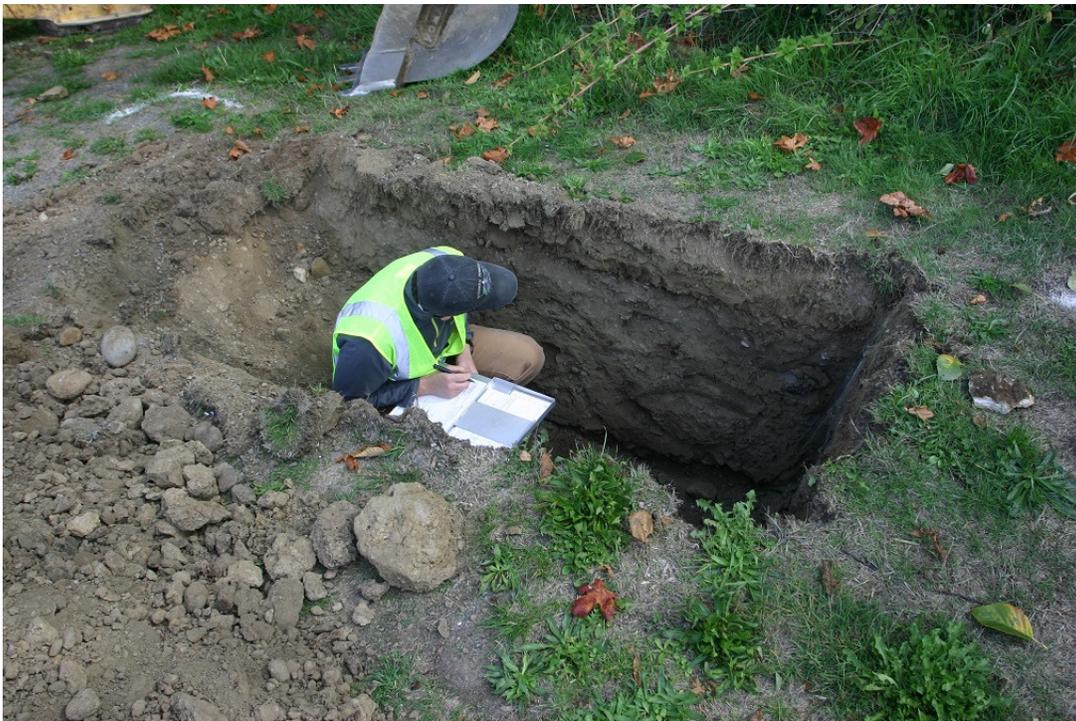
Photograph 2. Geologist inspecting west-facing profile of Test Pit #8 at Saltwater State Park.

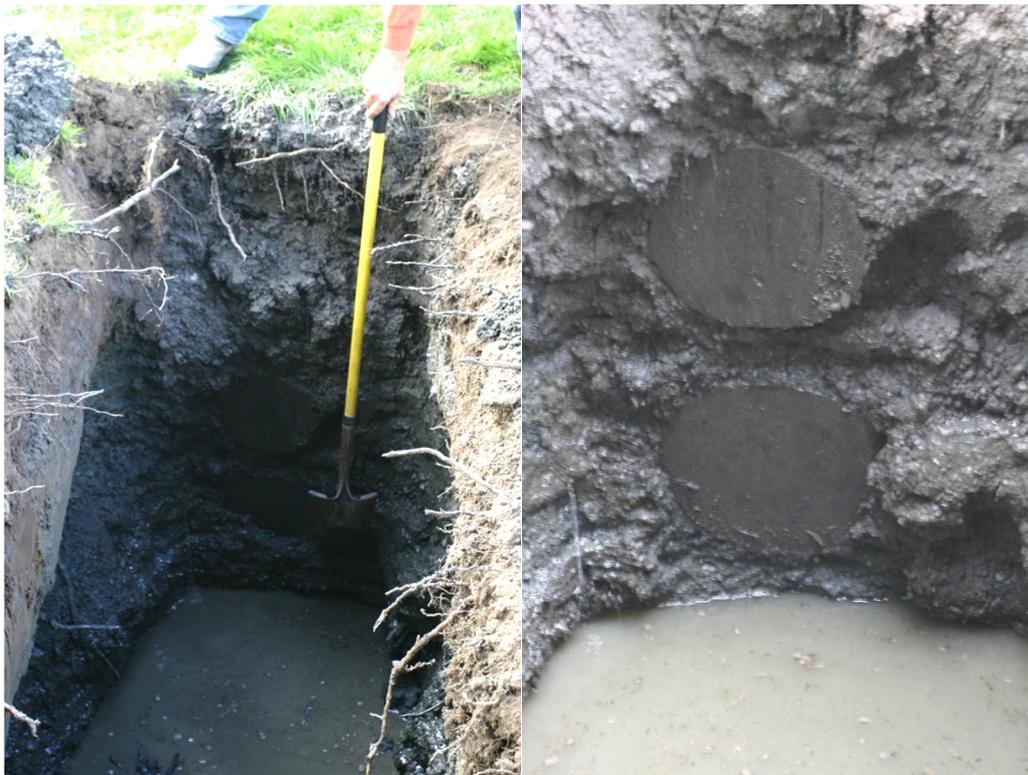
In TPs #2 and #3, historic period archaeological resources were identified. TP #2, which was located nearest to the site boundary of 45KI436 (**Figure 2**), revealed two buried saw cut poles approximately 76 centimeters (30 inches) below the surface (**Photograph 3A**). The poles, which are likely remnants of an abandoned revetment used to manage the former course of McSorley Creek, were exposed at the southern end of the test pit in profile. The poles measure 1-foot in diameter and are separated by approximately six inches (**Photograph 3B**). The length of the poles is unknown. Notes and photographs of the poles were taken and the test pit was backfilled.

Photograph 3. A. View of the south wall (north-facing) profile in Test Pit #2 exposing two saw cut poles next to shovel. B. Close-up view of two stacked saw cut poles in Test Pit #2, view is south.

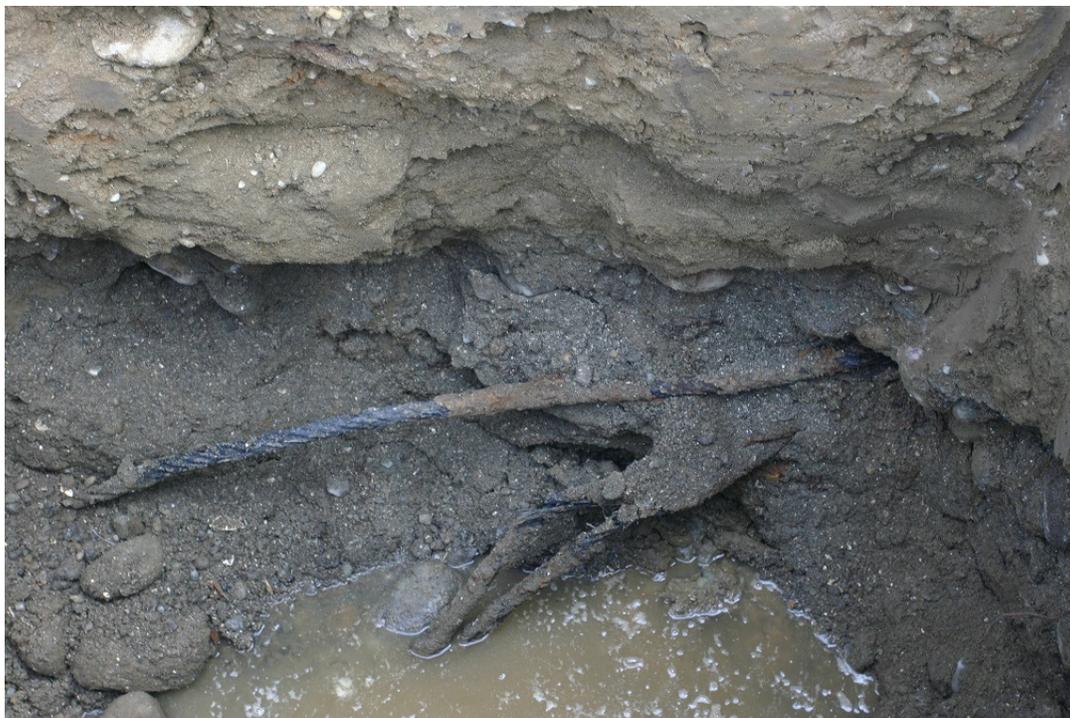
Photograph 4. An abandoned steel cable identified in Test Pit #3 likely associated with Saltwater State Beach's bulkhead that was partially removed.

State of Washington archaeological site forms for the two historic-period archaeological resources identified during the monitoring of the eight geotechnical pits at Saltwater State Park need to be filled out and submitted to DAHP for Smithsonian Trinomial assignment. This will be accomplished during the Project's cultural resources assessment, which is scheduled for 2016.

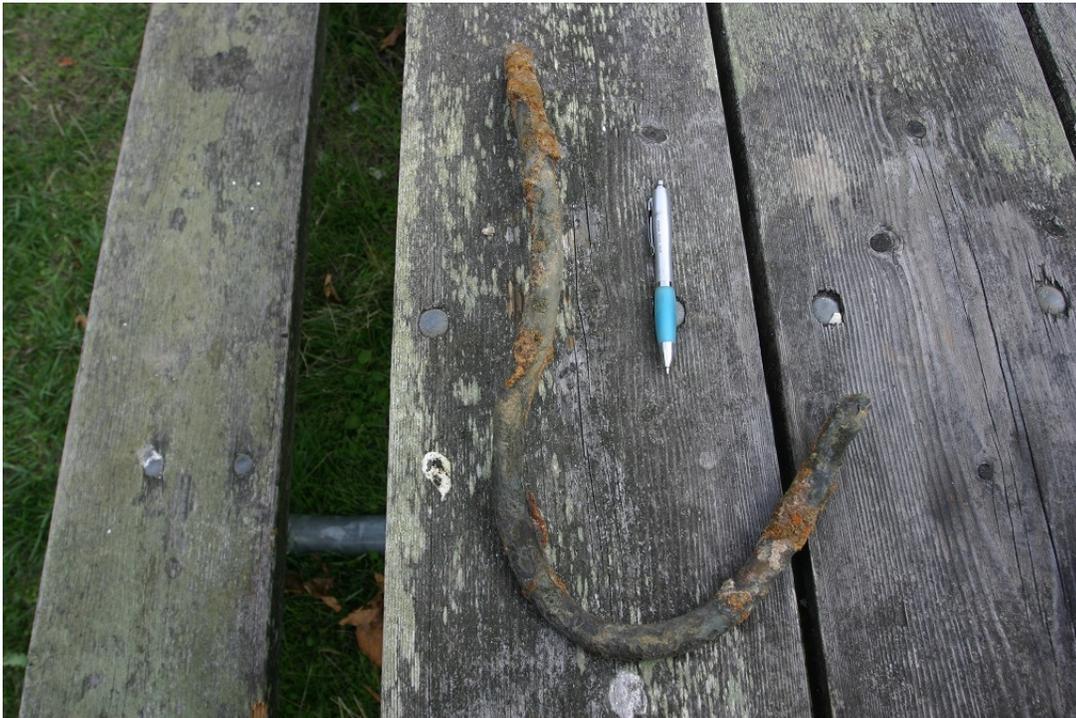
Photograph 5. Steel hook or clasp recovered from Test Pit #3 immediately above the buried steel cable.

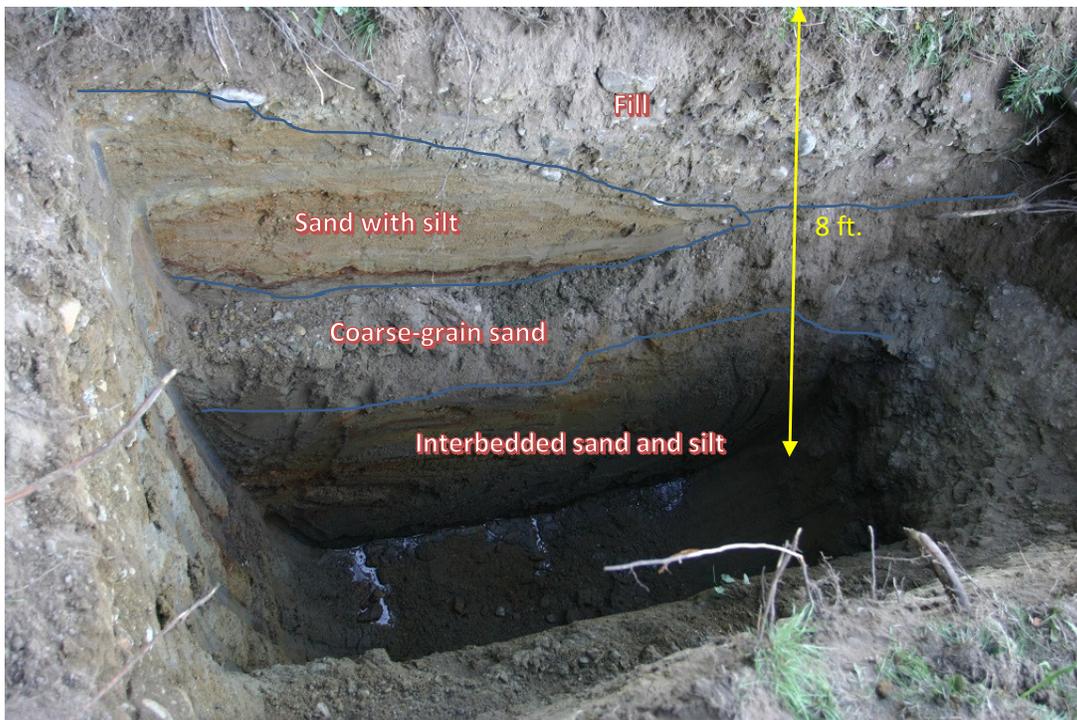
TP #1 was one of two geotechnical test pits that did not contain any shell. It also provided the most interesting stratigraphic profile of all eight test pits (**Photograph 6**). Fill material was identified in the top 20 to 60 centimeters (7 to 23 inches) of the test pit with the shallowest fill deposit along the northern end of the pit. The fill material is likely a result from the construction of the road/bridge prism that supports the park's access over the current course of McSorley Creek. An intact wedge of sand with silt is present from the test pit's north wall (south-facing) sitting atop a 45-centimeter (18-inch) thick deposit of coarse-grain sand. The stratigraphic contact between the sand with silt wedge and coarse-grain sand is a thin lens of soil oxidation

reduction. Below the coarse-grain sand, is a return to an interbedded sand with silt layer extending down to approximately 2.5 meters (8 feet) below the surface.

Photograph 6. View of the stratigraphic profile of Test Pit #1's east wall (west-facing), looking east.

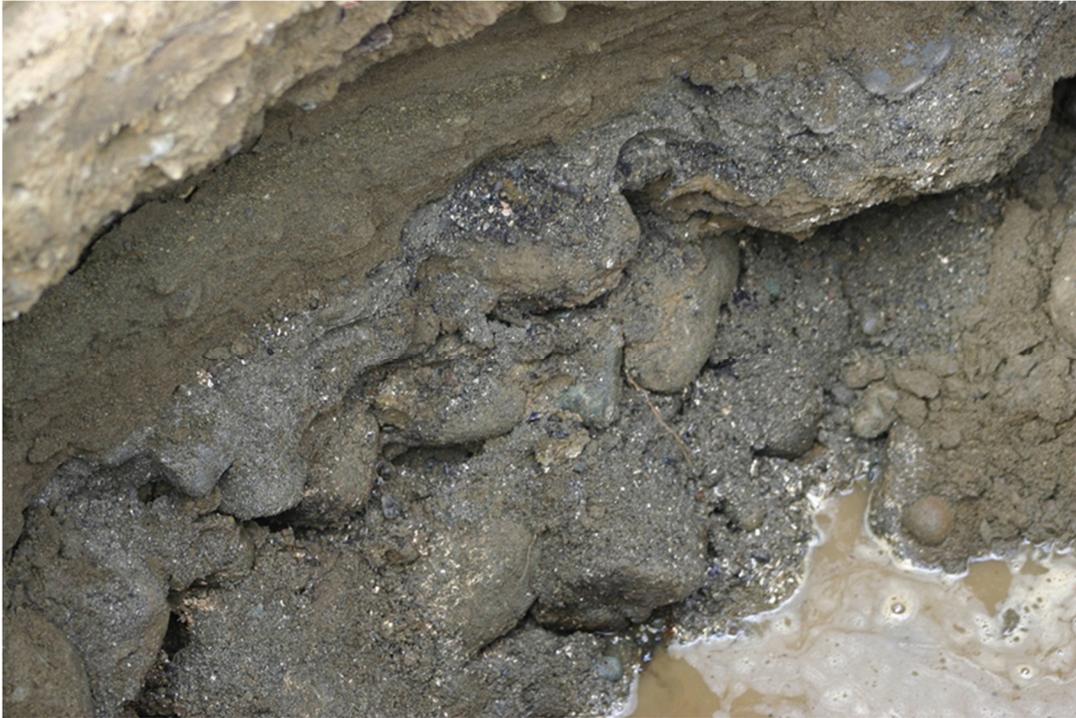
TP #3 is located along a portion of previously removed bulkhead within Saltwater State Park (**Figure 3**). Fill material was observed in the top 45 to 60 centimeters (18 to 24 inches) below the surface. Sand with silt continued down until changing over to a coarse-grain sand approximately 120 centimeters (48 inches) below the surface. It was at this sediment transition that the steel hook (**Photograph 3B**) was recovered. And it was another 15 to 30 centimeters (6 to 12 inches) into the coarse-grain sand that the steel coiled cable was uncovered. Below the abandoned bulkhead anchoring system, a layer of fine-grain sand was observed sitting atop a coarse-grain sand lens with both rounded cobbles and pulverized shell fragments (**Photograph 7**). This coarse-grain sand with rounded cobbles appears to be stratigraphic horizon associated with a former streambed of McSorley Creek directly below a period of stable and low-energy beach development (i.e., fine-grain sand).

Photograph 7. Stratigraphic profile at the bottom of Test Pit #3 showing a fine-grain sand lens atop a coarse-grain sand lens with both rounded cobbles and pulverized shell fragments.

The 2016 cultural resources assessment will need to focus on the buried beach deposits, especially located near TP #3 and TP #4, in an attempt to locate any cultural material in association with the observed natural beach deposits. An archaeological work plan describing the cultural resources assessment will need to be developed and reviewed by Parks, DAHP, and affected Native American tribes prior to carrying out the fieldwork. The fieldwork will need to be accomplished by excavating additional trenches in the park with a backhoe, as the excavation of shovel test probes by hand and shovel will not reach the buried beach deposits. In general, shovel test probes excavated by hand can only reach 1-meter (3.2-feet) below the surface. The observed buried beach deposits were largely below this depth. All sediment associated with the buried beach deposits exposed during the excavation of the cultural resources trenches will be screened for cultural material. Tribal monitors from the Muckleshoot and Puyallup tribes shall be present during the excavation of these trenches. Results from this cultural resources assessment will be presented in a DAHP-compliant technical report.

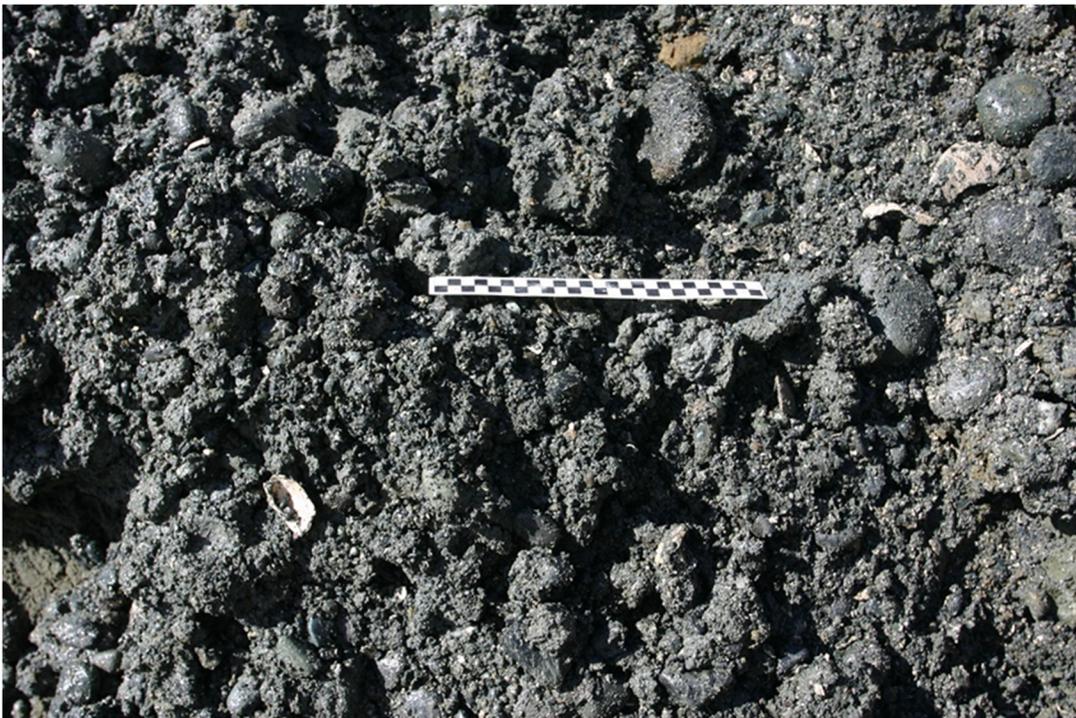
TP #4 is located amongst the made-land associated with the park's bulkhead and re-routed McSorley Creek (**Figure 3**). The made-land consists of imported fill material that was leveled on both sides of the current course of McSorley Creek and behind the bulkhead. The made-land was created during original park improvements. Fill dominated the top 1-meter (3.2-feet) of the test pit, with a thick sand with silt deposit below it. Two to 3 meters (6.5 to 9 feet) below the surface the water table appeared along with a coarse-grain sand with silt (gley) deposit (**Photograph 8**). Identifiable shell fragments were documented within this sediment, but no cultural midden (i.e., FMR, lithics, and/or bone) was observed in the pit. This stratigraphic horizon appears to represent a very old beach deposit that has the best potential for unknown

and significant cultural resources, although no archaeological material was identified during the monitoring effort of TP #4. Regardless, this area at this depth (i.e., 2 to 3 meters below surface) maintains the best chance of maintaining intact cultural deposits based on the results of the archaeological monitoring.

Photograph 8. Coarse-grain sand deposit mixed with silt (gley), shell fragments, and rounded cobbles from the bottom of Test Pit #4.
