Appendix J:  
Annotated Summary of  
Maintenance Requirements and  
Actions

## APPENDIX J –MAINTENANCE ACTIONS

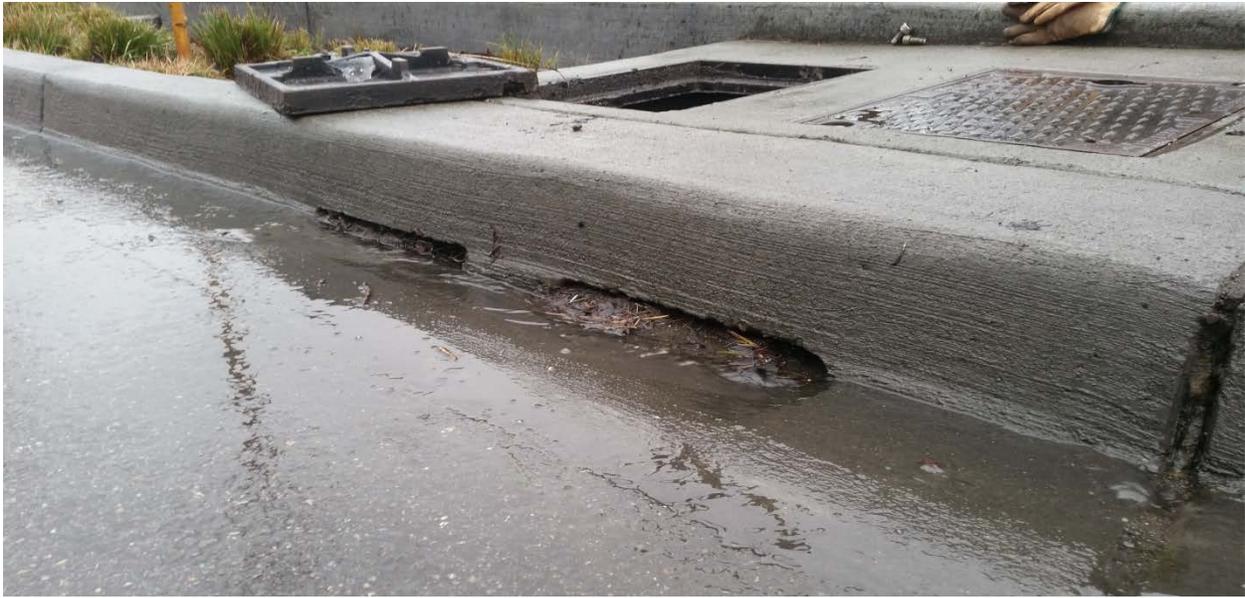
**Figure J-1. Debris blocking curb cuts at BPB1 inlet (January 21, 2016).**

As described in Section 2.3 of the main report, maintenance issues were impeding treatment at the bioretention planter boxes (BPBs) and Filterra® at various points of the study. The following provides a log of the maintenance performed at the site by City of Shoreline contracts (Table J-1). Despite these efforts, the BPB inlets (i.e., curb cuts to roadway) were frequently blocked. The project field crew frequently cleared the inlets to the BPB. They estimated curb cuts would need to be cleared as frequently as every other week at the height of the storm season to maintain their function.

It was unclear how street sweeping affected these maintenance needs. The field crew observed that sweeping would sometimes clear the BPB curb cuts, and other times block them more completely. This could be due to a several variables, including the distance of the sweeper from curb, the amount of debris on the roadway, and the time elapsed since the last curb cut cleaning.

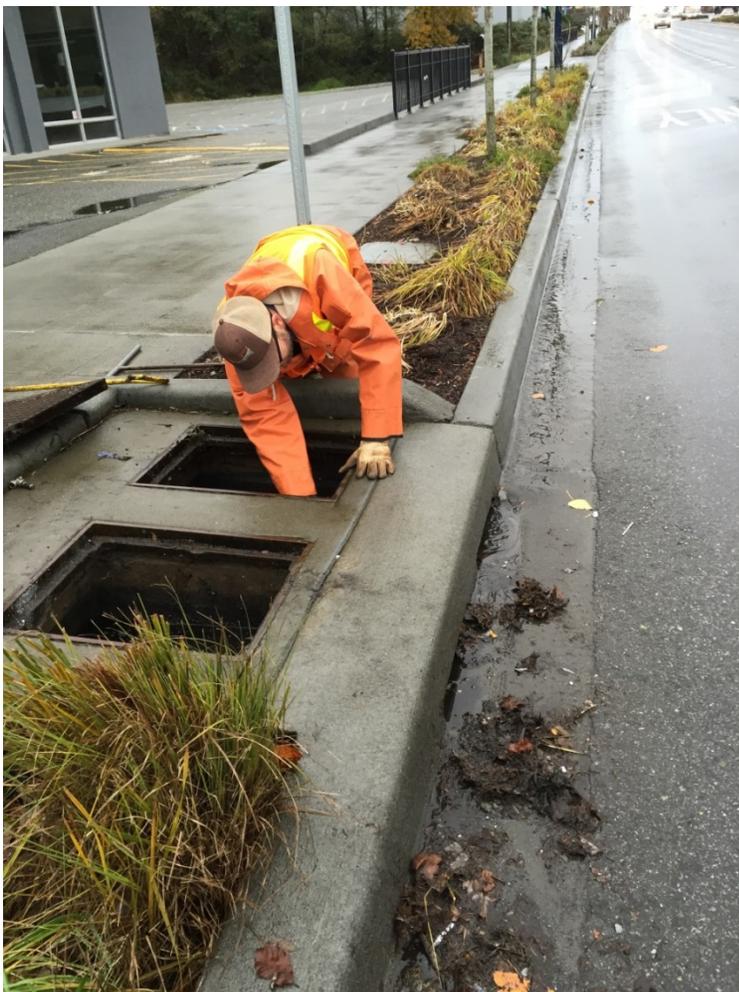
**Figure J-2. Clearing debris blocking curb cuts at BPB1 inlet (December 3, 2015).**

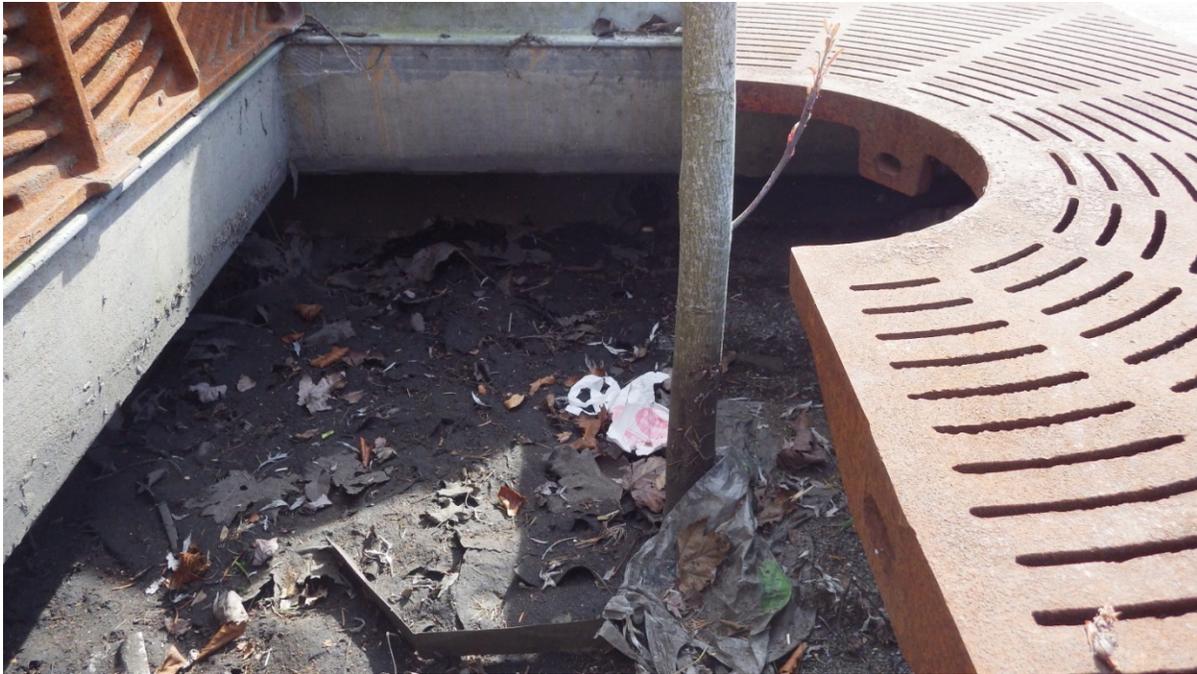
Additionally, the Filterra were draining at the beginning of this project. The media was replaced in September 2015. By the end of the project sampling period in March 2017 the media again needed to be replaced. It is likely that the Filterra were plugged by sediment build up at the surface of the media.

**Figure J-3. Sediment at the top of Filterra media (April 4, 2014).**

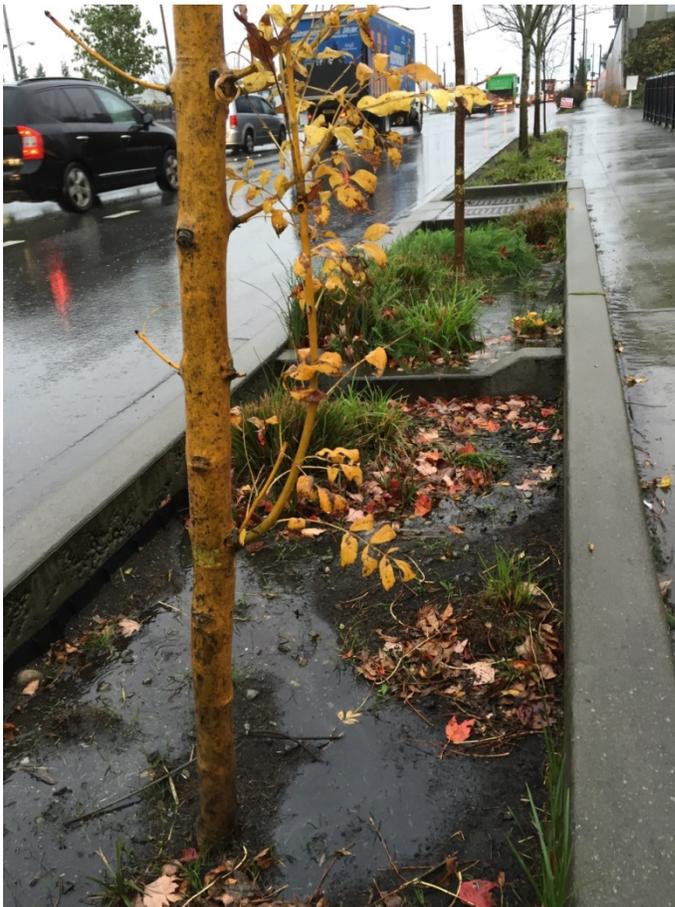
**Figure J-3. Sparse vegetation and yellowed trees at BPB2 - this did not appear to affect performance (October 26, 2016).**
