Preliminary Assessment for January 2009 Flood Magnitudes for King County Watersheds

Climate Change Impacts on River Flooding: State-of-the-Science and Evidence of Local Impacts

2009 Year 1 Post-Construction Monitoring of the Stuck River Drive Revetment Repair, White River

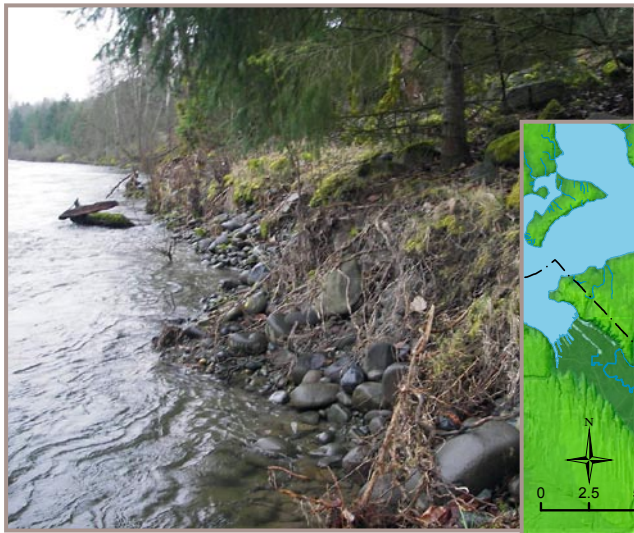
Photo 1. An eroded portion of the Stuck River revetment taken from the White River looking upstream just above the R Street Bridge. Photo: Ray Timm.

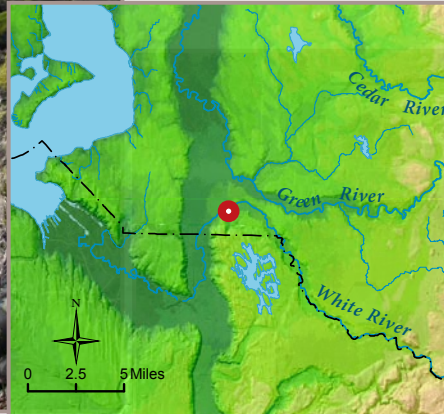
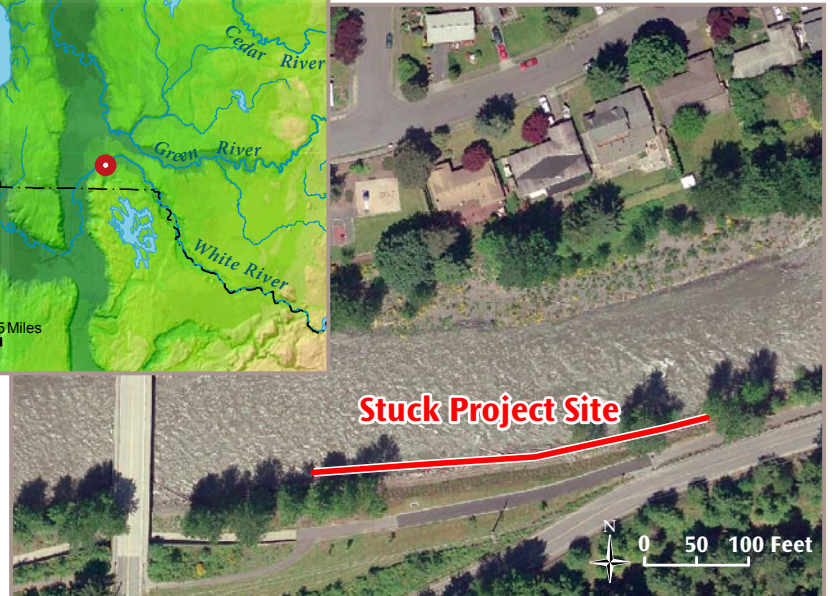
Map 1 & Photo 2. Regional/Vicinity map with approximate location of Stuck River Revetment Repair Project, topographic bed survey (light blue line), 7.5 miles above the confluence with the Puyallup River. Note, the bridge in the photo is R Street. Inset shows approximate location of project in the drainage.

The project site is on the left bank of the White River in the City of Auburn. The site is within a broad floodplain area about 7.5 miles upstream of the White River's confluence with the Puyallup River (Map 1, Photo 2). The left bank in this location is hardened continuously for about 2.5 miles upstream from the project site, and flow velocities along the left bank and throughout this reach can be high for fish during flood events. Because the site is in a reach that is largely confined by flood protection facilities, there is very little low velocity habitat or refuge for juvenile fish. The White River also carries a high sediment load.

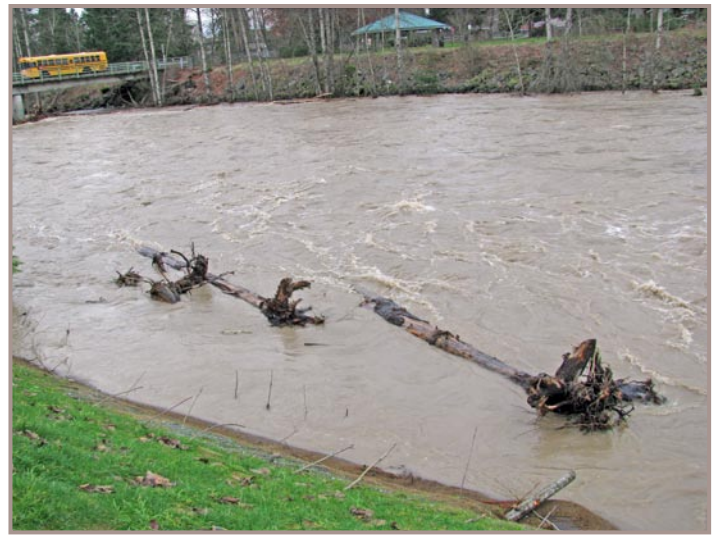
Photo 3. Stuck River Revetment Repair site during 12,200 cfs event, Jan. 9, 2009. Notice the difference in water velocities between the large wood and the bank, and channelward of the wood. Photo: Terry Butler.

The bank was indeed protected from damage during the January 2009 flood. Post-flood inspections revealed an intact facility with no signs of erosion. In addition, visual inspections close to the peak of the storm discovered slower-moving water around the large wood and boulders, contrasted by swift-moving water in the center of the channel (photo 3). A small amount of flood-borne wood floating downstream was recruited to the revetment repair, but did not cause any damage to the facility or anchored large wood.
