Source Tracing Lower Duwamish Waterway

Seattle Public Utilities
October 24, 2013

Lower Duwamish Waterway

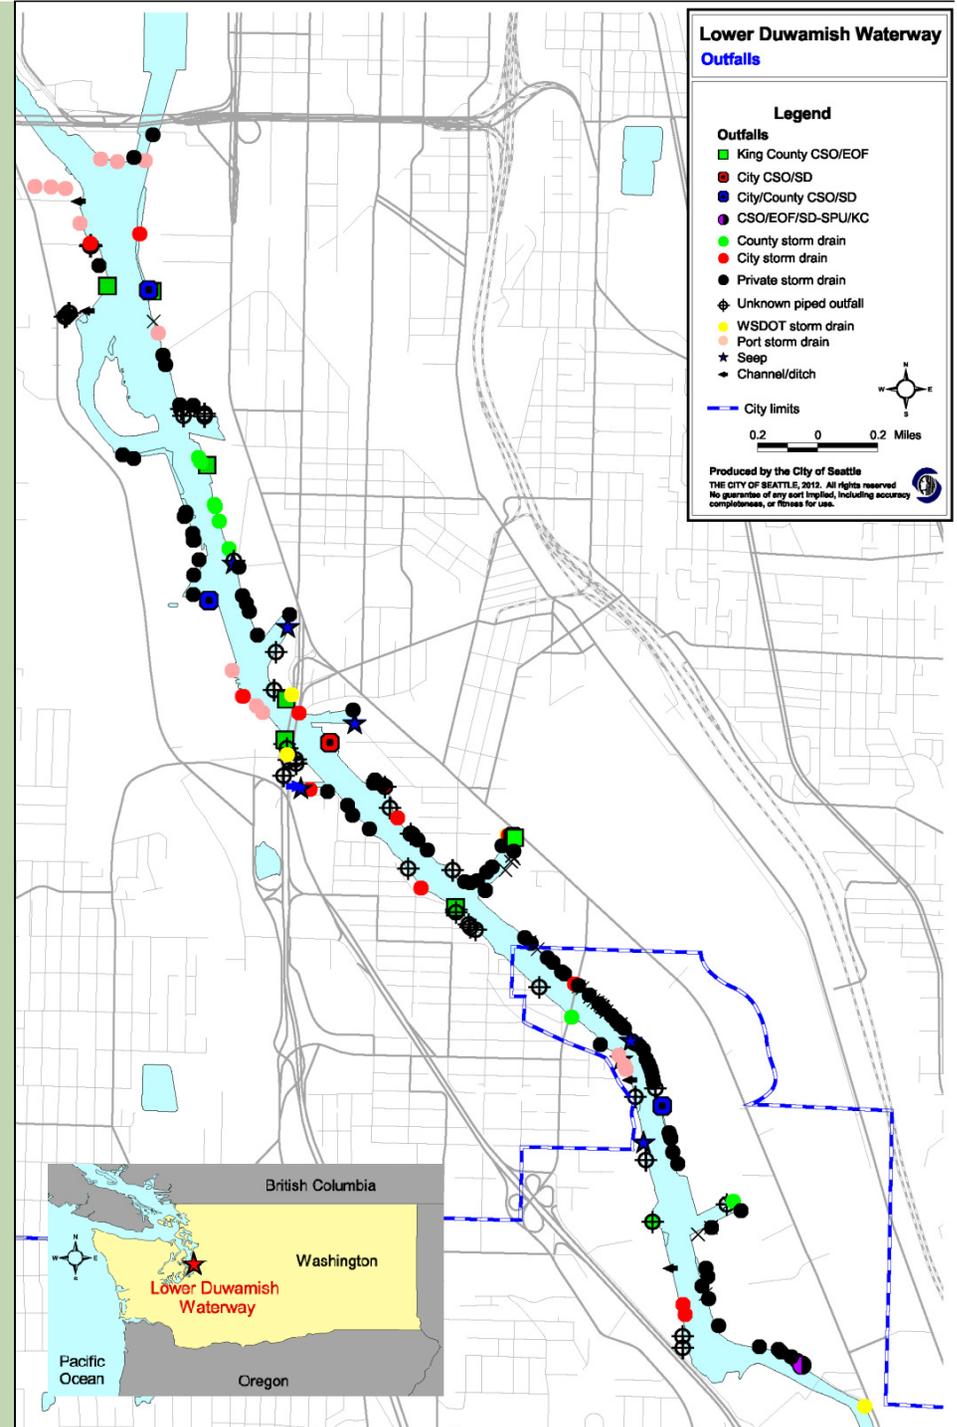
- 5 mile reach
- Tidally influenced

215 outfalls

- 151 storm drains
- 8 CSOs
- 4 emergency overflows
- 5 ditches/swales
- 7 major seeps
- 40 unknown outfalls

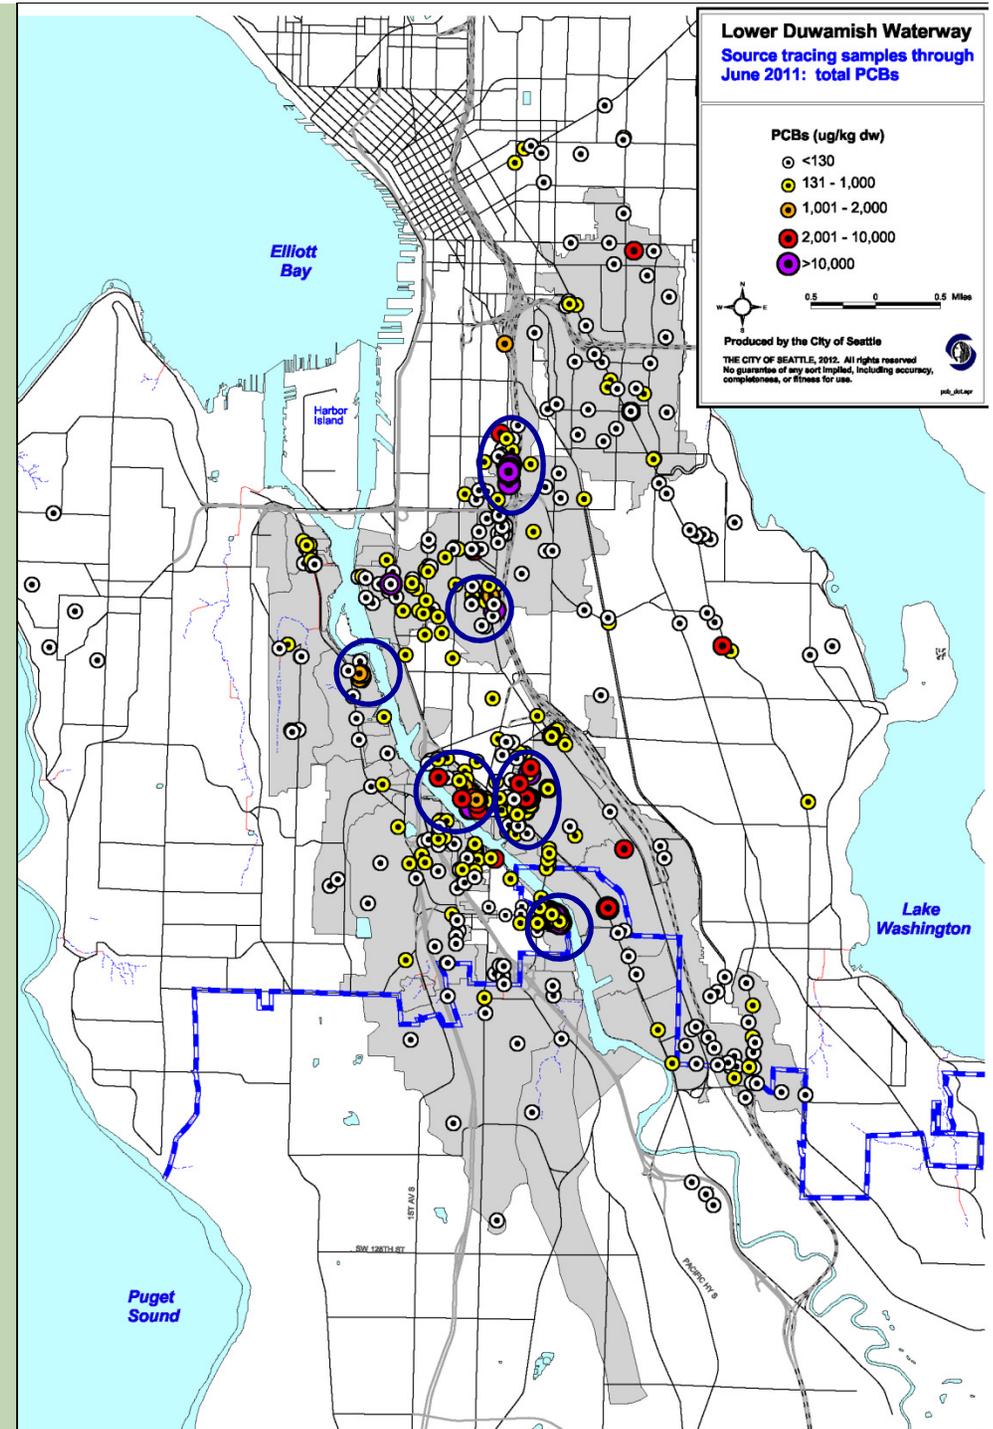
Source Tracing: PCBs

Samples through Dec 2012

Hotspots

- T117
- GTSP/NBF
- KC-Jorgensen SD
- Rainier Commons
- Others

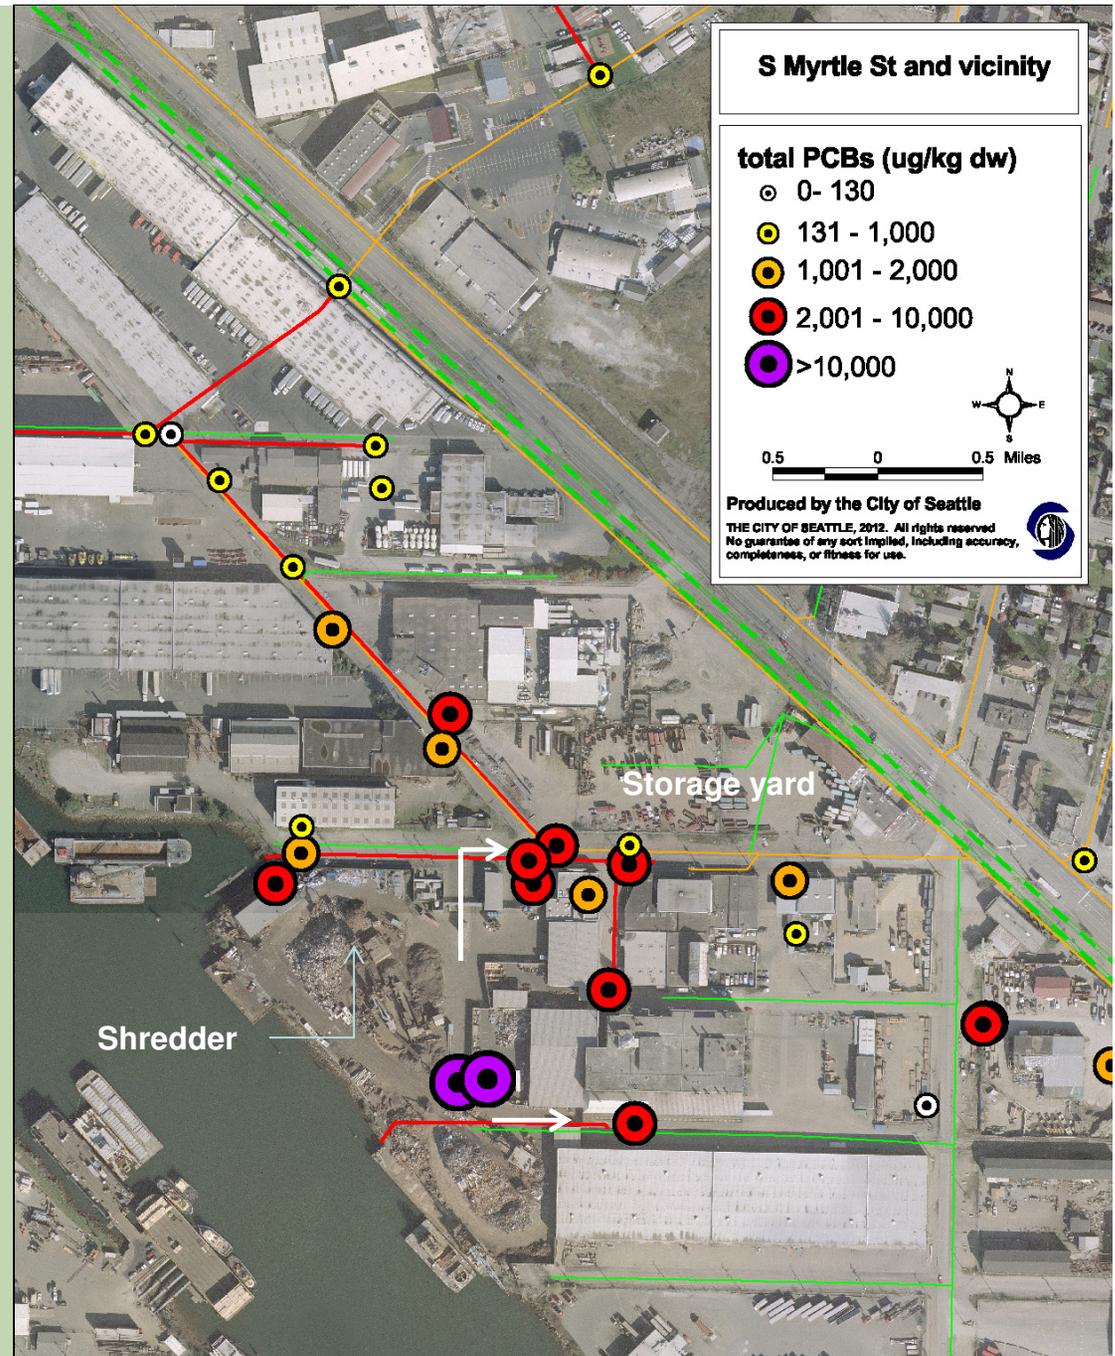
Metal Shredding Facility

- Elevated PCBs, Hg found:
 - Right-of-way and onsite catch basins
PCBs = 18.3 mg/kg
Hg = 2.72 mg/kg
 - Inline grabs
PCBs = 1.6 mg/kg
Hg = 1.88 mg/kg
 - Roof drains/gutters
PCBs = 4.6 mg/kg
Hg = 2.56 mg/kg
- Transport pathways:
 - Fugitive dust
 - Track out
 - Stormwater runoff

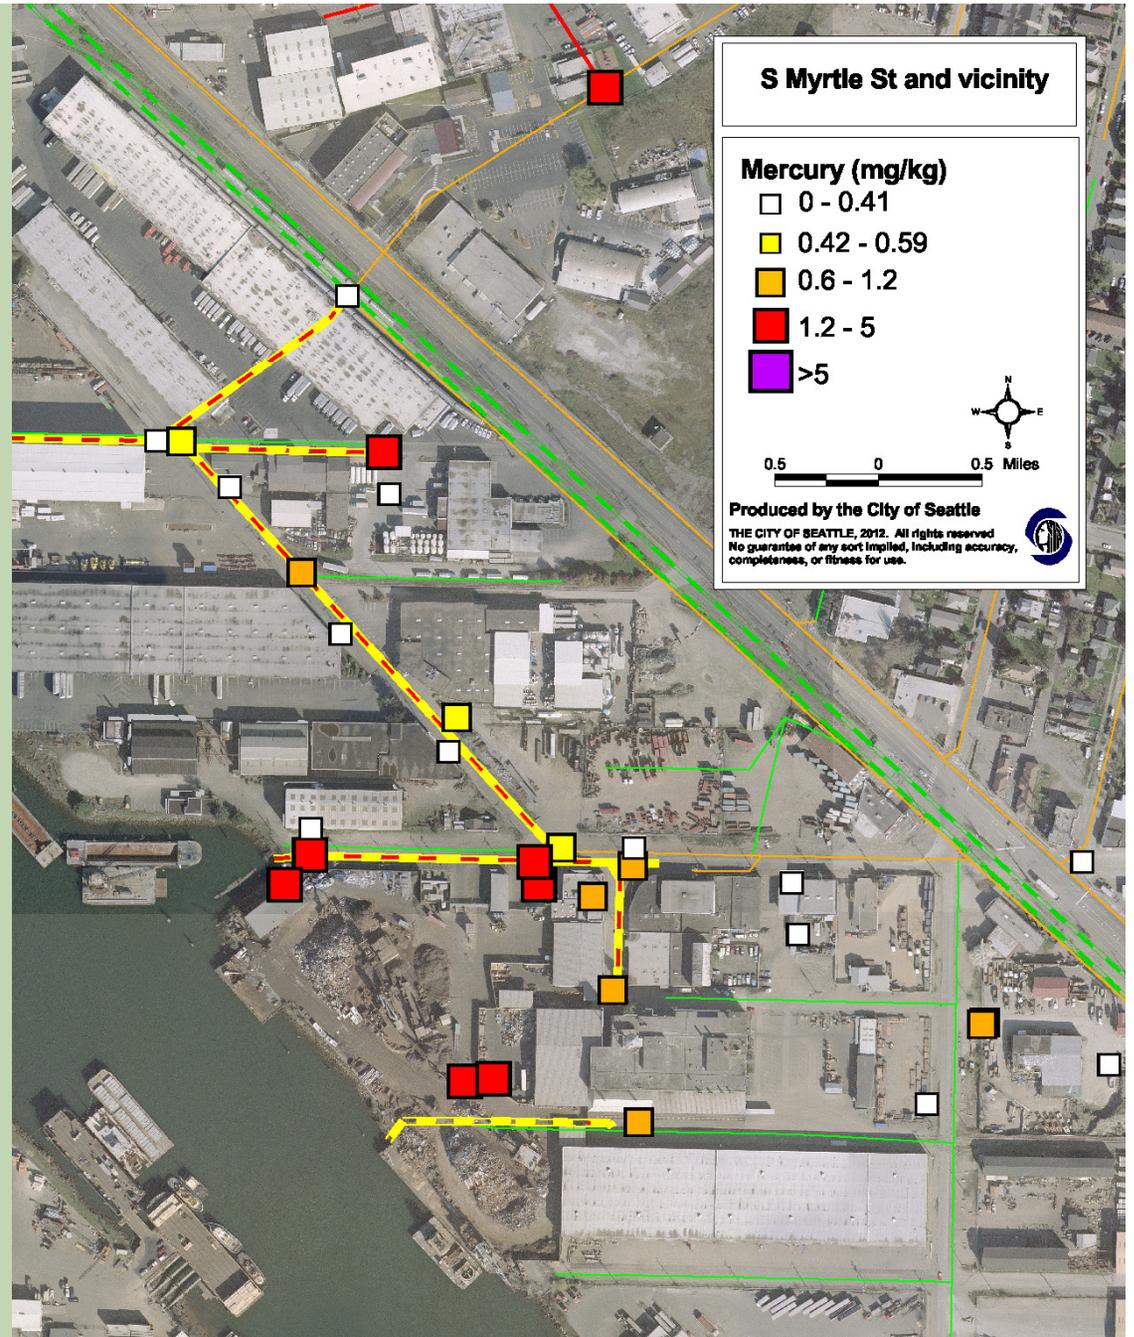
Metal Shredding Facility

- SPU cleans storm drains in 2009-2010
- PCBs and Hg elevated in CB adjacent to driveway entrance within 6 months
- CB cleaned several times, but PCBs, Hg remain elevated

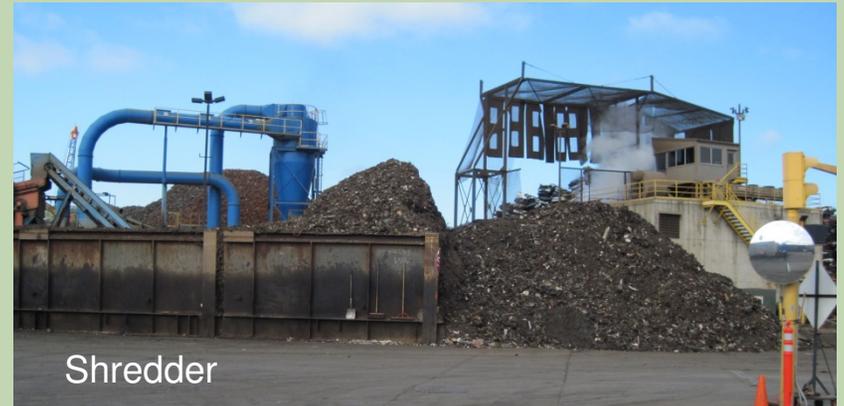
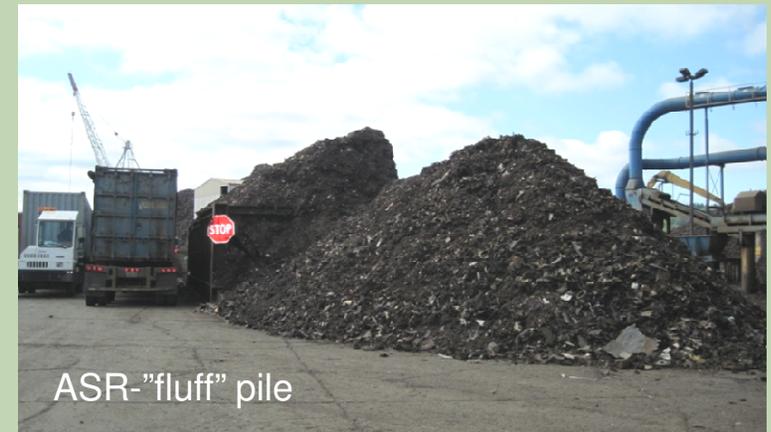
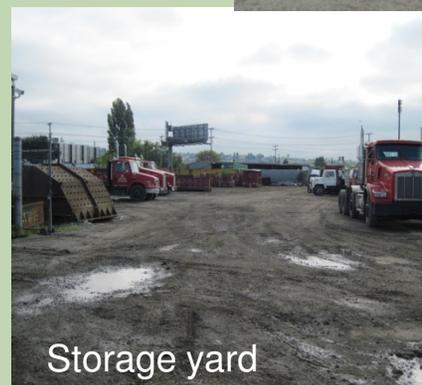
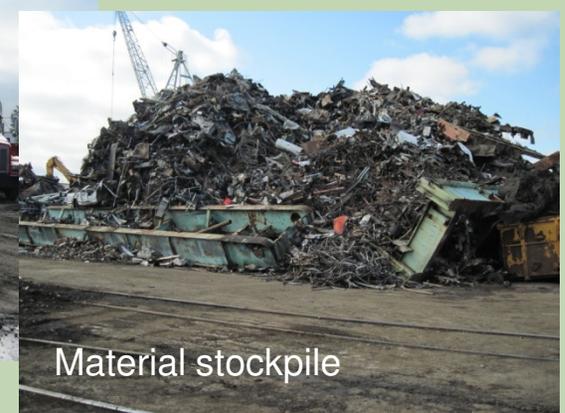
Metal Shredding Facility

- SPU issued NOV (2009), negotiated voluntary compliance agreement (2010-2011)
 - Route roof runoff through onsite treatment system
 - Sweep streets
 - Install Filterra™ unit in problem catch basin
- State revising NPDES permit

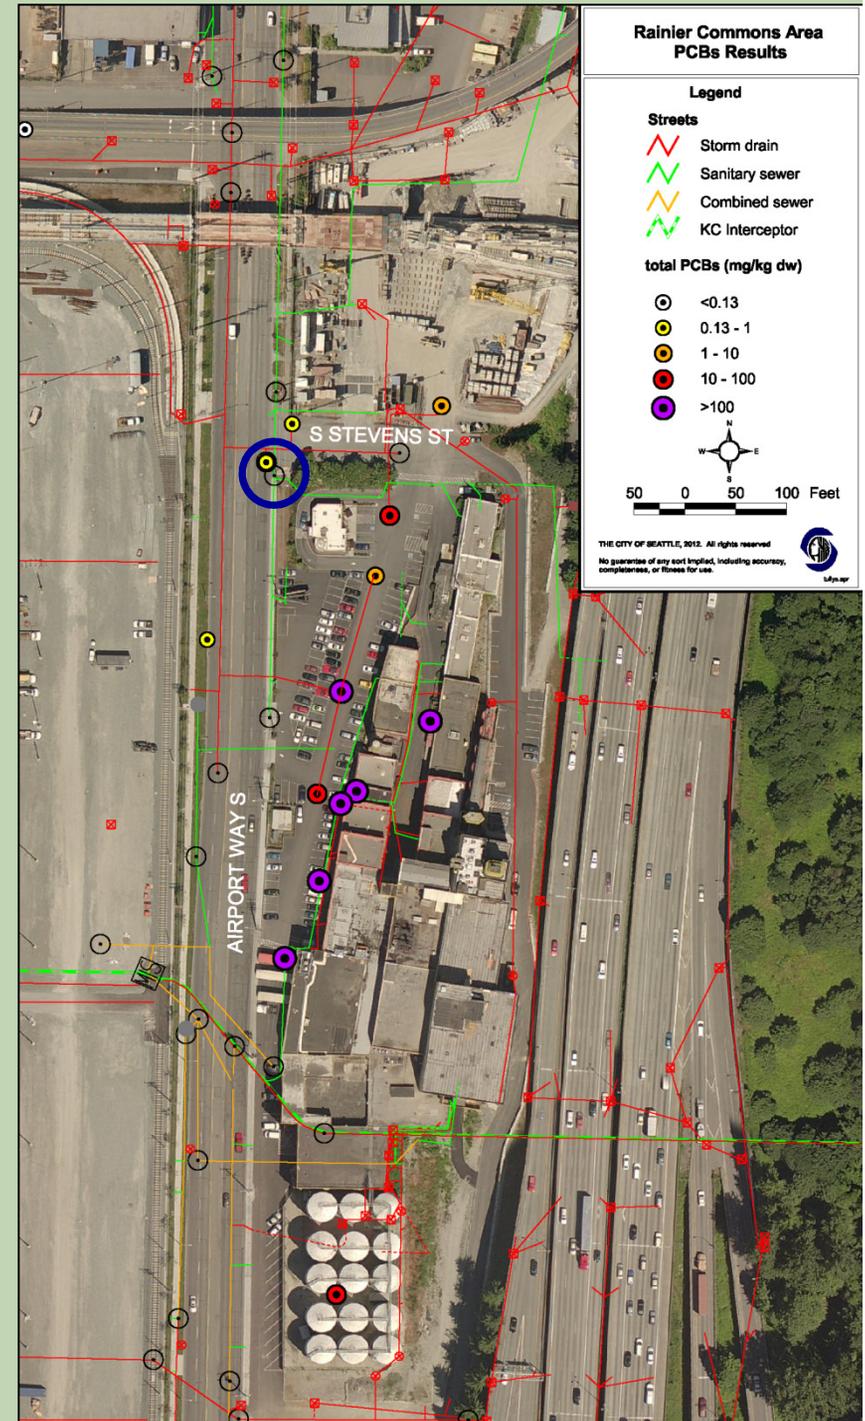
Old Brewery

PCBs in building paint

- 2004: Found 10 mg/kg PCBs in ROW catch basin
- Up to 321,000 mg/kg in exterior building paint
- EPA TSCA site
- 2013: EPA reviewing Work Plan for cleanup

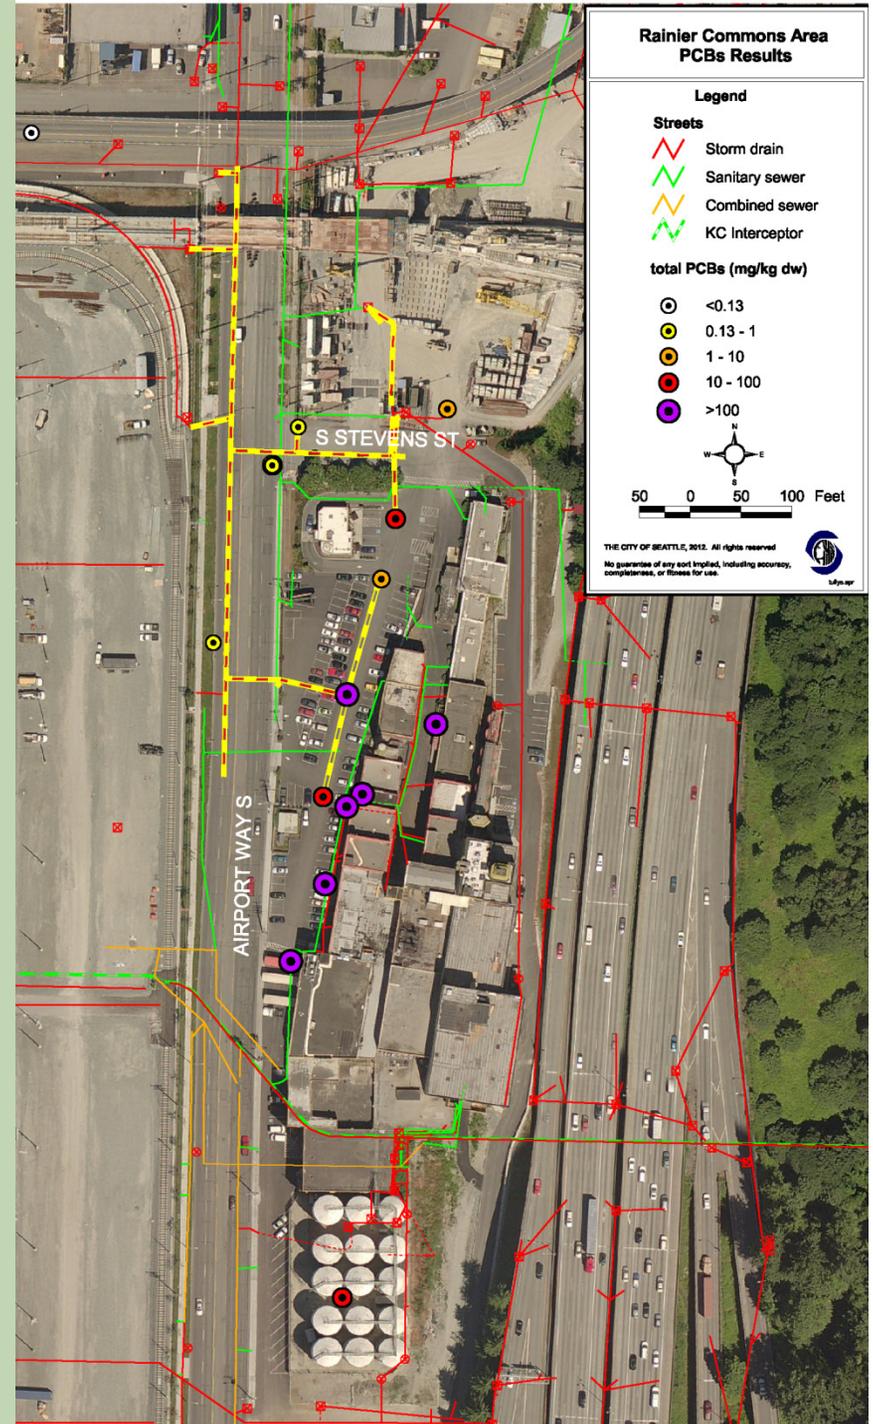
Old Brewery

PCBs in building paint

- 2004: Found 10 mg/kg PCBs in ROW catch basin
- 2008: SPU jets and cleans lines
- Owner installed filter fabric in CBs
- 2012: SPU re-samples lines
PCBs elevated (7.3 – 12.4 mg/kg)
- 2013: Rainier Commons jets and cleans lines again.

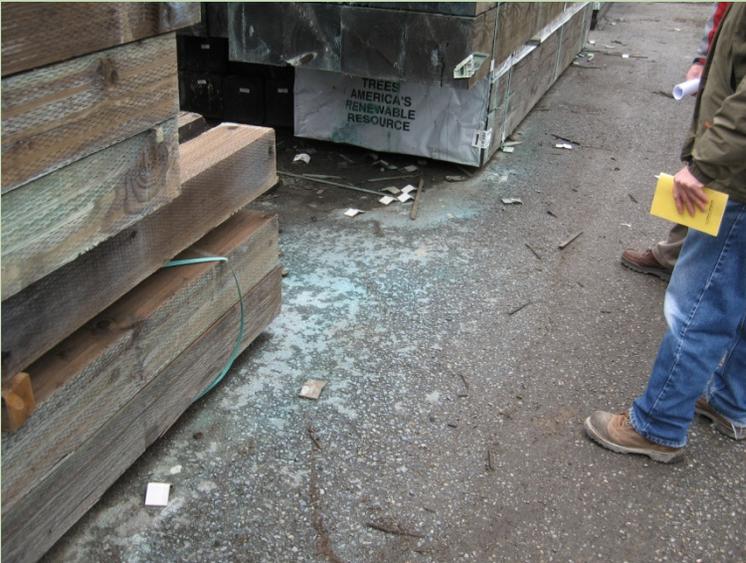
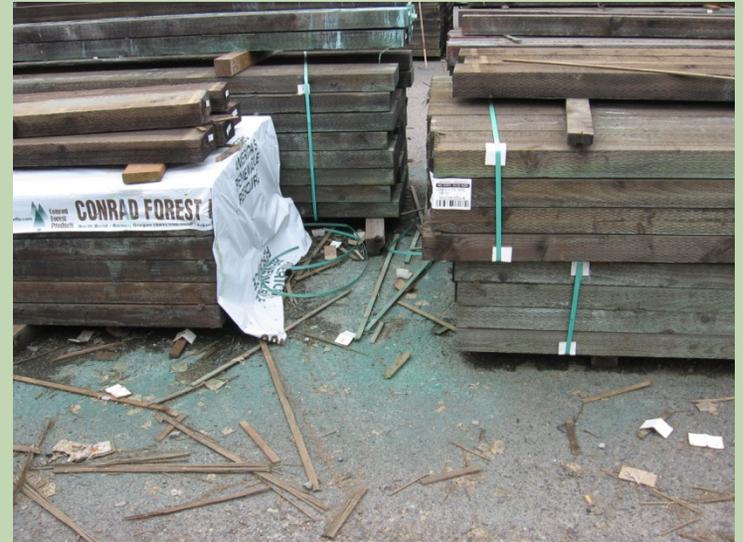
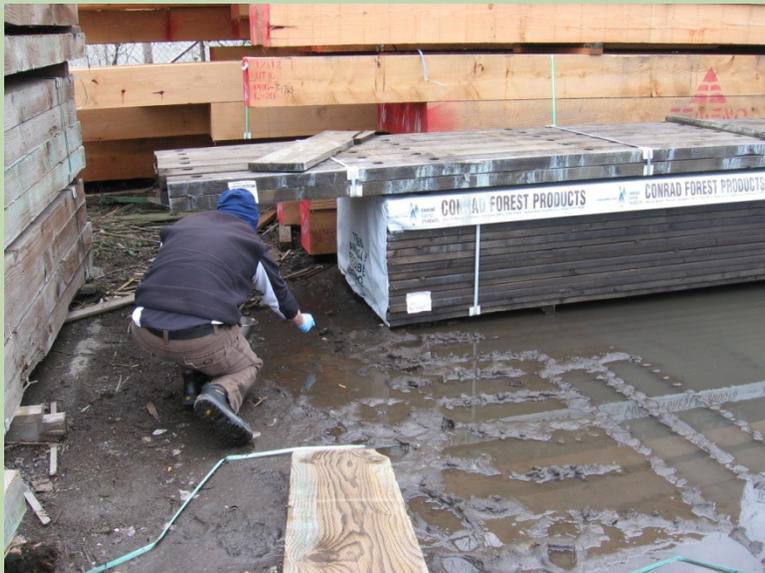
Arsenic

- Marine lumber storage yard
- Ammoniacal copper zinc arsenate (ACZA)
- 710 mg/kg As in dirt in yard
- 750 mg/kg As in ditch in street

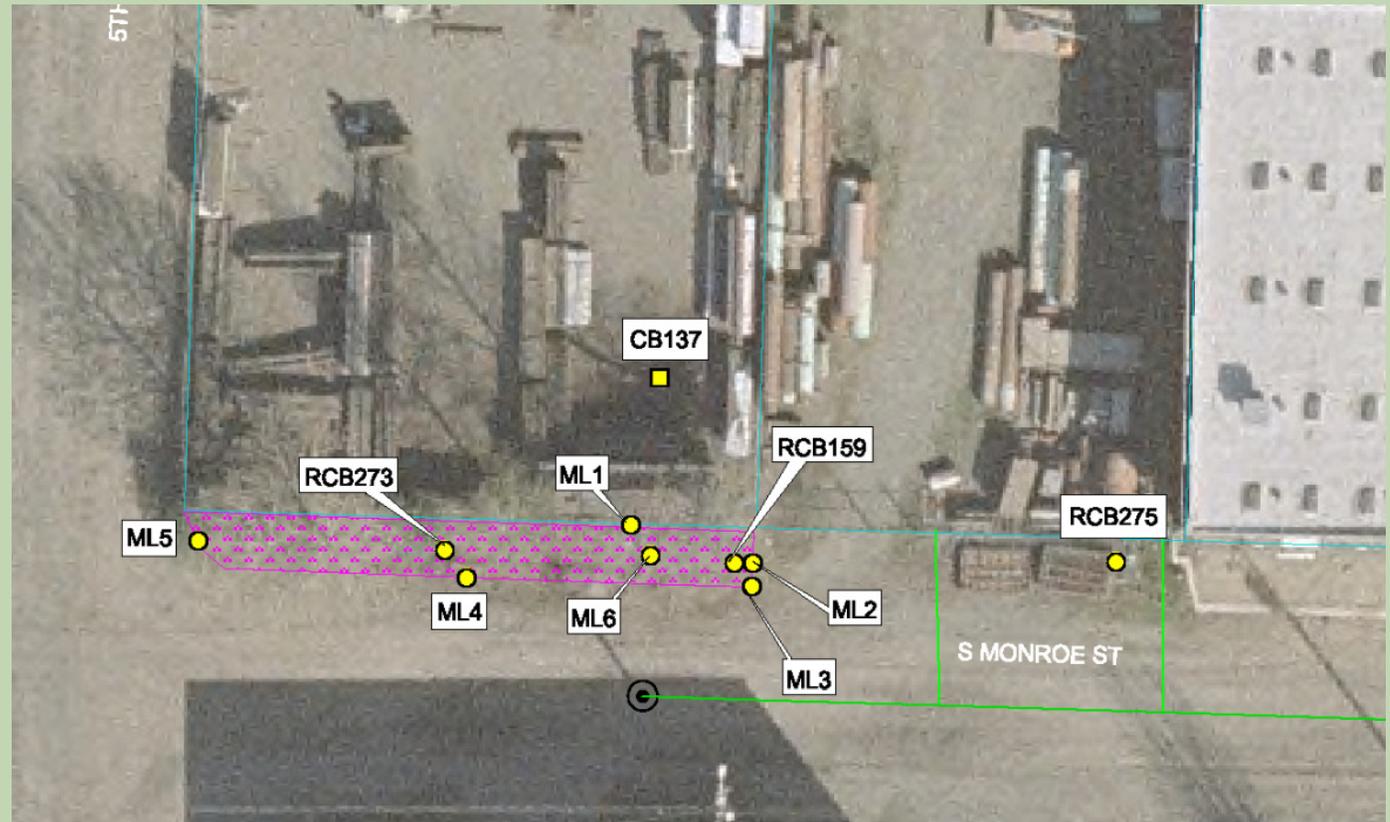
Arsenic

- Find 544 mg/kg As in ditch downstream of property
- Ecology order owner to cleanup
- Owner cleans up 10' x 100' section of ROW
- Up to 220 mg/kg As remains at edge of excavation
