King County

Science Seminar

Monitoring Water Quality in Central Puget Sound During the West Point Treatment Plant Restoration –

What Impacts Can We Assess?

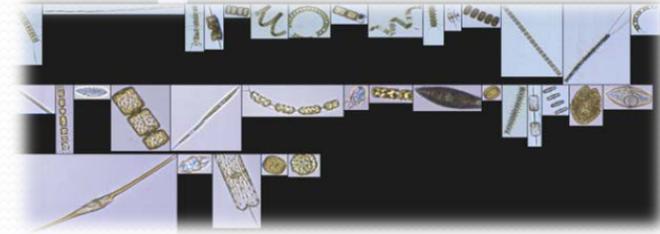
How Do We Monitor Water Quality?

- **Offshore & beach waters**
 - *Physical, chemical, & biological indicators*
 - *Routine sampling for decades*
- **Event response – beach waters**
 - *Fecal indicator bacteria; incident-dependent*
- **Moorings: since 2008**
 - *Automated sensors sample every 15-min*
- **Phytoplankton**
 - *Semi-Quantitative and FlowCam since 2014*
- **Zooplankton**
- **Sediments (offshore and beach)**

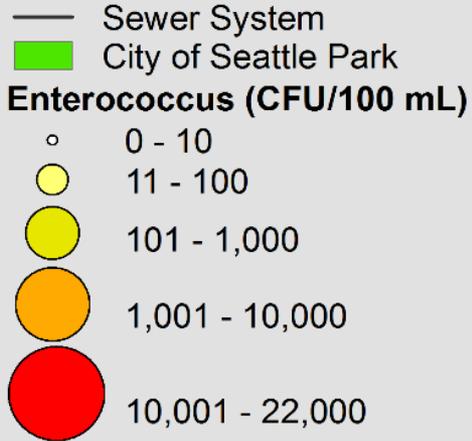
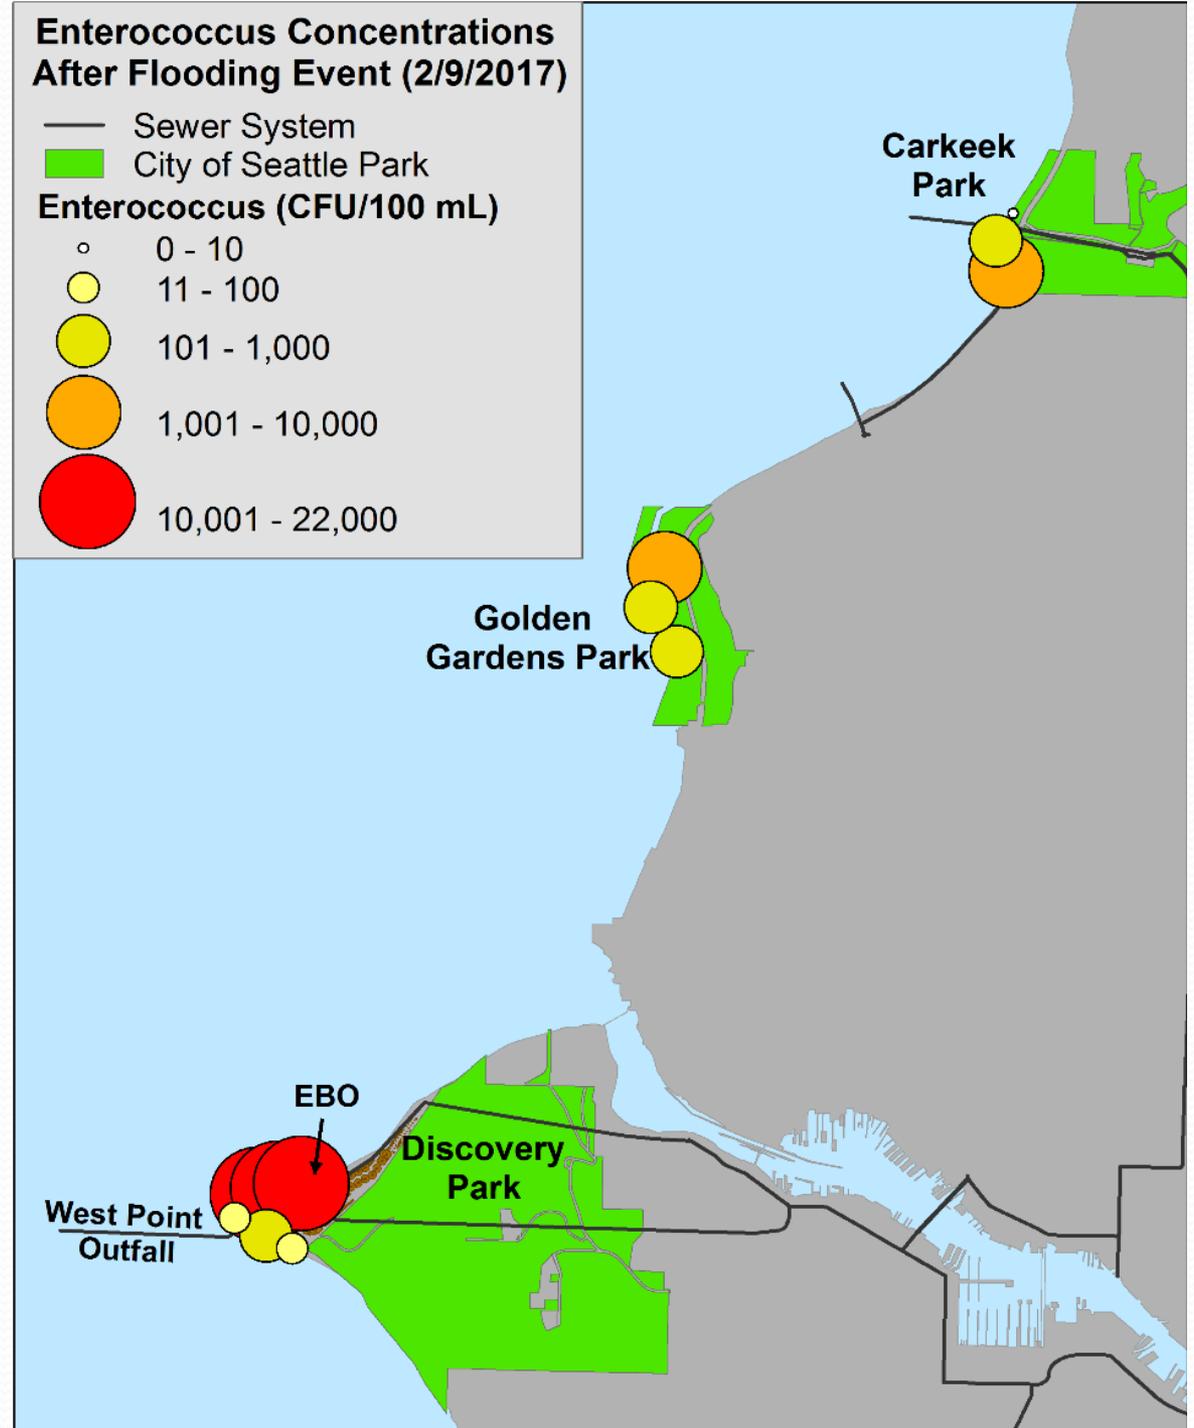
Feb. 9th Bacteria Levels

Enterococcus Concentrations After Flooding Event (2/9/2017)

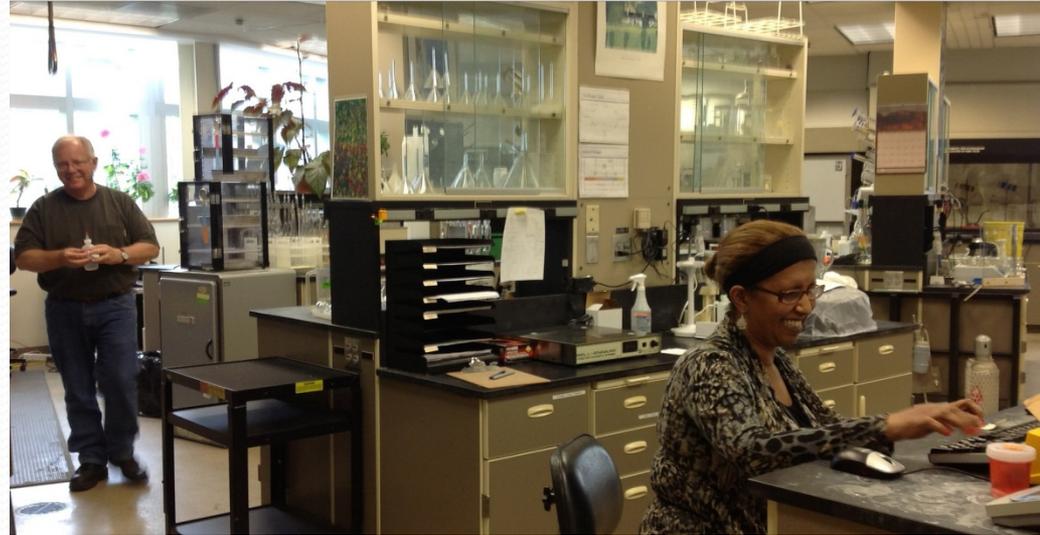
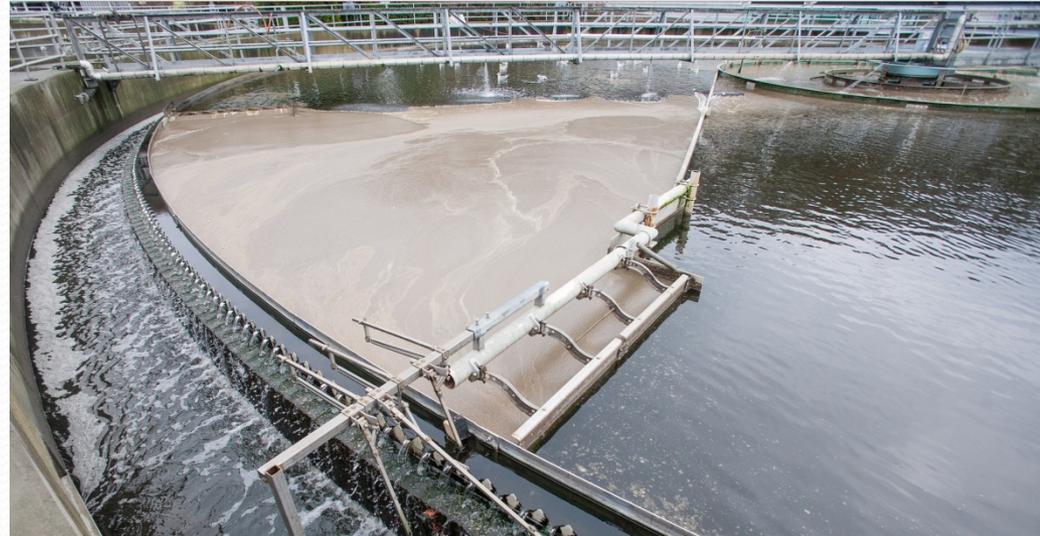
What was observed in the West Point effluent?

- Daily fecal coliform levels variable; met permit limits throughout restoration
- Total suspended solids (TSS) and carbonaceous biological oxygen demand (CBOD) did not meet permit limits until May 10th
- Nutrient levels generally similar to typical conditions
- Trace metals elevated from recent ranges; below historic levels and met mixing zone standards
- Acute & chronic toxicity tests showed no impacts on aquatic organisms in the lab

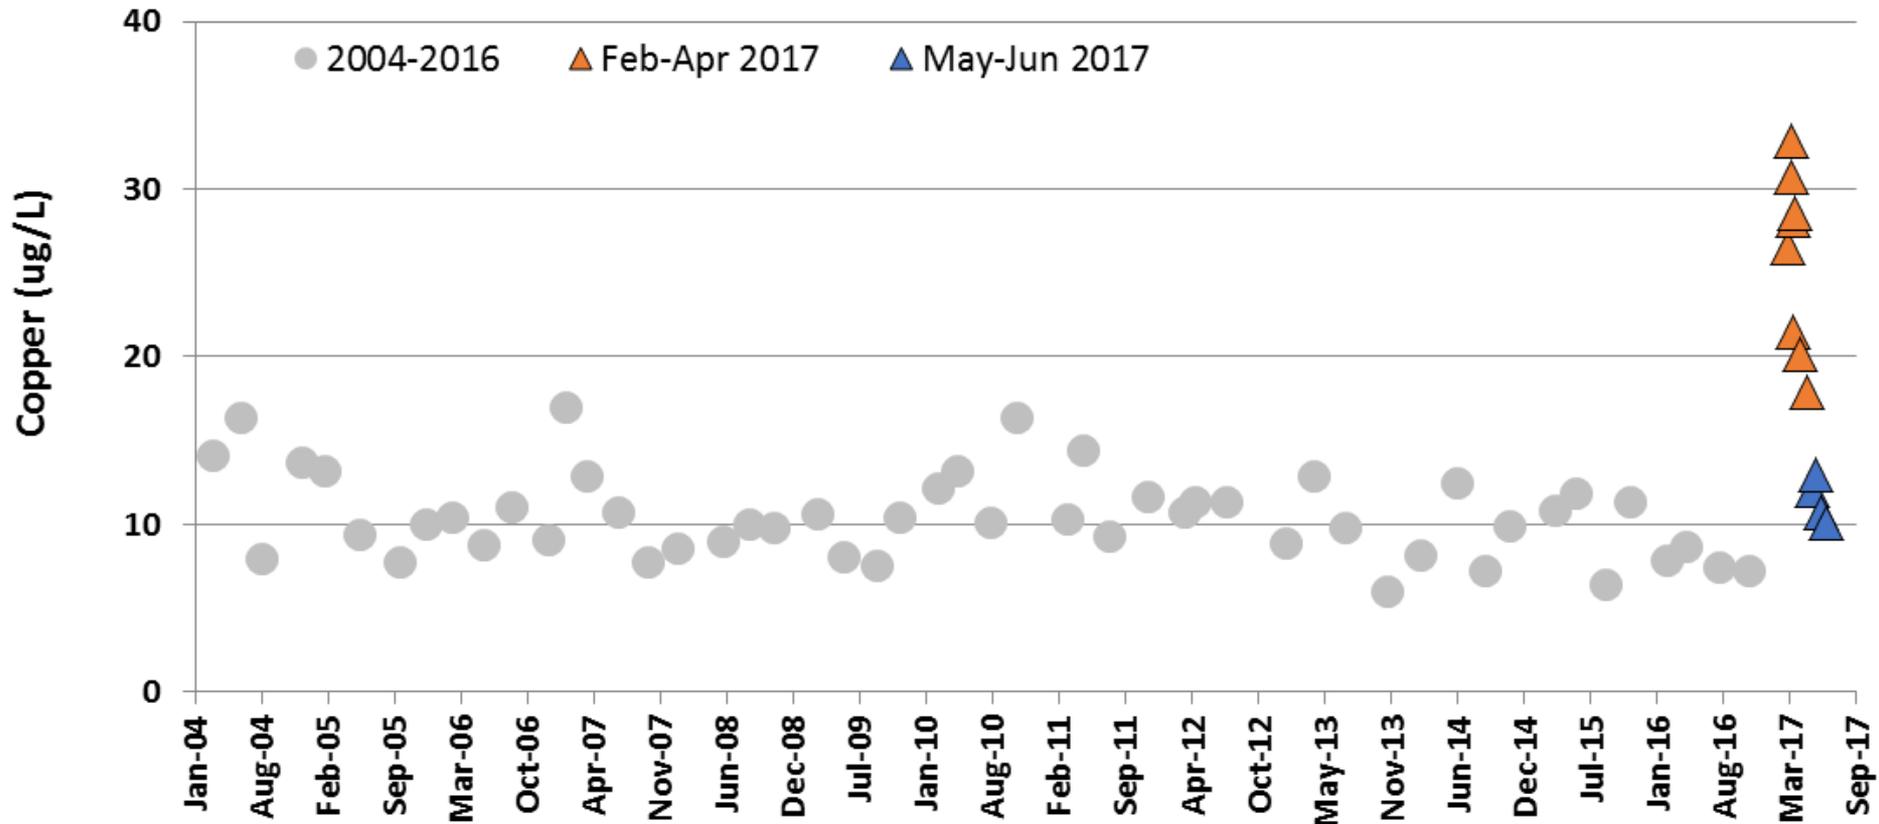
Example – Total Copper in Effluent

High historical data – City of Seattle implemented corrosion control for leaching pipes in 1982-83, so levels due to influent. Secondary treatment began at West Pt in late 1995.

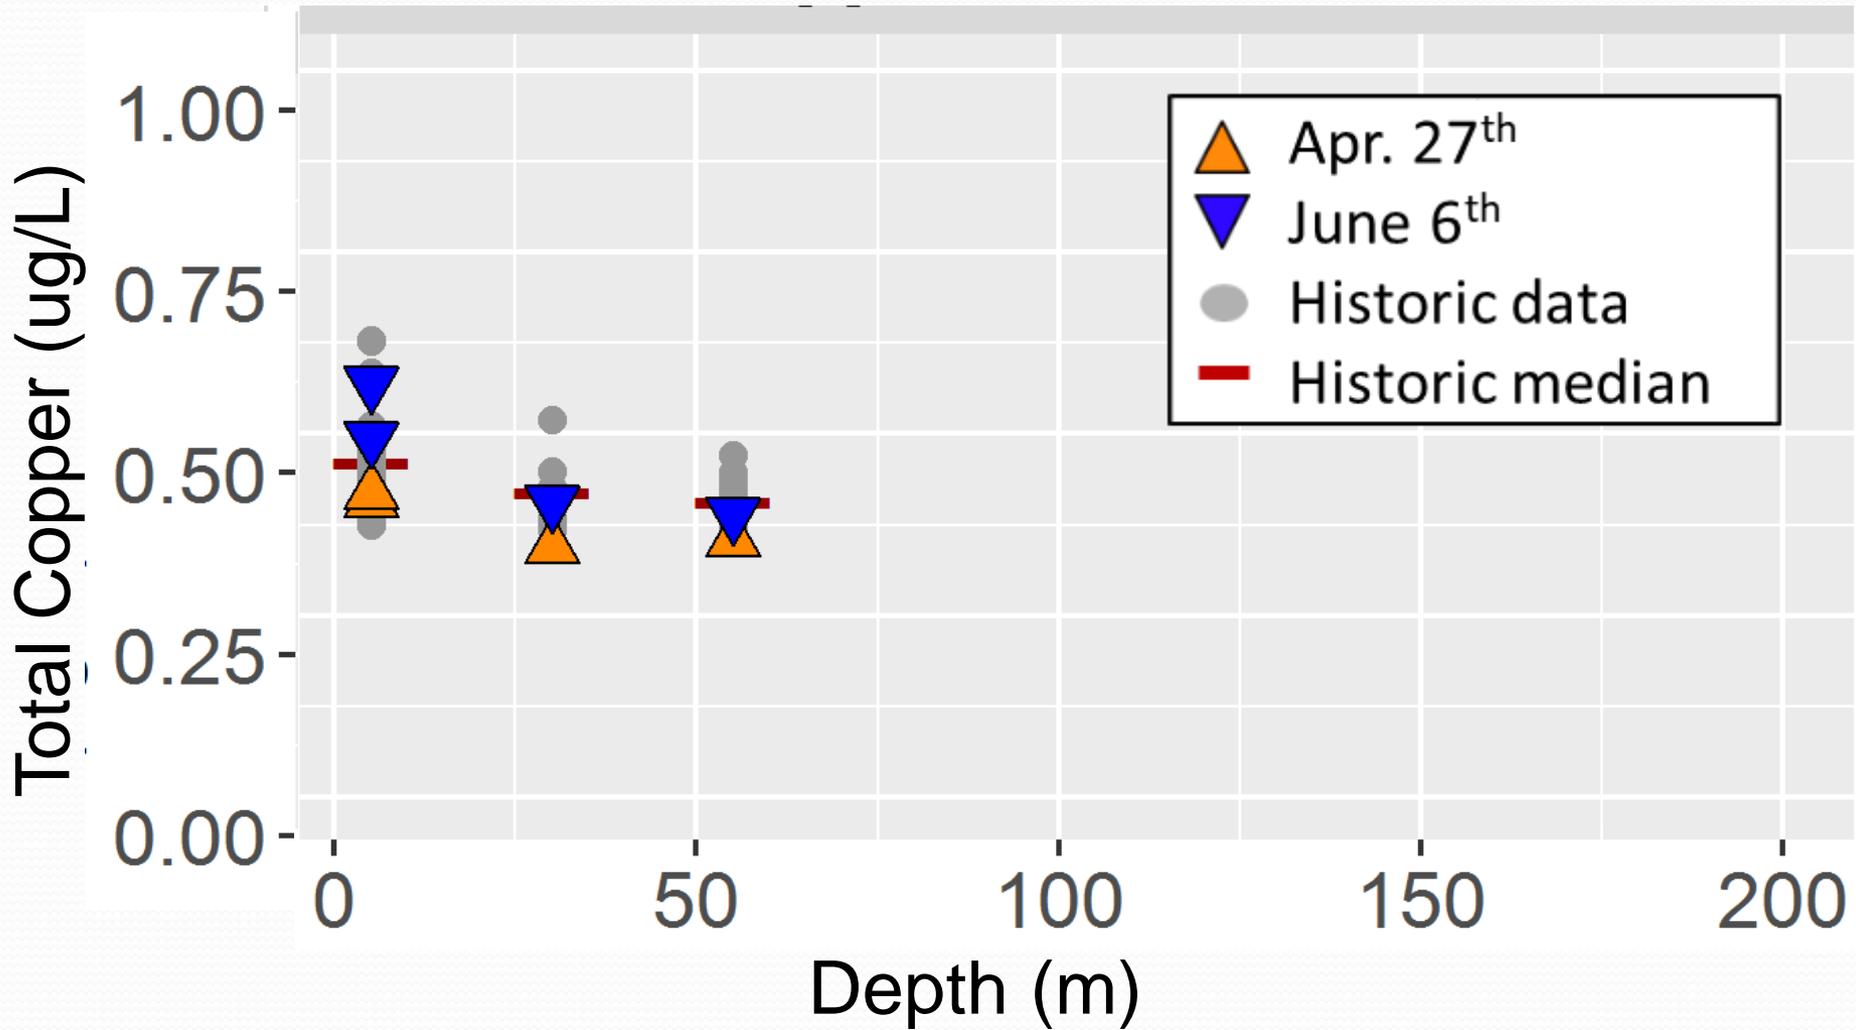
Total Copper at the West Point outfall site in Puget Sound

- Chronic marine water quality standard (dissolved) = 3.1 ug/L

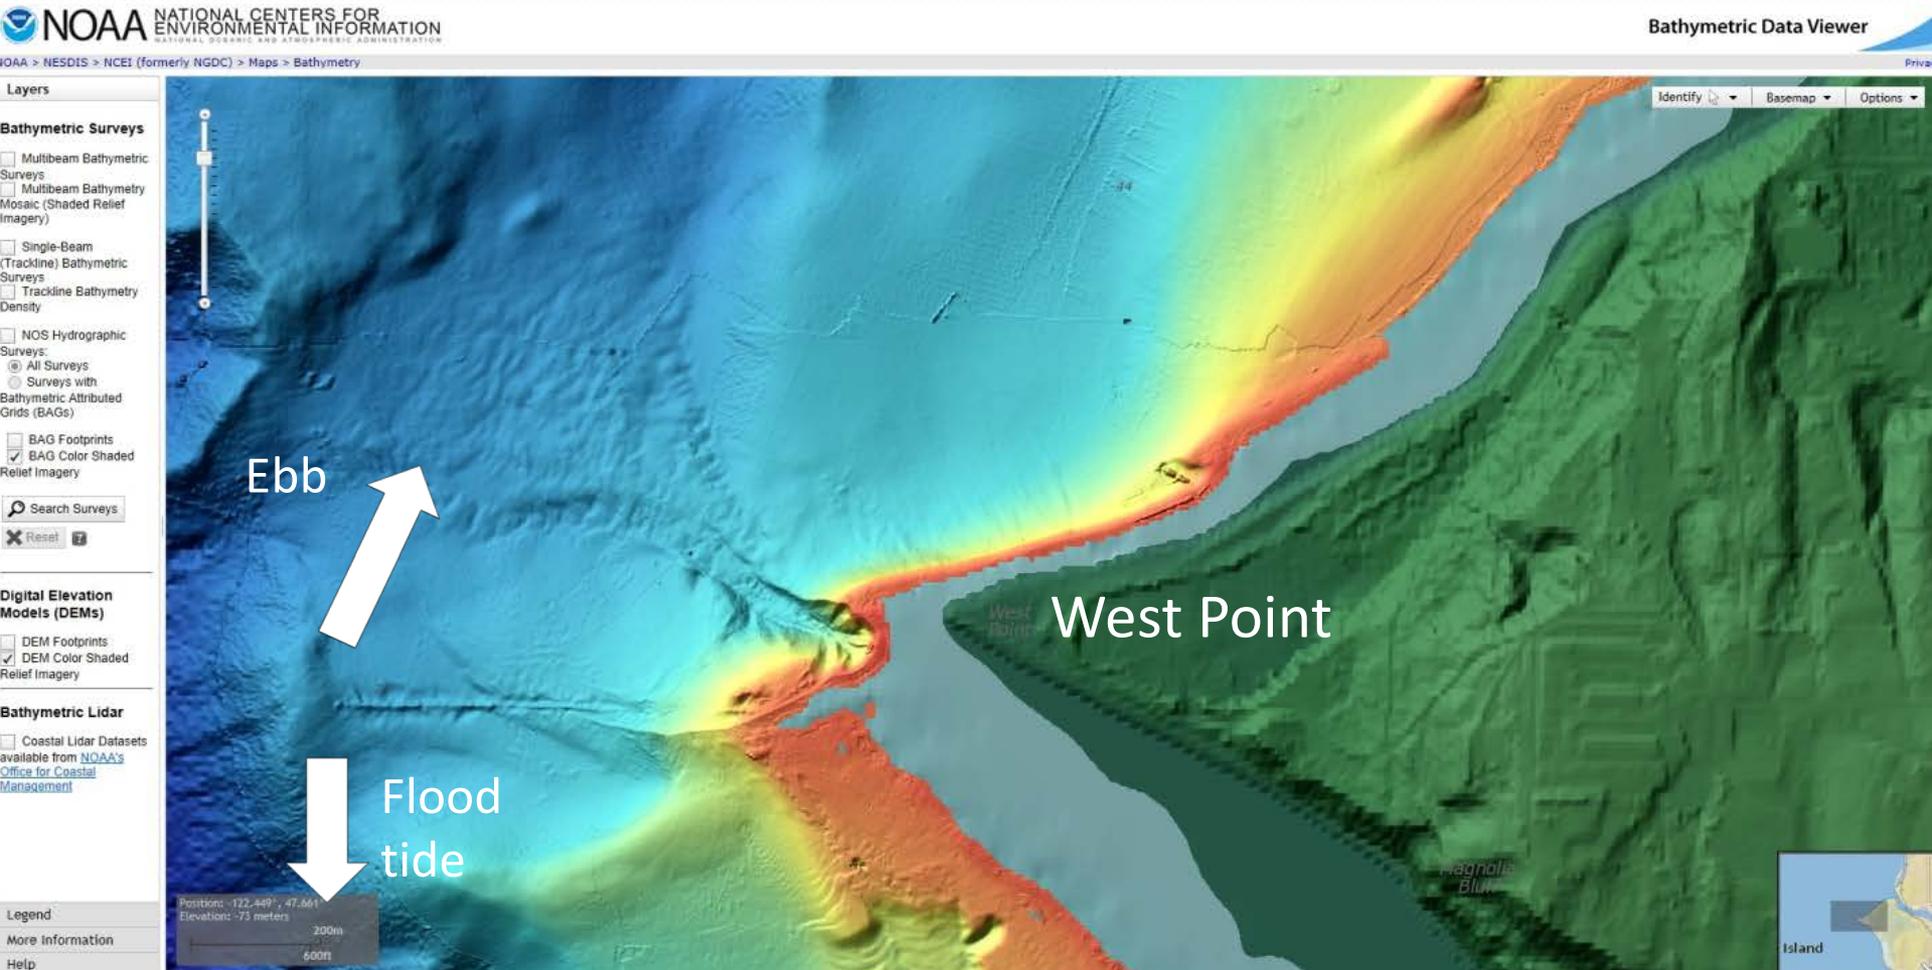
Mixing, tidal currents, and outfall depth contribute to the fate and dispersal of West Point effluent
