Water Quality: 2014 pumping event from Horseshoe Lake to a gravel pit located in The Villages proposed development

July 2014

King County

Department of Natural Resources and Parks
Water and Land Resources Division

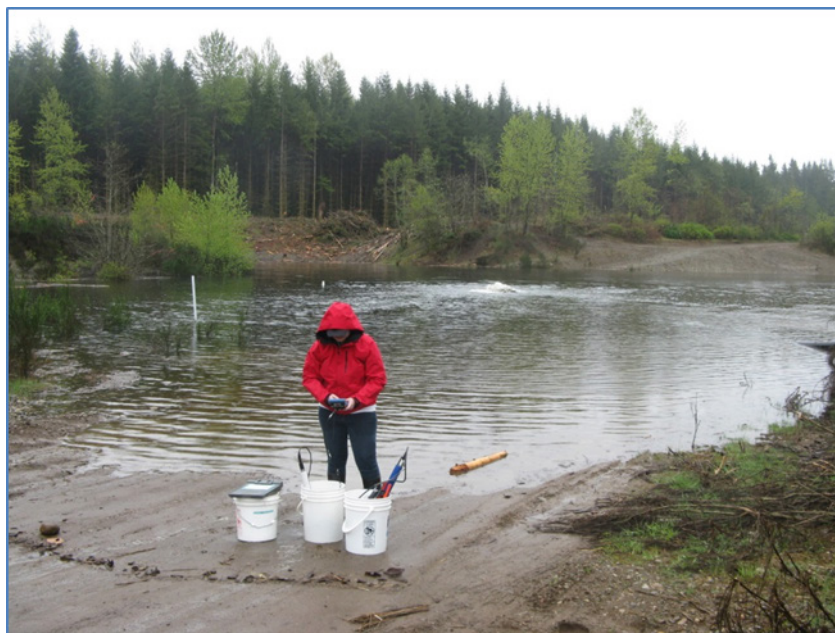
Figure 2. Site VGPIT1: The gravel pit infiltration pond, including the Horseshoe Lake pipe outlet in the distance. The sample site was approximately halfway between the standing pipe and shoreline.

- VGPI1: at the gravel pit infiltration site, characterizing the water pumped from the lake (see Figure 2 for photo);
- I321: at the outflow from the wetland outlet that flows to upper Crisp Creek, as it enters the culvert under 218th Ave SE (Figure 3);

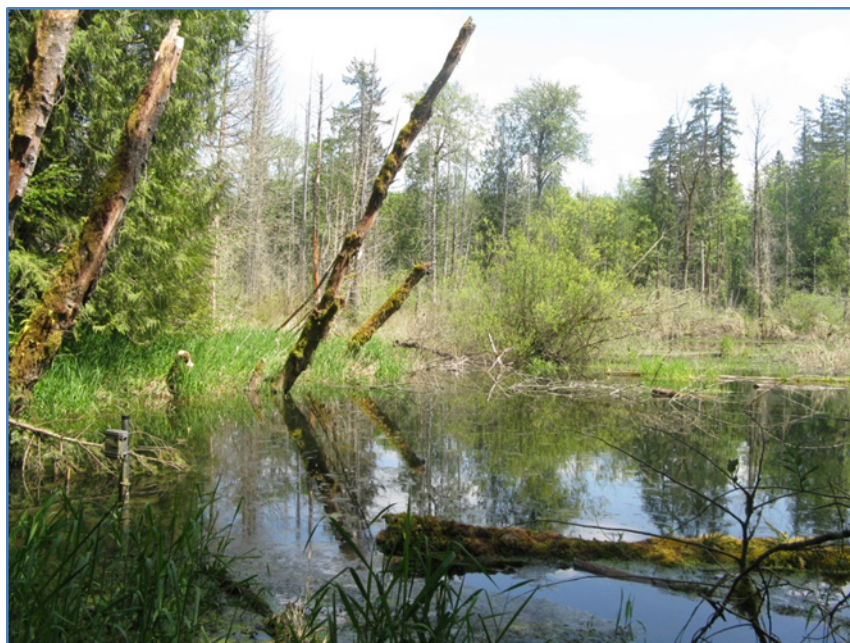
Figure 3. I321, wetland east of 218th Ave SE. near outlet. Taken from the sample site looking east.

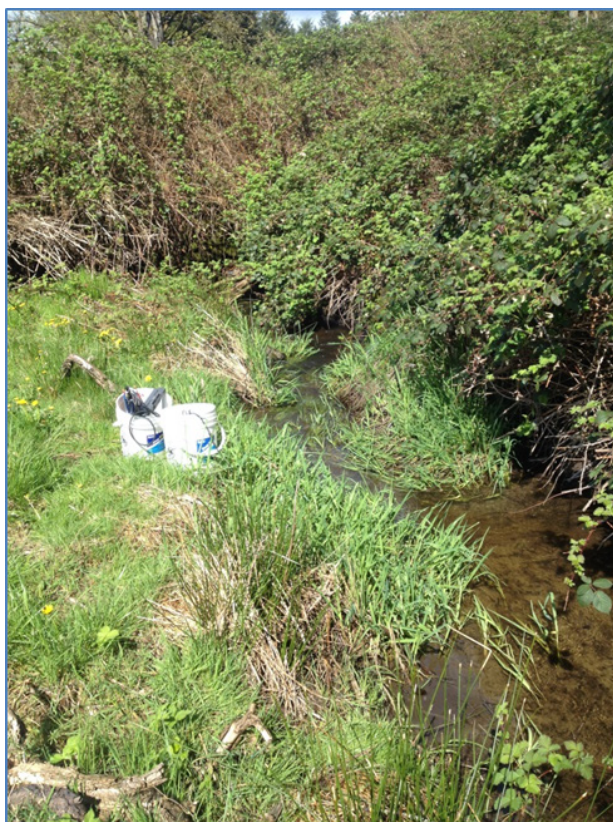
Figure 4. H321, valley tributary of Crisp Creek, east of 216th Ave SE. photo taken looking west towards 216th Ave SW.

- H321: at 216th Ave SE water was taken from a small tributary that flows along the valley bottom, draining the hillside as well as private property along the Green Valley Road before it enters Muckleshoot property (Figure 4).;
- F321: just above the hatchery intake. This location was also sampled in 2011 (Figure 5).
- A773B: eastern shoreline of Horseshoe Lake near the site of the pump intake. This was sampled once, at the same time as baseline sampling before the pump was turned on. Subsequent samples were taken at the VGPIT1 site where outflow from the lake came through the pipe.

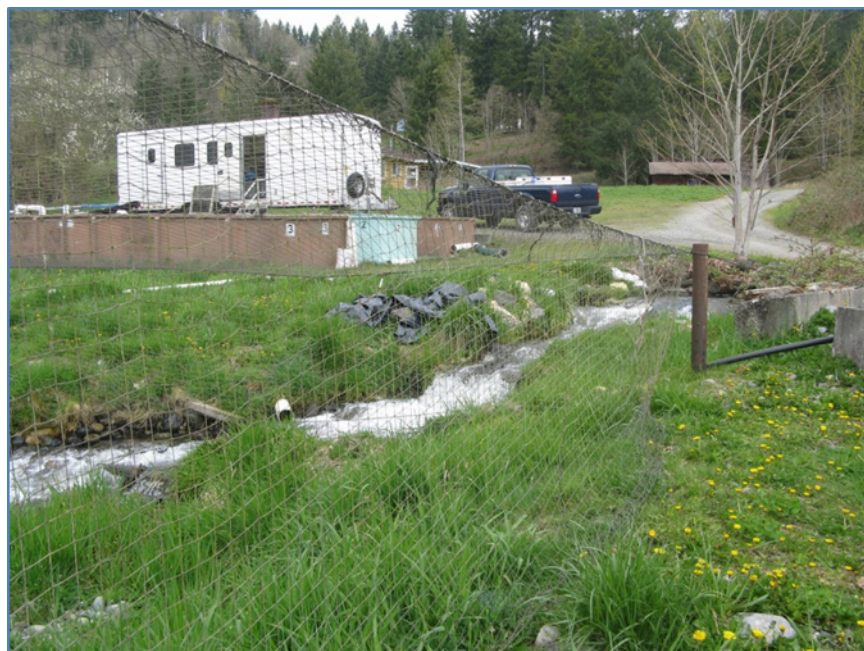
Figure 5. F321, Crisp Creek at hatchery intake. Picture taken looking north, with hatchery ponds to the left of the photo.

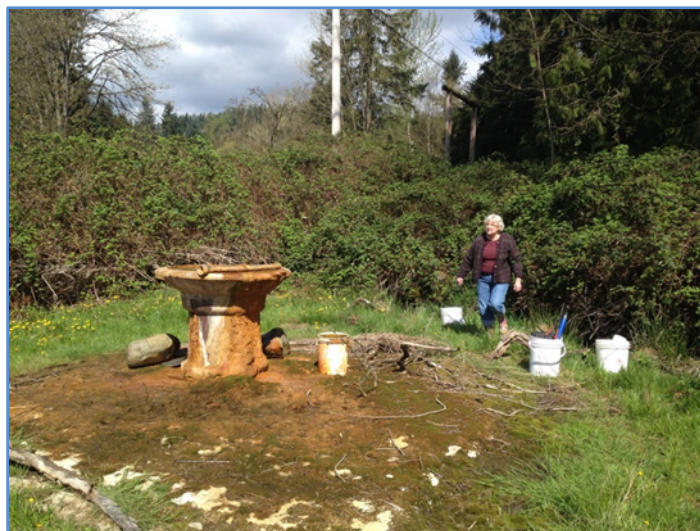
Figure 7. Ornamental well head with iron precipitation by sampling site H321 on the valley floor tributary to Crisp Creek.

The highest values in Crisp Creek were found in the small tributary to the east of the Hatchery ponds. Site H321 was consistently very high in total iron, and it was noted that a well head next to the sampling site had a large amount of precipitated iron on the structure (Figure 7). Talking with the property owners elicited the information that this well site had a commercial history of producing highly mineralized water for human consumption and that the well is very deep, originally drilled for locating coal seams viable for mining activities.
