MAY CREEK SEDIMENT TRANSPORT STUDY REPORT

King County

Anchor QEA, LLC

June 2009

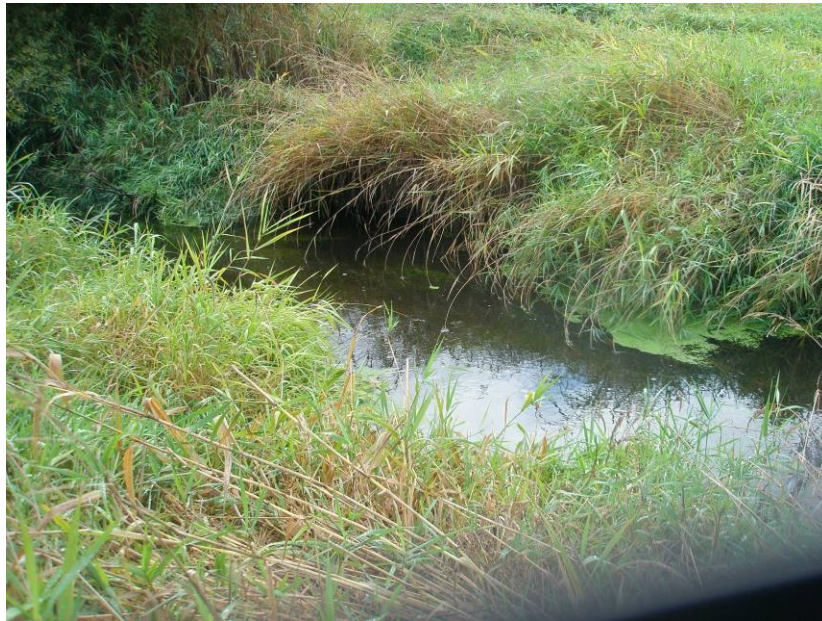
The project reach can be described in multiple parts, each with distinct features related to geomorphic and anthropogenic influences. In the upstream segment of the reach, from 148th to 146th Avenues, the channel is straight, narrow, and deep with a relatively flat gradient (Photograph 1). The stream has low banks with easy floodplain access. Flooding occurs frequently and the floodplain is typically wet and marshy much of the year. The floodplain and banks are thickly vegetated with reed canary grass, a few shrubs, and small trees.

Photograph 1. Upstream portion of the project reach near 148th Street.

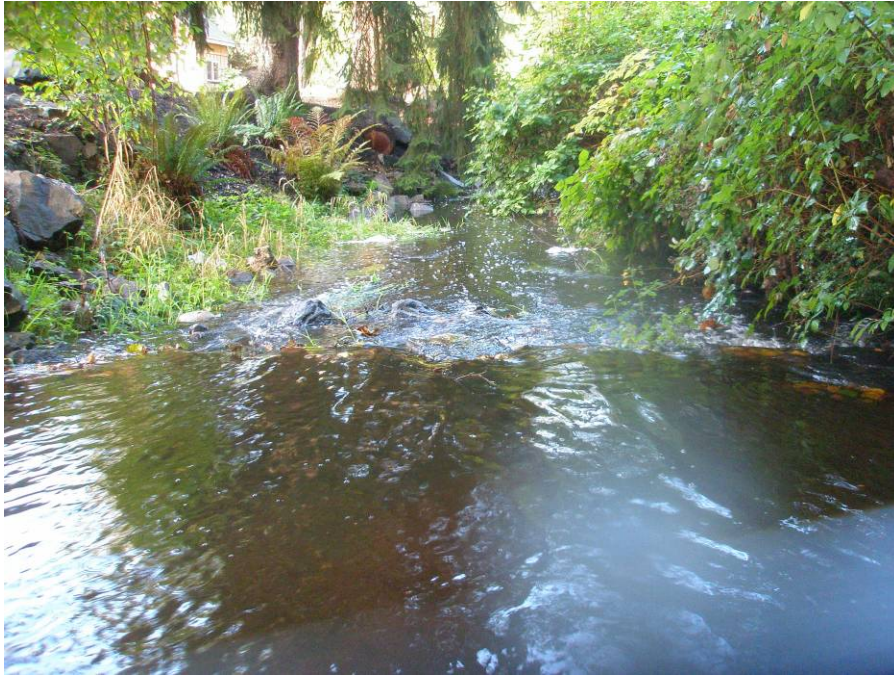
At 146th Avenue, May Creek begins to flow through a residential area where it is typically confined by riprap along the banks (Photograph 2). The bridge at 146th Avenue may act as a constriction point within this reach. The log weirs mentioned previously are located through this area down to the 143rd Avenue crossing. The stream is relatively flat (gradient of approximately 0.05%) through this section, the active channel is relatively narrow, and no gravel bar accumulations were observed. The creek is well connected to the floodplain and routine flooding occurs in this area.

Photograph 2. May Creek between the 146th and 143rd Avenue crossings, looking downstream at a log weir and rip-rap banks.

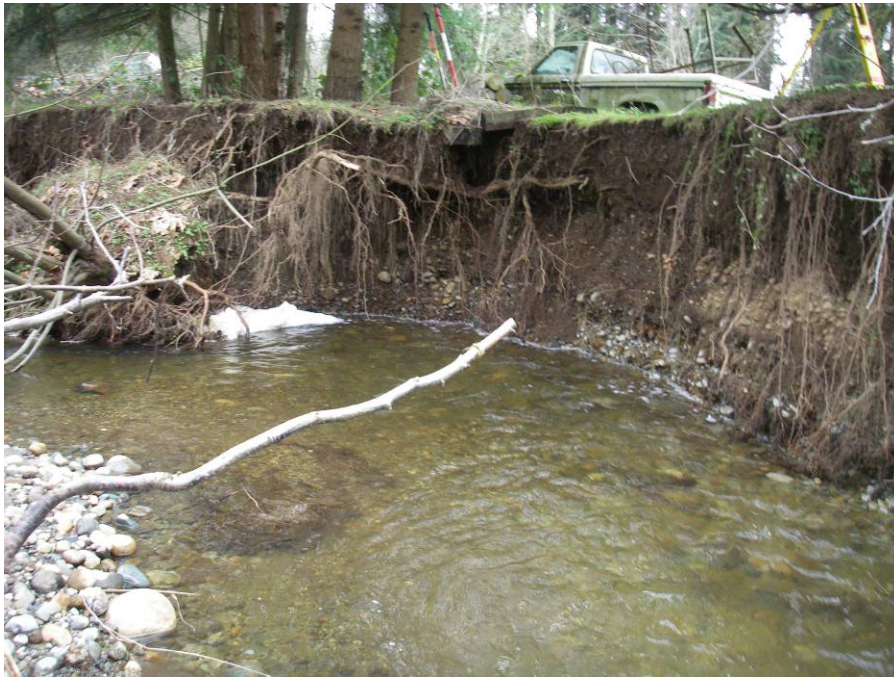
Downstream of the 143rd Avenue Bridge, the effect of incision is more apparent and influences the geomorphic conditions of May Creek. The stream takes a sharp turn to the southwest and again to the west, and the active channel is relatively wide and riffle-dominated. Active channel migration was observed through this segment. The floodplain area is reduced because the banks tend to be steep where the stream has headcut and eroded into ancient glacial terraces (present at Monitoring Site 3, as shown in Photograph 3). The largest amount of woody debris was observed in this part of the reach; much of the wood was contributed to the system by bank erosion.

Photograph 3. Glacial terrace banks at Monitoring Site 3, looking downstream.

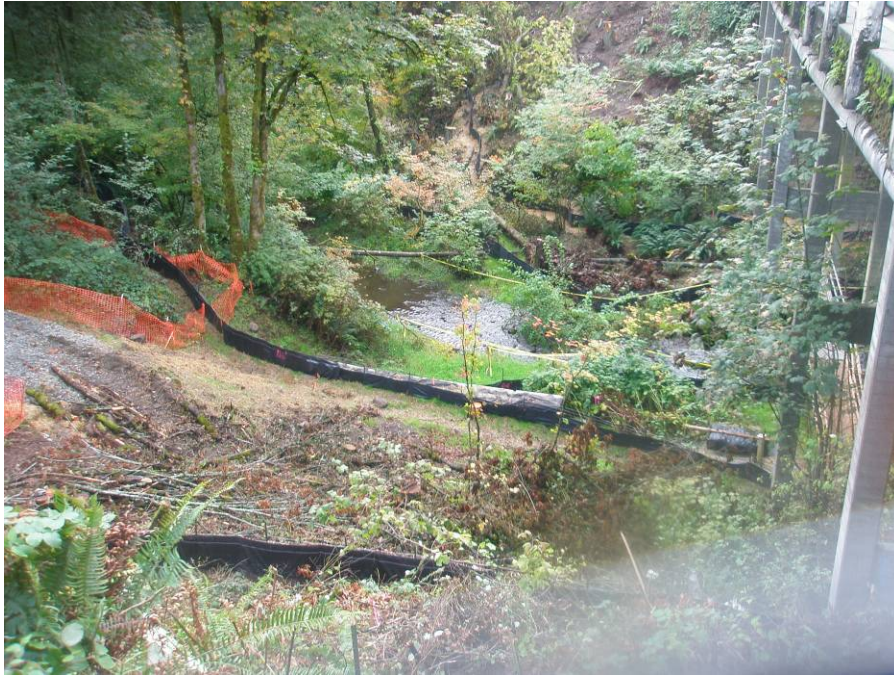
Between Monitoring Sites 3 and 2, the channel transitions from meandering and riffle-dominated to a straight and entrenched run-dominated system. The difference between the bed and top of bank height is greater and progressively increases moving down the valley. May Creek continues to become increasingly entrenched as it travels down the canyon through the downstream end of the project area (Photograph 4), including Station 1. Throughout the canyon and ravine areas, the channel has little ability to migrate because it is confined by steep banks composed of glacial deposits.

Photograph 4. The May Creek ravine at the Coal Creek Parkway crossing.

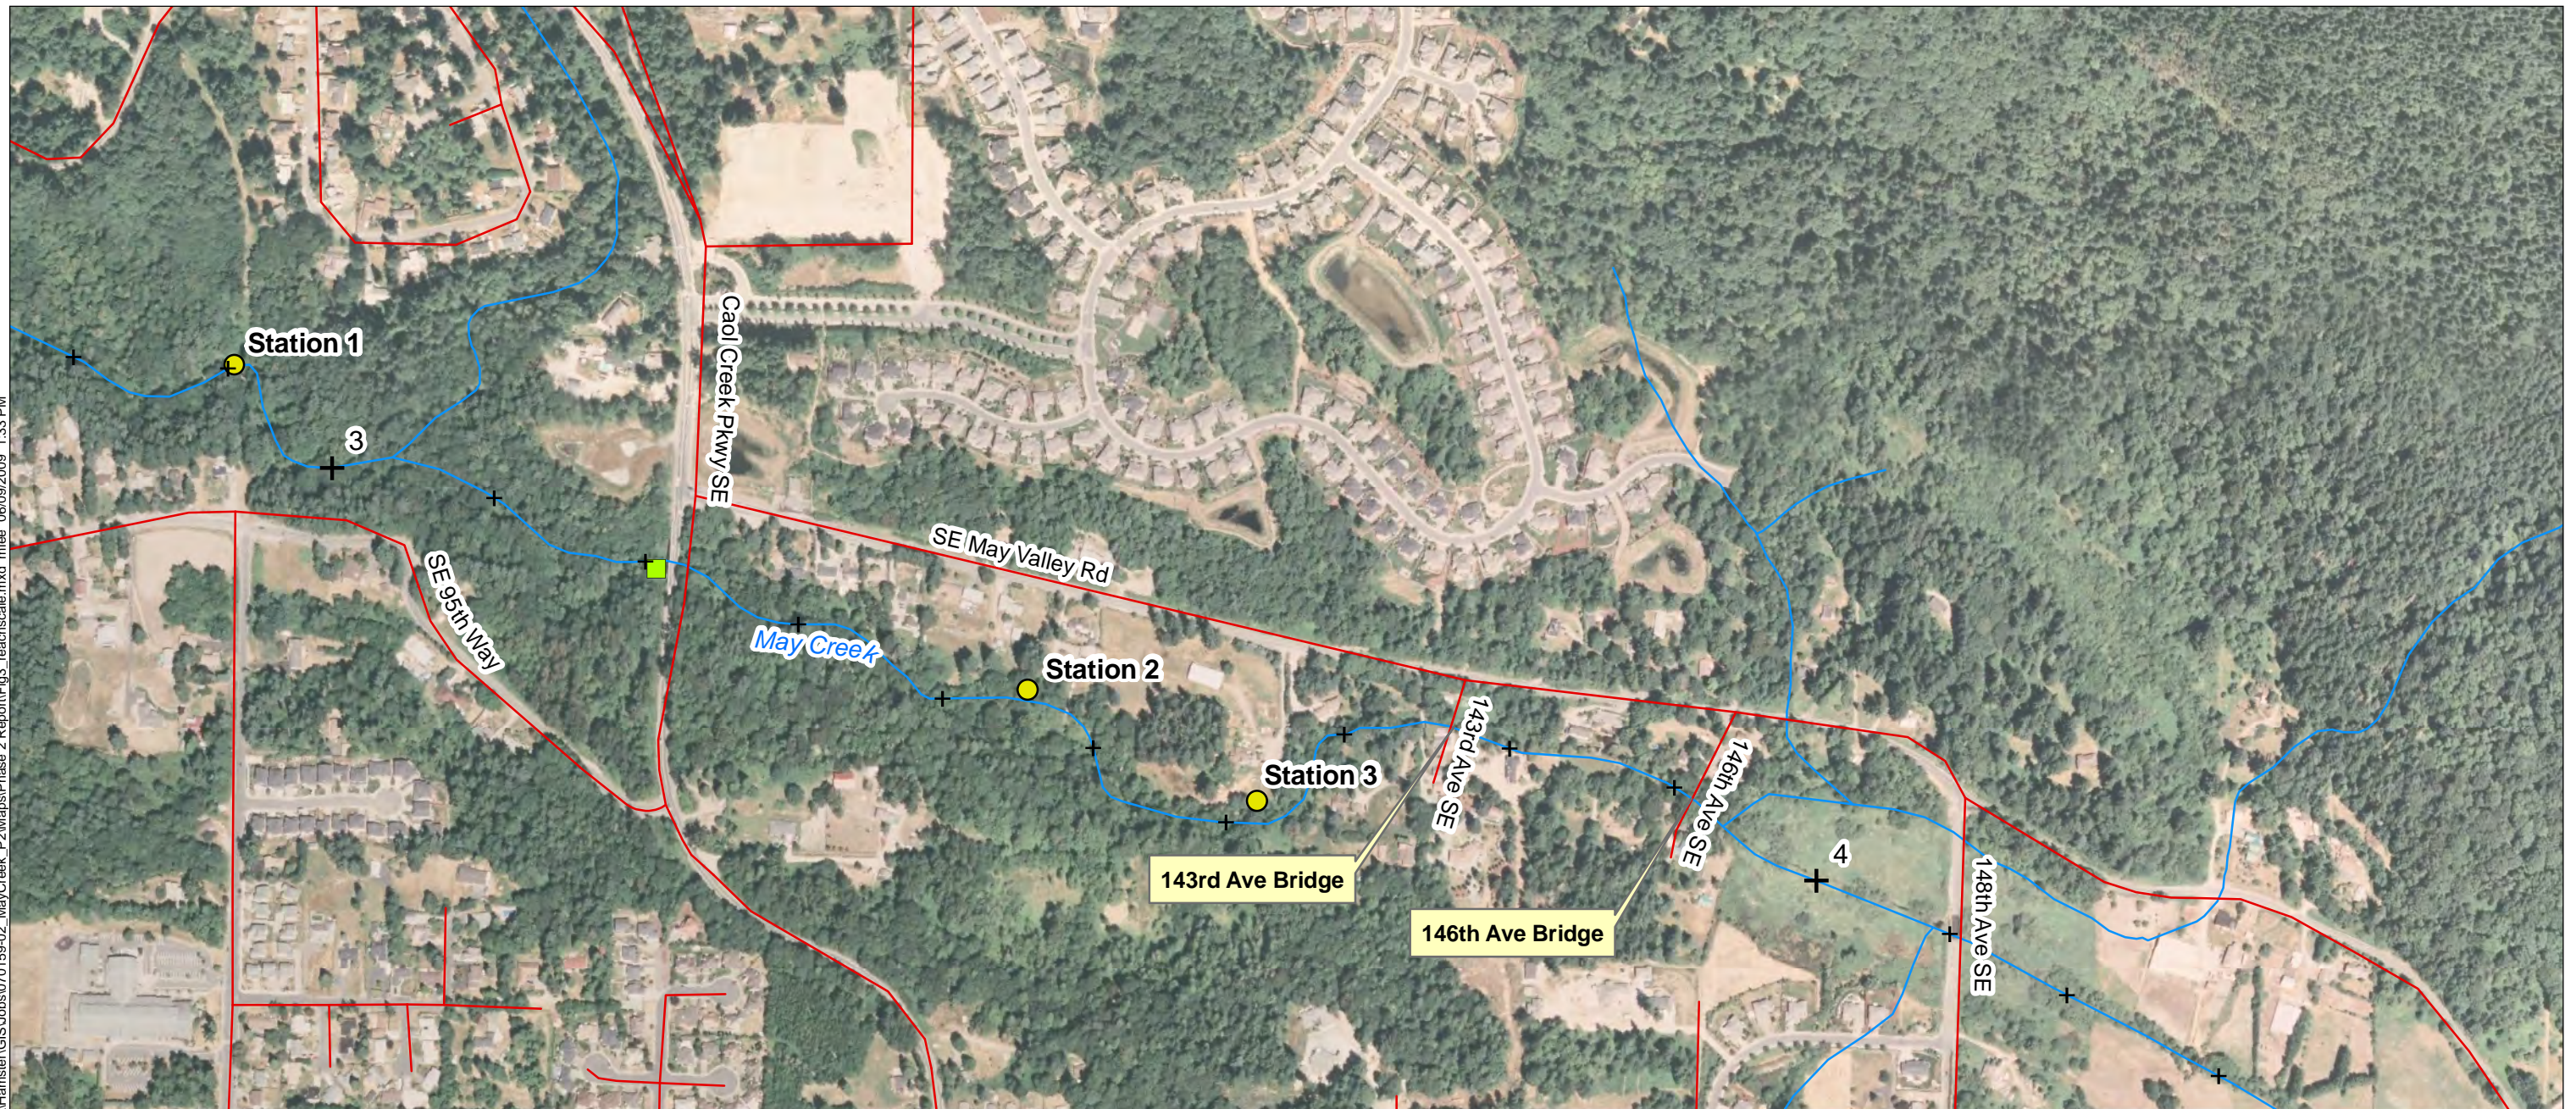
\\hamster\GIS\Jobs\070159-02_MayCreek_P2\Maps\Phase 2\Report\Fig3_reachscale.mxd mtee 06/09/2009 1:33 PM

the monitored stations (Gages May 1, May 2, and May 3) as part of the monitoring program developed specifically for this project. Figures 2 and 3 show the locations for these gages. Water level data are available for the May 1 gage from November 2007 through the middle of November 2009. Water level data are available for the May 2 and 3 gages from November 2007 through most of February 2009.

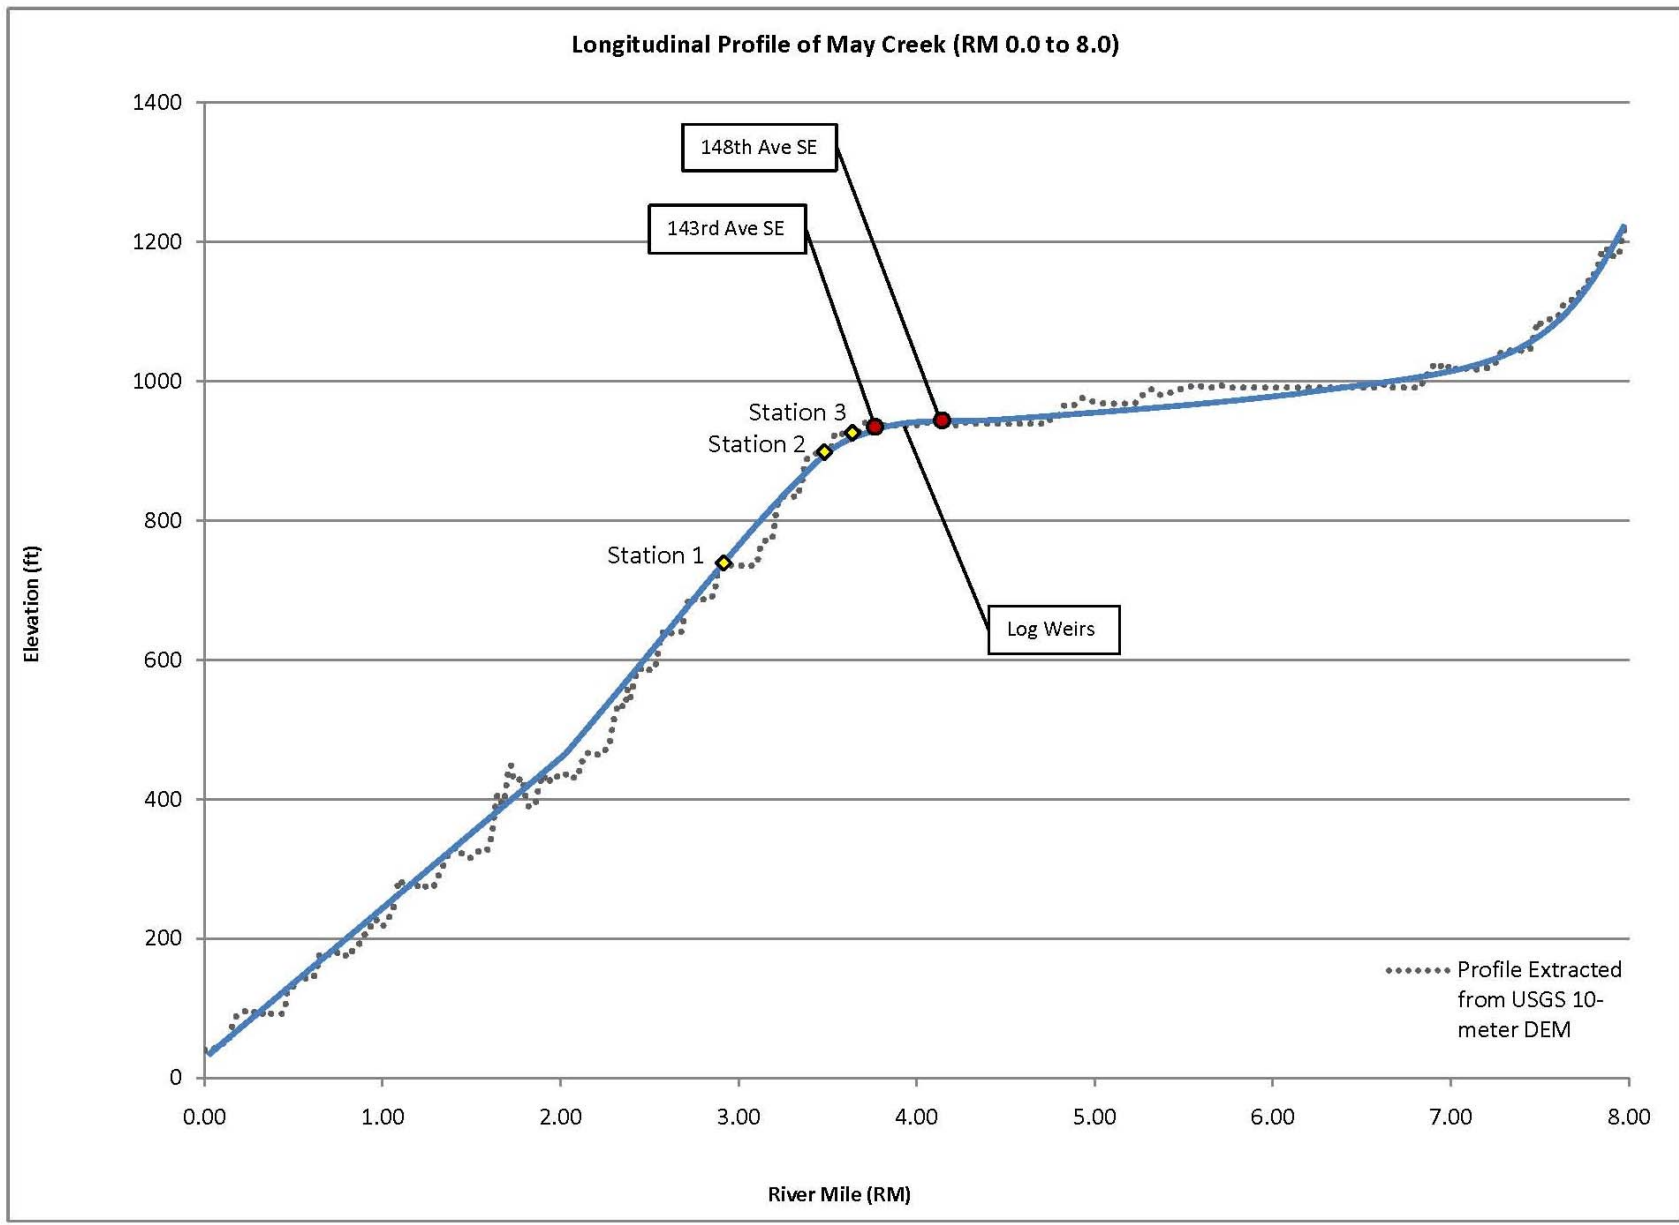
Figure 5: Profile of Thalweg of May Creek (RM 0.0 to 8.0)

The longitudinal profile displayed in Figure 5 is indicative of the incision of the stream into the glacial deposits that filled the valley during the last glaciation. This incision has advanced up the valley in the form of a headcut. Left unchecked, this headcut will continue to move up the valley floor in the form of a dynamic transition point from the low-gradient upper valley to the steep canyon below. Currently, headcutting may be impaired for a

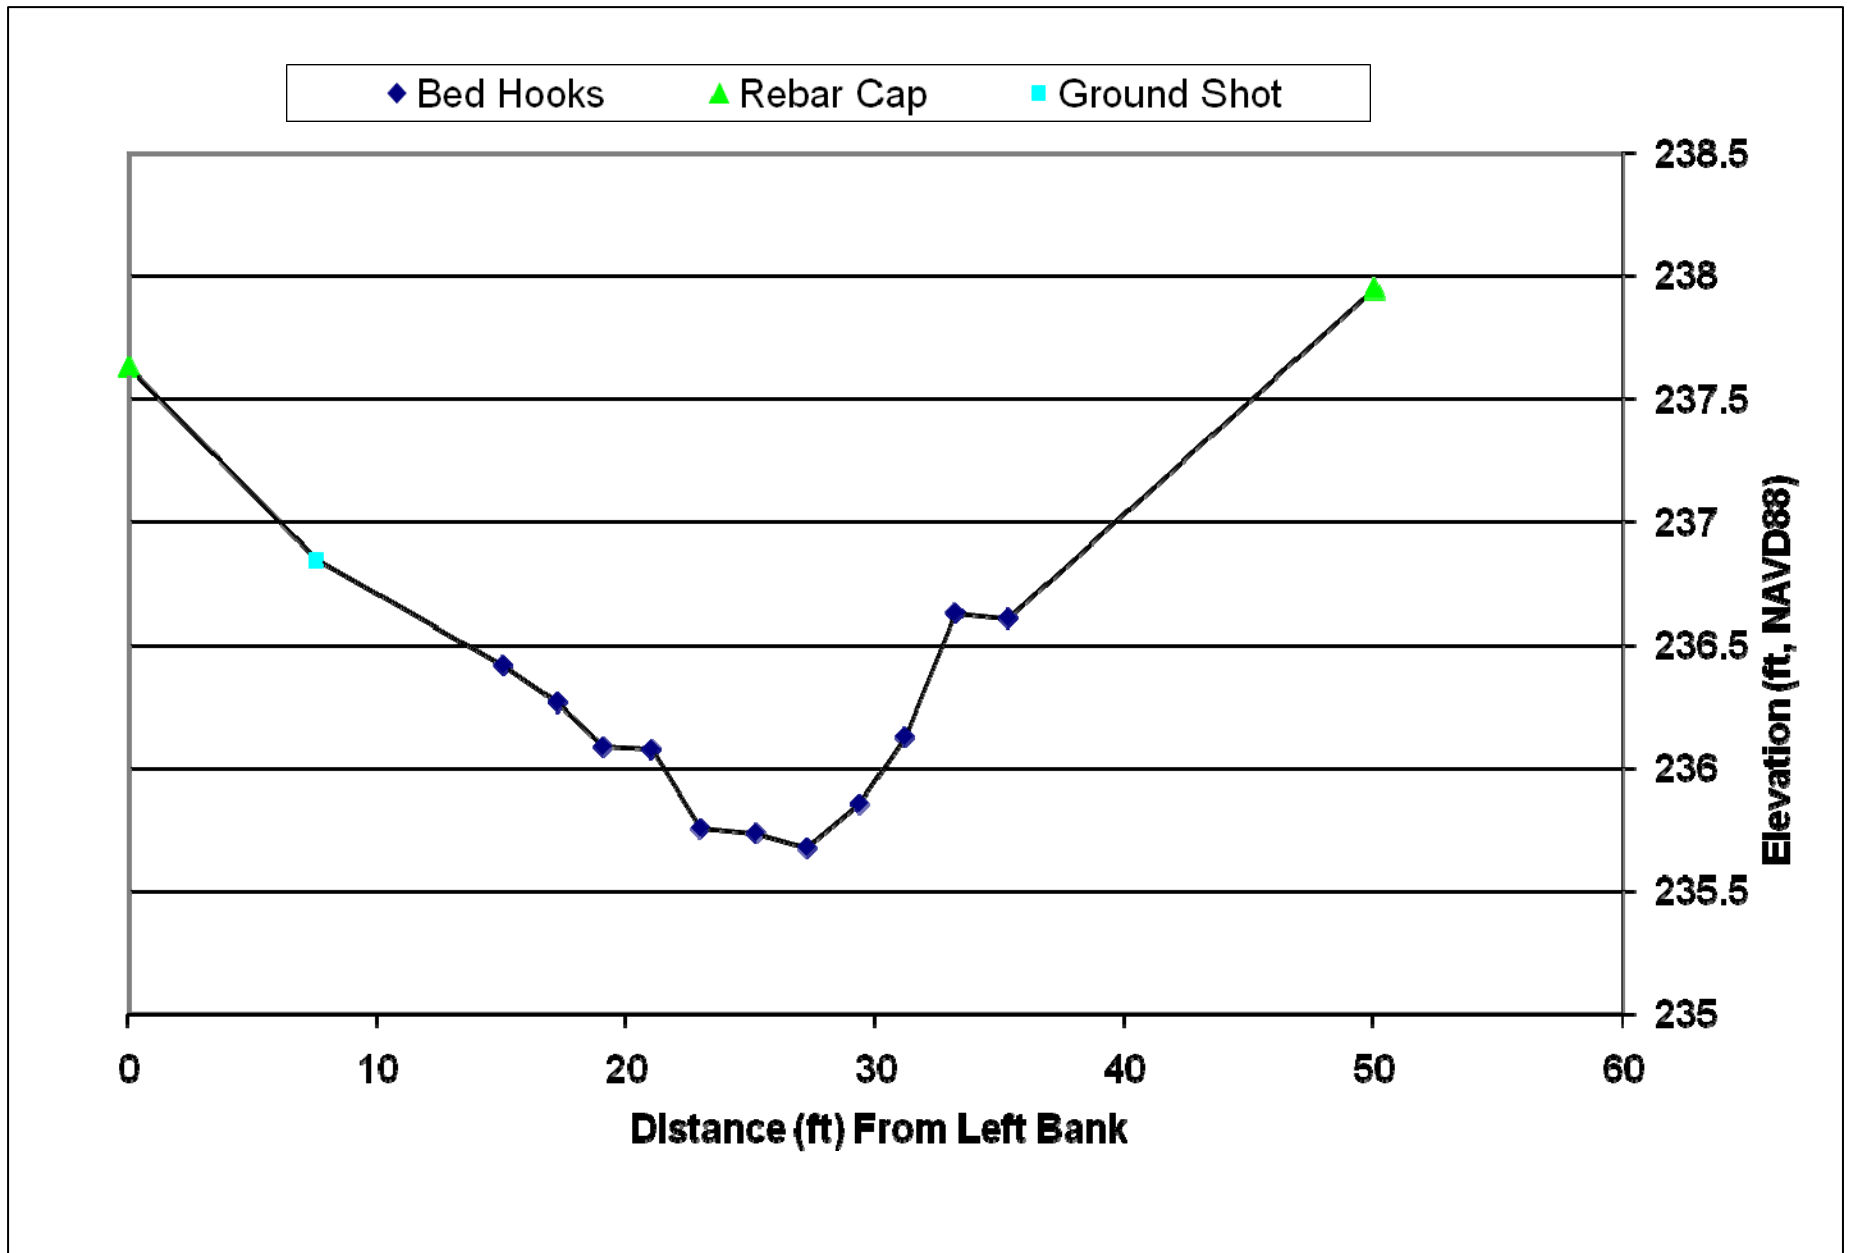
Figure 6: Station 1, Initial Elevation and Monitoring Pin/Hook Locations

Each monitoring station included bed hooks to monitor sediment transport of the streambed and bank pins to monitor erosion of the streambanks. Pressure transducers with internal data loggers were also installed in the creek channel at each monitoring station to collect daily maximum water surface elevation data. Transducer data was collected periodically by King County personnel. The location and condition of bed hooks and bank pins were documented during each site visit. Bed hooks consisted of eye bolts driven into the streambed at 2-foot intervals. Colored flagging was attached to each eye bolt to improve visibility during monitoring. Bank pins consist of 2-foot lengths of rebar driven flush into the bank. Each monitoring station also included a left and right bank rebar with cap. The rebar represented benchmark points along the specific cross-section. All measured distances in the monitoring spreadsheets were measured from the left bank rebar benchmark. Figures 6 through 8 in Appendix A show the initial geometry of the monitored stations and the location and spacing of all monitoring hardware.

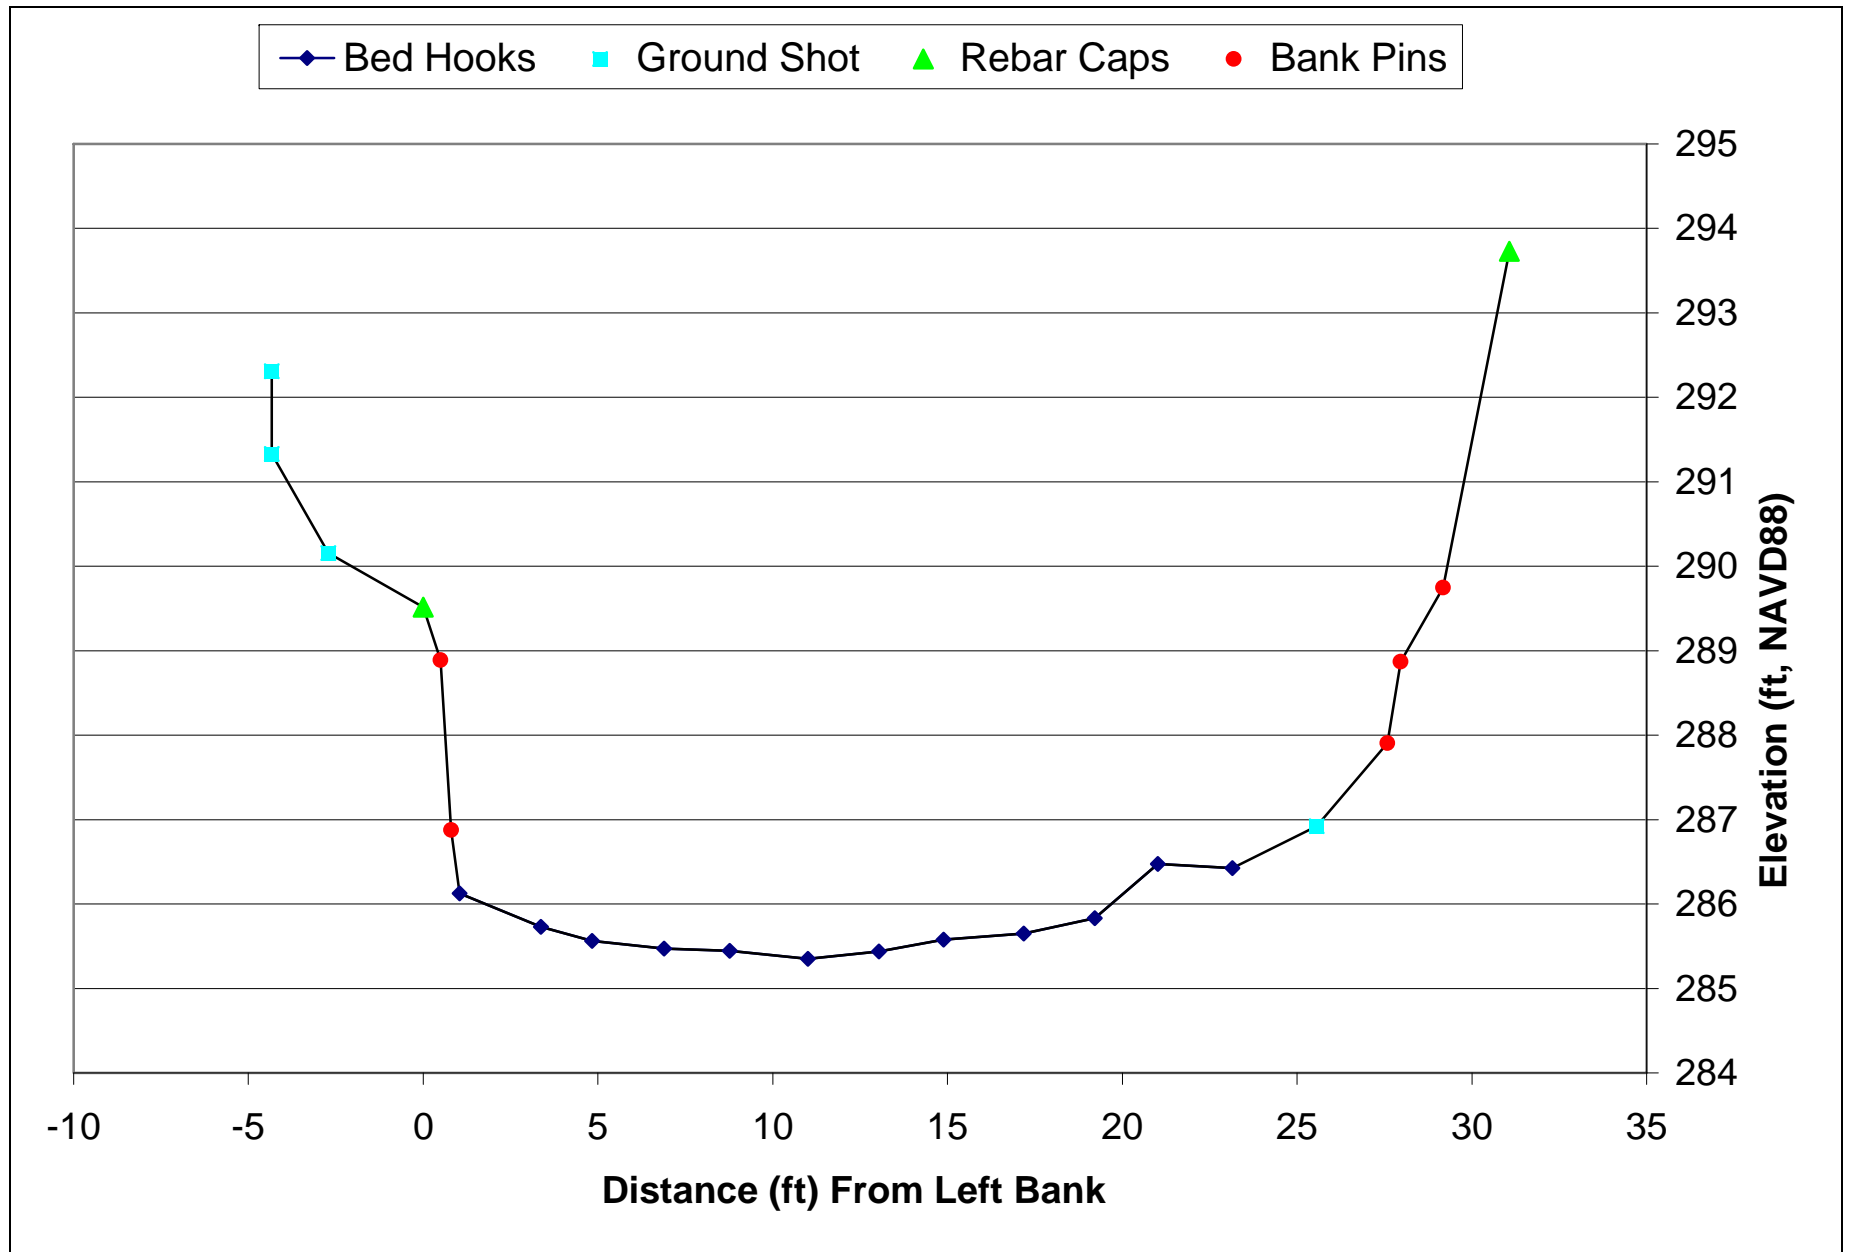
Figure 7: Station 2, Initial Elevation and Monitoring Pin/Hook Locations

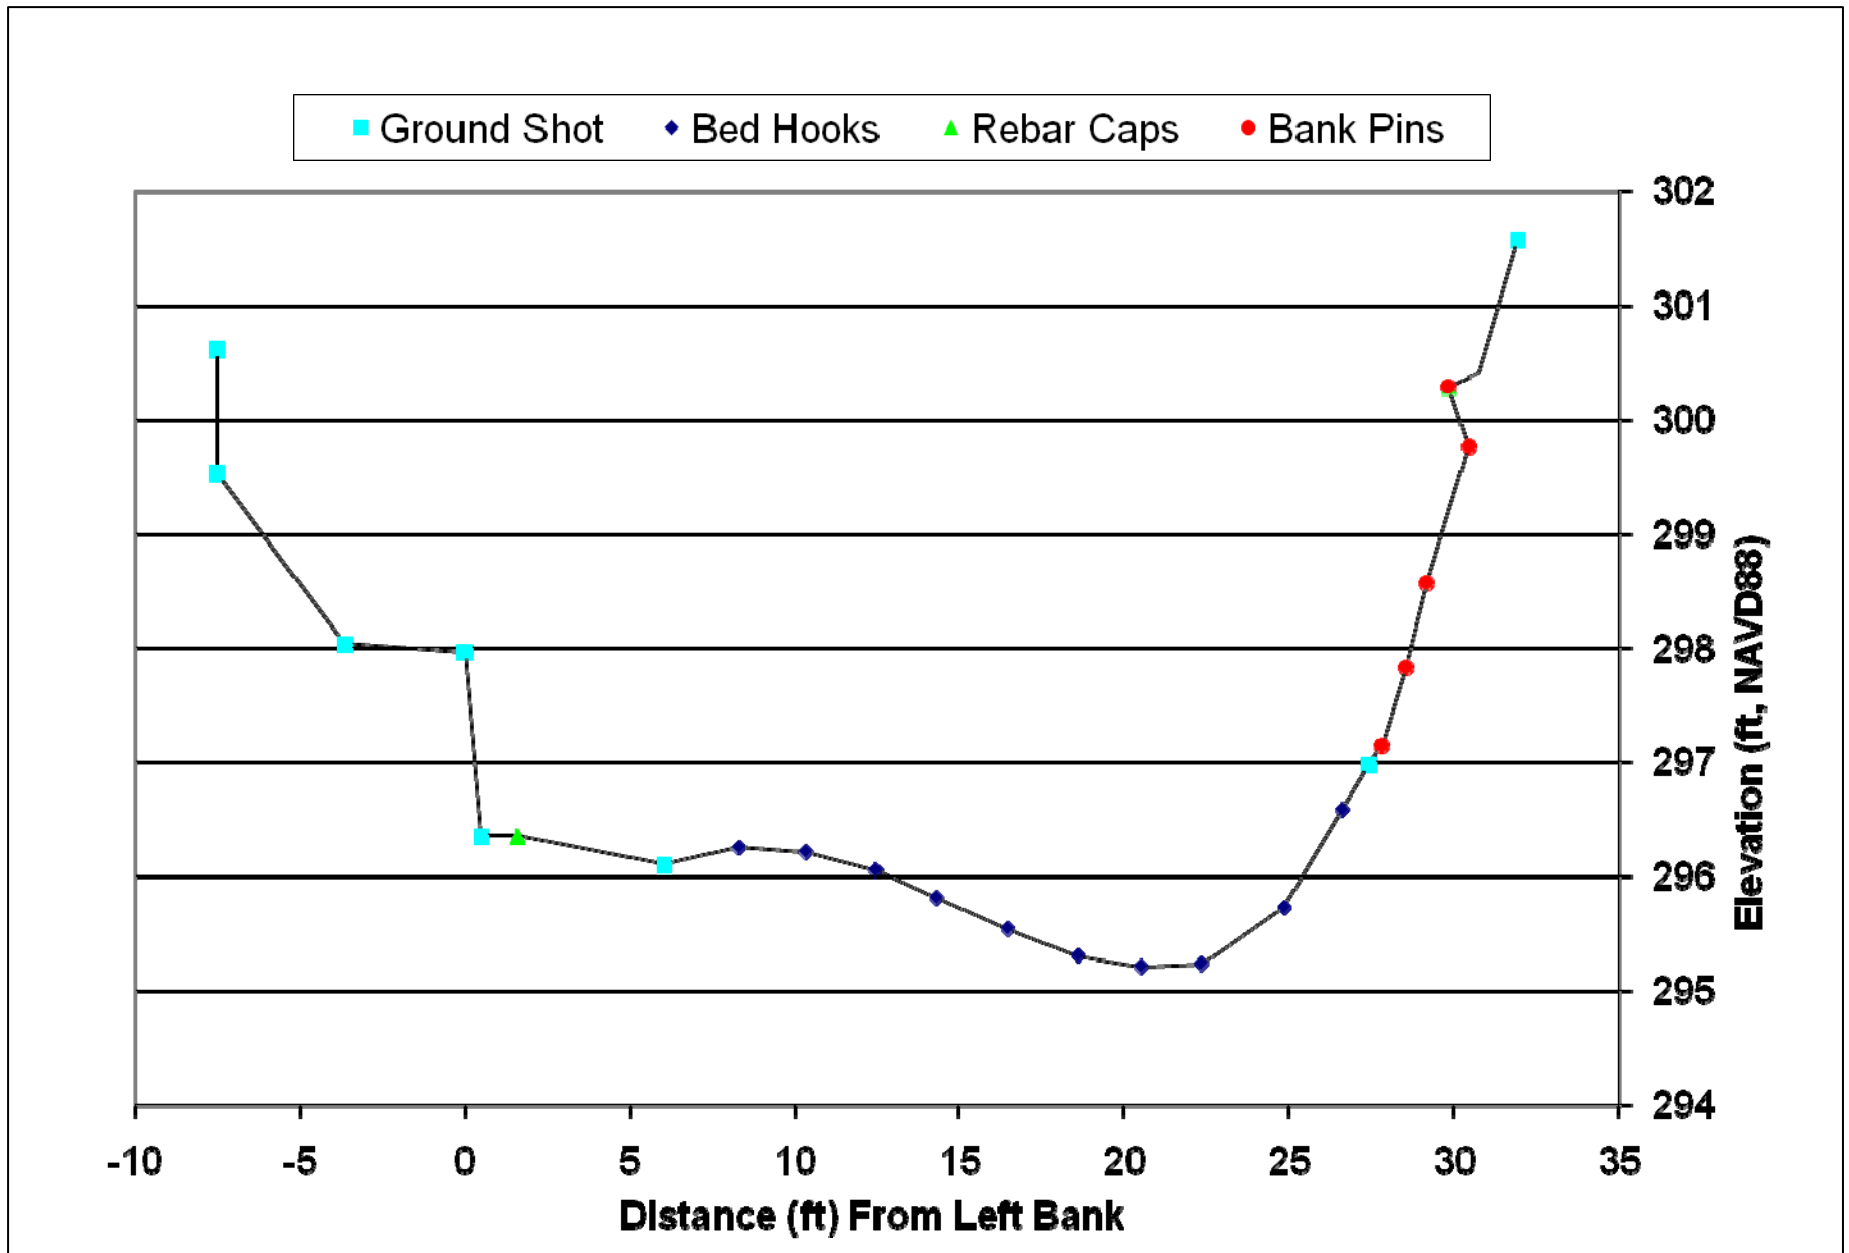
Figure 8: Station 3, Initial Elevation and Monitoring Pin/Hook Locations

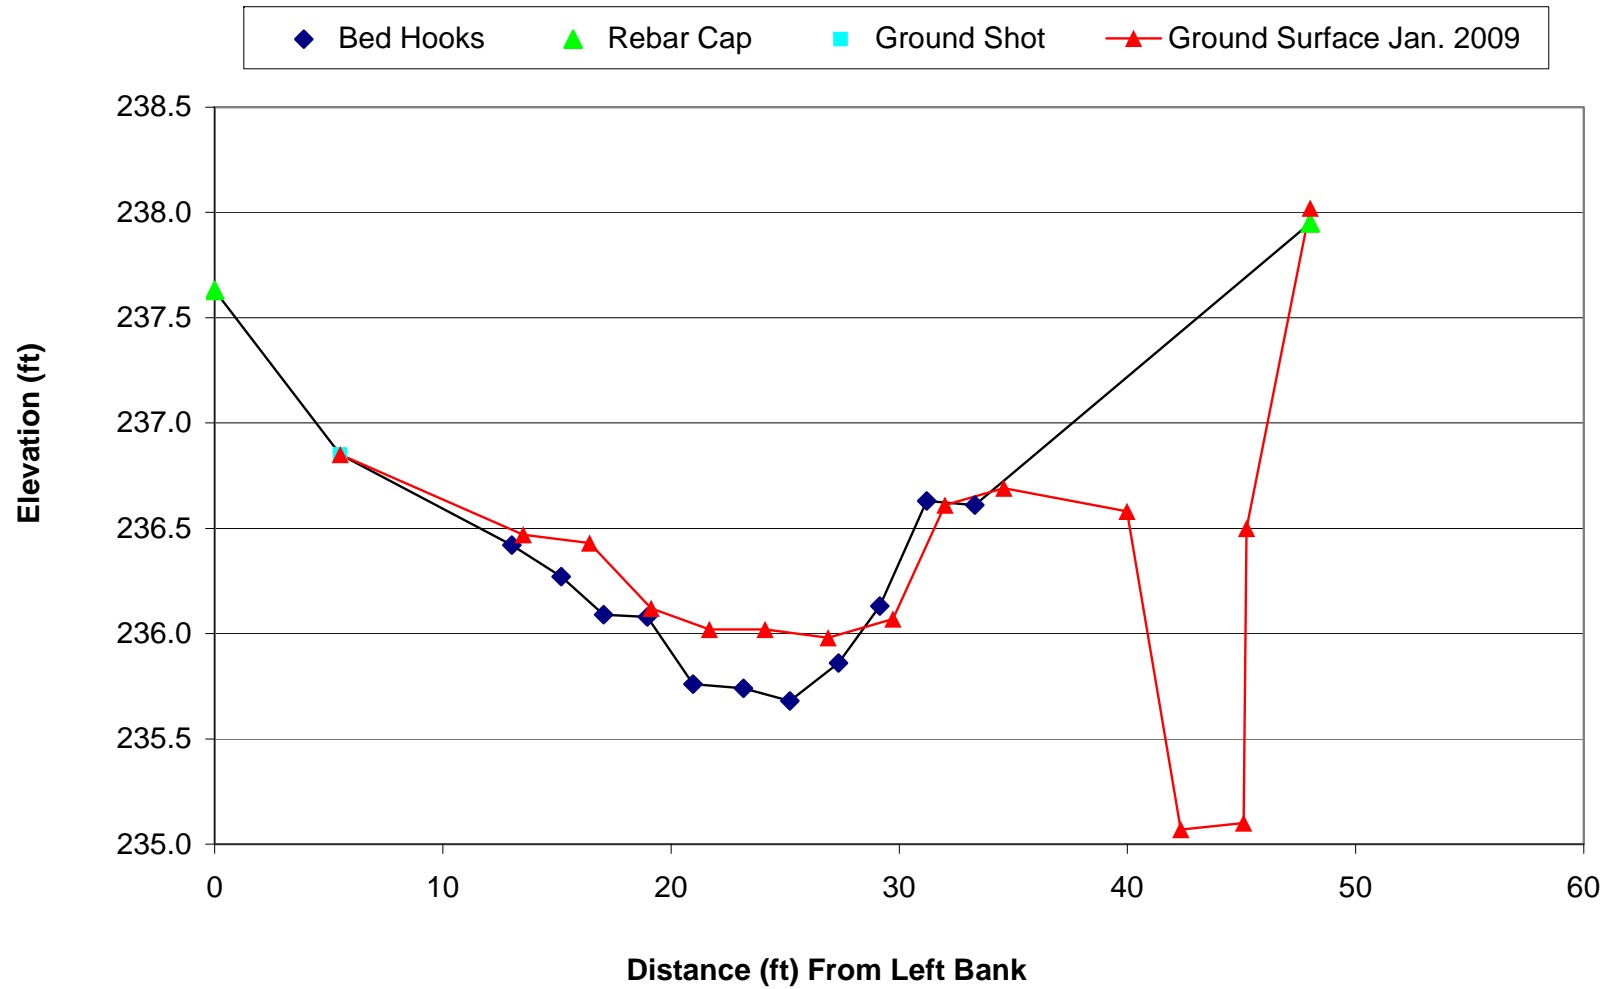
Figure 9: Station 1, Initial and Final Bed Elevations

The initial and final cross-section geometry for each of the monitored stations (middle cross-section) is provided in Figures 9 through 11, in Appendix A. From November 2007 to January 2009, Station 1 exhibited approximately 0.5 feet of deposition in the channel and now occupies a side channel off the right bank. It is not apparent from the survey data if that side channel existed prior to the January 2009 survey due to lack of resolution in the earlier survey data. Station 2 appears to be relatively stable over the same time period, with slight degrading (maximum of 0.5 feet) of the left side of the channel bottom. Station 3 exhibited the most dramatic change over the course of the monitoring period, where the thalweg moved toward the right bank approximately 15 feet and the right bank moved approximately 10 to 15 feet. The original thalweg location shows about 1 to 1.5 feet of deposition.

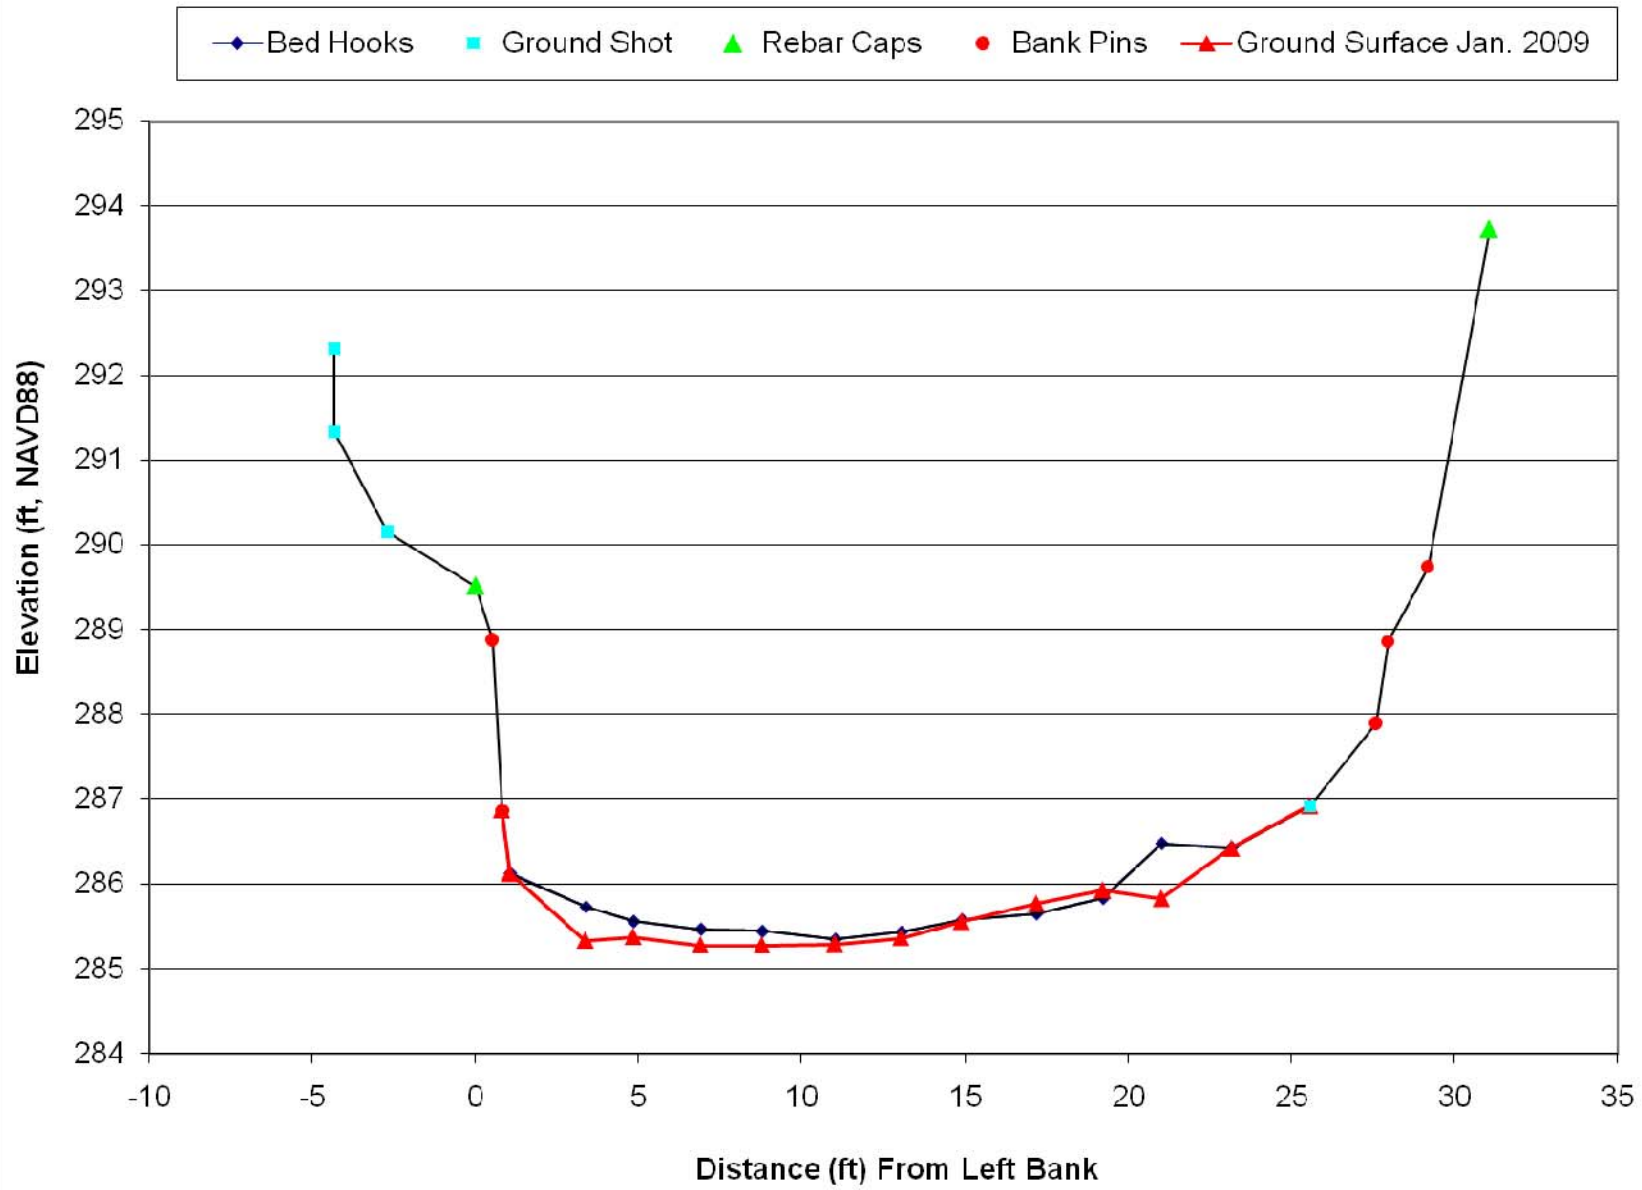
Figure 10: Station 2, Initial and Final Bed Elevations

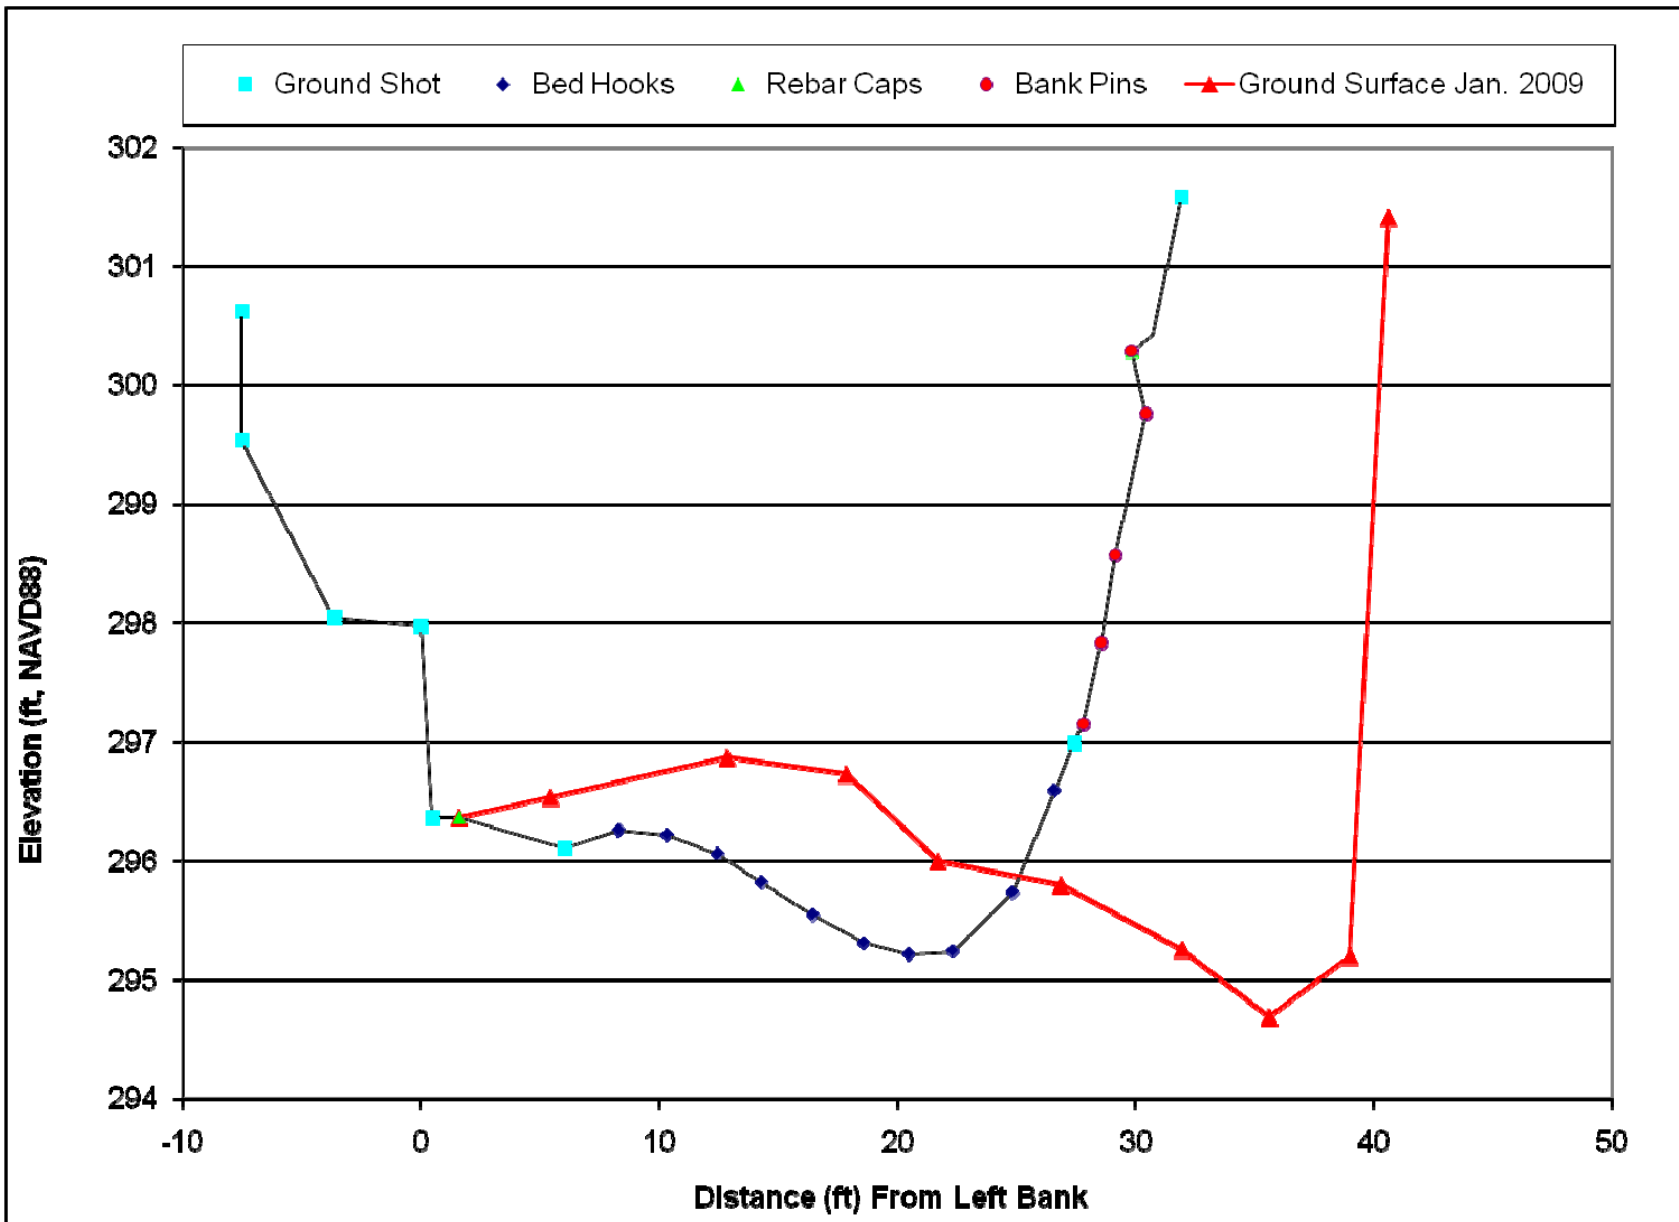
Figure 11: Station 3, Initial and Final Bed Elevations
