MAY CREEK SEDIMENT TRANSPORT STUDY REPORT

King County

Anchor QEA, LLC

June 2009

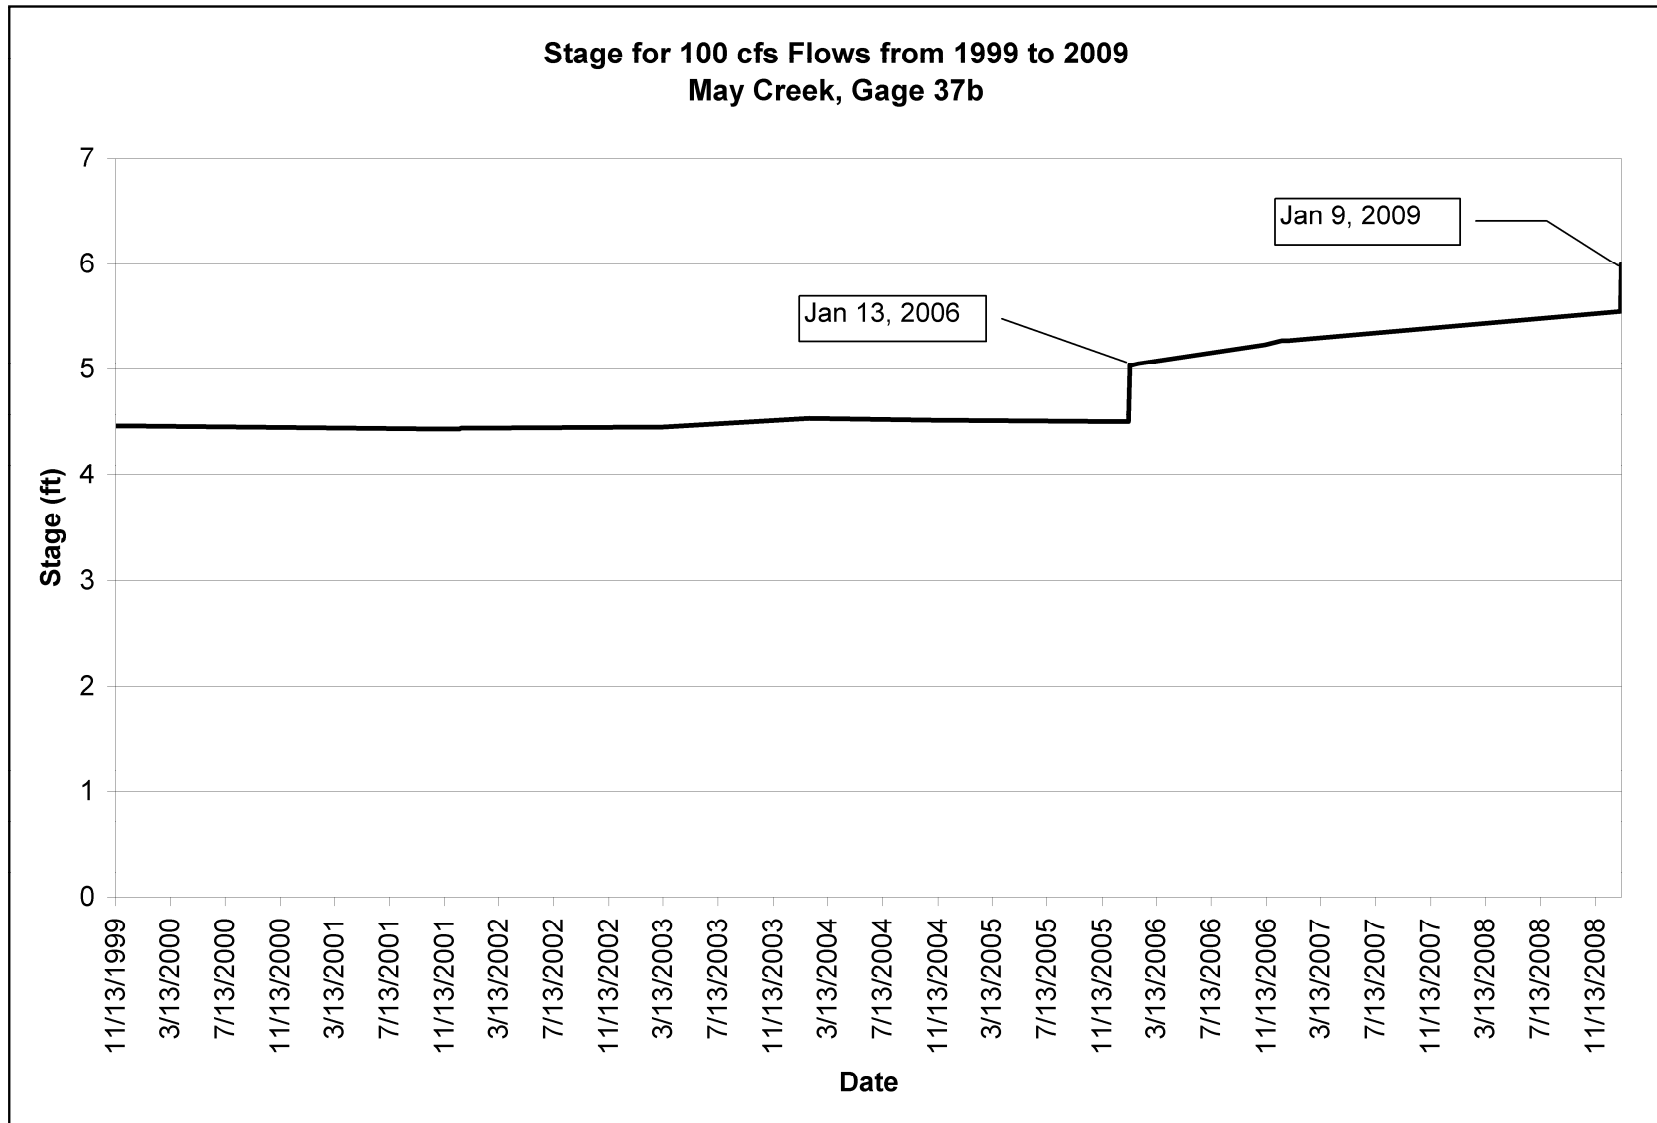
Figure 12: Comparison of Water Surface Elevation for 100 cfs Flows for Gage 37b

Gage 37b is located between the two monitoring stations, Stations 1 and 2. This gage was to be used to provide flow data for the sediment mobility study. However, a drift in the water surface elevation data was found in the gage data through inspection of flow events from 1999 through 2009. Figure 12 shows a plot of the water surface elevation data recorded by Gage 37b for each 100-cfs flow from November 13, 1999 through January 9, 2009. The water surface elevation data are consistent through January 13, 2006, where a distinct jump occurs. Following this jump, the water surface elevation continues to rise for each subsequent 100-cfs flow event until January 9, 2009, where another significant jump occurs. These perturbations are likely caused by wood debris depositing in the channel adjacent to the gage affecting the measured water surface elevations. Therefore, following January 13, 2006, the stage flow relationship for this gage was not a constant. Since the project monitoring period occurs within this window of time, the flow data directly from Gage 37b could not be reliably used in this study.

The purpose of the gage scaling between Gages 37a and 37b was to extend the flow record from Gage 37b beginning at January 11, 2006 (just prior to the initial jump shown in Figure 12) through the current extent of flow record at the time of this analysis for Gage 37a (February 5, 2009). The data obtained from both gages include mean hourly flow and corresponding stage for various periods of record. Where some hourly data were missing for

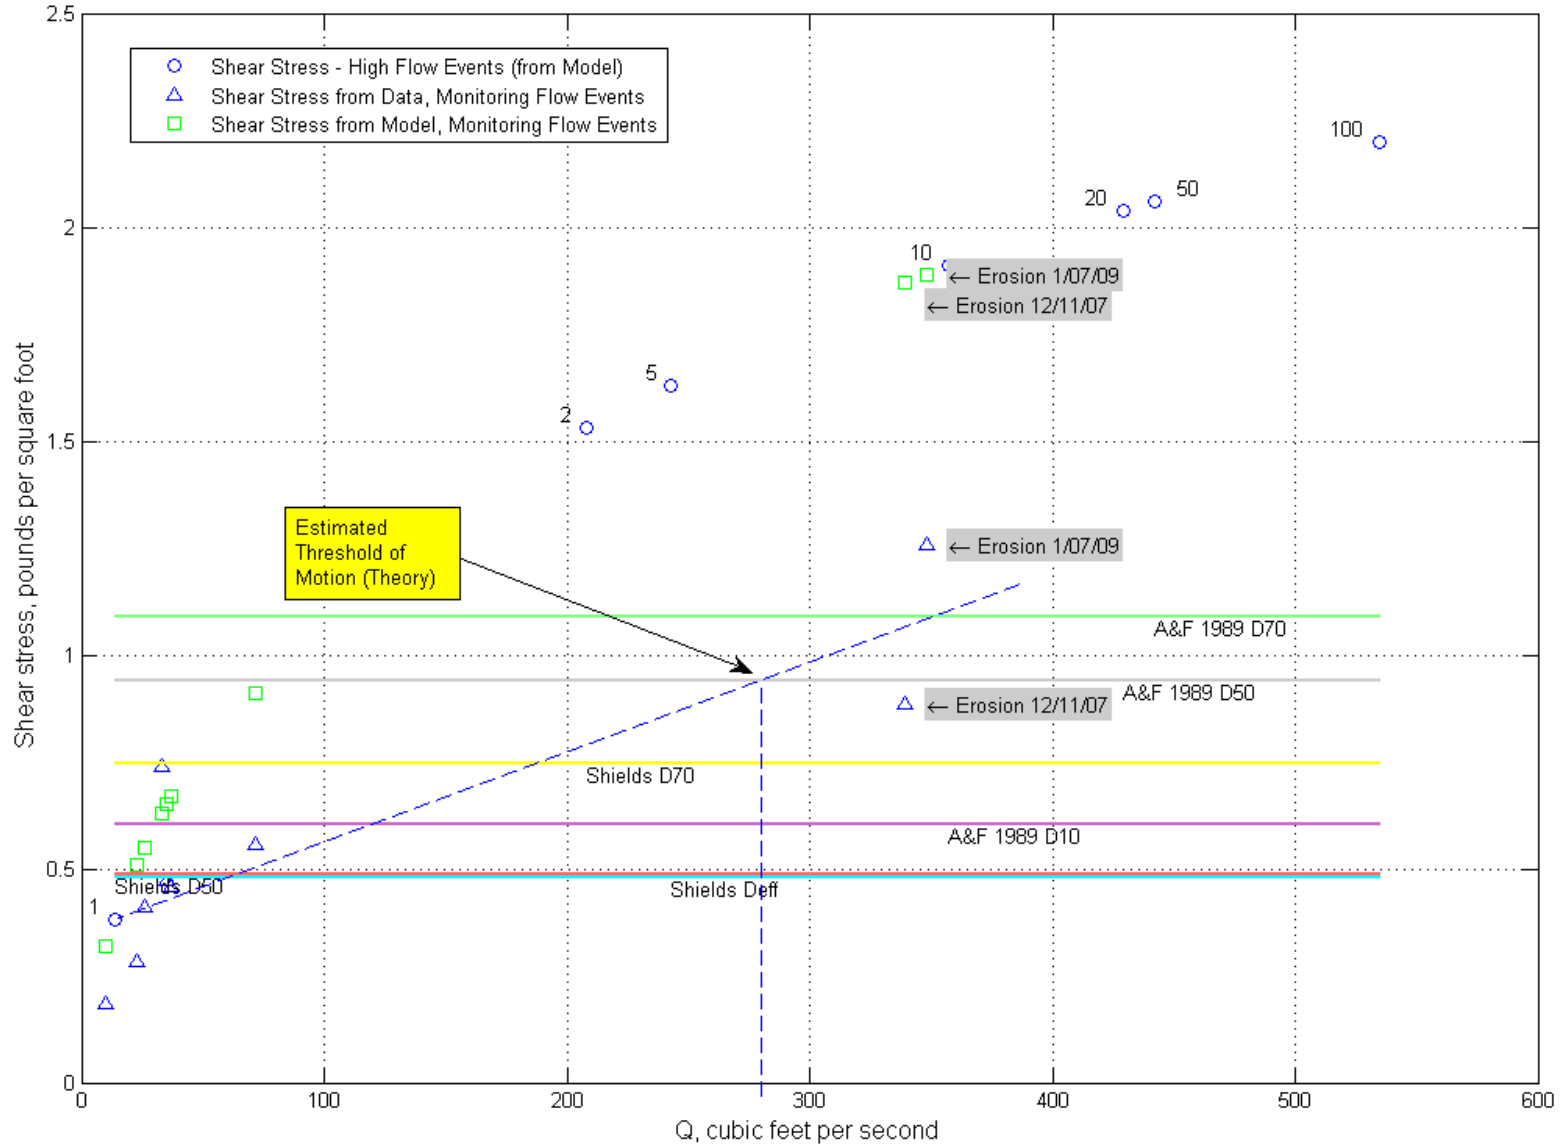
This Figure 15: Station 2, Relationship between Flow and Shear Stress

From monitoring data and notes, it is clear that the threshold of motion lies somewhere between 70 and 350 cfs, as no erosion was observed during the 70 cfs event and erosion was observed during the two 350 cfs events. Since there are no monitoring flow events in between those two bookends, the data set must be interpolated to provide estimates of bed shear stress (at each station) for flows between 70 and 350 cfs. This interpolation was done using a graphical approximation to define a trend for the data. Plots were created for each station (Figures 14 through 16) that includes the following data:

1. Critical shear stress estimates (shown as colored lines on the plots)
2. Bed shear stress for high flow events provided by the HEC-RAS model (shown as blue circles on the plots labeled with associated return period). Note: These values were not shown for Station 1 as they were found to be unreliable.
3. Bed shear stress for monitoring flow events provided by the HEC-RAS model (shown as green squares on the plots)
4. Bed shear stress for monitoring flow events calculated directly from data (shown as blue triangles on the plots)

The critical shear stress for each station (in lbs/ft²) using Ashford and Ferguson (1989) and the d_{50} of the bed is 1.8 for Station 1, 0.9 for Station 2, and 0.8 for Station 3 (Table 6). The flow discharge in each station that corresponds to this estimated critical shear stress was found using the trend lines plotted in Figures 14 through 16. The procedure for this is described below:

1. The critical shear stress value for the station is found on the vertical axis of the plot (Figures 14 through 16)
2. A line is drawn horizontally on the plot at that critical shear stress value (shown as the thick grey line labeled A&F D50)
3. From the intersection of that horizontal line with the data trend line a corresponding value of discharge (Q) along the x-axis can be determined.

Using this methodology, the flow discharge which corresponds to the threshold of sediment bed motion for Stations 2 and 3 is approximately 280 cfs and 275 cfs, respectively. Station 1, however, shows a different behavior than Stations 2 and 3. The trend line plot (Figure 14) shows that the estimated critical shear stress for the section (1.8 lbs/ft²) is larger than the calculated shear stress from the monitoring event where erosion was observed (1.3 lbs/ft²). This could imply that a different estimate of critical shear stress is applicable for Station 1. However, there are several complicating factors present at Station 1. During the course of the monitoring period, and shown in the pre- and post- survey data provided in Figure 9, the original channel has filled in with approximately 0.5 feet of sediment and a deeper narrower
