# Stillaguamish Big Trees Project

Rodney Pond & Scott Moore  
Snohomish County Surface Water  
Management

# Project Specifics

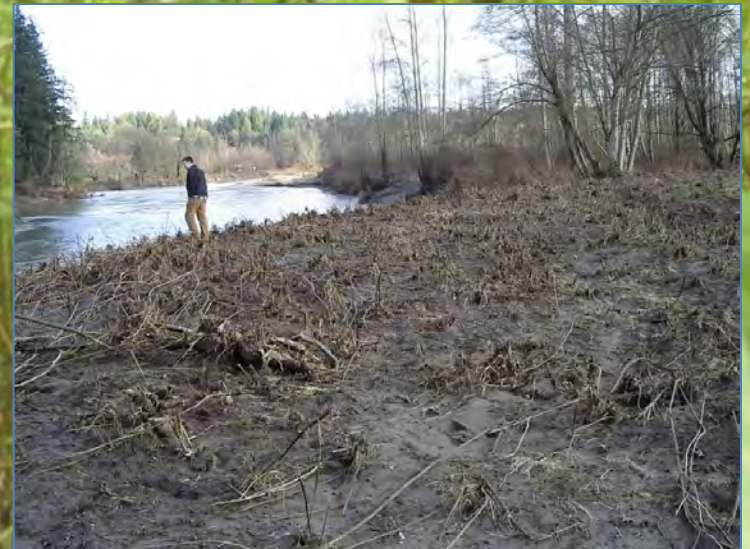
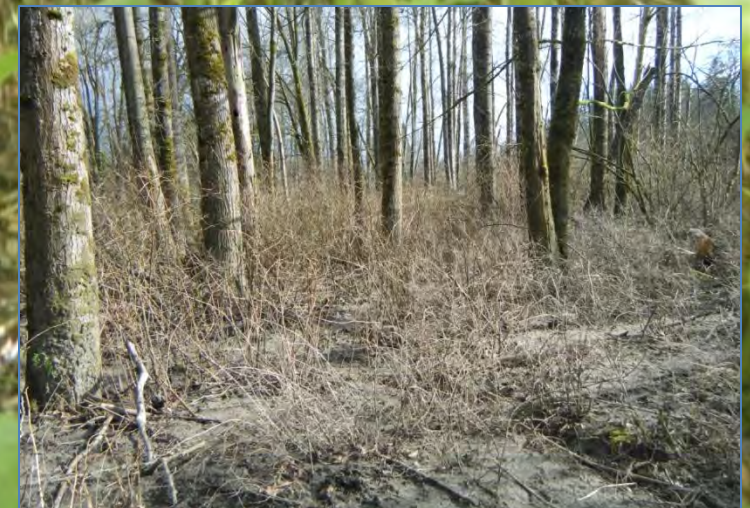
## SF Stillaguamish Running 7DADMax H<sub>2</sub>O & ADMax Air Temp (°C) & DMax Flow (FT<sup>3</sup>/S)

In-stream temperatures regularly exceed WA state WQ standard for core salmonid habitat during the summer

Lack of mature trees providing near stream shade - 32% forested, only 12% conifer

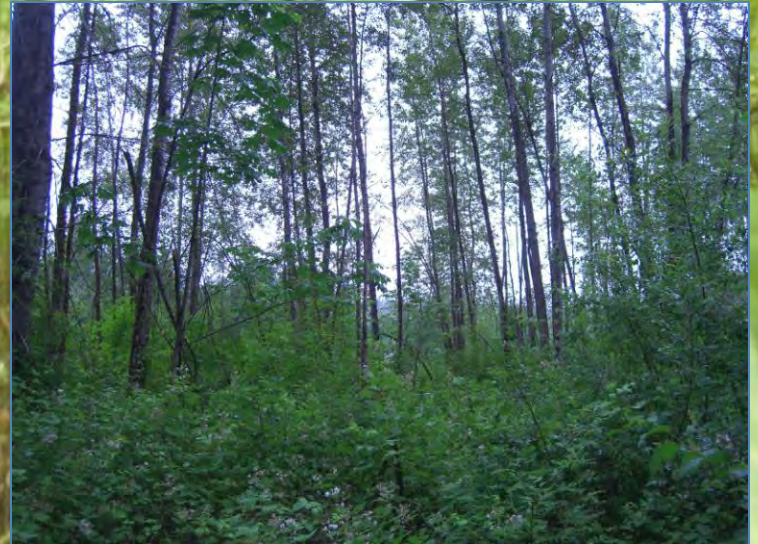
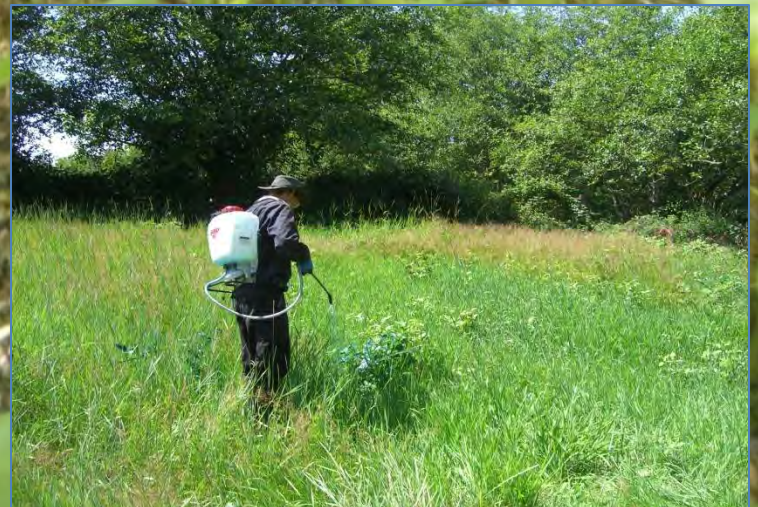
Focus on establishing native conifers for long term ecosystem function and stability

Use larger stock size for faster establishment and greater survivorship

Under-plant deciduous floodplain forests to manage succession

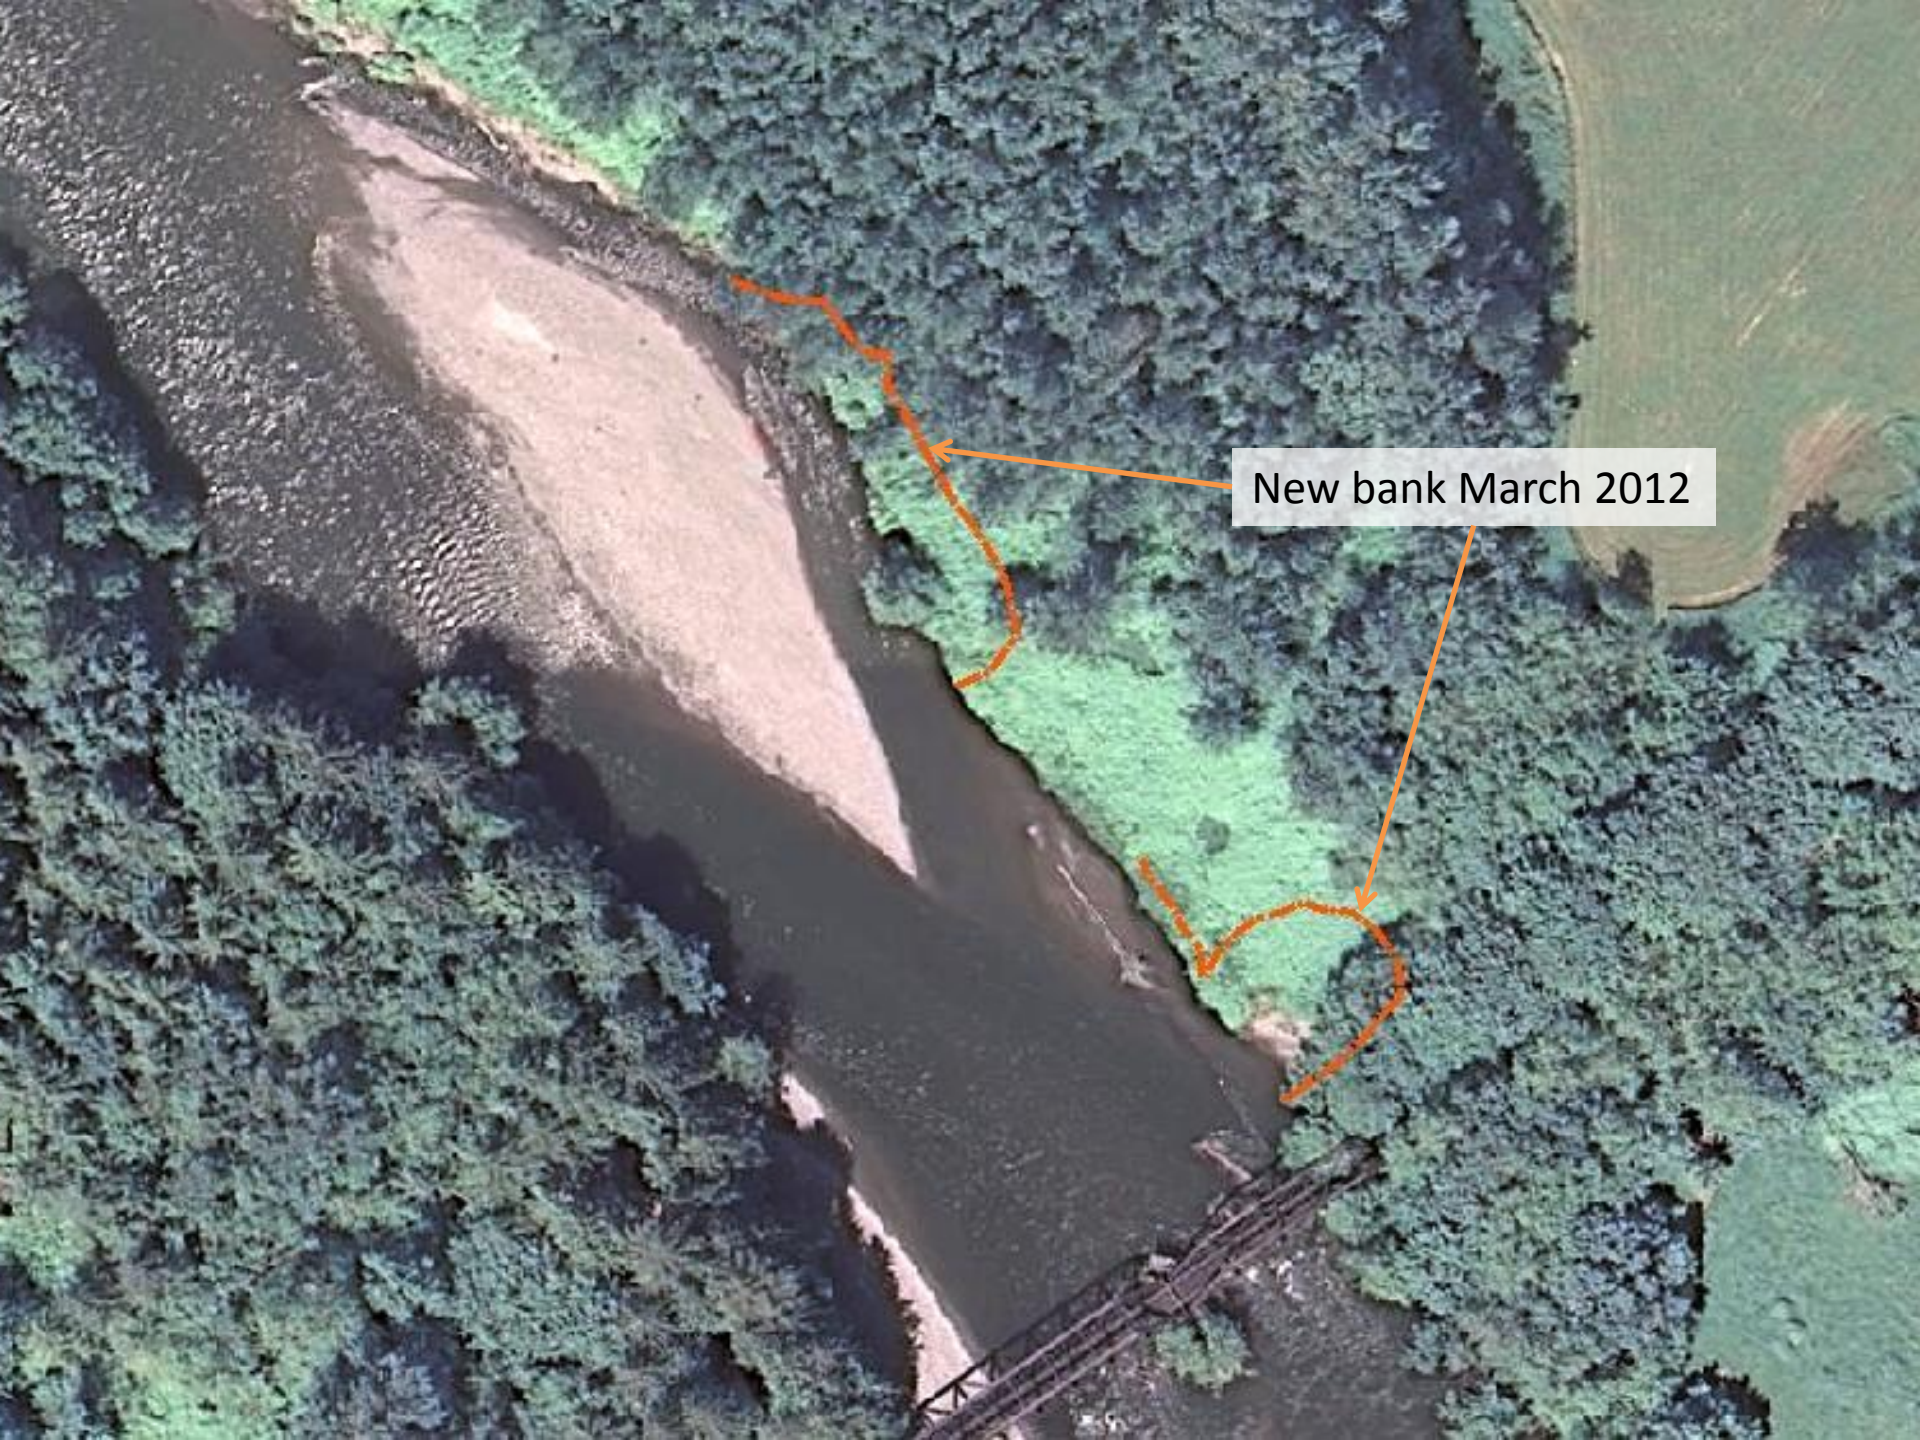
New bank March 2012

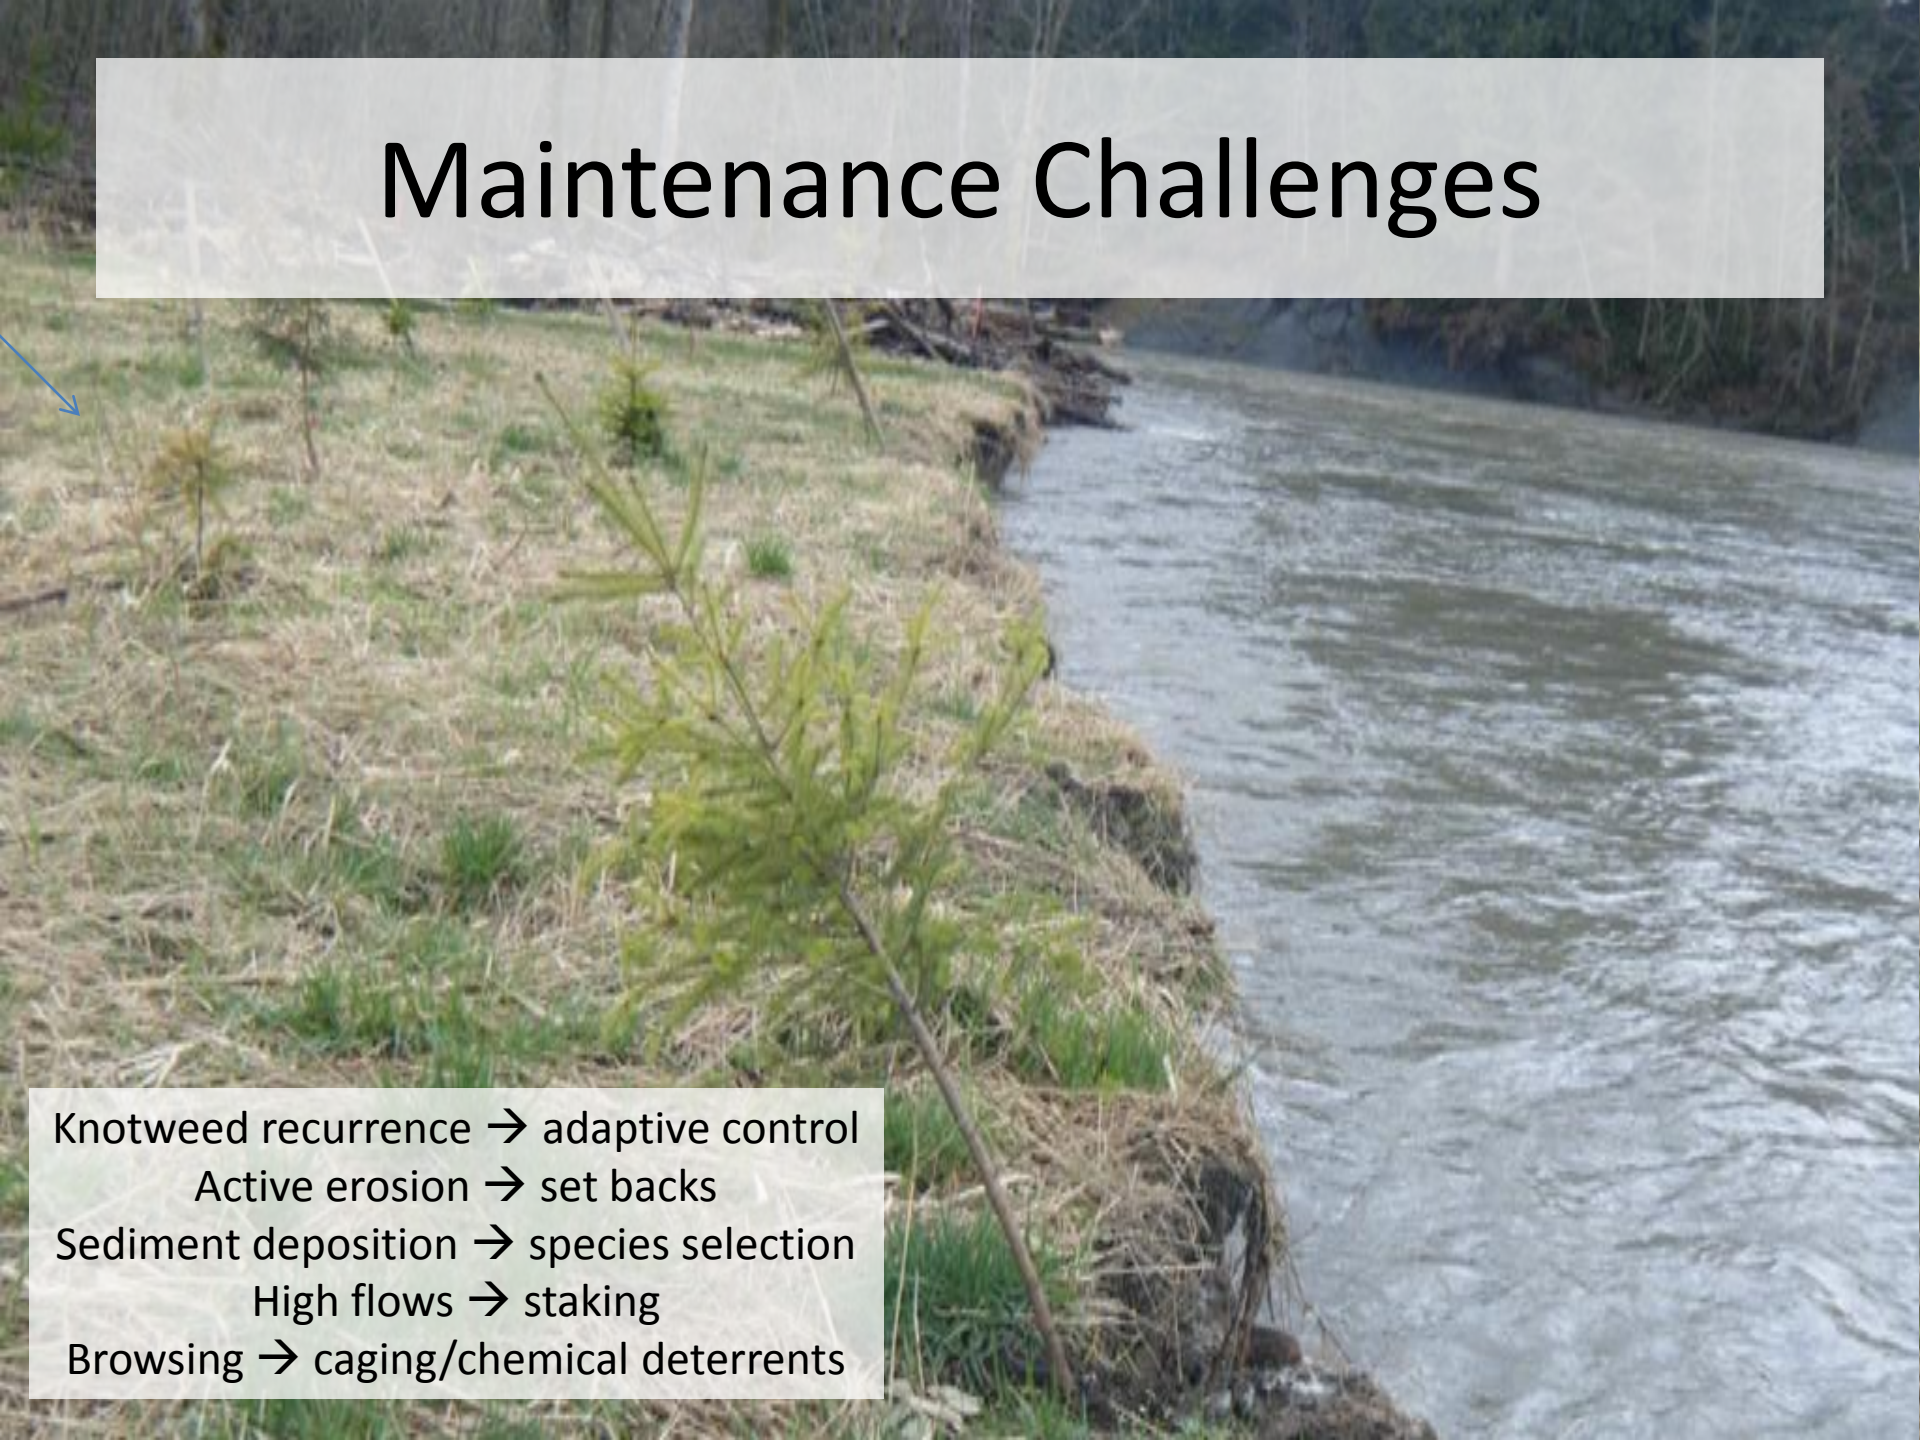
Knotweed recurrence → adaptive control  
Active erosion → set backs  
Sediment deposition → species selection  
High flows → staking  
Browsing → caging/chemical deterrents
