Subject: Seattle Metro Final Design Engineering For The Carkeek Transfer/CSO Facilities Project
North Beach Force Main Inspection Report

Subject: North Beach Force Main
Excavation and Evaluation - Task 561

Transmitted herewith is our report on the excavation and evaluation work accomplished on the North Beach Force Main in northwest Seattle between the North Beach Pumping Station and Carkeek Park.

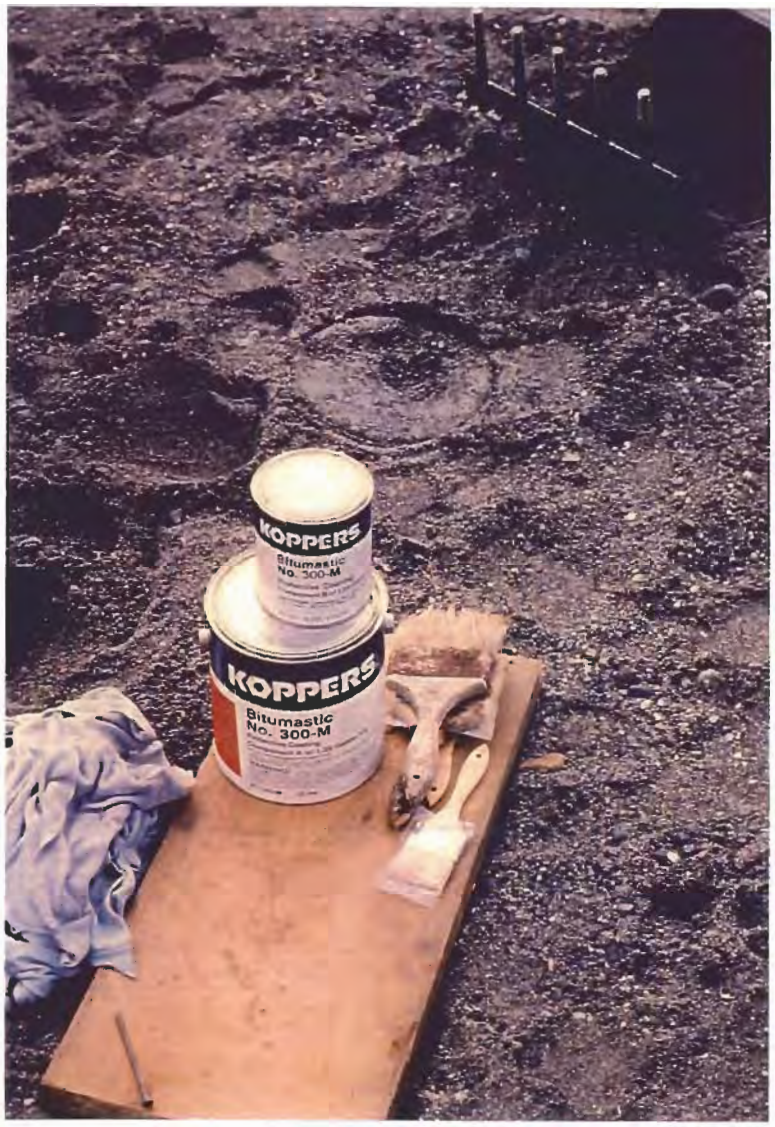
PICTURE NO. 8

KOPPERS Bitumastic No. 300-M protective coating at Excavation No. 1 site on April 19, 1989; used for applying a second coat of protective coating to the tapping sleeve and gate valve assembly prior to installation on the force main, and for touch-up repair prior to backfilling the excavation.

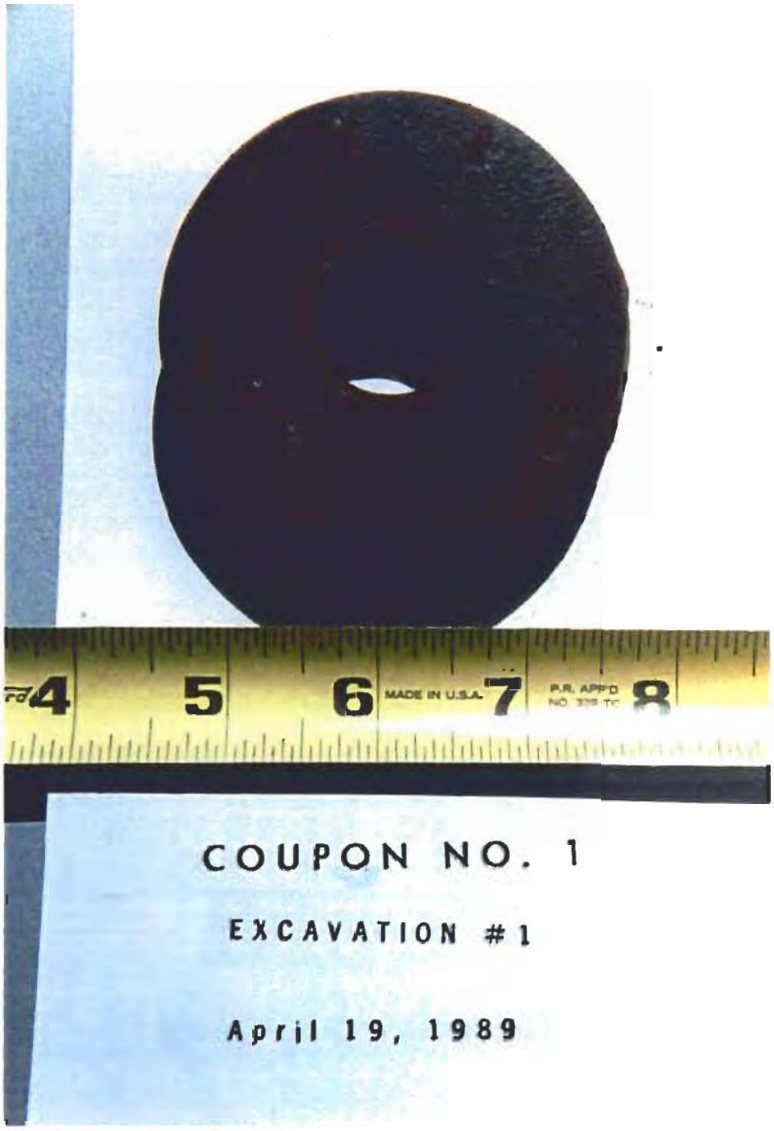
PICTURE NO. 25

The exterior surfaces of Coupons Nos. 1 and 3 (removed from the force main at Excavations Nos. 1 and 3 respectively) appeared to be in very good condition, with a thin film of tightly adhering graphitization and no pitting evident. Coupon No. 2 (removed from Excavation No. 2), however, showed some pitting activity.

Close-up of exterior surface of Coupon No. 1 as removed from Excavation No. 1 on the North End Force Main, before cleaning.

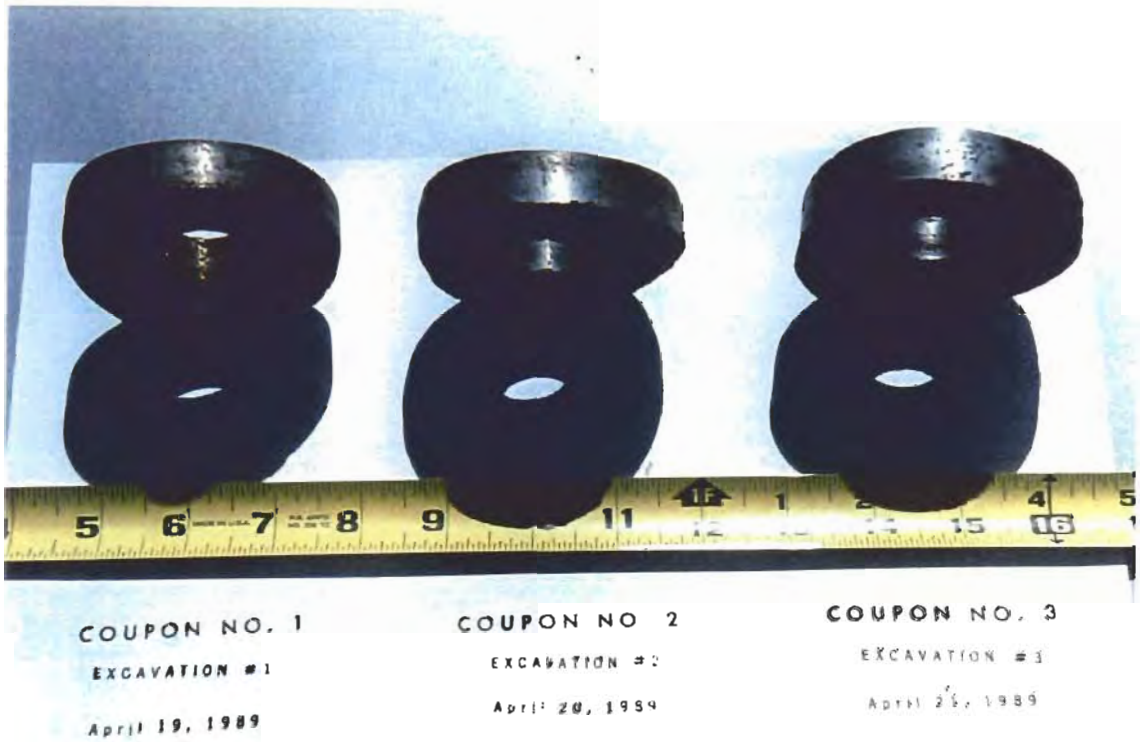
PICTURE NO. 28

Coupons removed from the North Beach Force Main showing the pipe wall thickness. The average thicknesses were measured as follows:

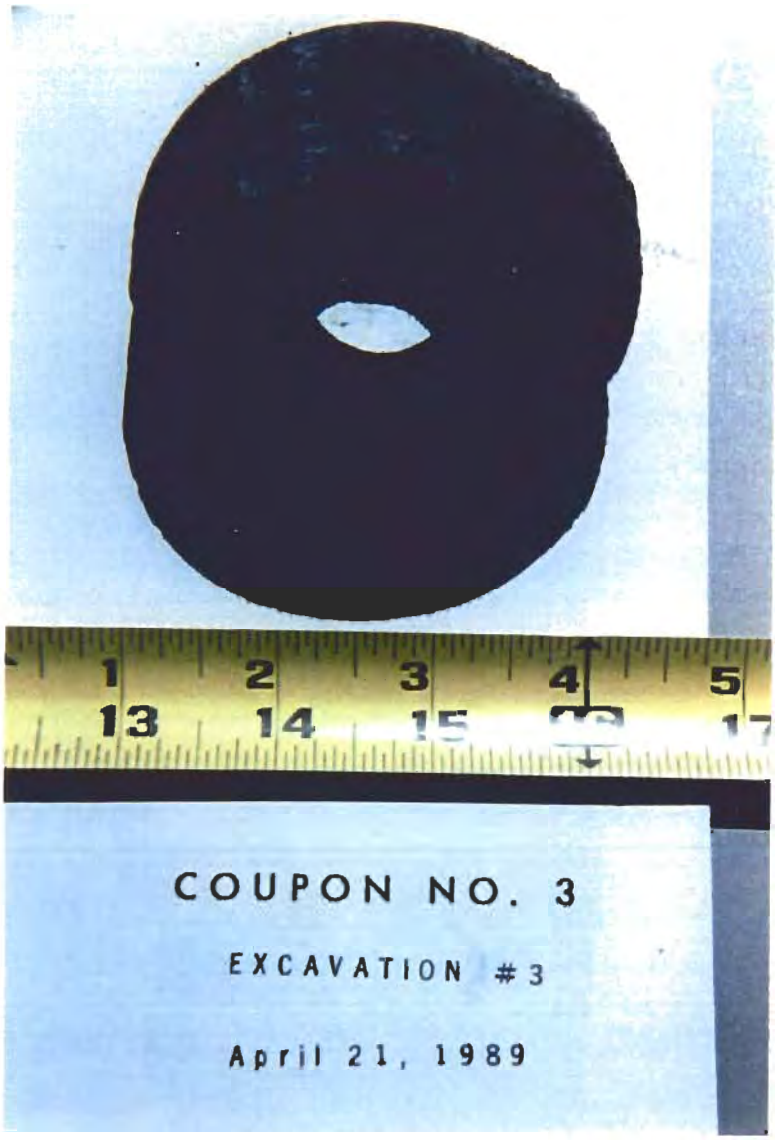
PICTURE NO. 32

Close-up of interior surface of Coupon No. 3 removed from the North Beach Force Main at Excavation No. 3, before cleaning. Only a very thin film of cement mortar lining was noted on small area on this coupon. It is believed that the lining came off during the cutting of the coupon out of the pipe.

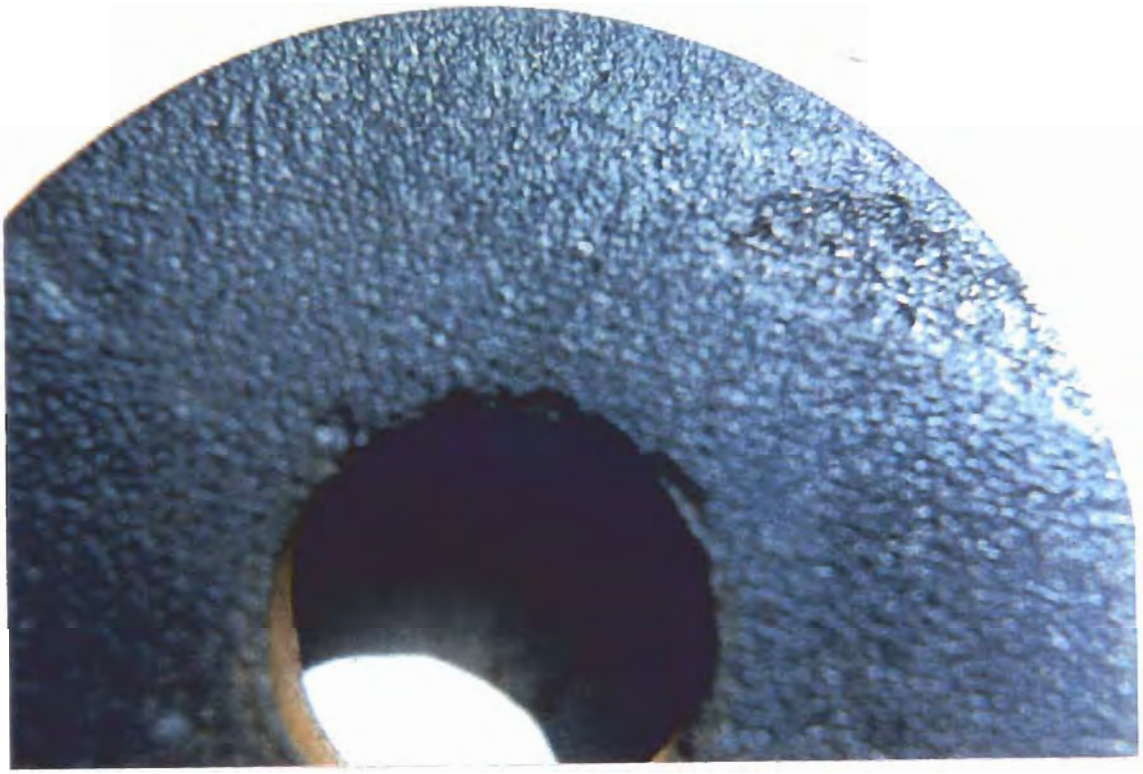
PICTURE NO. 34

Close-up of exterior surface of Coupon No. 1 removed from the North Beach Force Main at Excavation No. 1, after cleaning lightly with a power wire brush. Some very superficial pitting was noticeable on the surface of this coupon.

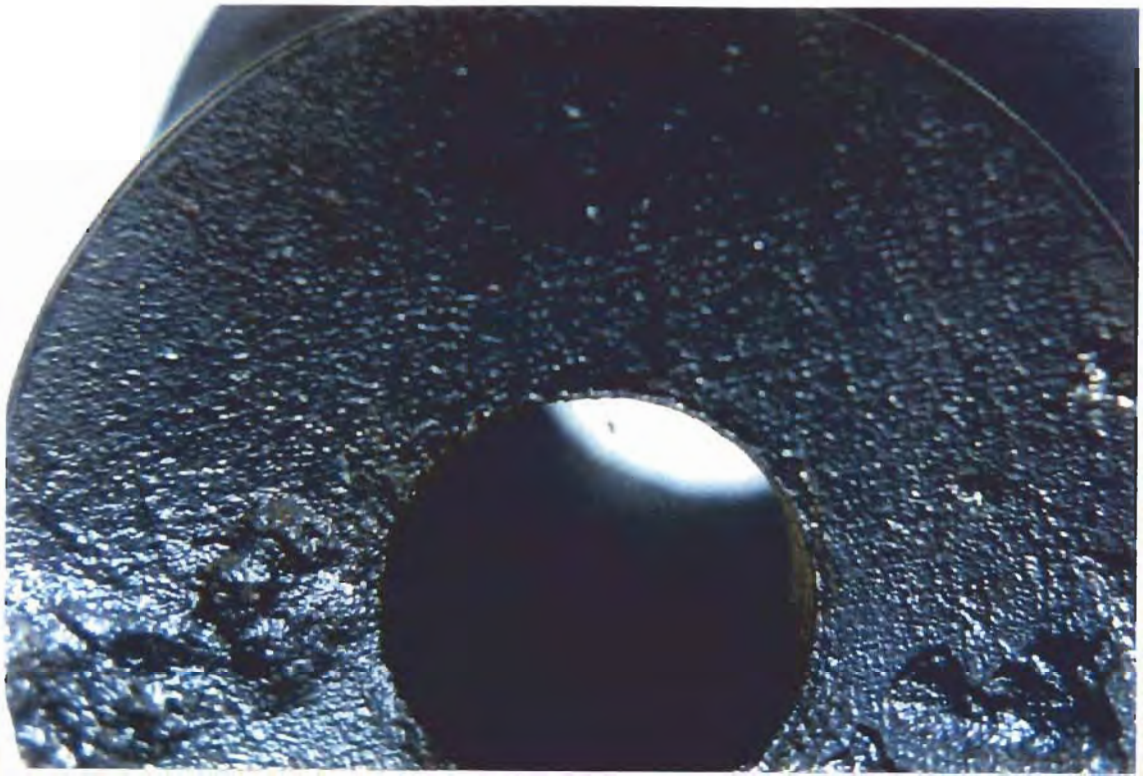
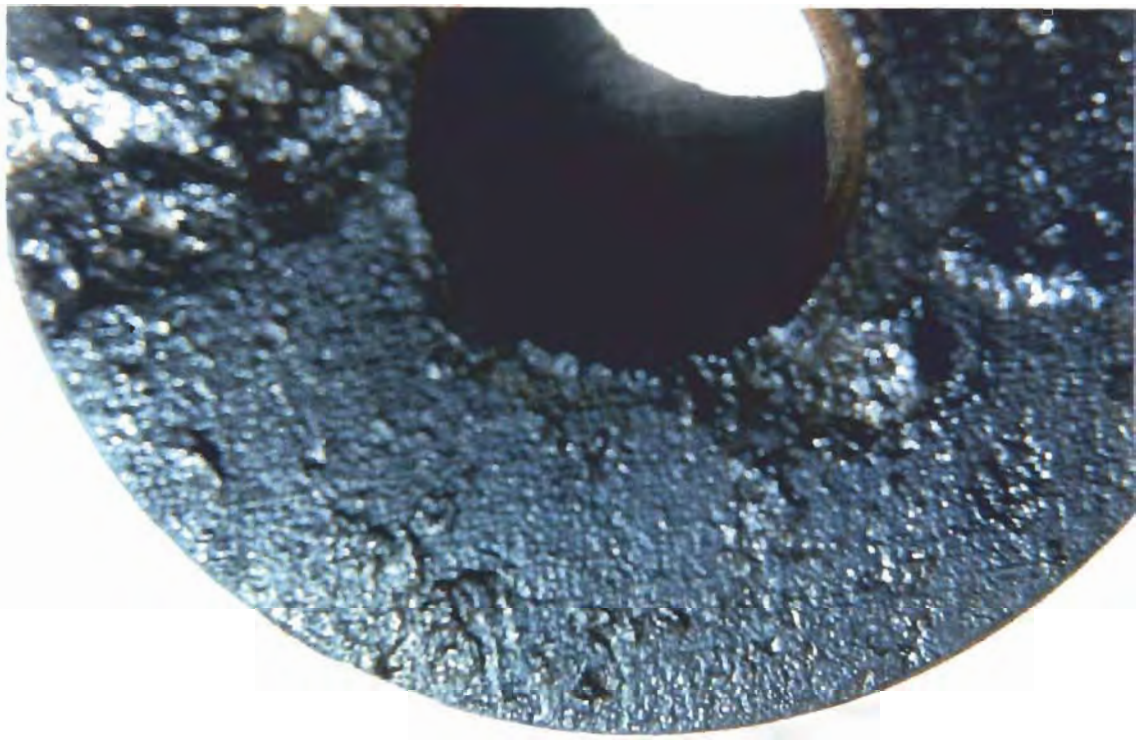
PICTURES NOS. 35 and 36

Enlargements of the exterior surface of Coupon No. 1 removed from the North Beach Force Main at Excavation No. 1, after cleaning. Note the superficial pitting at a few locations on the surface.

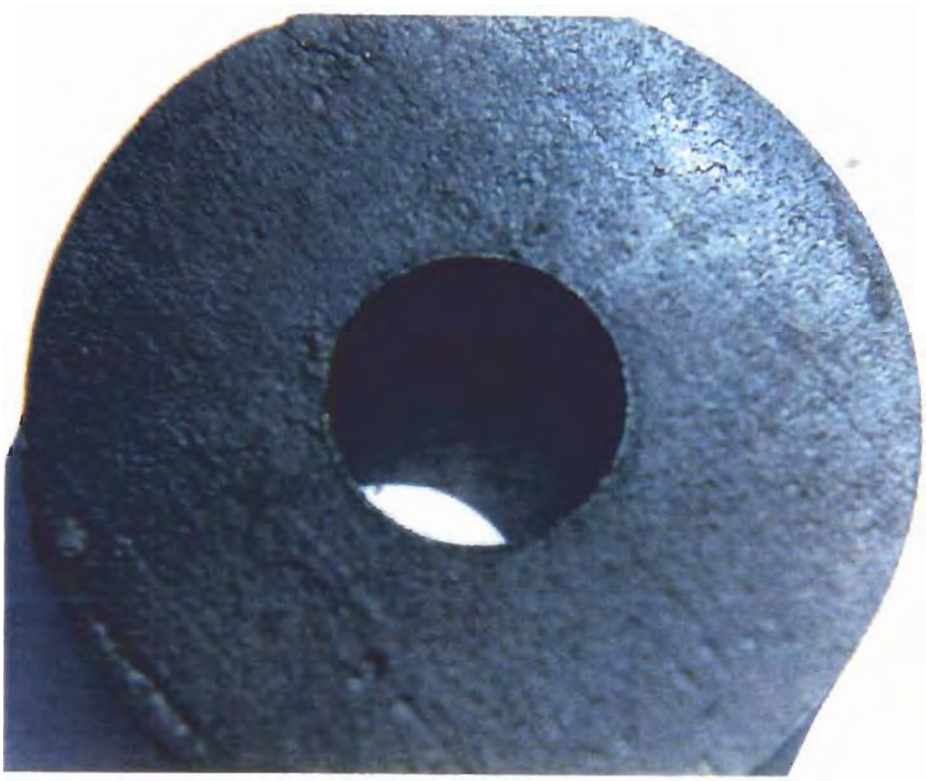
PICTURES NOS. 38 and 39

Enlargements of exterior surface of Coupon No. 2 removed from the North Beach Force Main at Excavation No. 2, after cleaning. Note the extensive pitting on surface, with graphitization build-up directly over pits.

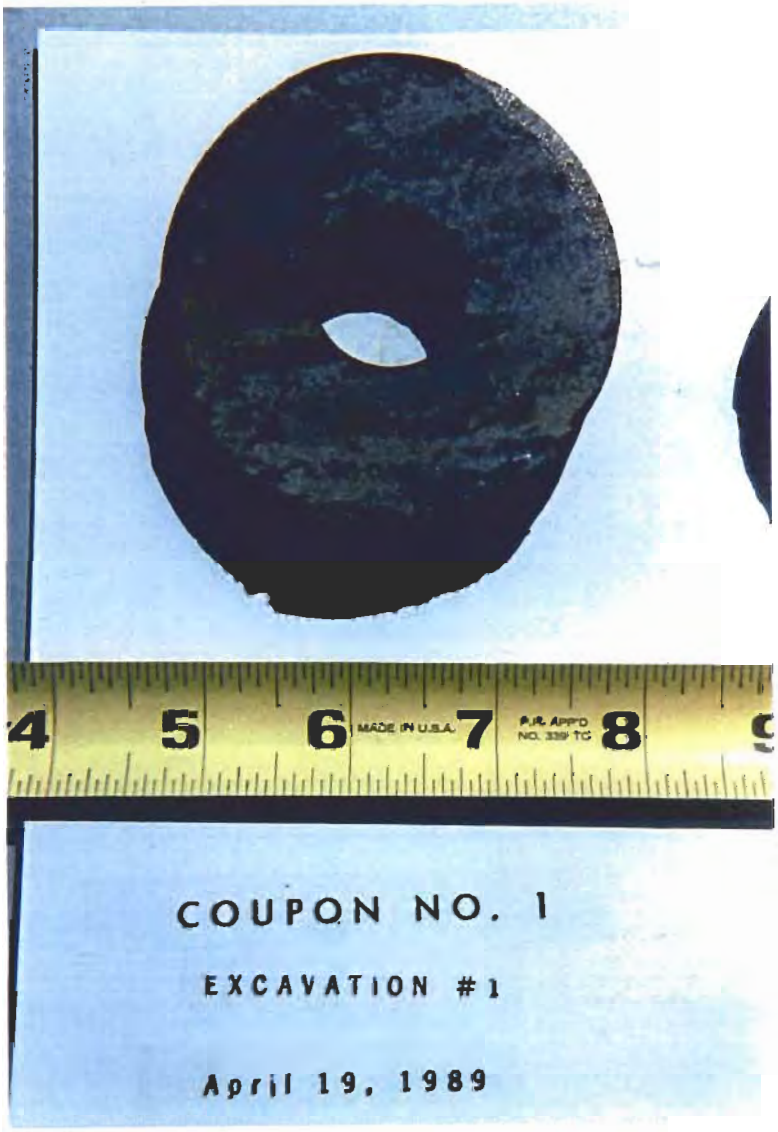
PICTURE NO. 44

Close-up of the interior surface of Coupon No. 1 removed from the North Beach Force Main at Excavation No. 1, after cleaning lightly with a power driven wire brush to remove scale and debris. Note the thin layer of cement mortar lining on the interior surface.

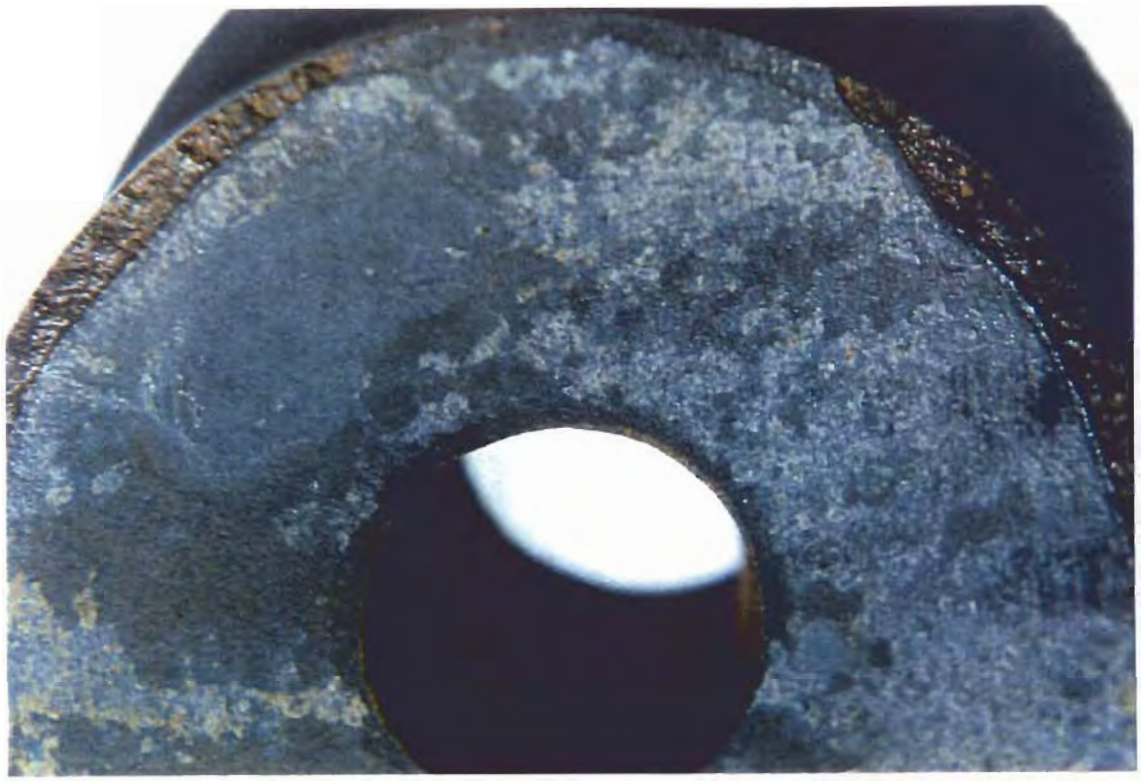
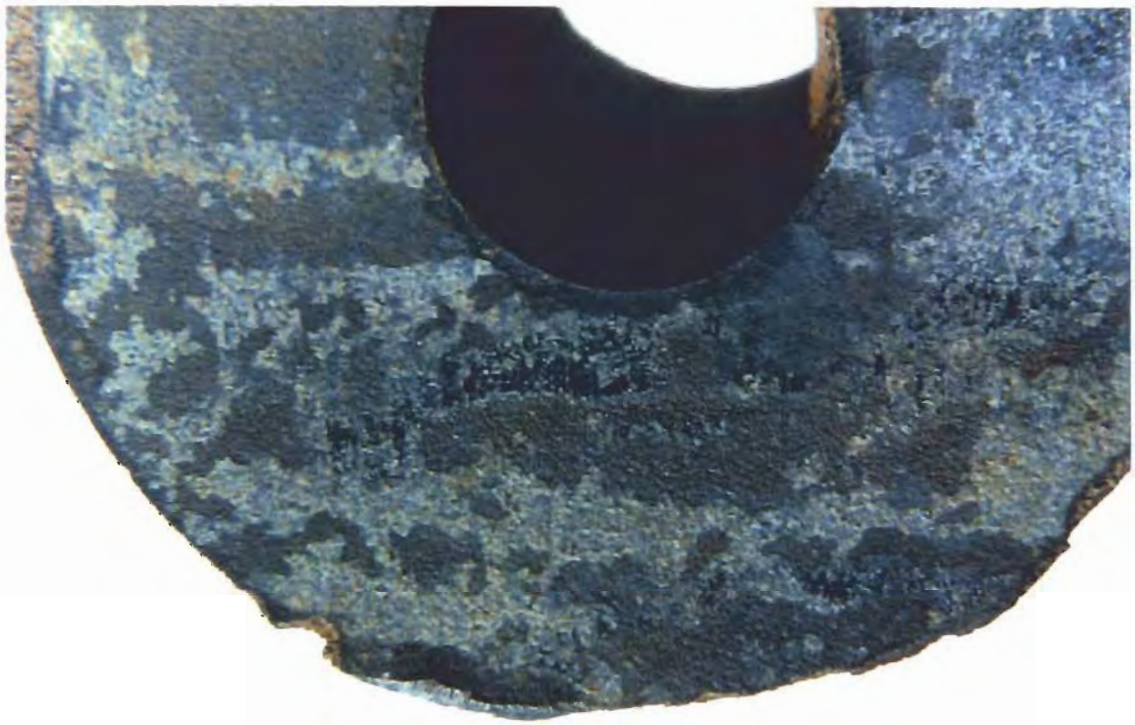
PICTURES NOS. 46 and 47

Enlargements of the interior surface of Coupon No. 1 removed from the North Beach Force Main at Excavation No. 1, after lightly cleaning. The thin layer of cement mortar lining is quite evident.

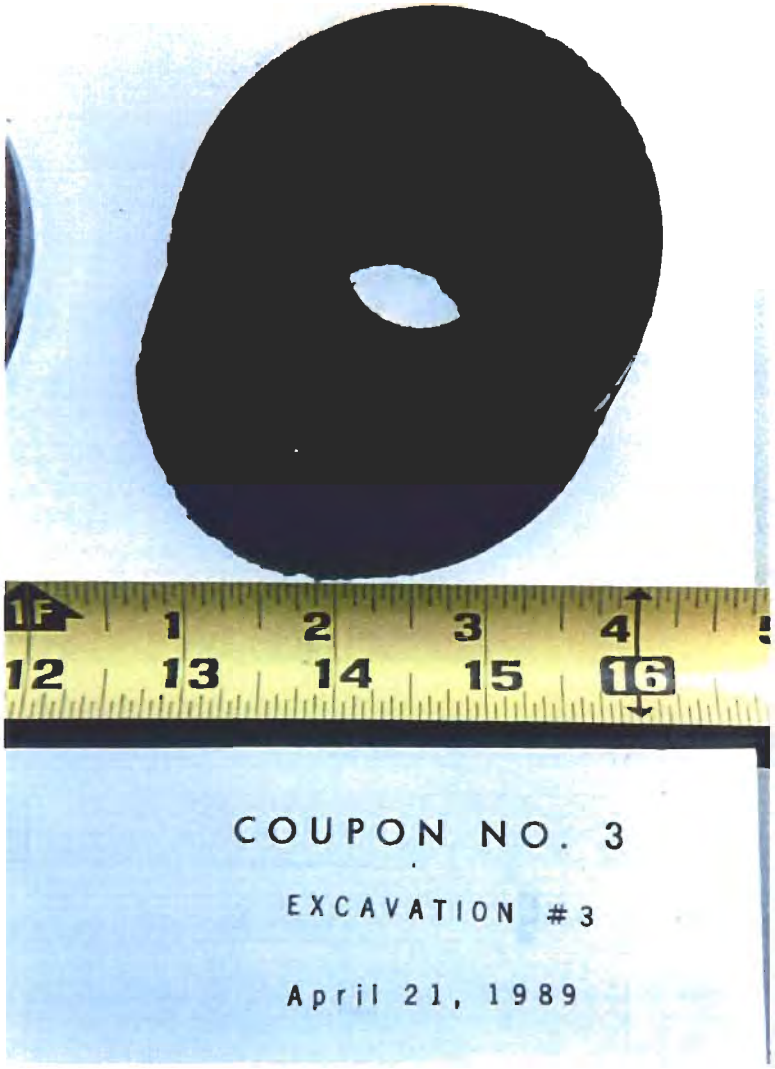
PICTURE NO. 52

Close-up of the interior surface of Coupon No. 3 removed from the North Beach Force Main at Excavation No. 3, after cleaning lightly with a power driven wire brush to remove scale and debris.

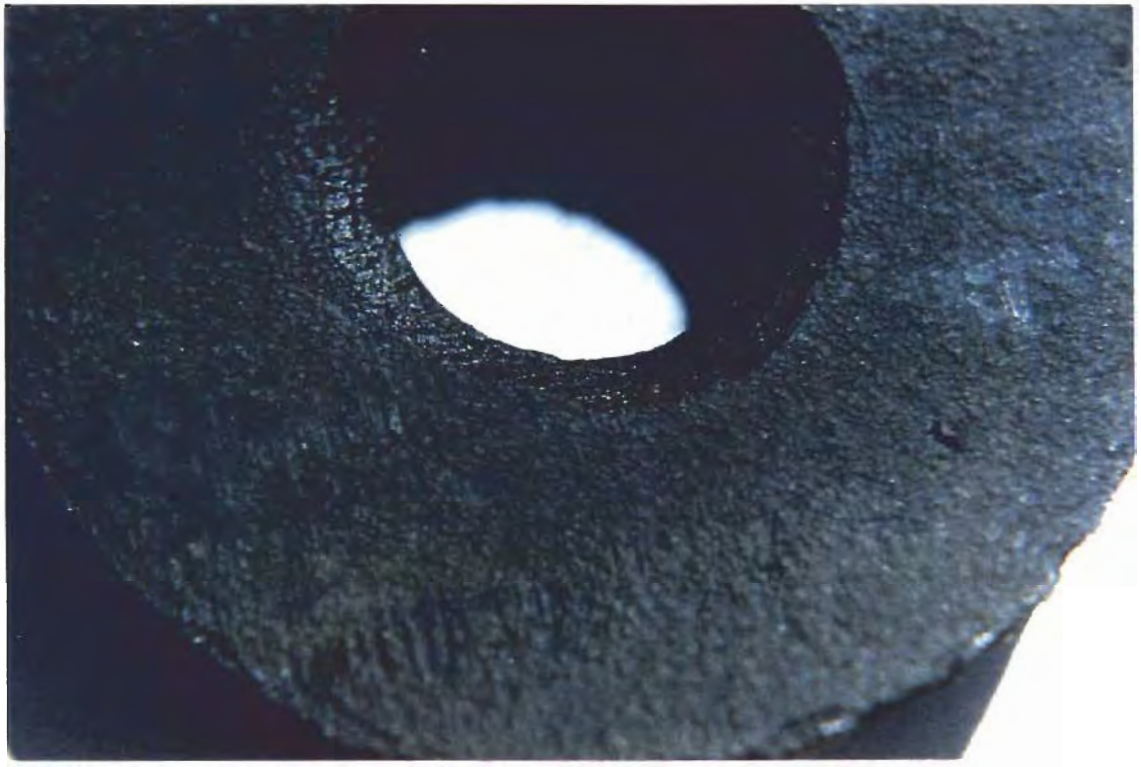
PICTURES NOS. 54 and 55

Enlargements of the interior surface of Coupon No. 3 removed from the North Beach Force Main at Excavation NO. 3, after lightly cleaning.

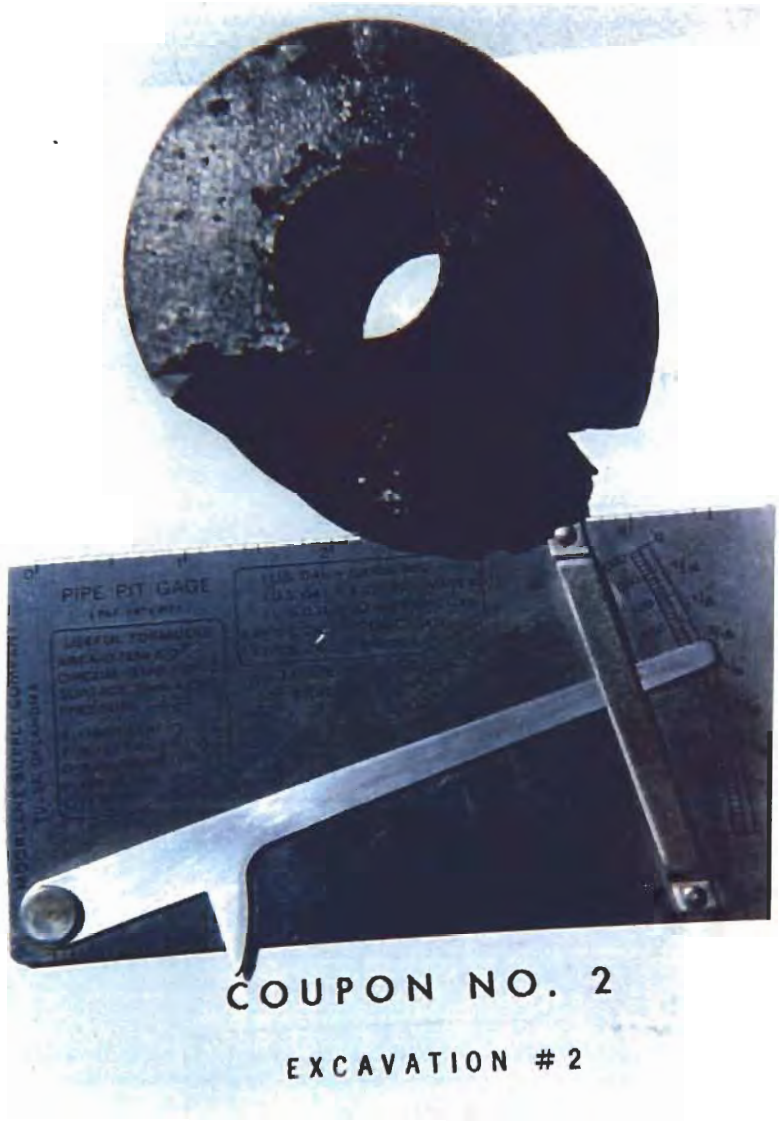
PICTURE NO. 56

Coupon No. 2 as sectioned by SCAN TECH, INC. for wall thickness measurements and metallurigical testing. Sectioning was done across a deep pit in the exterior surface of the coupon -- see the following pictures Nos. 57 and 58.

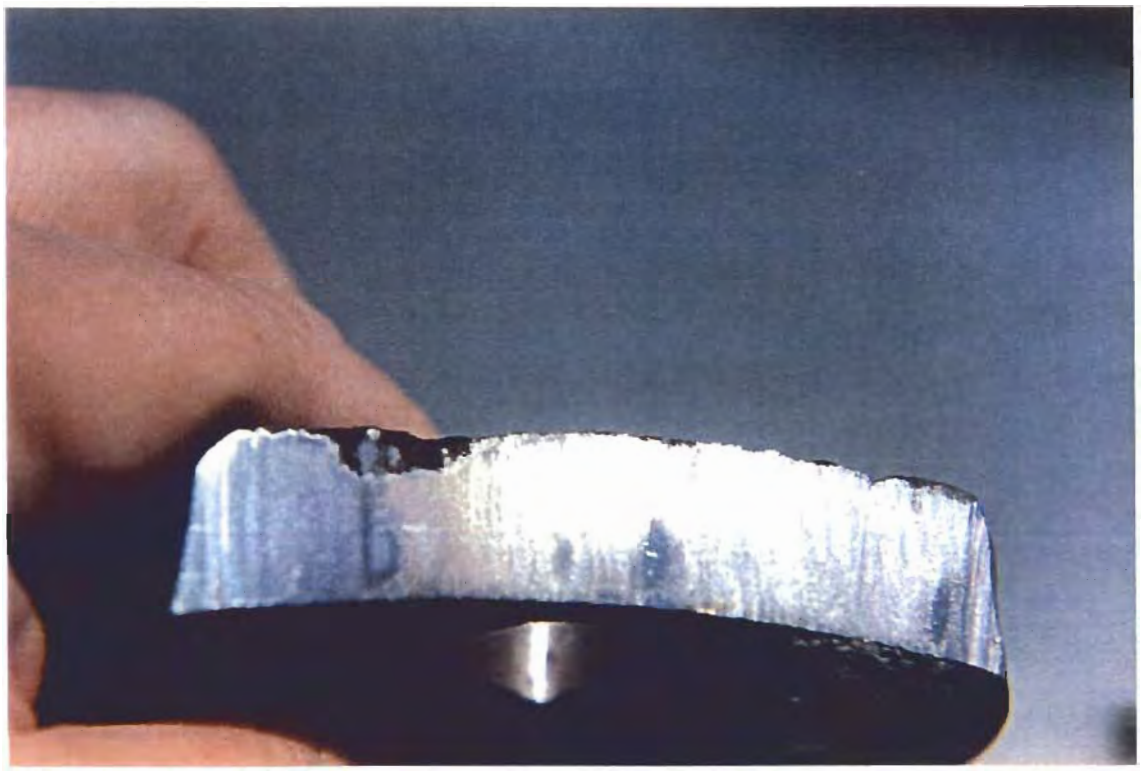
PICTURE NO. 57

Based on the evaluation made of the three coupons removed from the force main, and using the rather deep pitting found in Coupon No. 2 as a "worst case" situation, it has been estimated that the force main could operate for another 31 years before complete penetration of the pipe wall occurs, resulting in a leak.

Large section of Coupon No. 2 showing cut across deep pit. The pit depth was measured at 0.22", with the thickness of the pipe wall remaining beneath the pit measured at 0.44". The pit area was filled with tightly adhering graphitization.

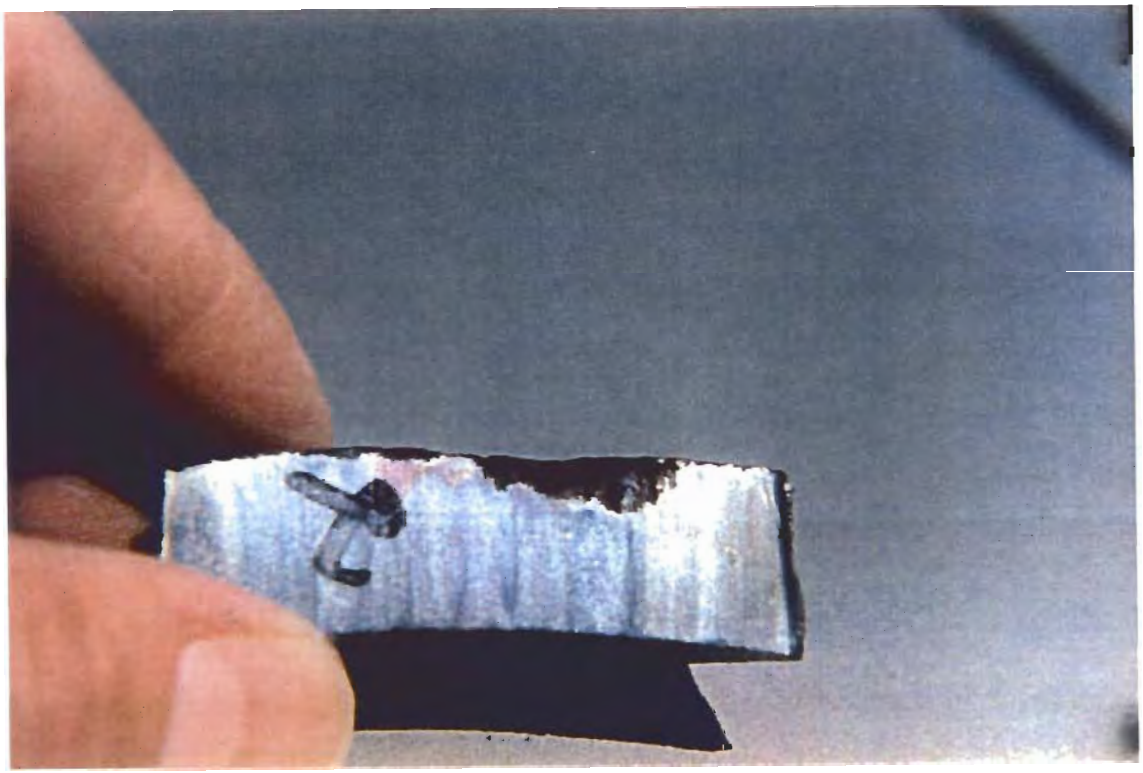
PICTURE NO. 58

Small section of Coupon No. 2 showing cut across deep pit. The pit depth was measured at 0.22", with the thickness of the pipe wall remaining beneath the pit measured at 0.44". The pit area was filled with tightly adhering graphitization.
