**BRIGHTWATER POST-CONSTRUCTION**

# **Eelgrass Program: 2009 Eelgrass Transplant Report**

**Task 400 – Eelgrass Transplanting**

**December 2009**

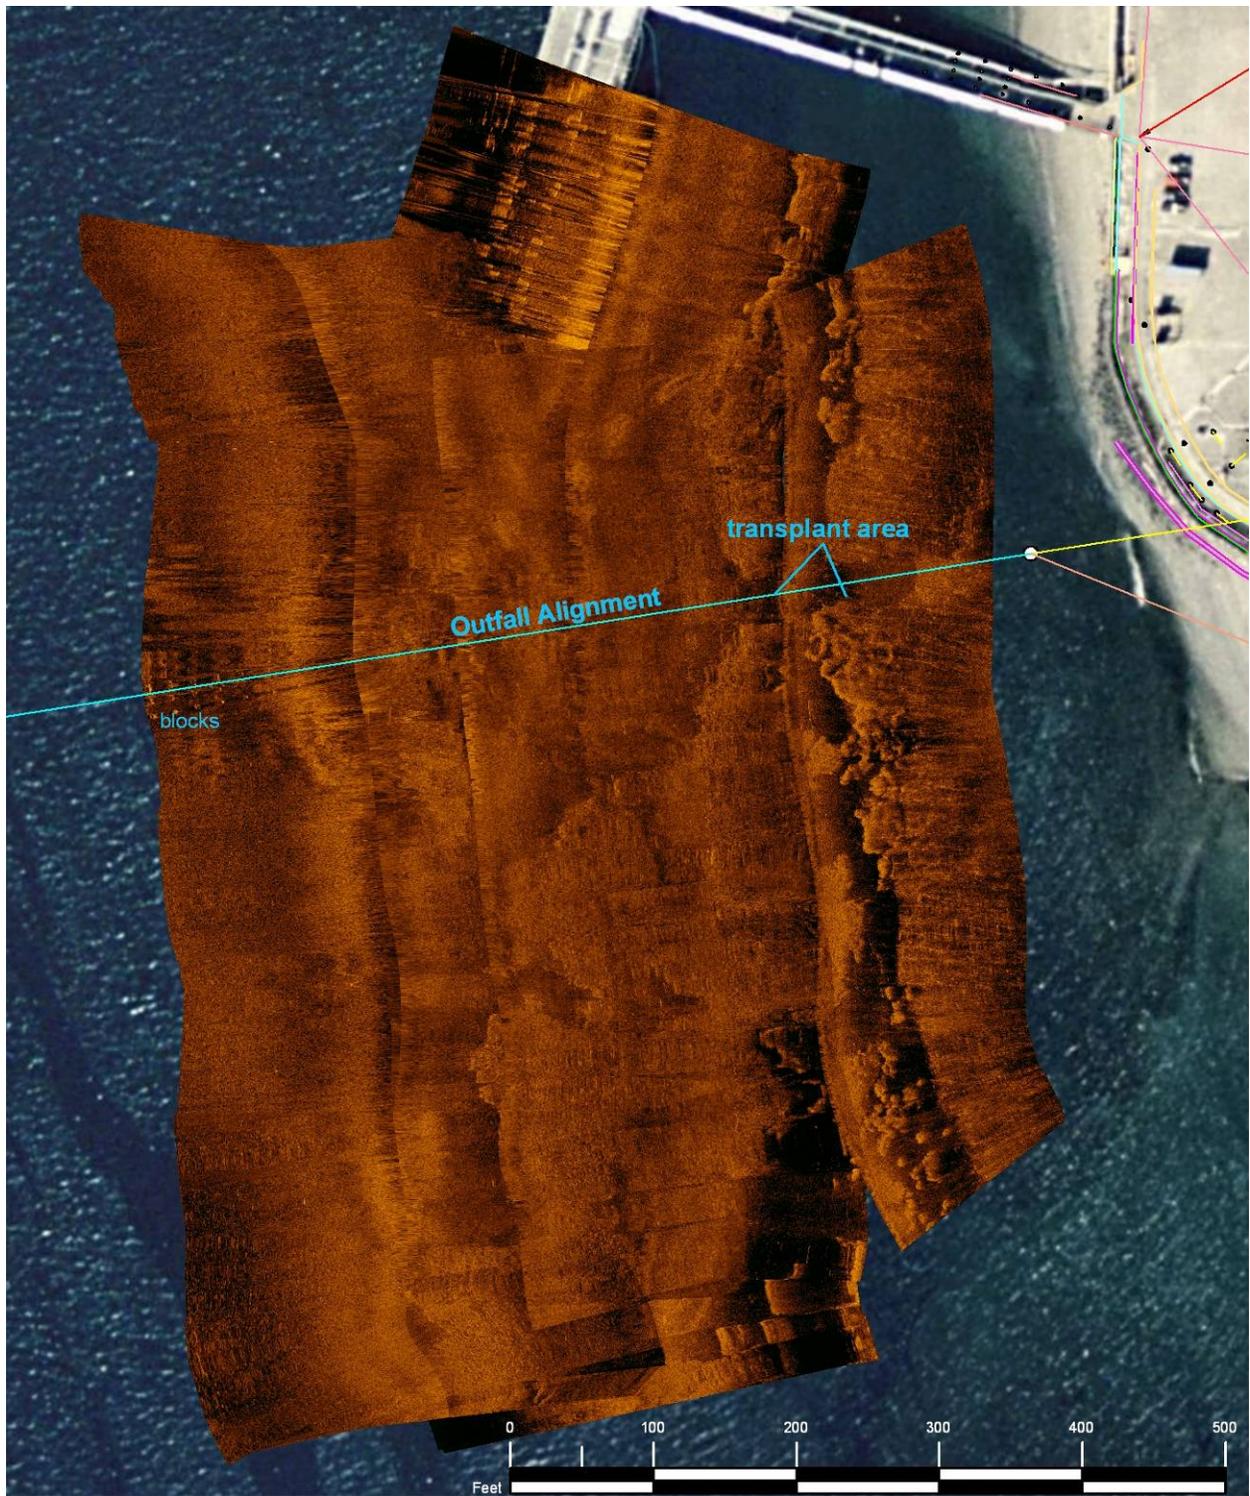
The processed side-scan sonar mosaic (Figure 5) revealed very subtle variations in texture typical of very shallow, mixed-seafloor, environments. Specific variations in eelgrass plant density were not easily discernable due to geometric distortion typical in side-scan mosaics. Movement of plants due to tidal currents as well as plant shading of seafloor “uphill” of the sonar further complicated the acoustic image results. The eelgrass bed extents, however, were distinguishable from the surrounding sediment. An example of the acoustic texture signature of eelgrass is shown in Figure 6.

Figure 5. Side-scan sonar mosaic of survey area. Pipeline anchor blocks are visible on the western side of the image. The area to receive transplanted eelgrass is highlighted. Outfall alignment data provided to GRS by Triton Marine Construction for bathymetric surveys conducted during the pipeline lay.

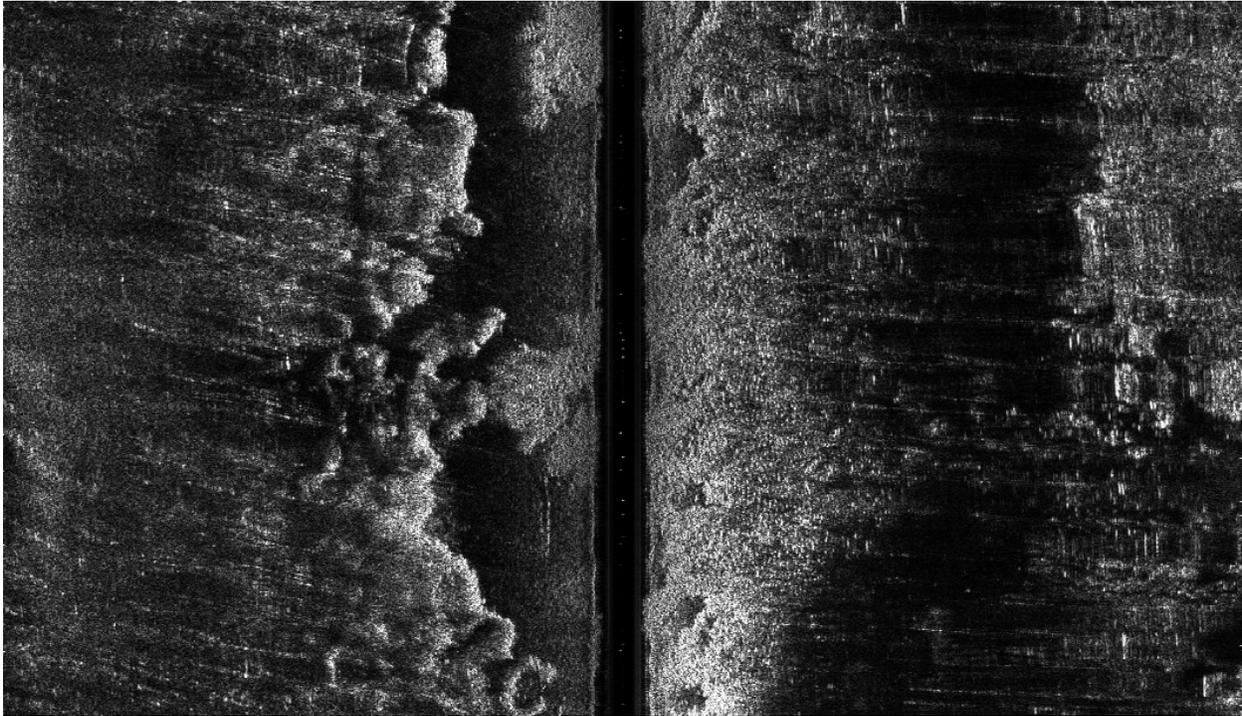
**Figure 6. Side-scan waterfall view of eelgrass clumps (center-left) and mixed-density beds (center-right). Gap in the middle is the water column directly under the sonar towfish. The swath width is 100 m. The shoreward direction is to the left.**
