# GEOMORPHIC HAZARDS AND RISKS ASSESSMENT AND ALTERNATIVES ANALYSIS

SOUTH FORK SNOQUALMIE RIVER  
CIRCLE RIVER RANCH NEIGHBORHOOD

Prepared for  
King County  
Water and Land Resources Division  
River and Floodplain Management Section

July 31, 2012

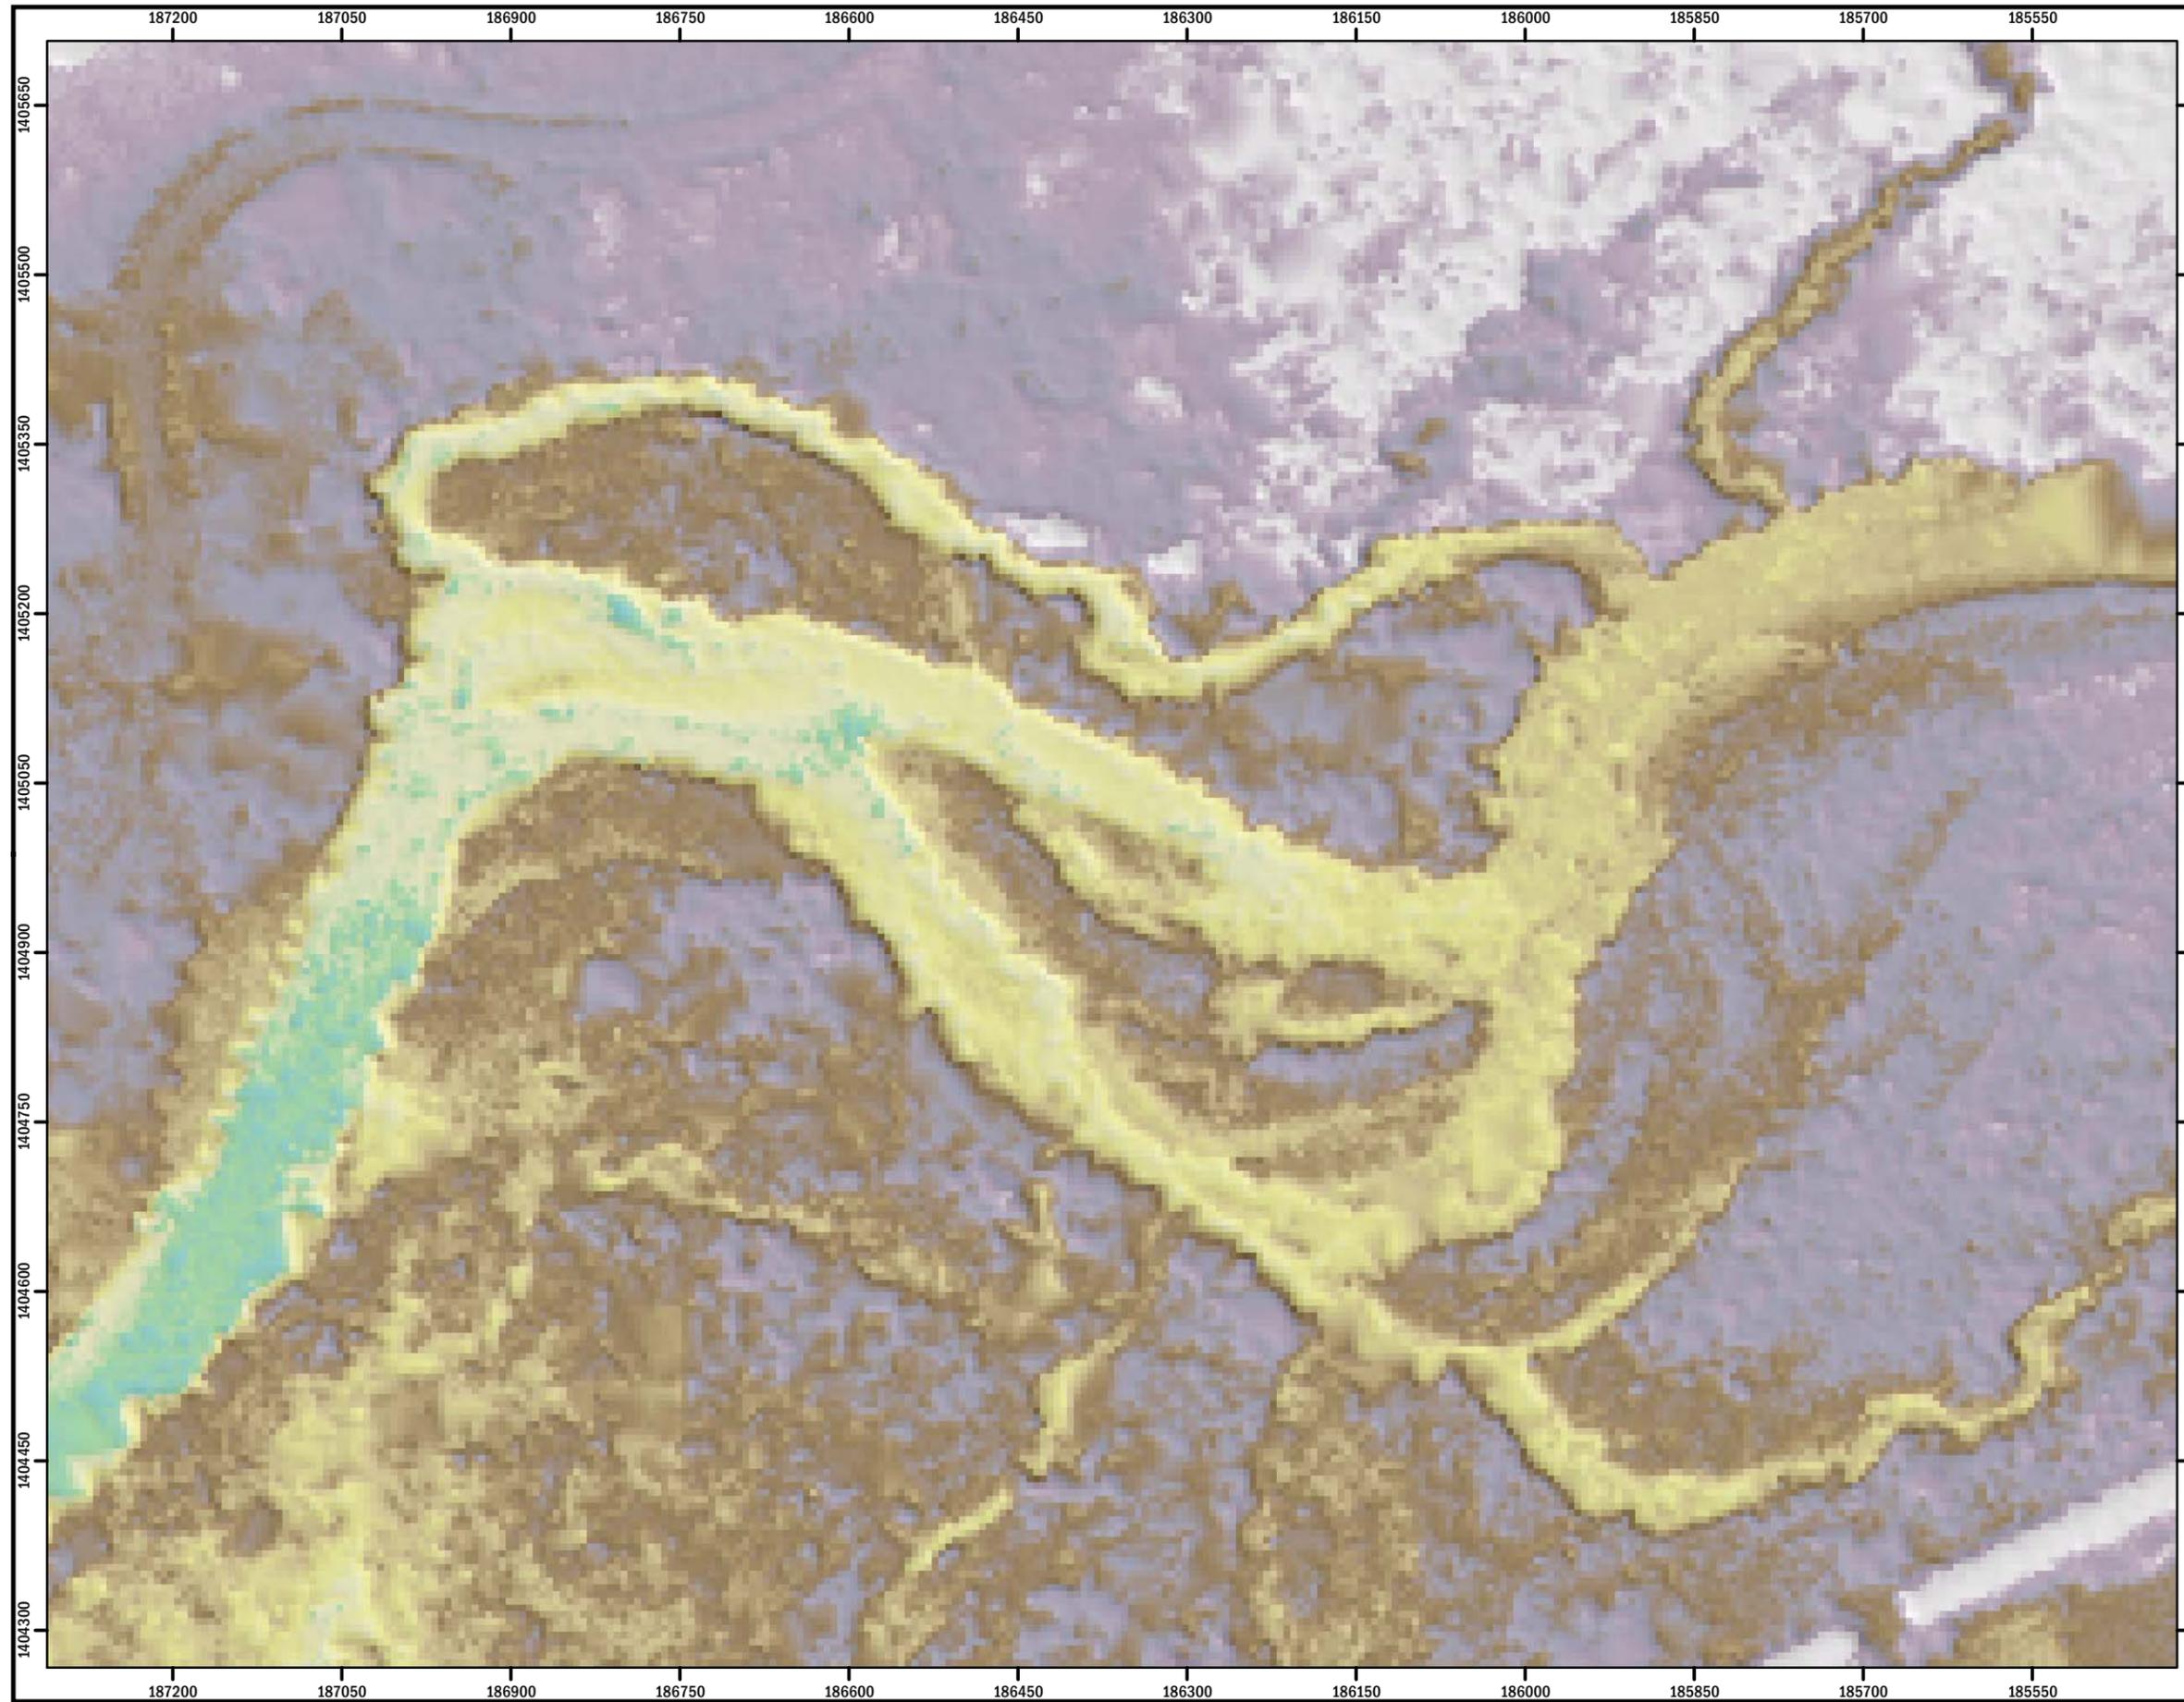
Figure C-1.  
2002 LiDAR at Circle River Ranch  
Area, South Fork Snoqualmie River.

Comparison of the 2002 and 2010 lidar data with the aerial photography for 2002, 2005, 2007, 2009, and 2010 (see Attachment C figures) was completed to note any channel changes during this time period. Aside from the 2010 aerial photography, vegetation in the aerial photos makes it difficult to note distinct features in the side channel. However, features in the main channel were easily observed in these photos. When compared to the 1993 channel position (Figure 2), the lidar and aerial photos from 2002 to 2010 (Attachment C) indicate that the main channel from RM 1.4 to 1.7 migrated in the direction of the right bank. In 1993, the left bank side channel was active and may have conveyed as much flow as the main channel, based on the relative channel width evident in the historic channel alignment (Perkins 1996). Between 2002 and 2005, it appears that aggradation in the main channel downstream of the side channel inlet began to limit the amount of flow accessing the left bank side channel. By 2007, after the 2006 flood of record (approximately 13,600 cfs, or about a 50-year recurrence event [King County 2011a]), the left bank side channel was mostly plugged with sediment. Significant erosion had occurred at the “land bridge” and at the right bank in front of the Hibbert property (house number 41524, Figure B-2). The 2009 and 2010 aerial photography show continued gravel bar deposition in the main channel, increased flow splitting into the side channel, and increased local widening and erosion in the side channel.

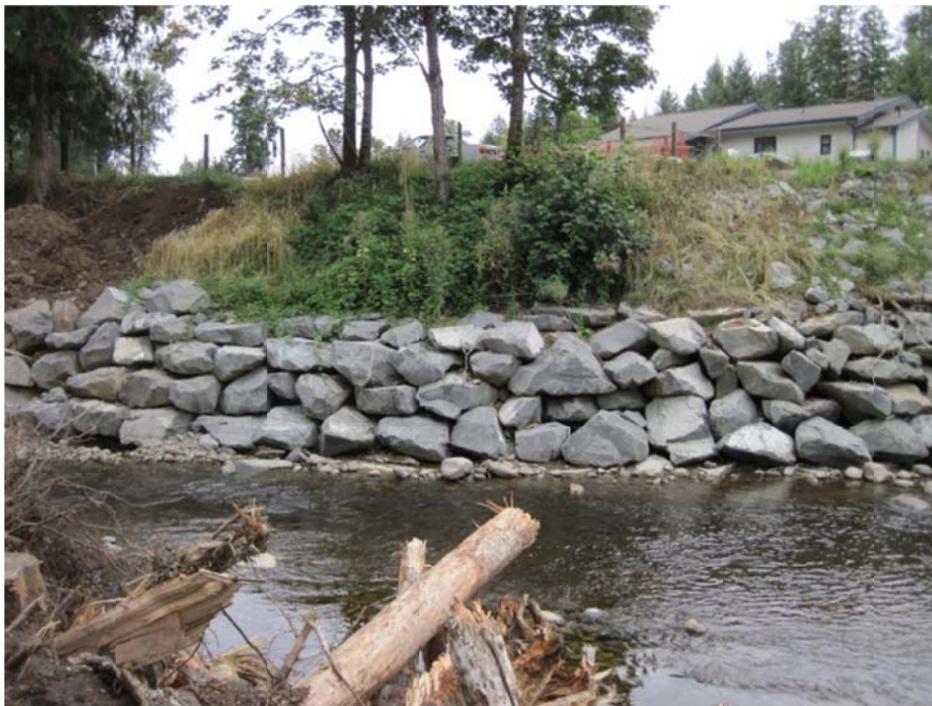
Figure F-2. Temporary riprap placement on the Mashel River near Eatonville in Pierce County, Washington, along an actively eroding bank.

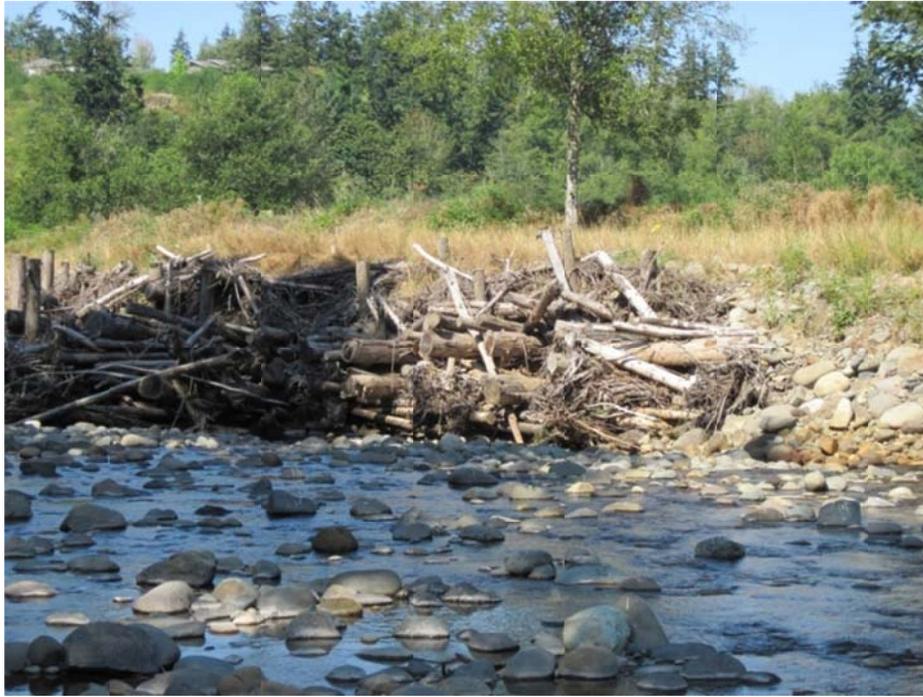
Figure F-3. Log cribwall constructed on the Mashel River near Eatonville in Pierce County, Washington along an actively eroding bank.

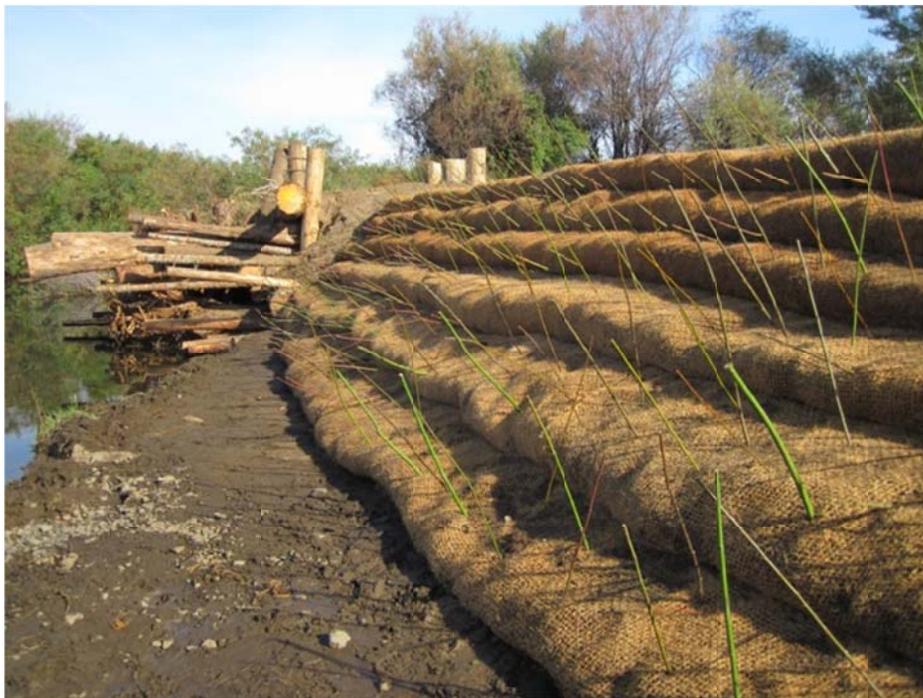
Figure F-4. Reinforced soil lifts constructed on the Touchet River near Touchet in Walla Walla County, Washington, along an actively eroding bank.

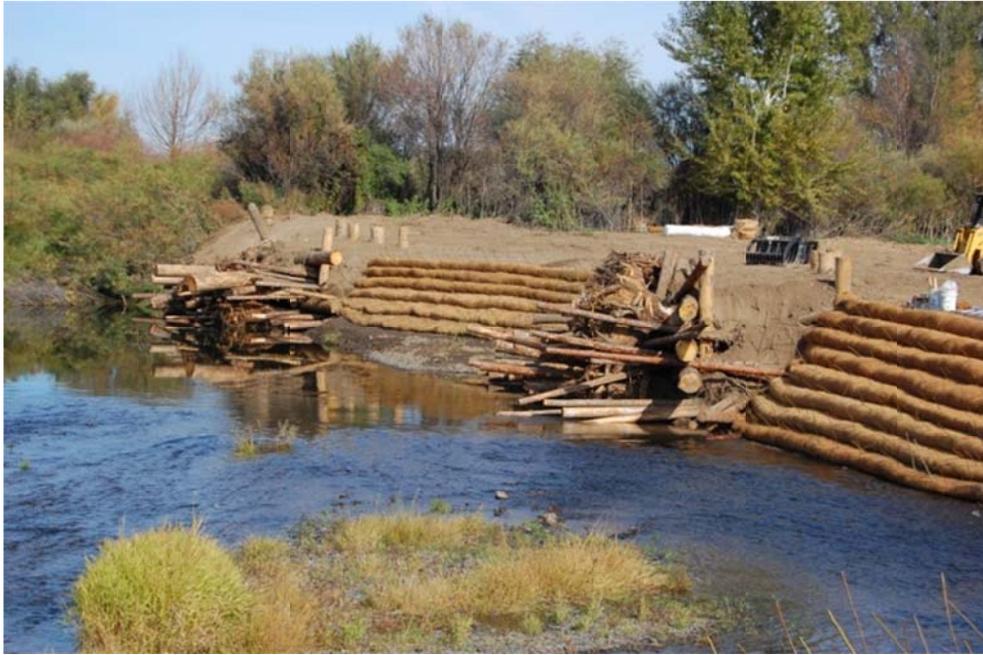
Figure F-5. Multiple bank deflector ELJs constructed on the Touchet River in Walla Walla County, Washington, to deflect flows away from actively eroding bank and into side-channels along opposite bank. The banks between the ELJs were reconstructed using reinforced soil lifts.

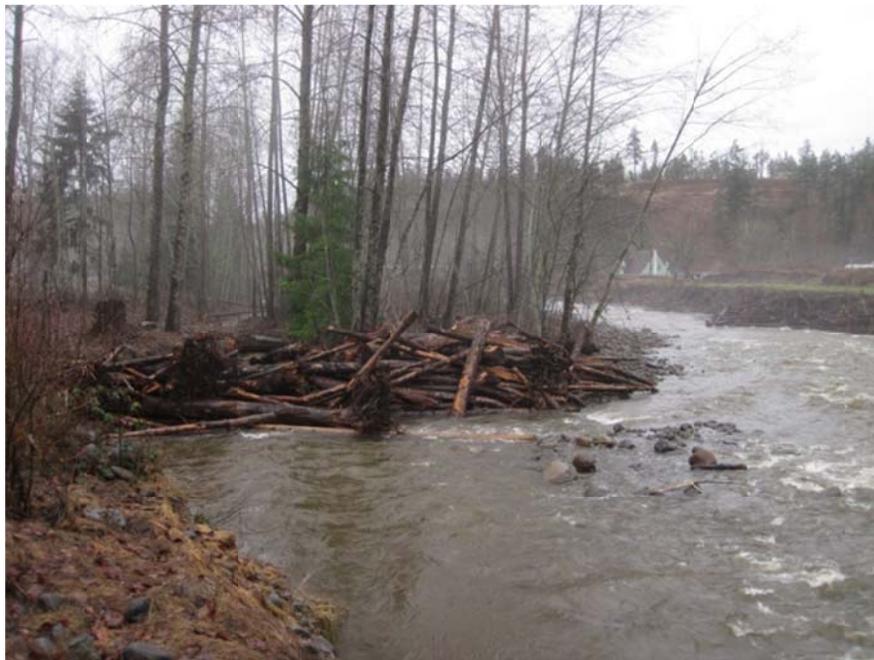
Figure F-6. Large logs added to an existing natural logjam on the Mashel River near Eatonville in Pierce County, Washington, to prevent an avulsion down the side-channel behind the logjam and to trap mobile wood debris.

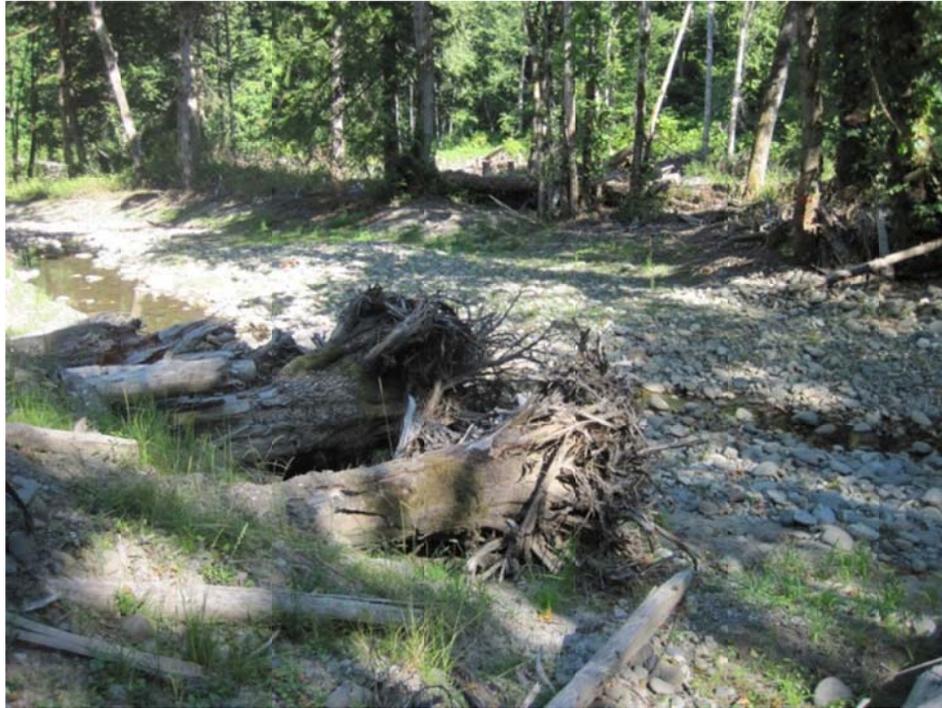
Figure F-7. LWD added to roughen an exposed side-channel bank on Morse Creek near Port Angeles, Washington.

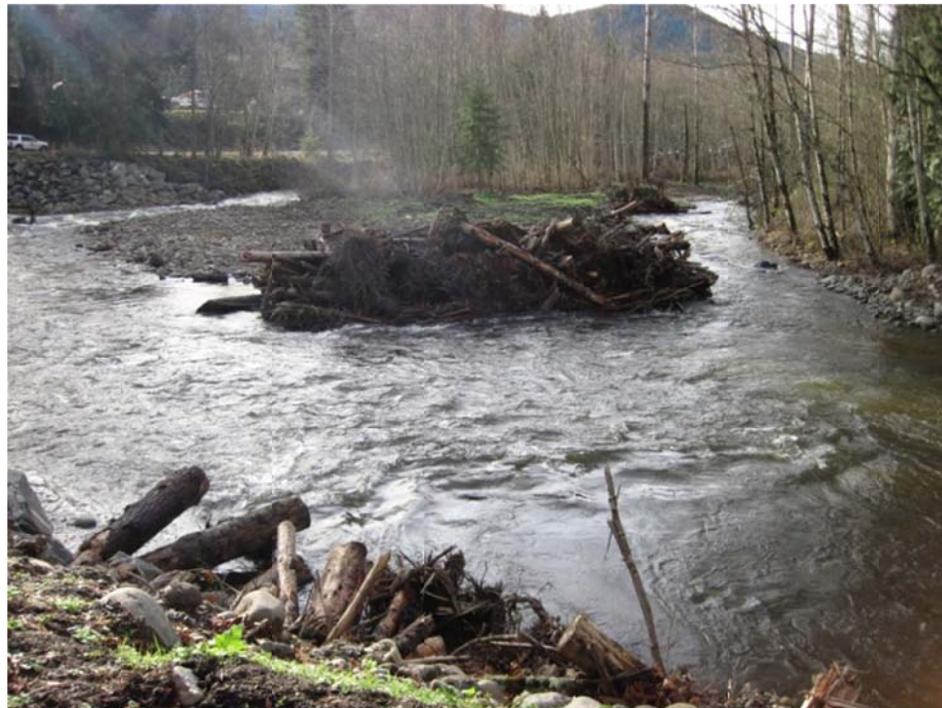
Figure F-8. Apex ELJ constructed at side-channel inlet on the Mashel River to deflect flows from the main stem and into the side-channel.
