MAY CREEK EROSION STABILIZATION DRAFT REPORT

MAY CREEK SEDIMENT TRANSPORT STUDY PHASE 3

King County
Department of Natural Resources and Parks
201 Jackson Street, Suite 600
Seattle, Washington 98104

Anchor QEA, LLC
1605 Cornwall Avenue
Bellingham, Washington 98225

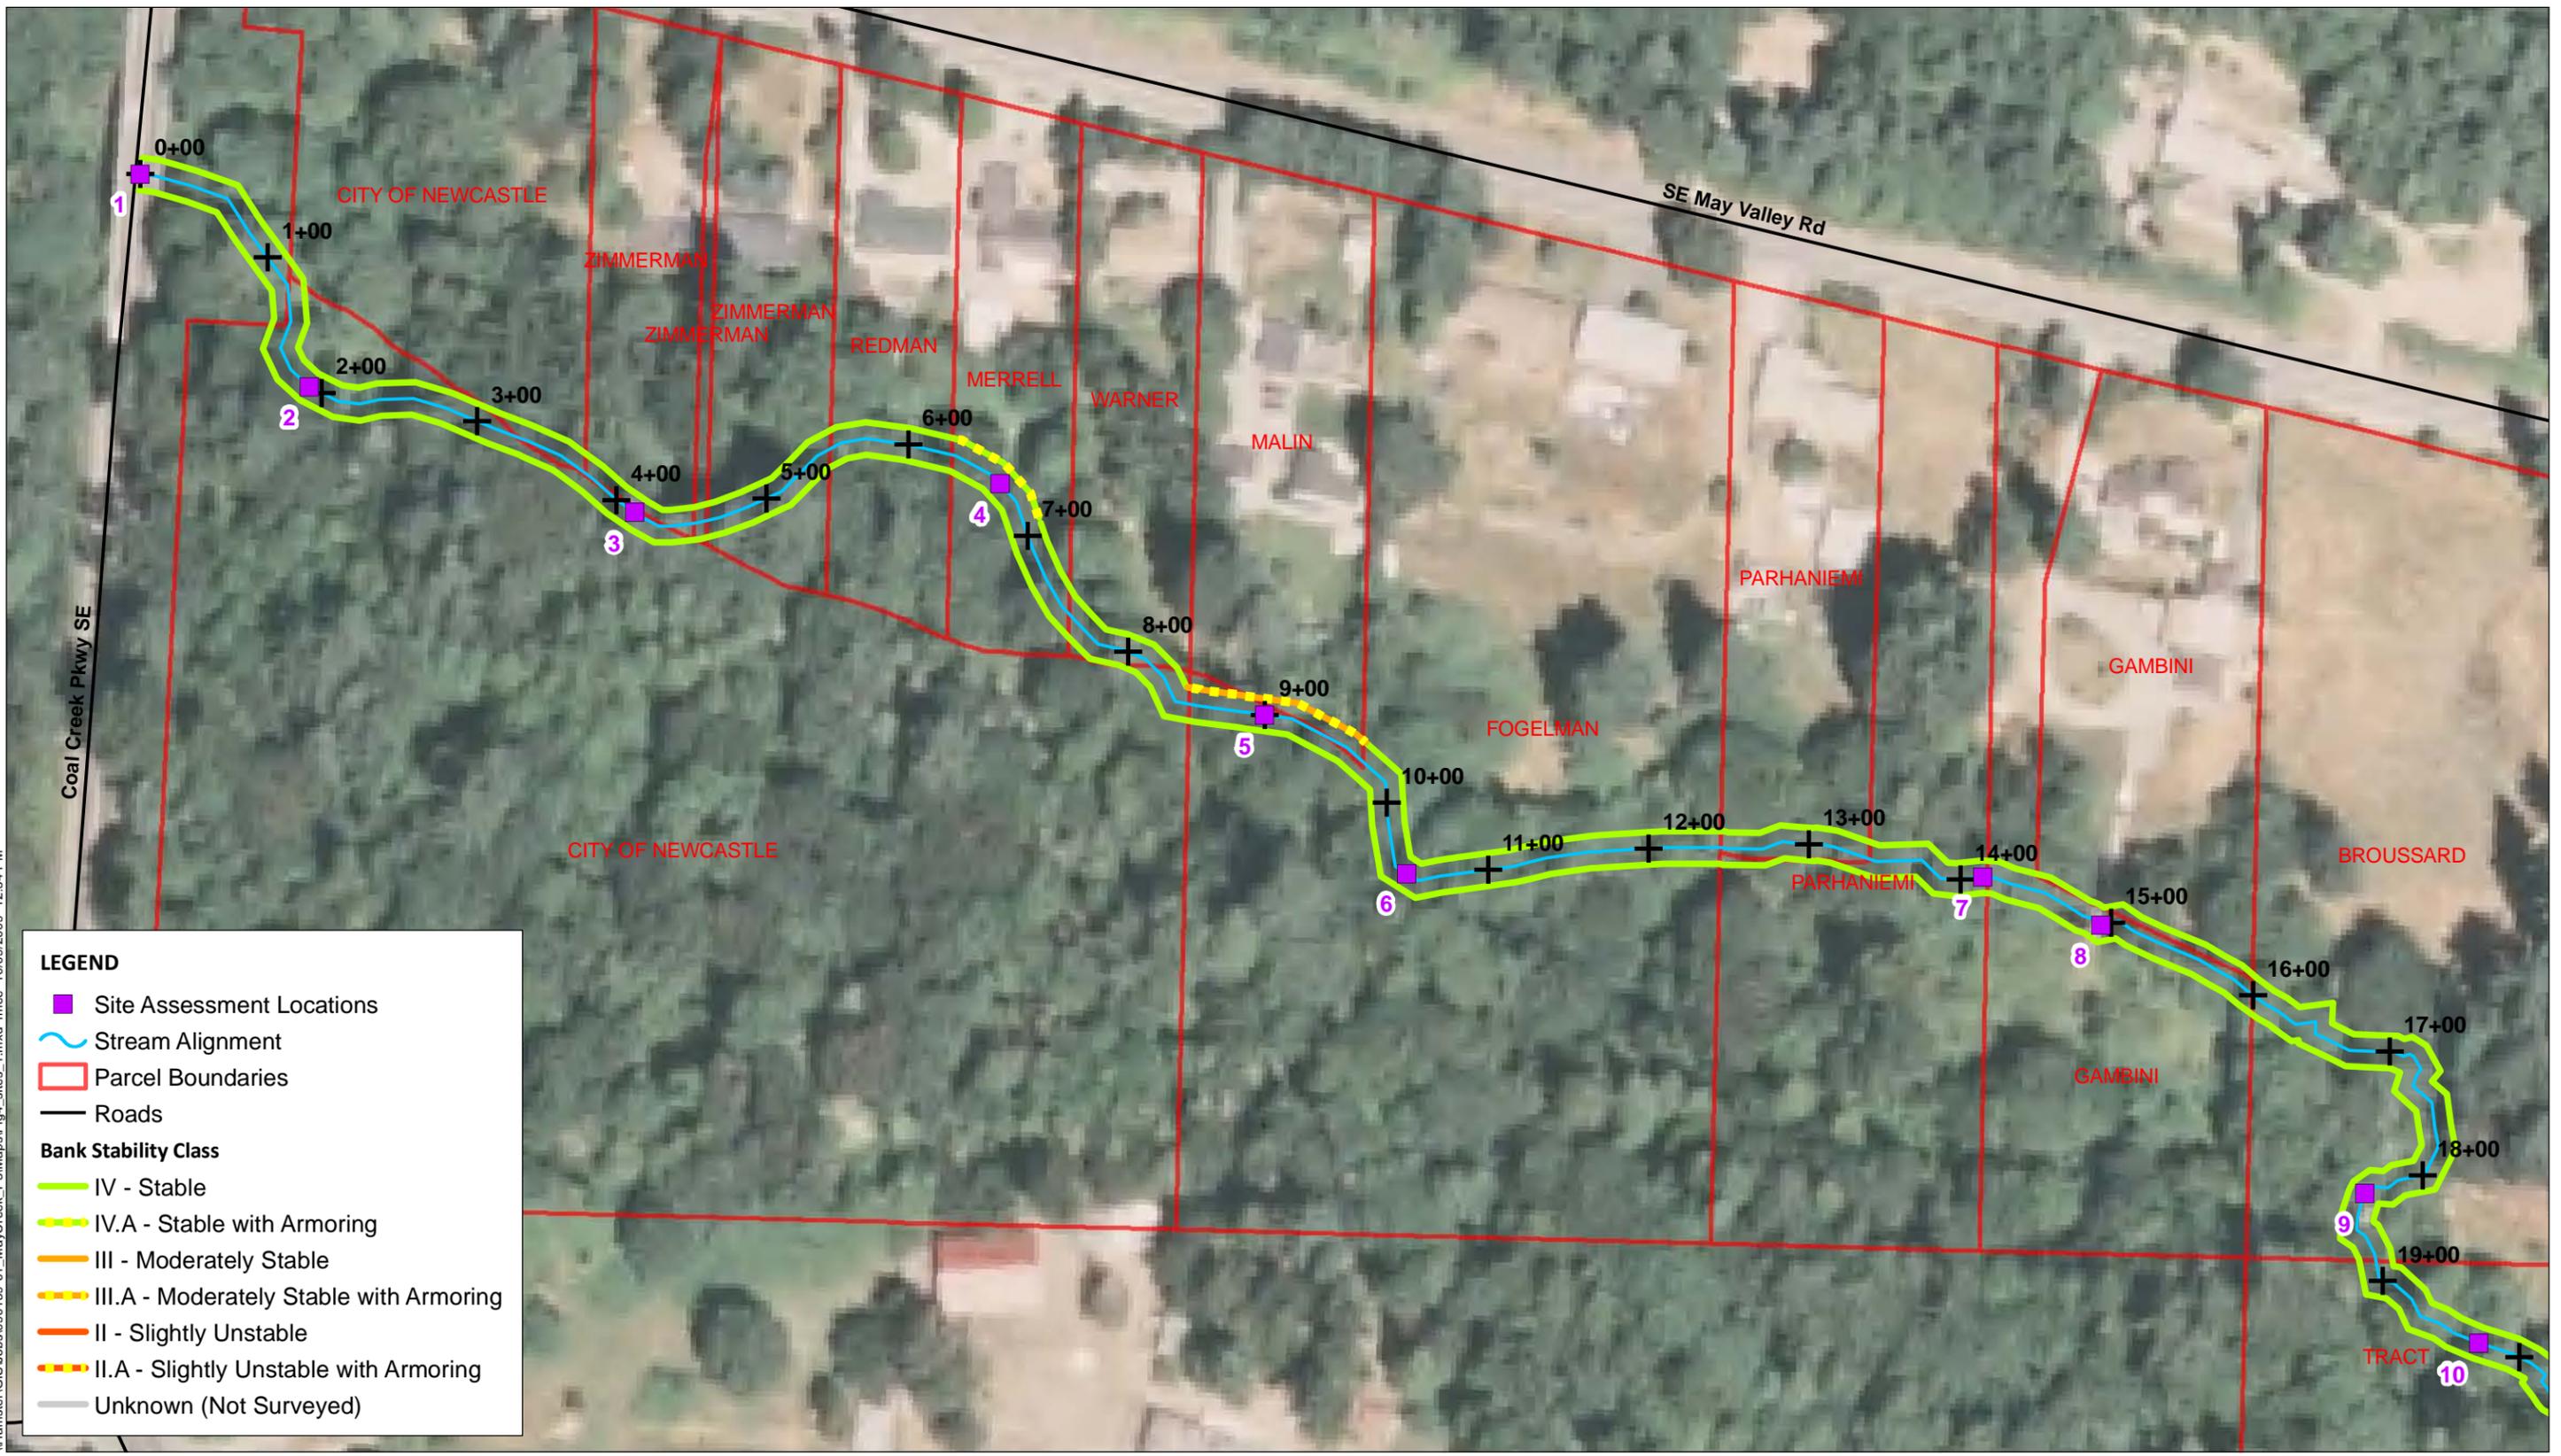
Figure 4
Bank Stability Classes and Site Locations, Lower Reach
May Creek Erosion Stabilization Report
King County/ May Creek Sediment Transport Study Phase 3

These outcrops are likely subject to some erosion but it is minor in comparison with the sandy glacial outwash deposits that make up the banks and floodplain in other locations. Because the channel is entrenched, minimal evidence of lateral erosion was observed. Evidence of incision was observed, although a majority of the banks were classified as stable (Figure 4). Some undercutting of structures and the presence of features that were implemented to prevent erosion were observed including bank reinforcement in the form of riprap. Additional observations in Reach 1 include an undercut foot bridge and concrete debris in the channel from previous bridge abutments.

Habitat conditions in Reach 1 are better when compared to the other project reaches. Juvenile salmonids were observed in deep pools forced by clay outcrops and pool spacing was more frequent. However, little to no functional large woody debris (LWD) was observed through most of this reach. Spawning gravels were limited in some areas but primarily present through the reach. Vegetation in the riparian corridor is well-developed although it includes a large amount of invasive species, particularly Himalayan blackberry.

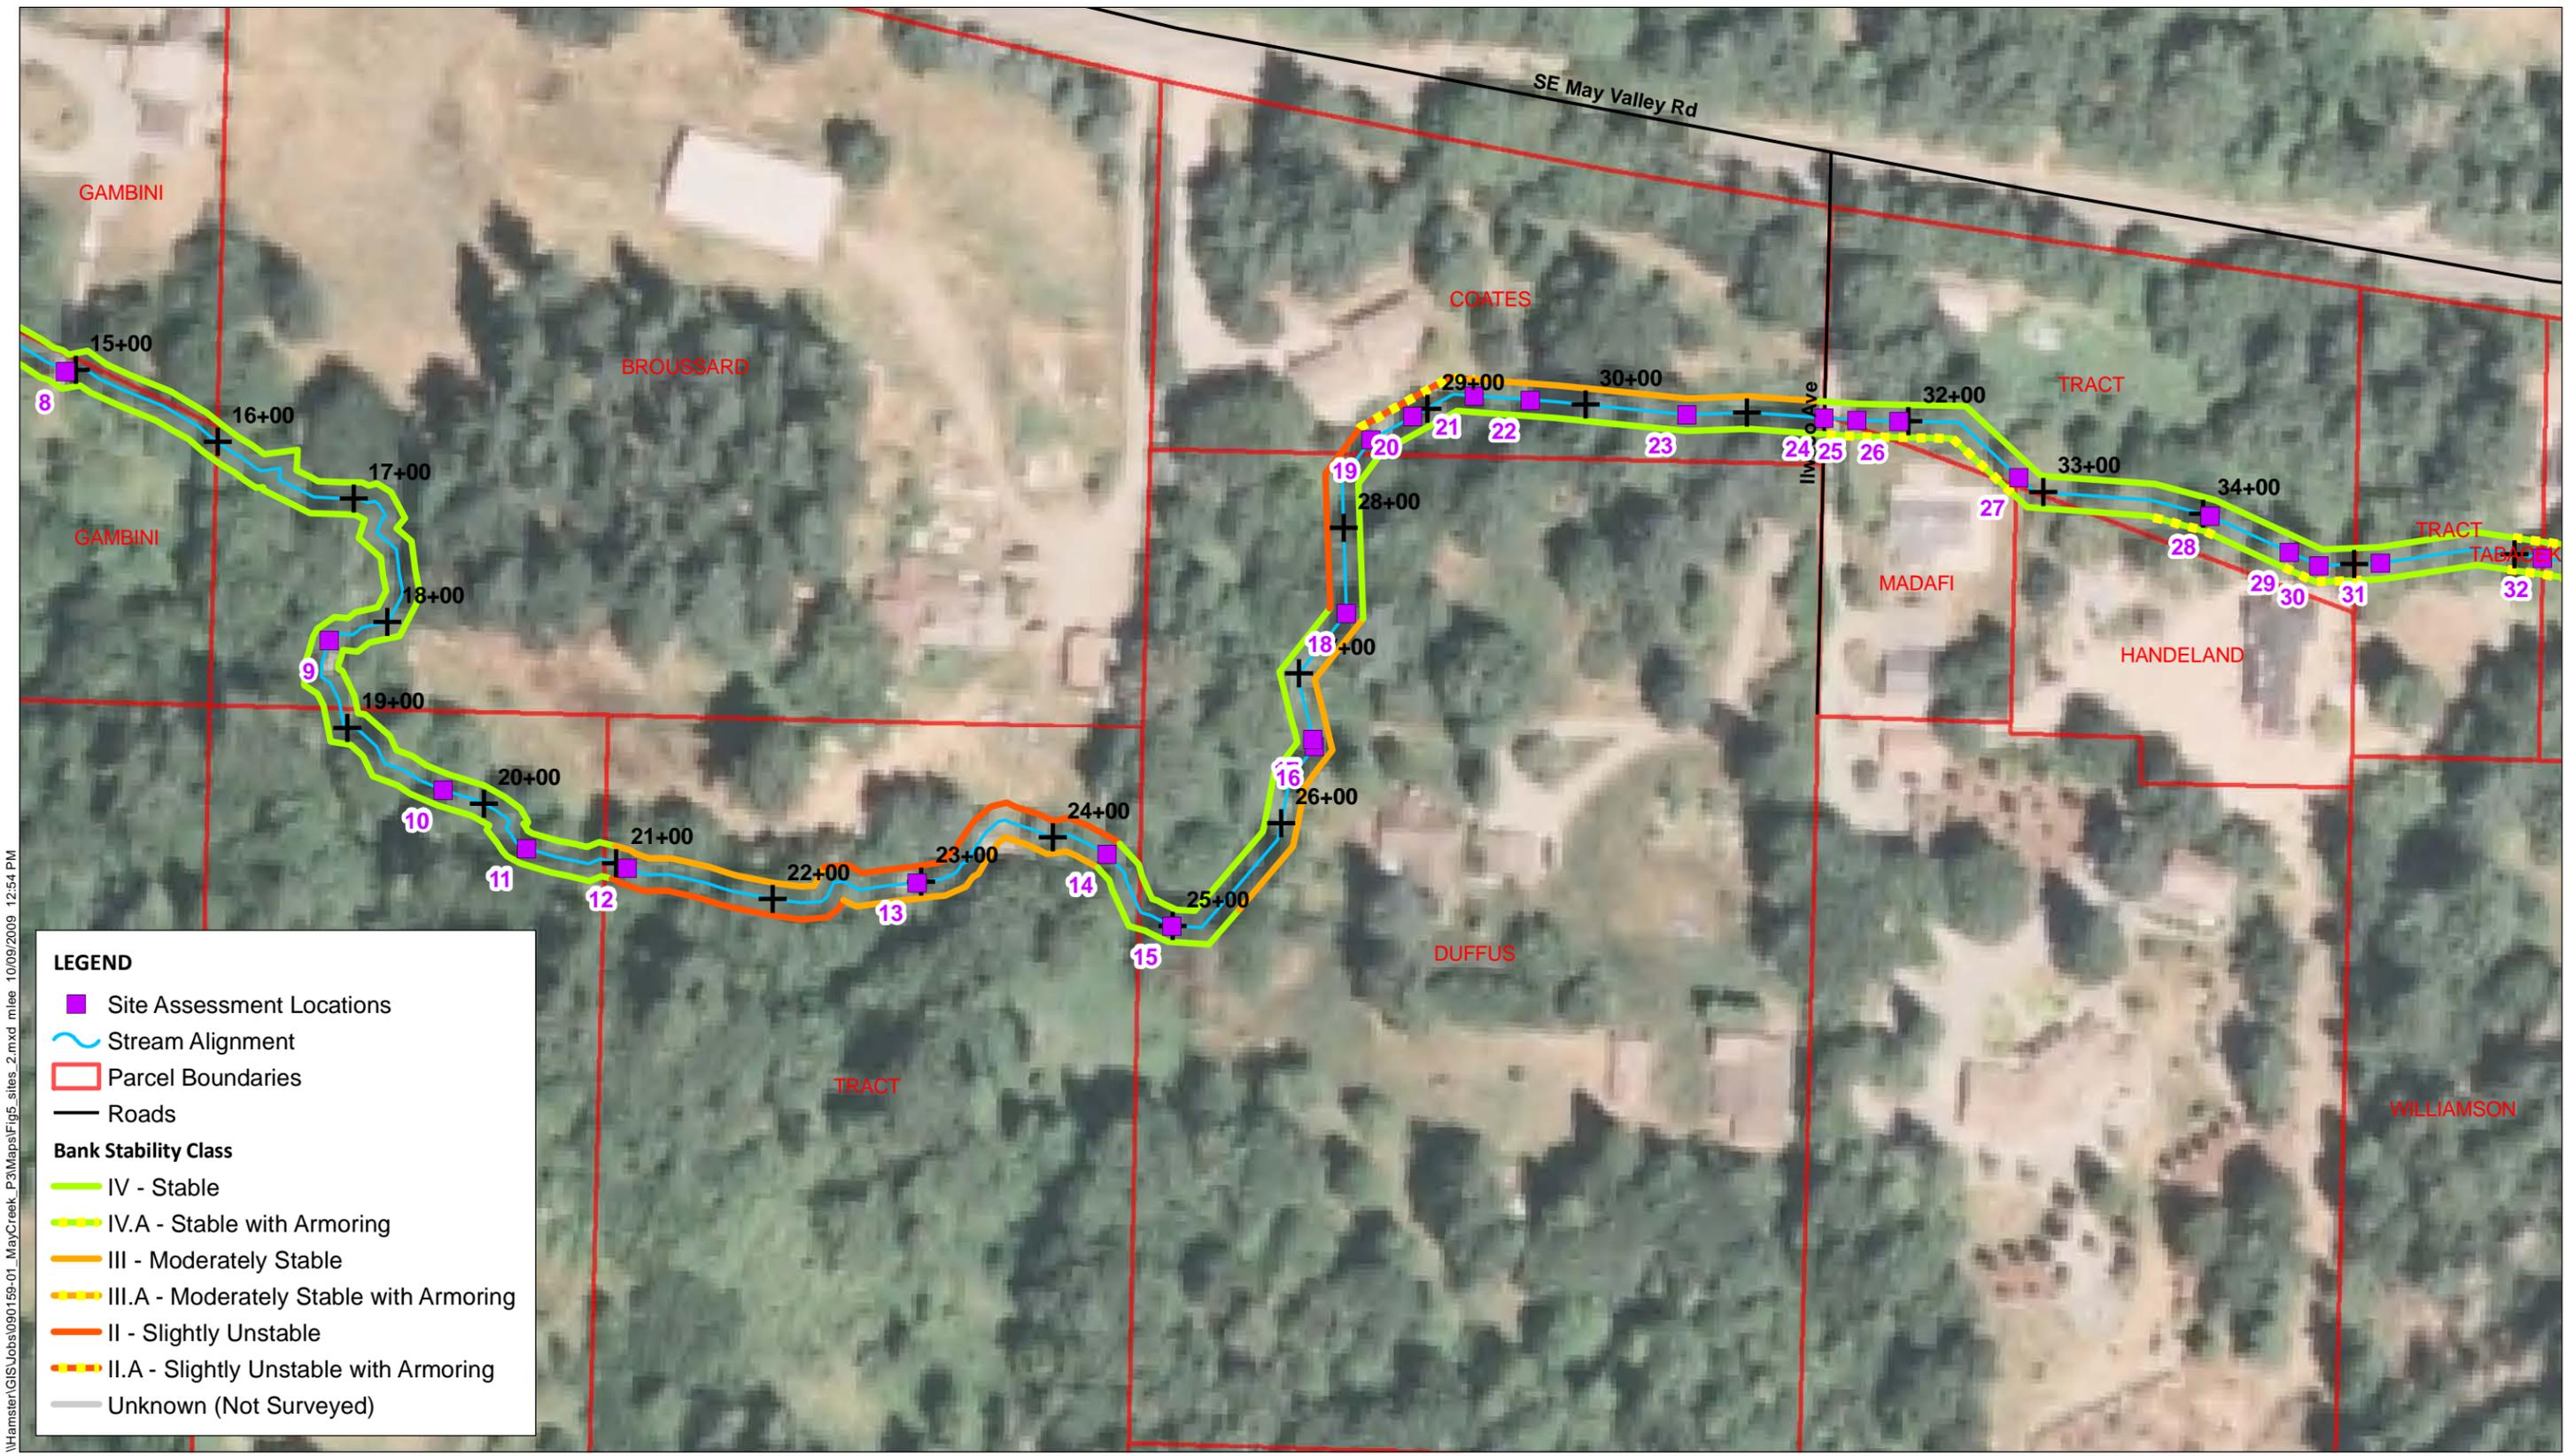
Figure 5
 Bank Stability Classes and Site Locations, Mid-Reach
 May Creek Erosion Stabilization Report
 King County/ May Creek Sediment Transport Study Phase 3

Some evidence of recent erosion was observed in Reach 3, which is likely due to the effect of infrastructure. The banks were classified as stable, although primarily because of the presence of armoring (Figure 5 and 6). Stream stabilization features and other infrastructure of note includes seven rock or log weirs, two private road bridges reinforced with riprap, two private pedestrian foot bridges, concrete debris in the channel, approximately 450 feet of channel lined with vertical stone sidewalls, and approximately 155 linear feet of additional riprap.

Instream habitat conditions in Reach 3 are degraded by infrastructure. Weirs create slow flat-water pools during low flows allowing for warm water and growth of weeds on the channel bottom. Spawning-sized sediment is lacking throughout a majority of the reach, much of this sediment is likely prevented from moving downstream by the weirs. Riparian vegetation is sparse and the lack of shading is a concern, particularly where the channel runs through landscaped yards (i.e., grass lawn banks). Where riparian vegetation exists it is typically not well developed or is overgrown by Himalayan blackberry, morning glory and other invasive plants.

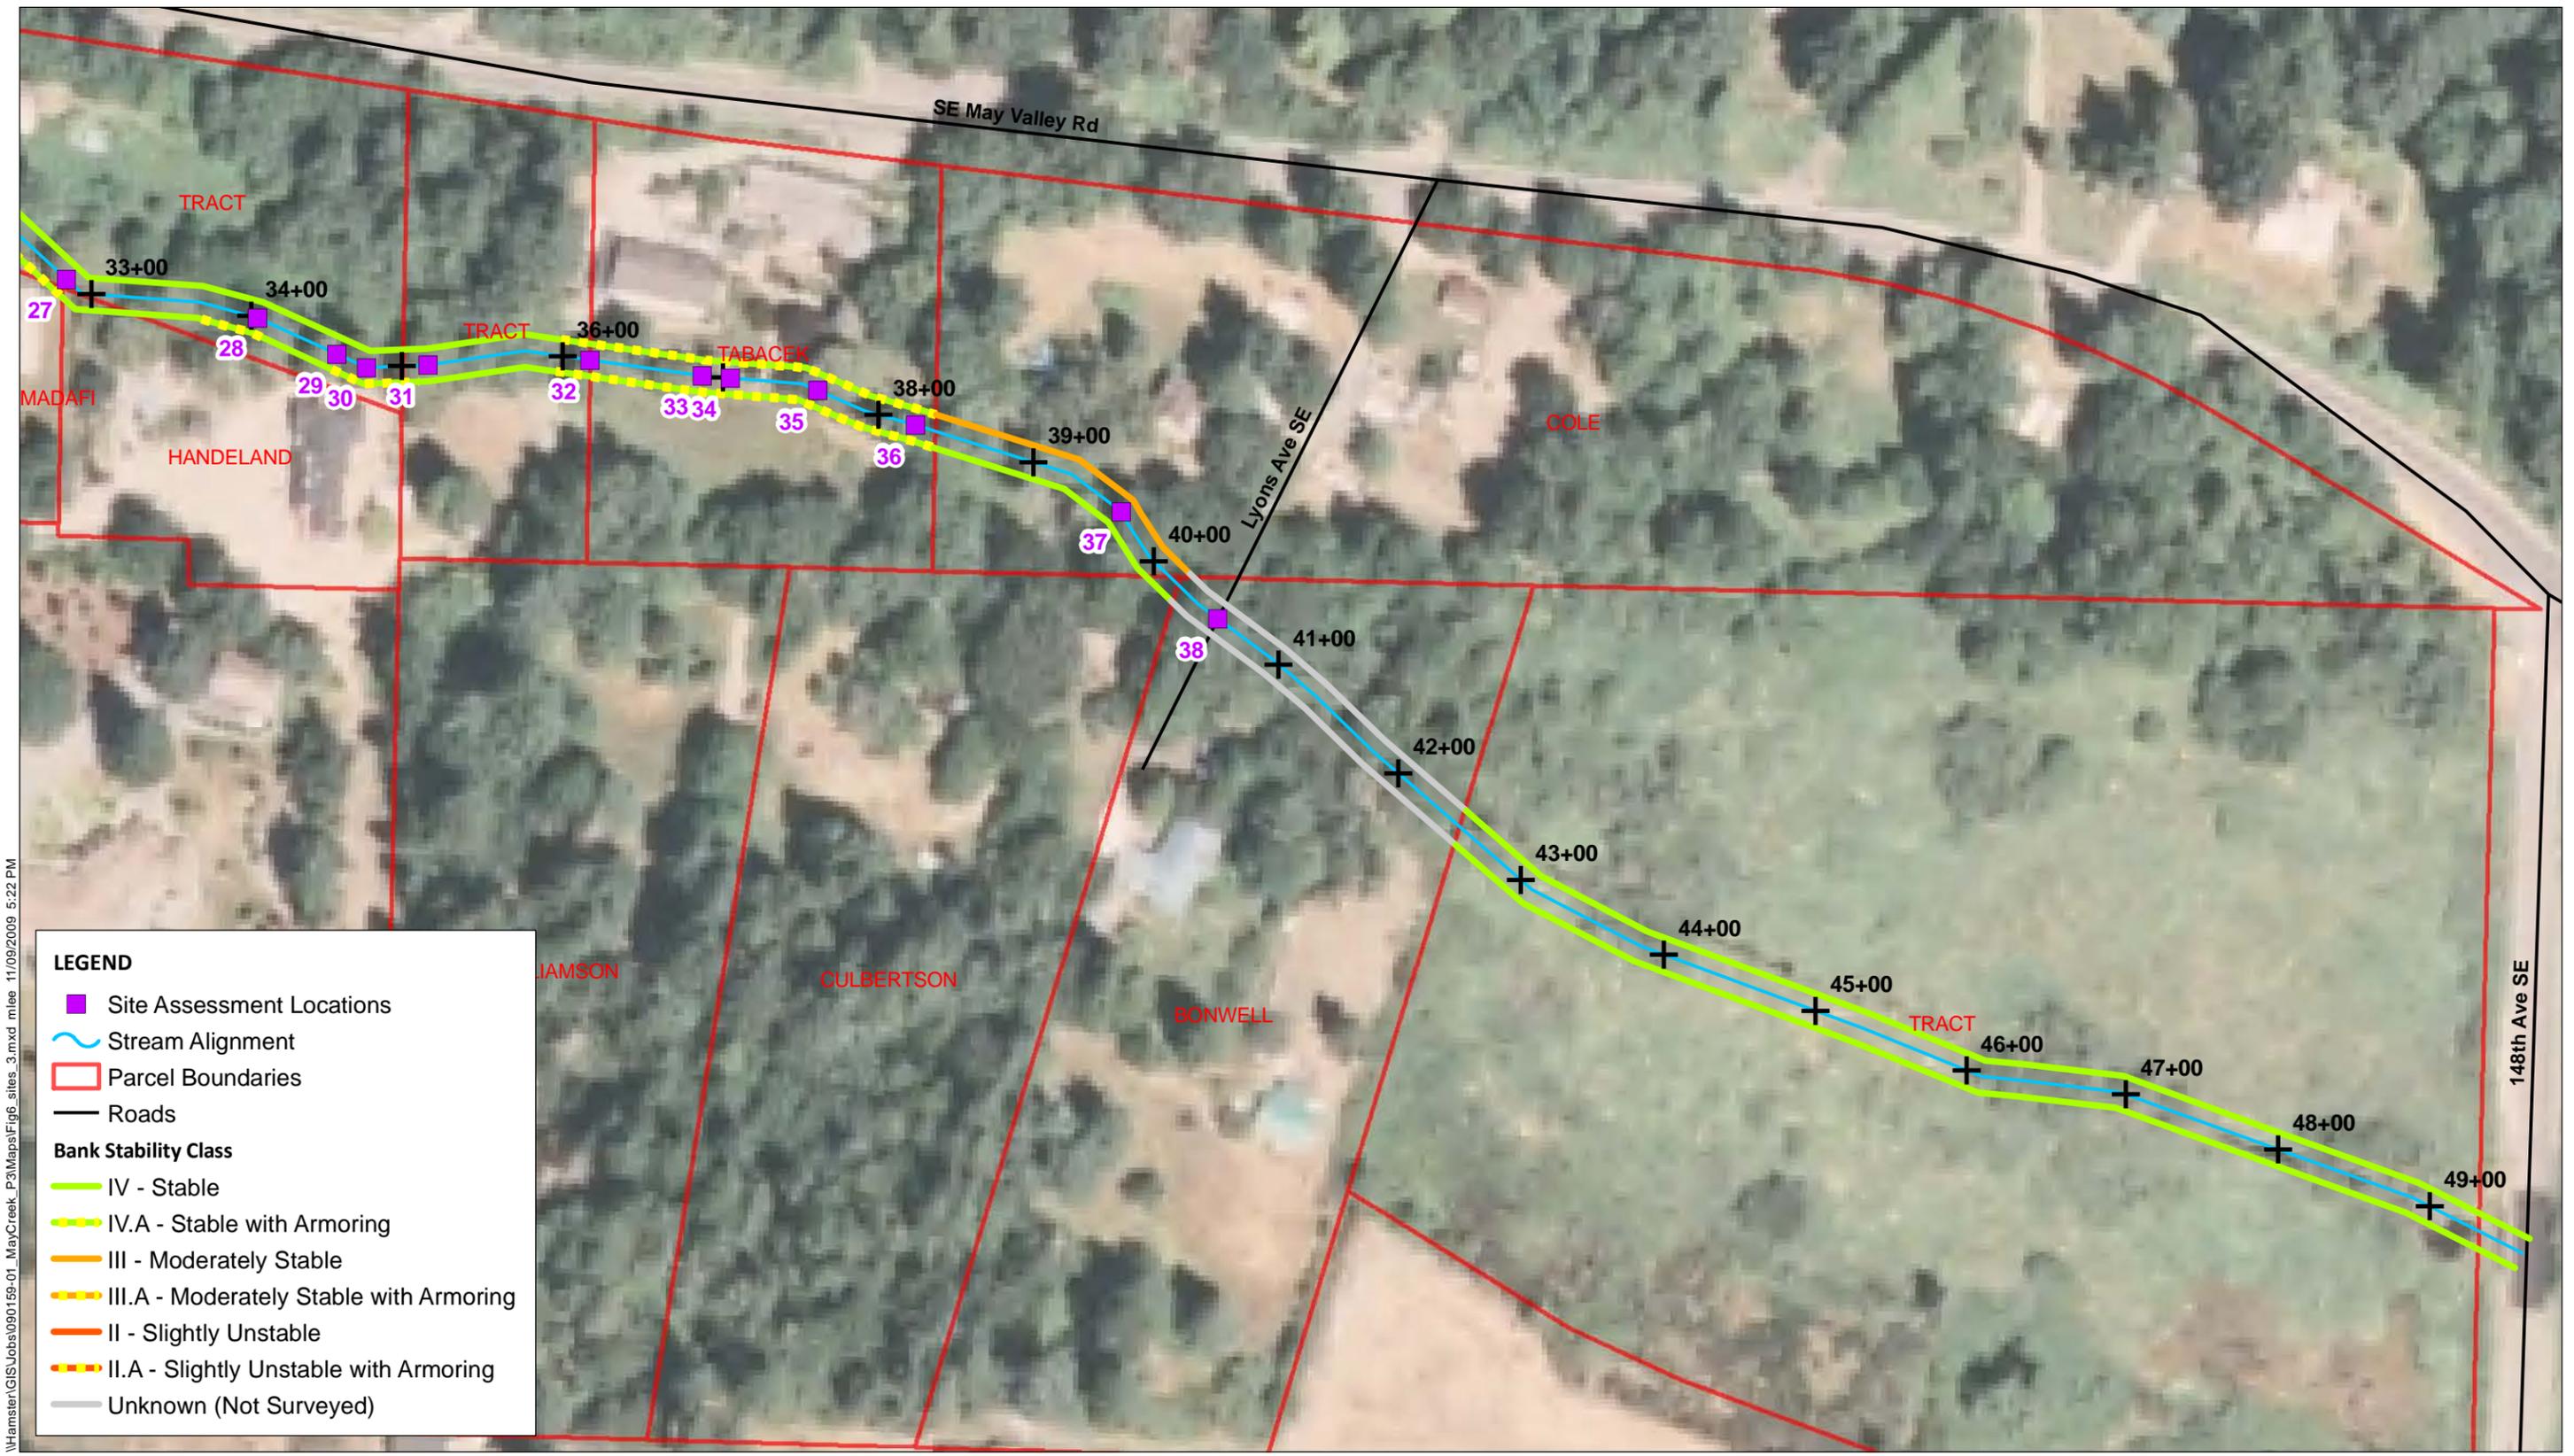
Figure 6
Bank Stability Classes and Site Locations, Upper Reach
May Creek Erosion Stabilization Report
King County/ May Creek Sediment Transport Study Phase 3

Reach 4 is located from the Lyons Avenue crossing to the 148th Avenue SE crossing (Station 40+50 to 49+00). Due to access restrictions, the portion of Reach 4 upstream of the Lyons Avenue Bridge to approximately Station 41+50 was not assessed. The remainder of Reach 4 is straight, deep (approximately 3 feet or more at low flows) and narrow with a relatively flat grade as it flows through a wide, shallow floodplain. The floodplain and banks are vegetated with dense reed canarygrass with some other brush and immature trees. Despite the lack of mature vegetation, the banks are stable and channel migration is minimal (Figure 6). The banks are low relative to the water surface and flooding occurs frequently. The floodplain is wet much of the year and water is temporarily stored in the floodplain wetlands. According to anecdotal evidence, a bedrock outcrop exists in the channel near Station 40+00 which likely acts as a grade control to prevent erosion and headcutting upstream of the outcrop. Erosion and stabilization measures such as weirs or riprap was not observed in Reach 4, although the channelization of the creek through the tract area downstream of 148th Avenue SE indicates that the channel has been straightened in the past.

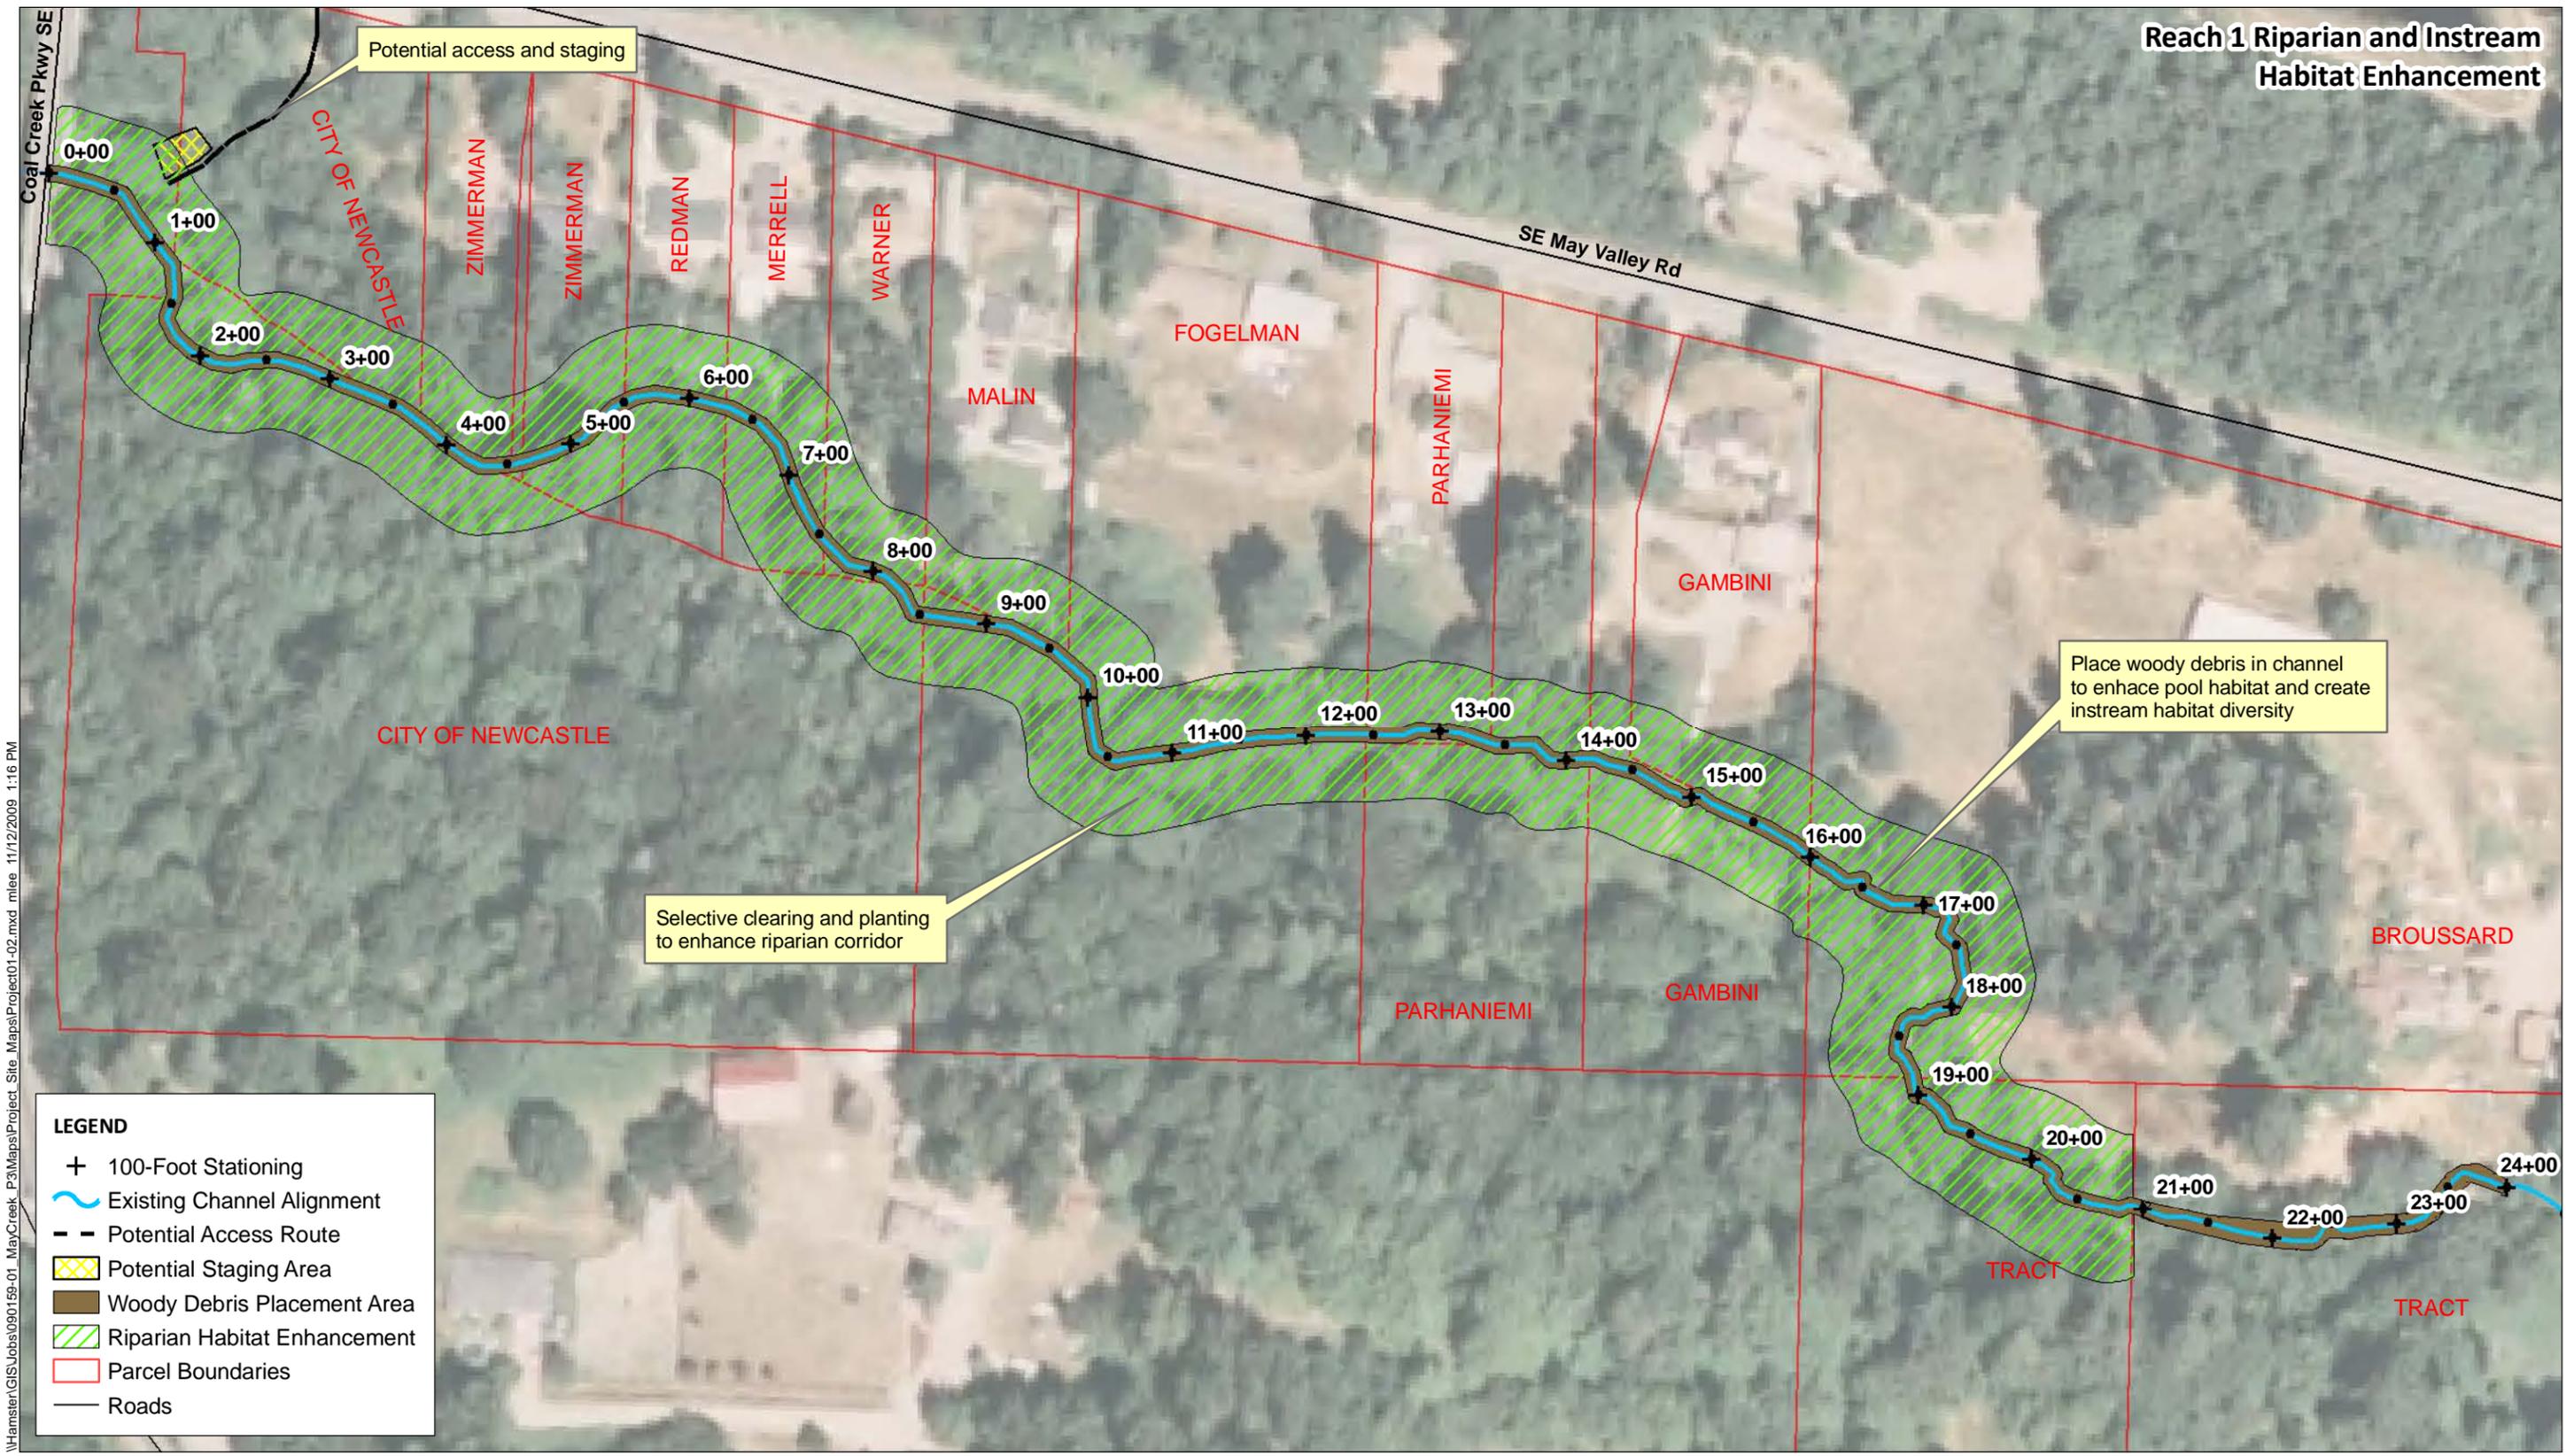
Reach 1 Riparian and Instream Habitat Enhancement

The channel throughout Reach 1 is characterized as a plane bed channel with intermittent pools and riffles among resistant outcrops. Coarse sediment delivery to the reach has been restricted by instream structures (weirs) upstream of the Ilwaco Avenue crossing. Bank erosion downstream of the crossing does contribute sediment to Reach 1 although accumulations of clean gravel are sparse in some areas. Pools forced by resistant outcrops are present within the reach, but the quantity and quality of these features is limited by the spacing and configuration of the outcrops. Little to no functional LWD was observed within the reach and therefore habitat benefits are limited for instream species.

Riparian vegetation in Reach 1 is generally well developed, although habitat conditions are somewhat degraded by invasive species. Numerous mature trees are present throughout the reach that provide a thick canopy cover. Understory brush is moderately dense and composed of a mixture of native plants such as fern and small vine maples, and invasive species, most significantly Himalayan blackberry. Ground cover is variable, with dense patches of reed canarygrass in some locations along the valley floor.

Place LWD at selected locations throughout Reach 1 to create stable hydraulic conditions capable of locally creating deep pools. The location and size of the LWD would be based on natural pool spacing and site-specific hydraulics.

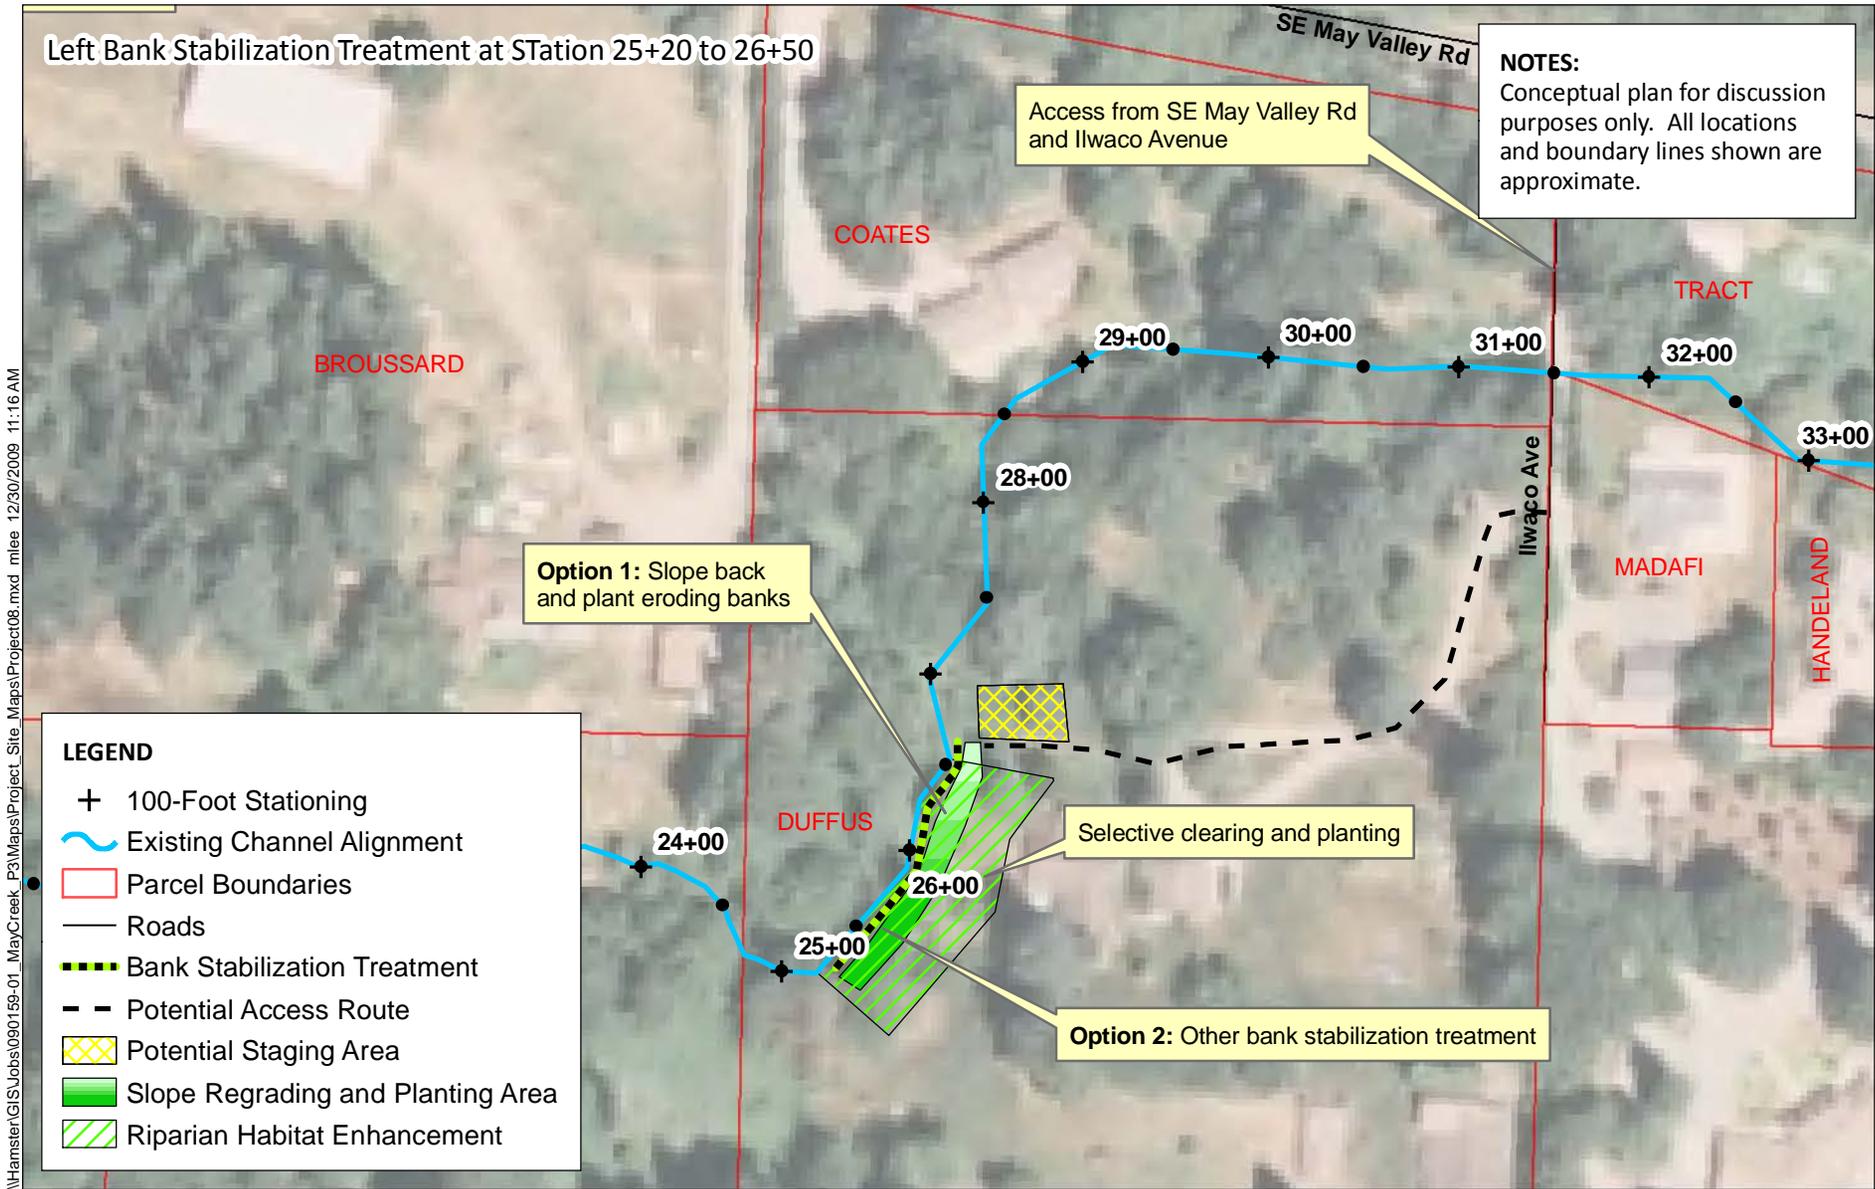
Figure 13

This segment of the stream is characterized as a run with a pool forced by a resistant outcrop at the downstream end. Instream habitat conditions are characterized by a clean mobile gravel bed, moderate velocities, and moderate water depths at low flow.

The left bank has a moderate amount of mature trees and several immature trees and native woody plants that create a well-developed understory. However, invasive species including English ivy and Himalayan blackberry are moderately dense within the understory. The right bank has some mature trees and a high density of young deciduous trees in the floodplain with sparse groundcover.

Project 8 will install a bank stabilization treatment from Station 25+00 to 26+50 (Figure 13).

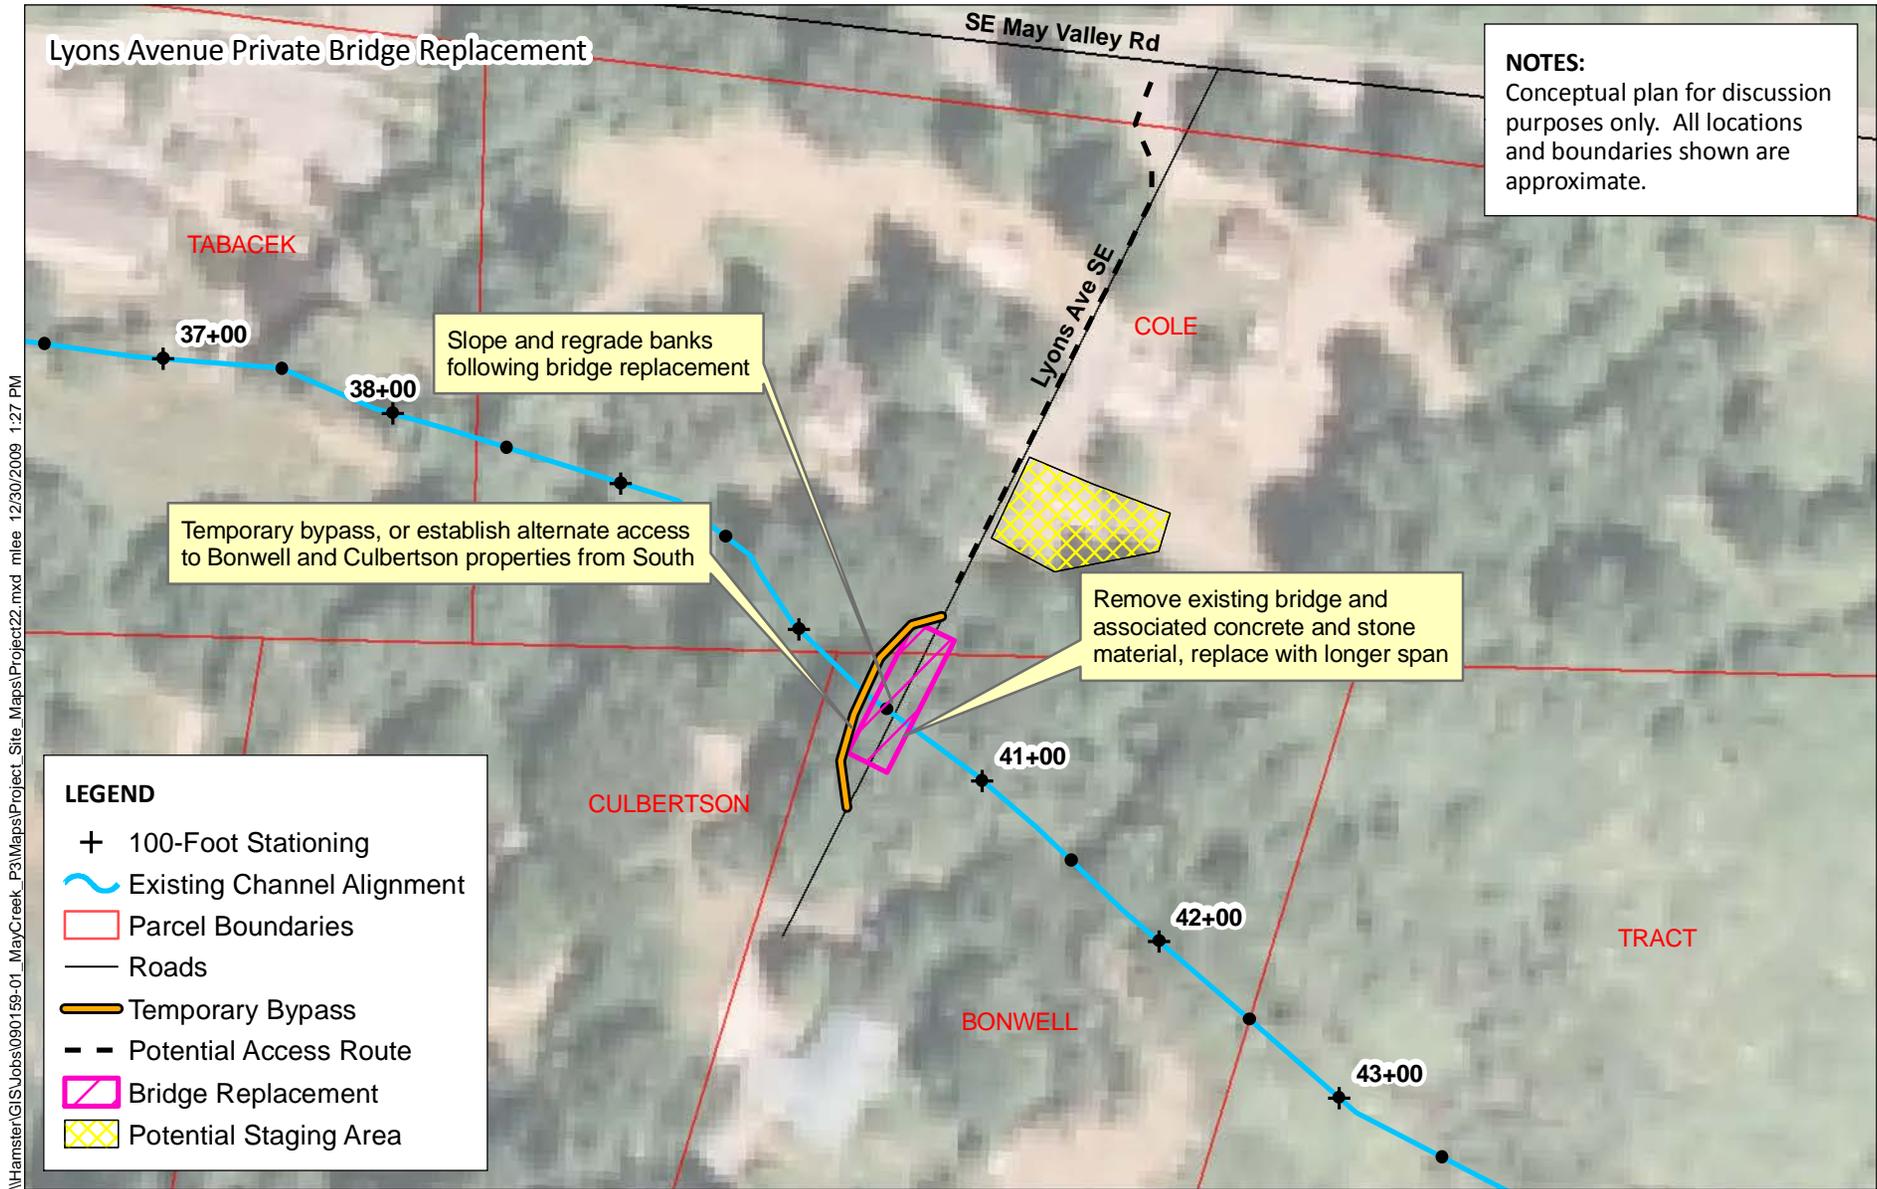
The channel through this area is a plane bed run. Instream habitat conditions are characterized by gravel and cobble substrate, moderate velocities, and moderate to low water depths at low flow. Concrete debris contributed to the channel from the bridge has degraded instream habitat at this location.
