Allen Lake Outlet Stream Reconnaissance

December 10, 2012

1.0 Purpose and Scope

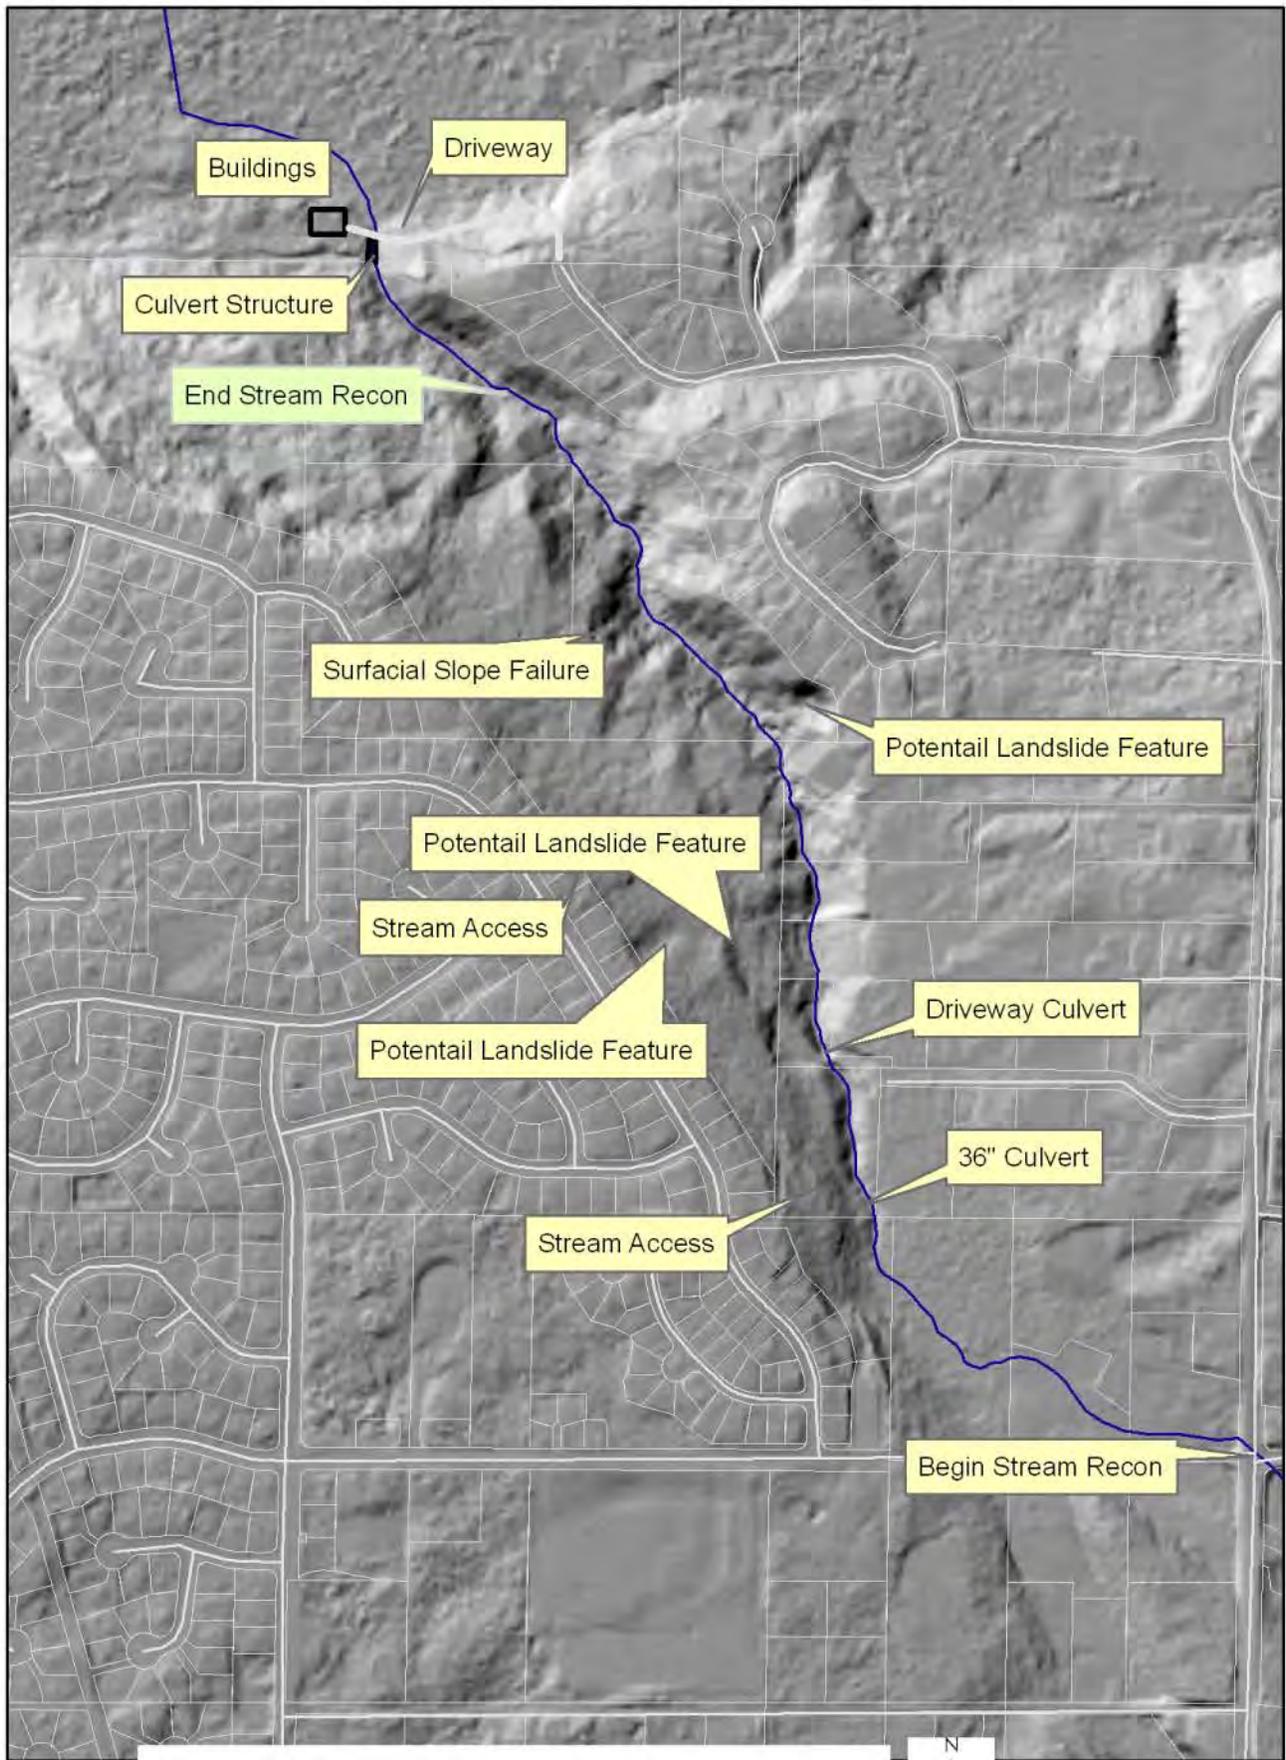
Figure 4

No landslides are shown on published geologic maps. Only large scale features are normally mapped. However, the LiDAR image (Puget Sound LiDAR, 2003) of the drainage exhibits features that are typical of landslide terrain. These features include uneven ground surface and subtle head scarp. The LiDAR image is shown in Figure 4.

King County has mapped the drainage slopes as landslide hazard areas as shown in Figure 6 (DDES and 2005 SWDM Landslide Hazard Drainage Areas Designations). In general, the steep drainage slopes are well vegetated with trees and underbrush. However, intermittent areas of unstable ground were observed based on visual evidence of weather scarps, tilted and bent trees, hummocky ground topography, and over steepened slopes with thick soil cover. Associated Earth Sciences identified the steep slope of the Cedar Park Subdivision, Reach 2 of this report, as a moderate to high risk of shallow landslides in the form of debris flows. The report noted a past debris flow on adjacent property. The Associated Earth Sciences report stated there was a low risk of deep seated landslides. Based on current observations, the valley and inner drainage slopes are susceptible to landsliding. LiDAR imaging supports this finding based on the terrain in Figure 4.

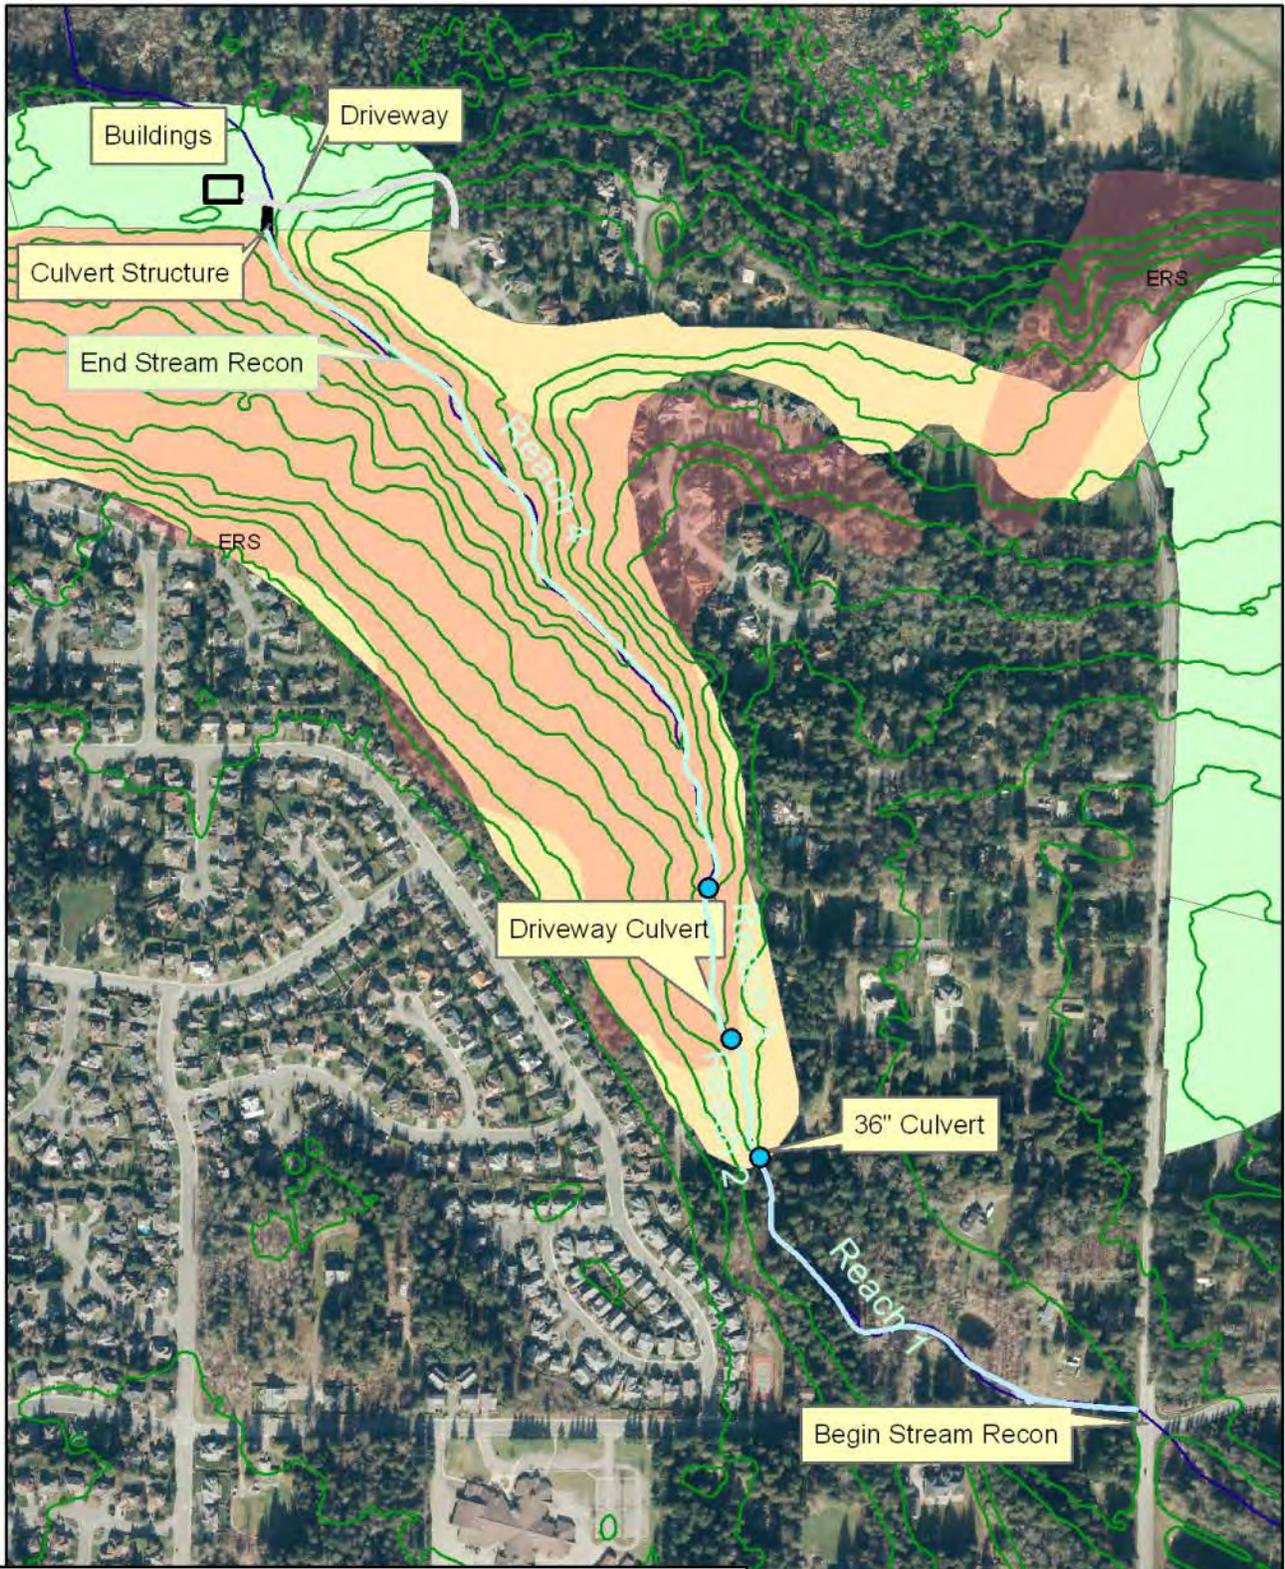
Legend Figure 6

The slopes are mapped as erosion hazard areas (DDES) and shown on Figure 6. The majority of the slopes west of the stream have slopes that are 20% or greater and would therefore be considered to have moderate to high erosion potential. In the upper slopes where till predominates, the erosion potential of these steep slopes would typically impact only the surficial weathered zone of the dense till. This weathered till zone would have rapid runoff and is susceptible to erosion from sheet or channel flow while the underlying till would be considered to have low erosion potential due to its high density and cohesive properties. The advanced outwash materials are highly prone to erosion and sediment transport during high-channel flows. Severe erosion has occurred from single rain events where culverts discharge on the steep slopes in the area. The advanced outwash is visible in the channel and has eroded where the stream has migrated against the slope. The colluvium and soils on the slopes is highly susceptible to erosion. The fine organic sediments on Reach 4 valley bottom are unconsolidated highly susceptible to erosion.

King County has mapped seismic hazards coinciding with the alluvial fan deposits in the lower portion of the drainage (Figure 6).

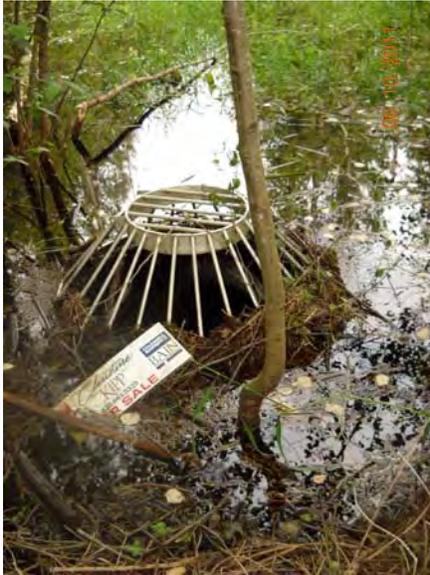
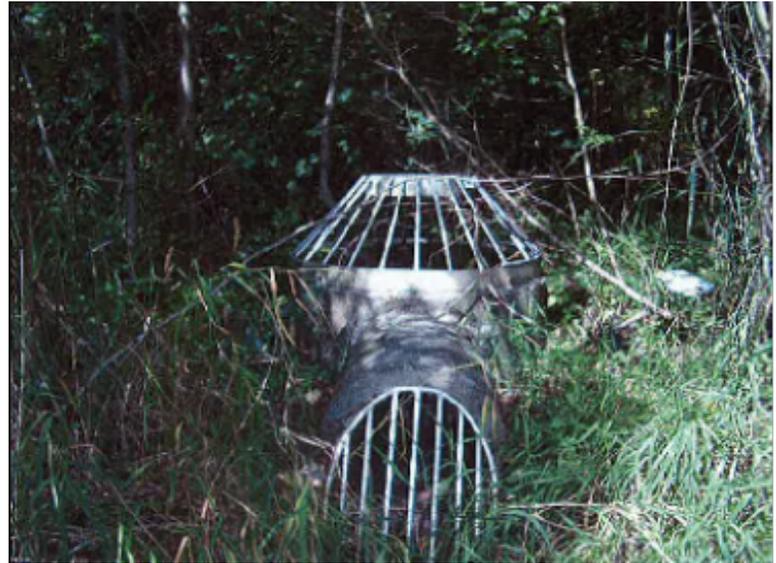
Photo 1. Reach 1 – Culvert at 244th Avenue crossing, upstream end catch basin with overflow and birdcage. A lower side pipe is underwater in this photo, and allows fish passage upstream, if kept clean of debris.

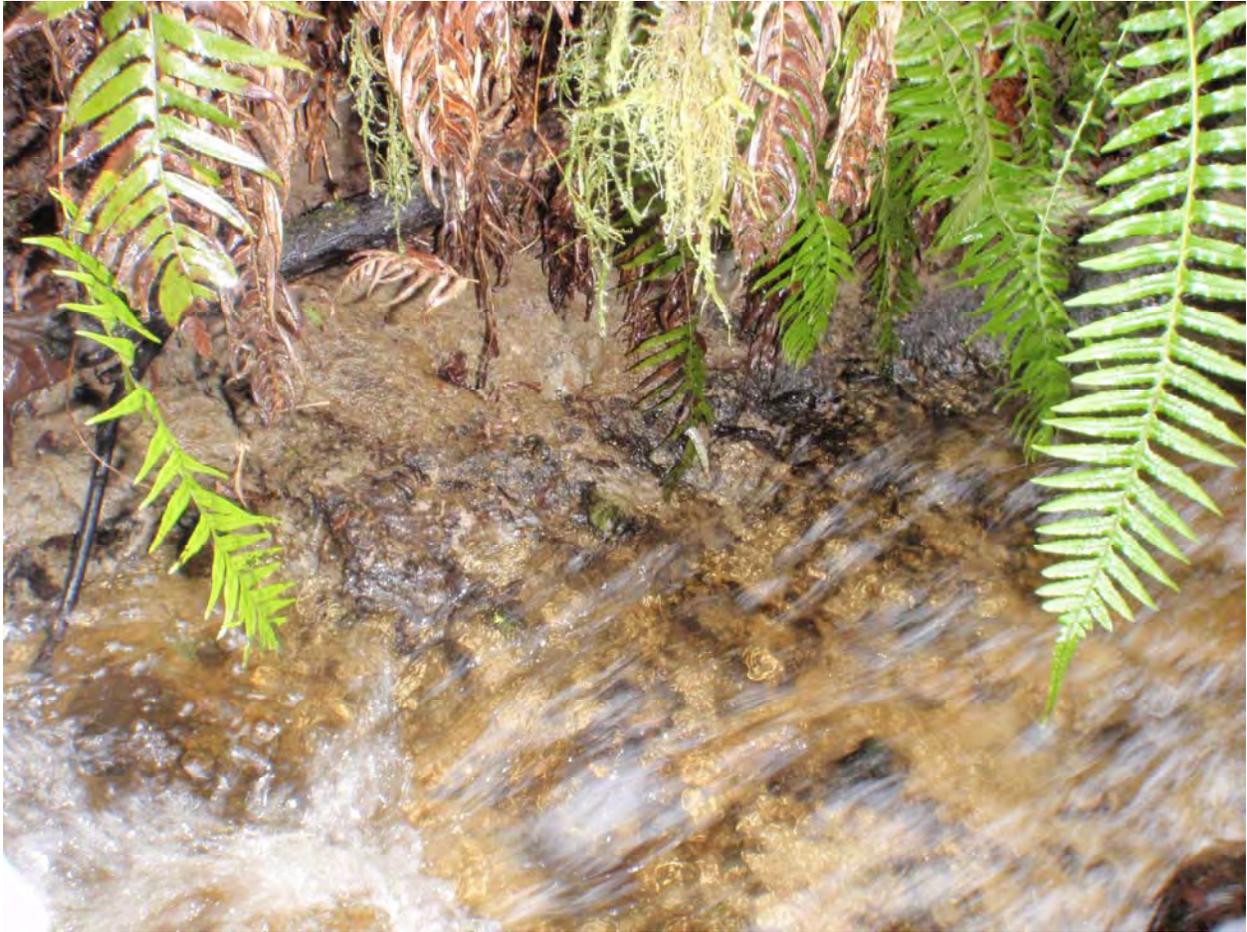
The geology in this reach is mapped as Recessional Outwash (see Photo 4). Light tan compacted sediments are exposed in the stream channel north of parcel 9073. The formation is composed of silt and fine sand with pebbles and appears composed of fine layers and the layers appear slightly contorted. The formation maybe lake deposits (lucustrine) overlain by a layer of stream gravel and cobbles which thins in the stream bed. The gravel and cobbles are sub-rounded to rounded and predominately granites and diorites derived from recessional outwash. Banks are incised 1.5 feet and undercut. Glacial Till caps the hills on either side of the lower drainage.

Photo 4. Reach 1 – Stream bed exposure of fine consolidated sediments in the stream bank. (mapped as Recessional Outwash)

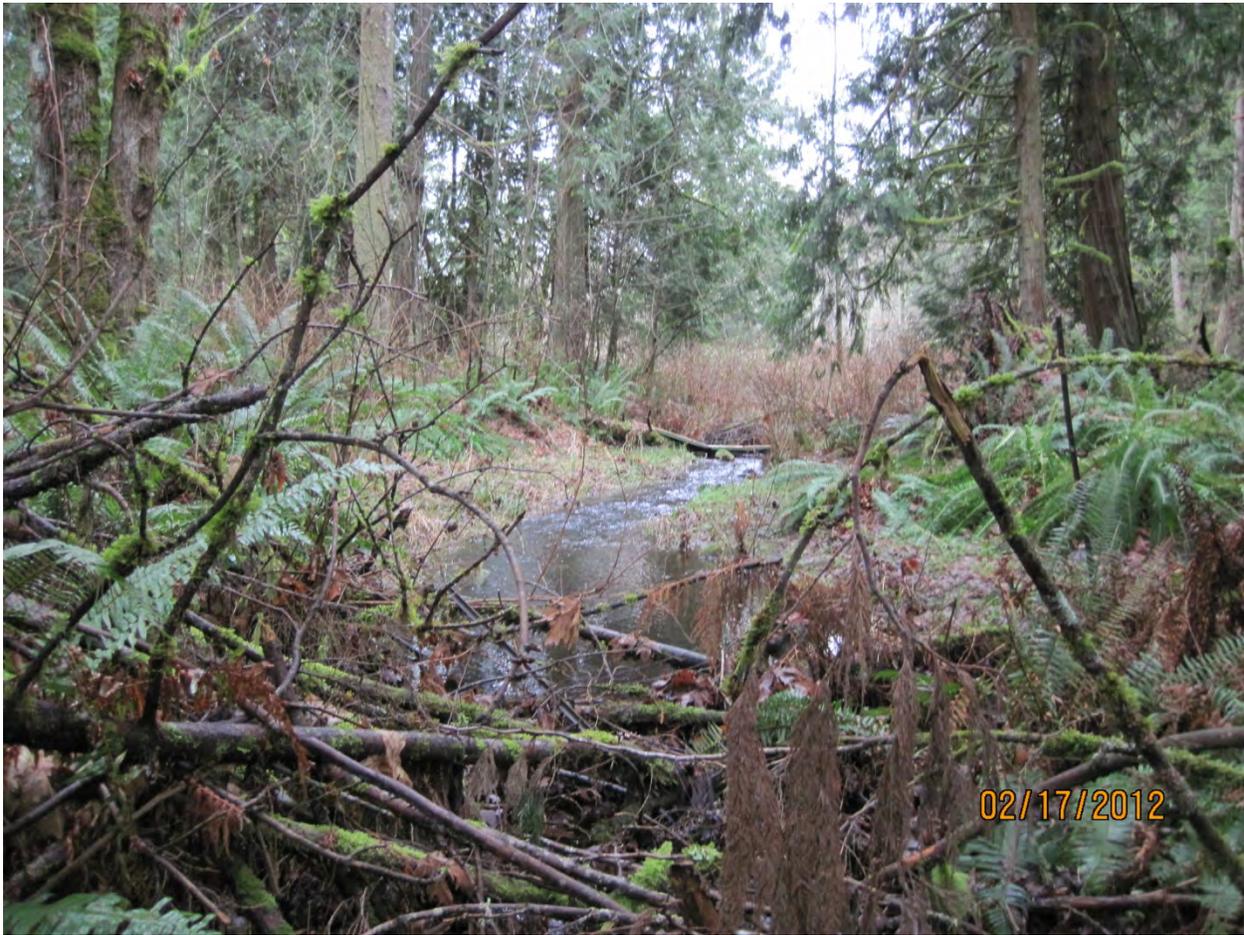
Large Woody Debris (LWD) is in short supply in this cleaned and somewhat channelized reach of the stream. The area near 244th has reportedly been relocated, explaining the diagonal culvert alignment. Mostly small diameter woody debris and some smaller diameter alder were the only woody debris present. One large parcel (9073) along the creek (about 450 linear feet of stream) could not be accessed, but was viewed from parcels immediately upstream and downstream. Reach 1 flows across the plateau and is low gradient, pool/riffle and run habitat that is mostly gravel bedded. It contains two debris accumulations in parcel 9073, created by what appeared to be thin gauge steel storage cabinet doors (or possibly metal garage door segments) set up apparently as light weight bridge crossings. The metal doors have accumulated small branches, leafy, and woody debris. Both debris accumulations appeared fish passable, with low heights and fairly large and long plunge pools directly below each debris accumulation providing fish easy passage over, around, or through in either direction (see Photos 3 through 7).

Photo 5. Reach 1 – Small woody debris accumulations at small metal bridges. Fish passable around and through debris.

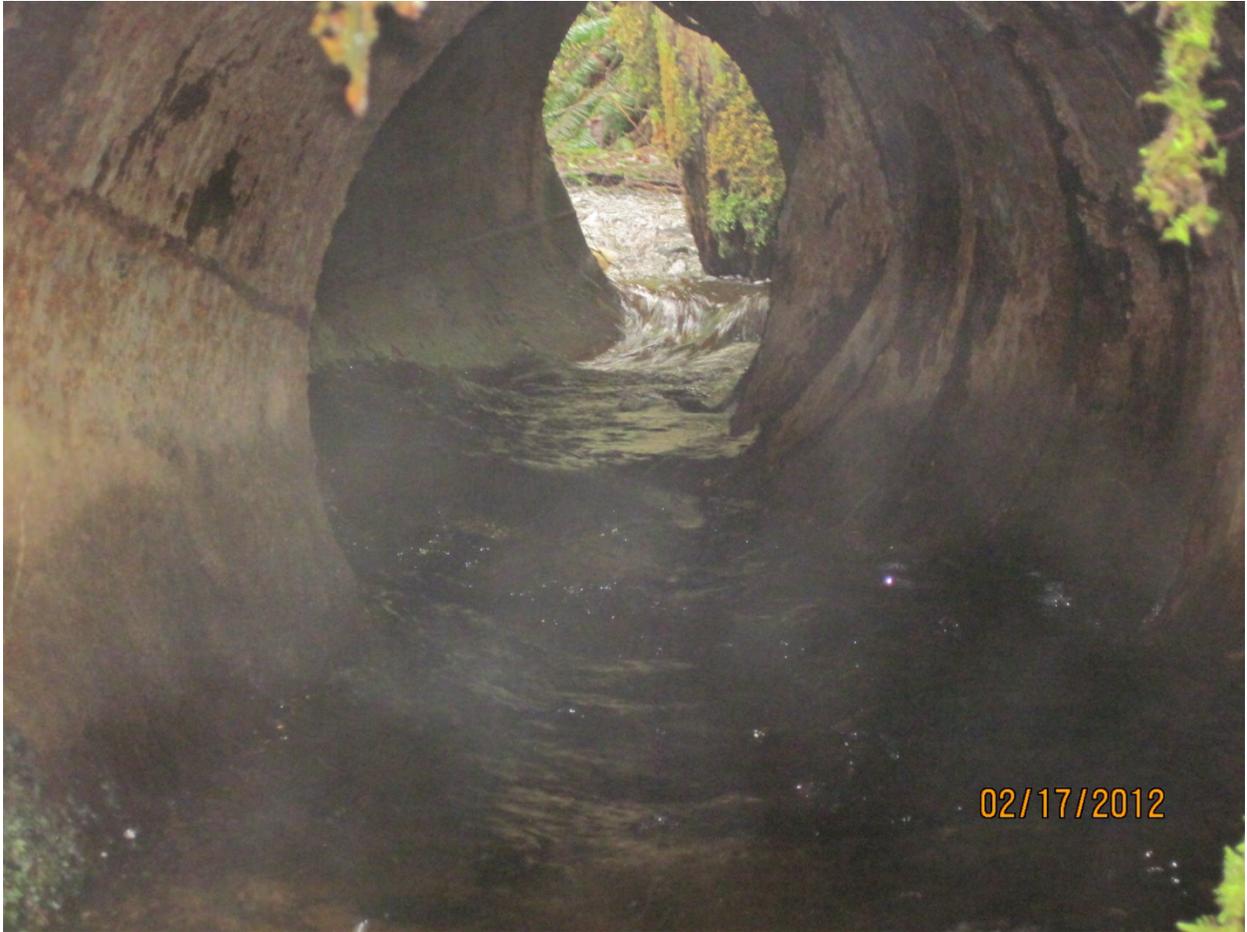
The culvert at Parcel 9043 and 2324 is a 36 inch diameter, 10 to 12 foot long, smooth steel pipe (see Photos 8-11). The culvert is poorly constructed of thick steel pipe composed of short curved sections welded together that created several bends in the culvert, both horizontally and vertically. The culvert underlies a single lane old driveway or logging road that crosses the stream. It is covered with only about a foot of road fill material. Downed trees on the road bed suggest this road is no longer used. The culvert is set at a 2% to 3% grade and has a 1.6 foot drop at the downstream end (water surface to water surface) (see Photos 12 and 13). There is a fairly large culvert plunge pool that is 10 feet wide, 12 feet long, with a maximum depth of 1.5 feet. Based on the

Photo 10. Reach 2 – View inside old logging road smooth steel pipe showing fish resting areas in curves, and low gradient. Fish passable.

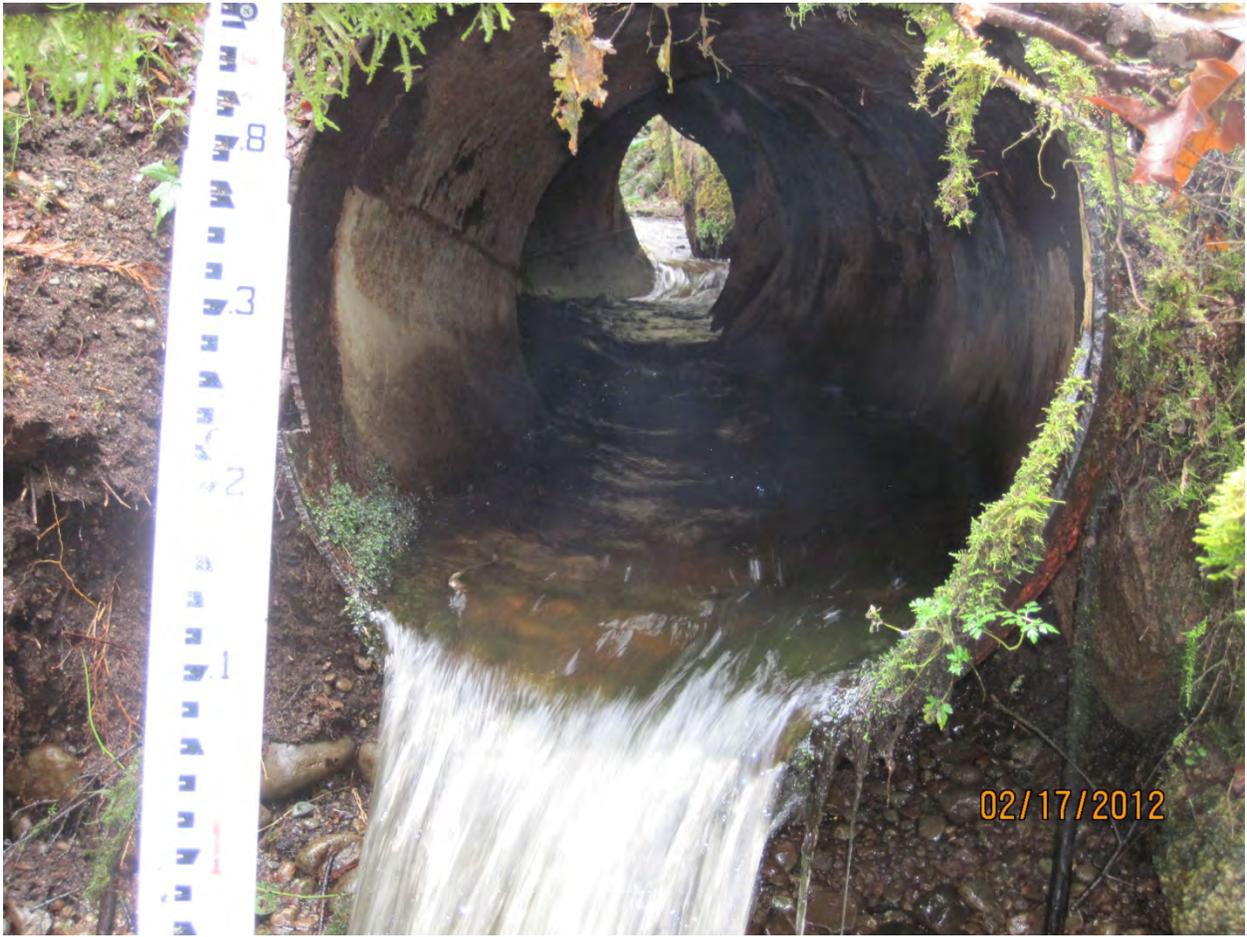
Photo 11. Reach 2 – Downstream end of smooth steel logging road pipe looking upstream.

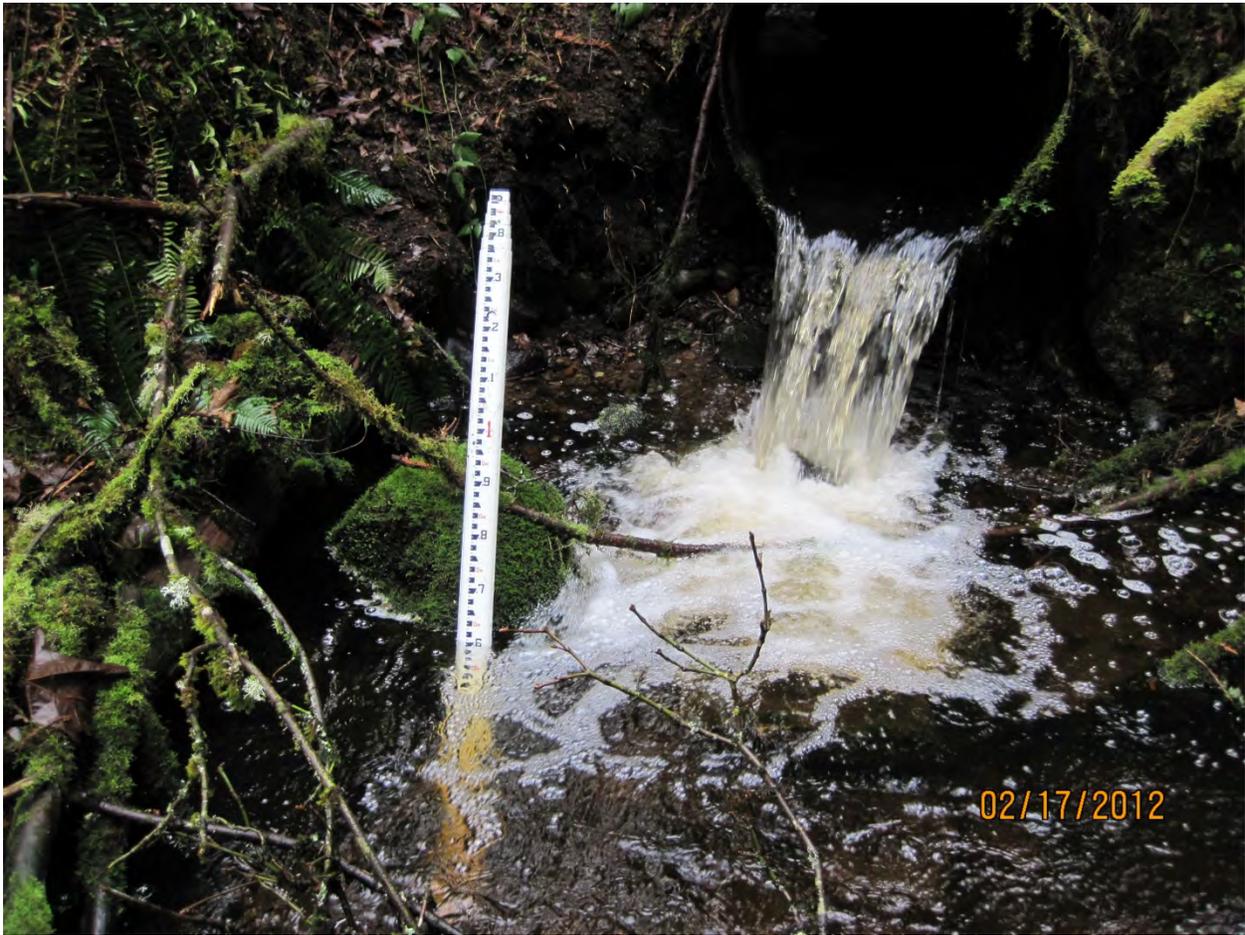
Photo 12. Reach 2 – Deep (0.6 meter, 23 inch) plunge pool at downstream end of old logging road pipe, enabling upstream fish passage.

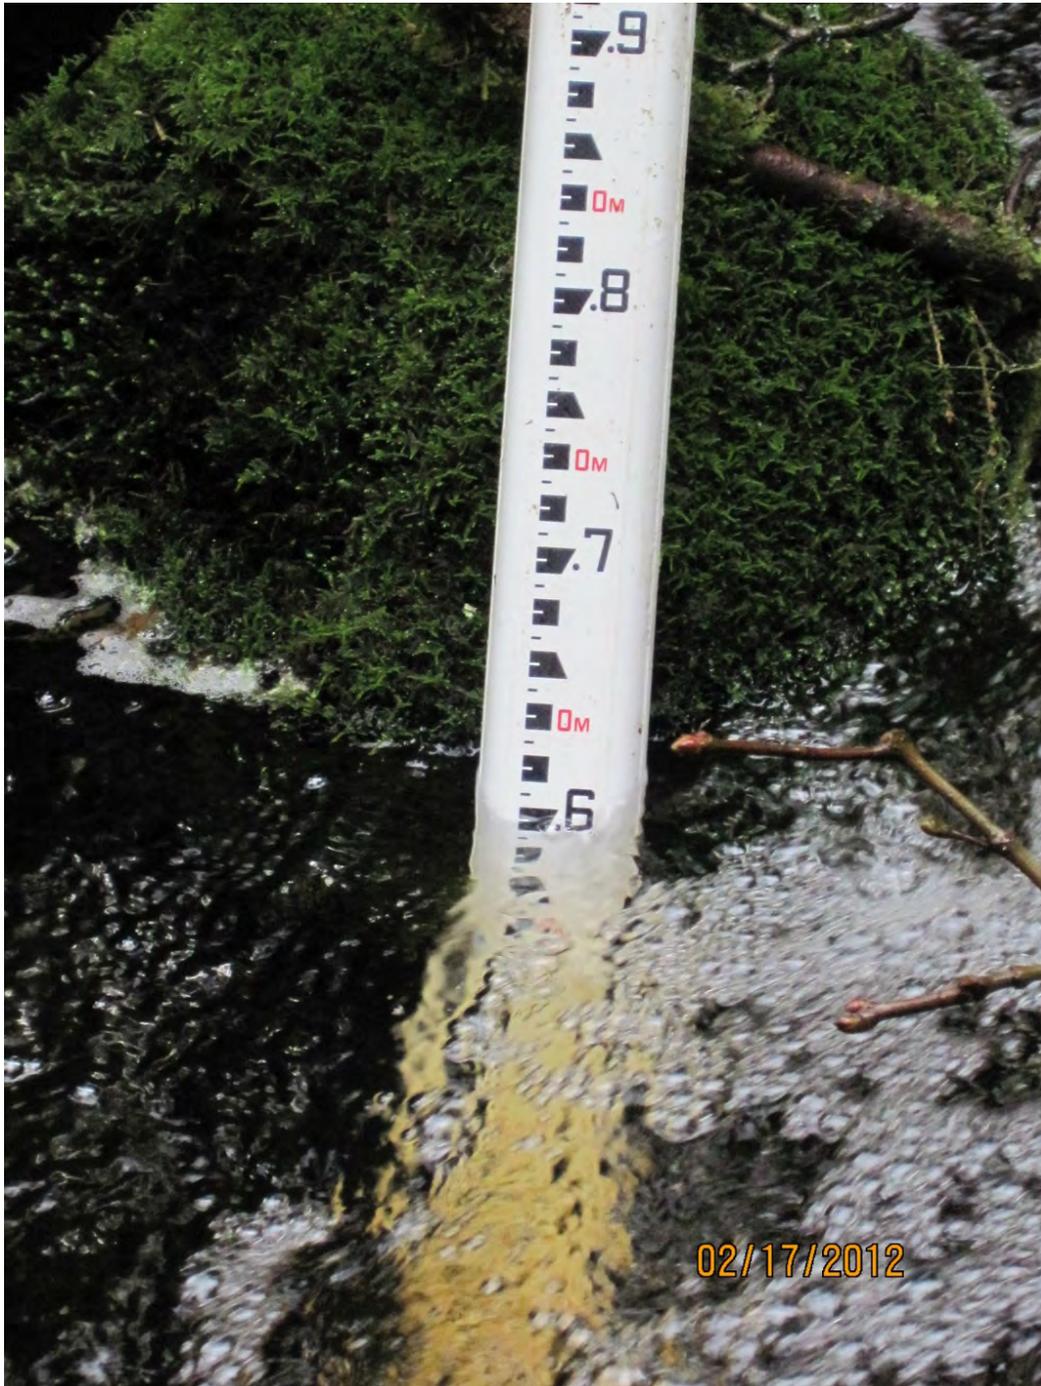
Photo 13. Reach 2 – 0.6 meter deep plunge pool at old logging road pipe.

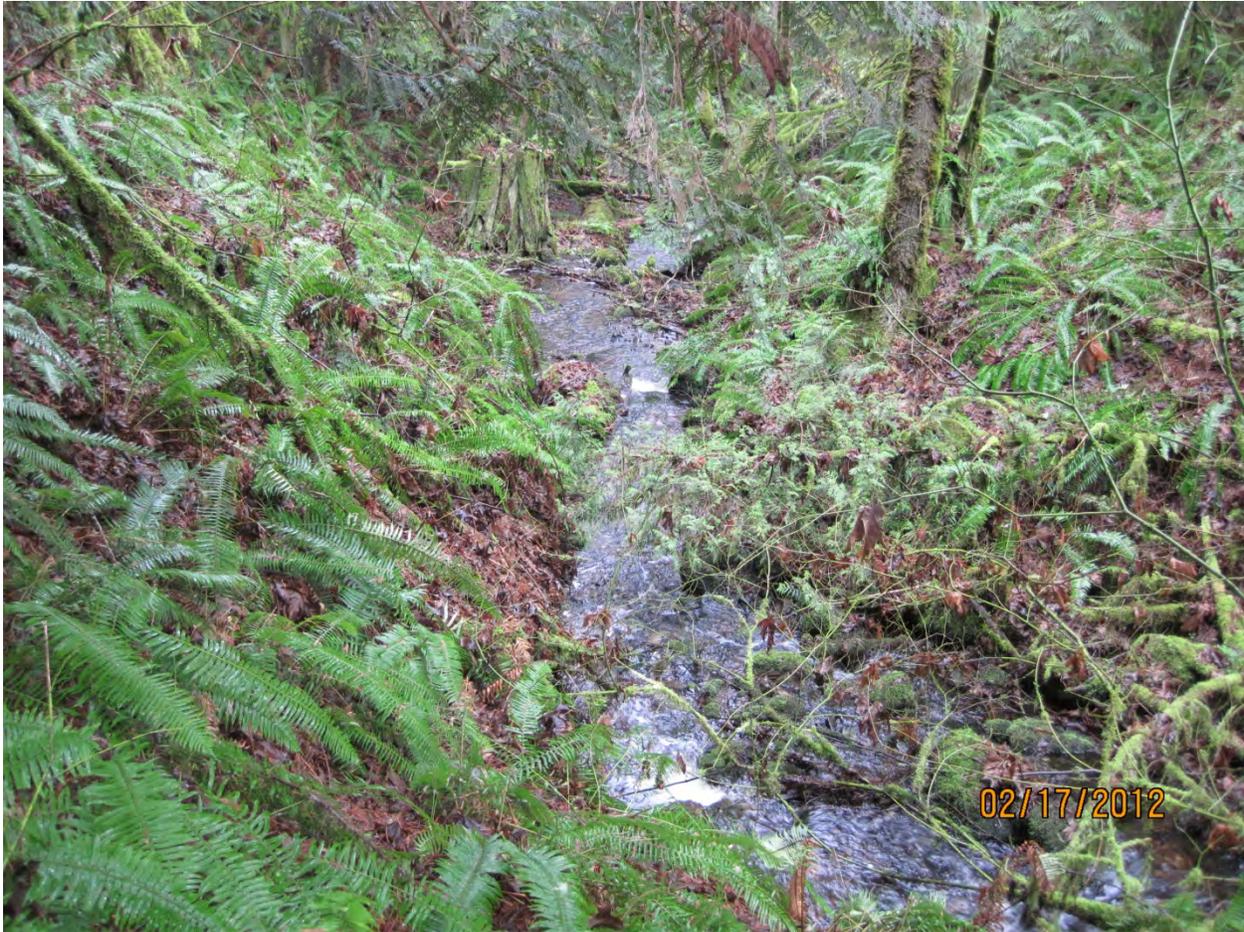
Photo 14. Reach 2 – Typical habitat at upper end of ravine reach. Note large old growth stump in channel bottom.

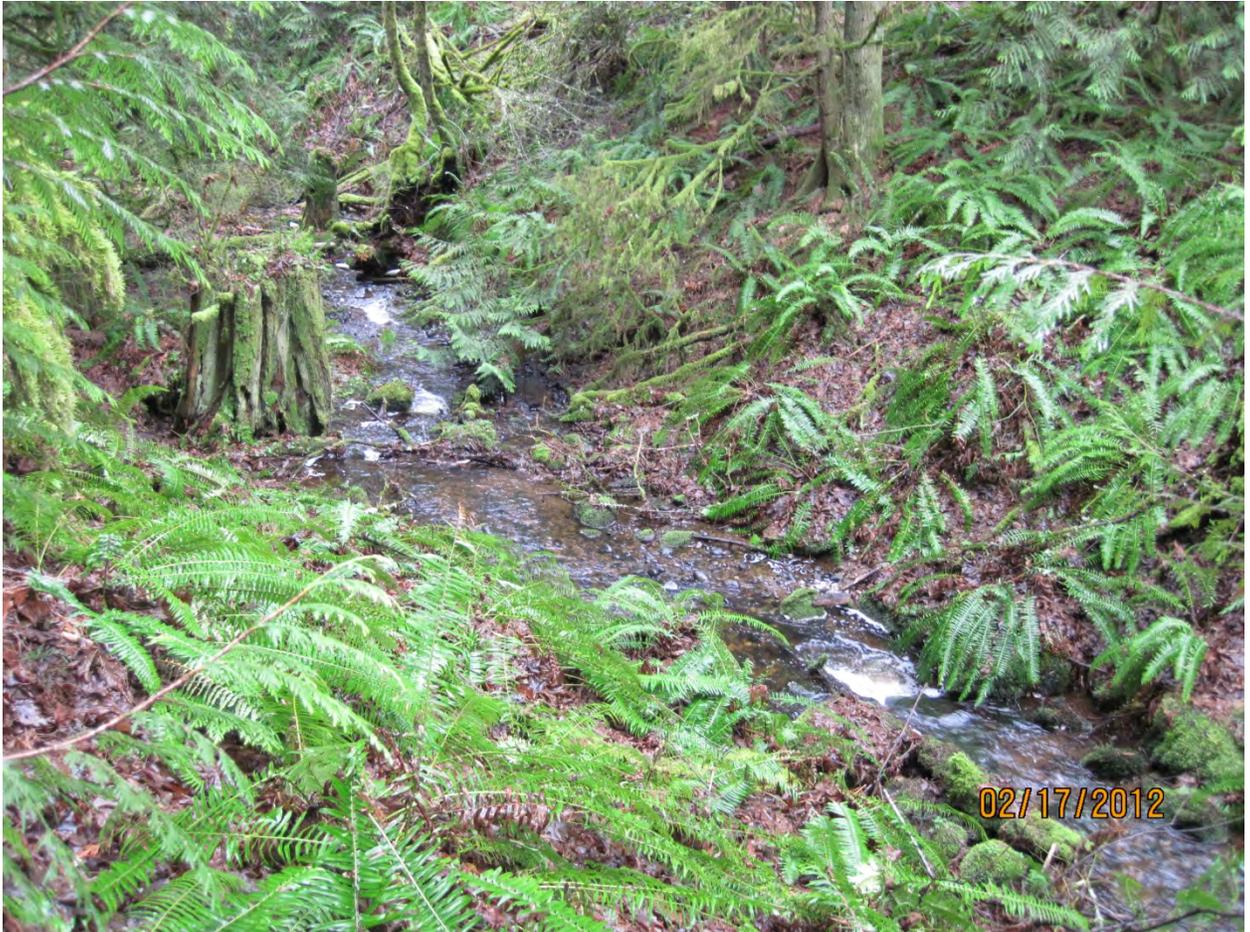
Photo 15. Reach 2 - Typical stream channel descending into upper end of ravine reach, with large woody debris (LWD) stump in stream bed, small drops, pools, and riffles.

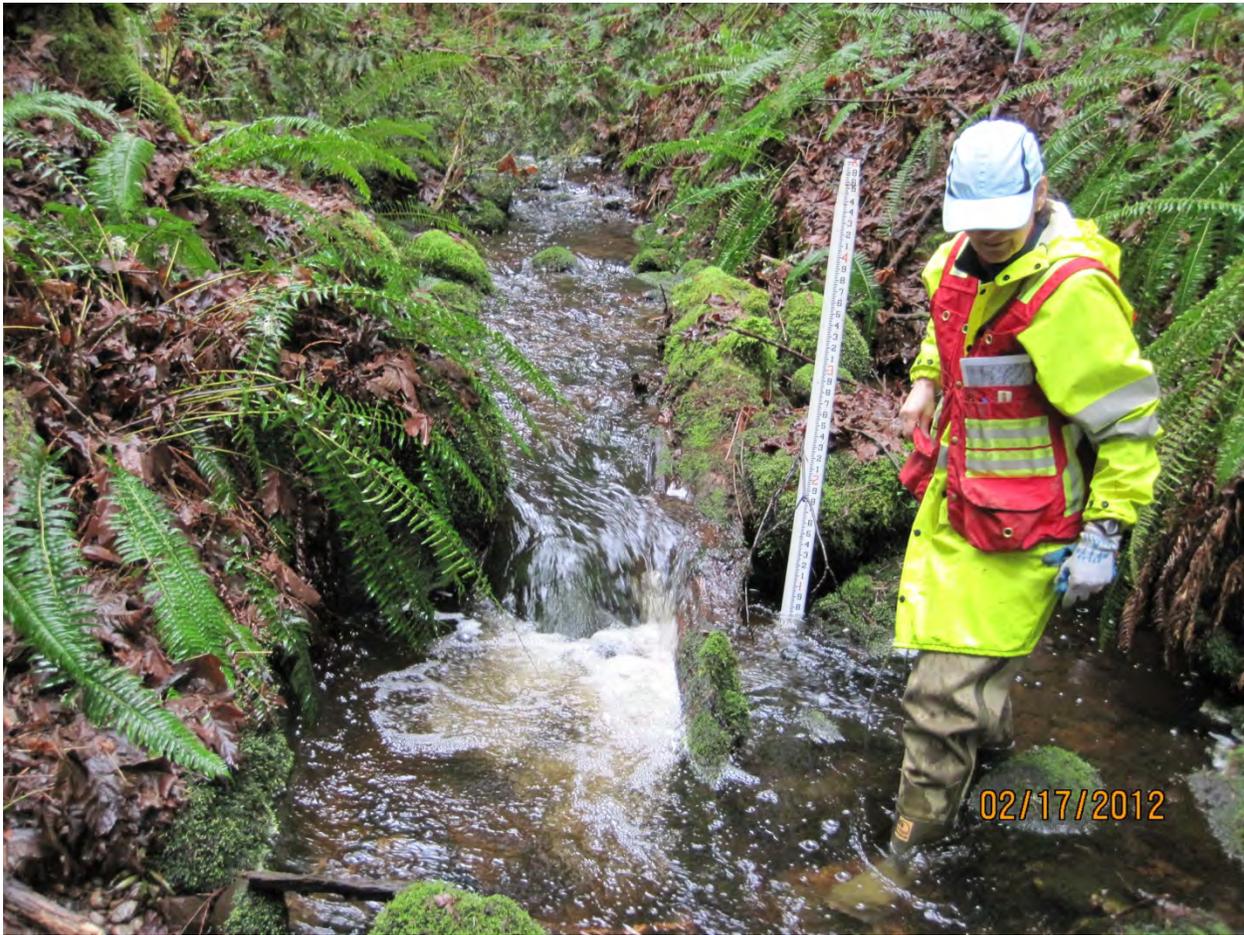
Photo 16. Reach 2 – Close up of drop pool caused by large boulders and large woody debris in the channel. This is a close up of the drop pool visible in Photo 15 (lower right corner).

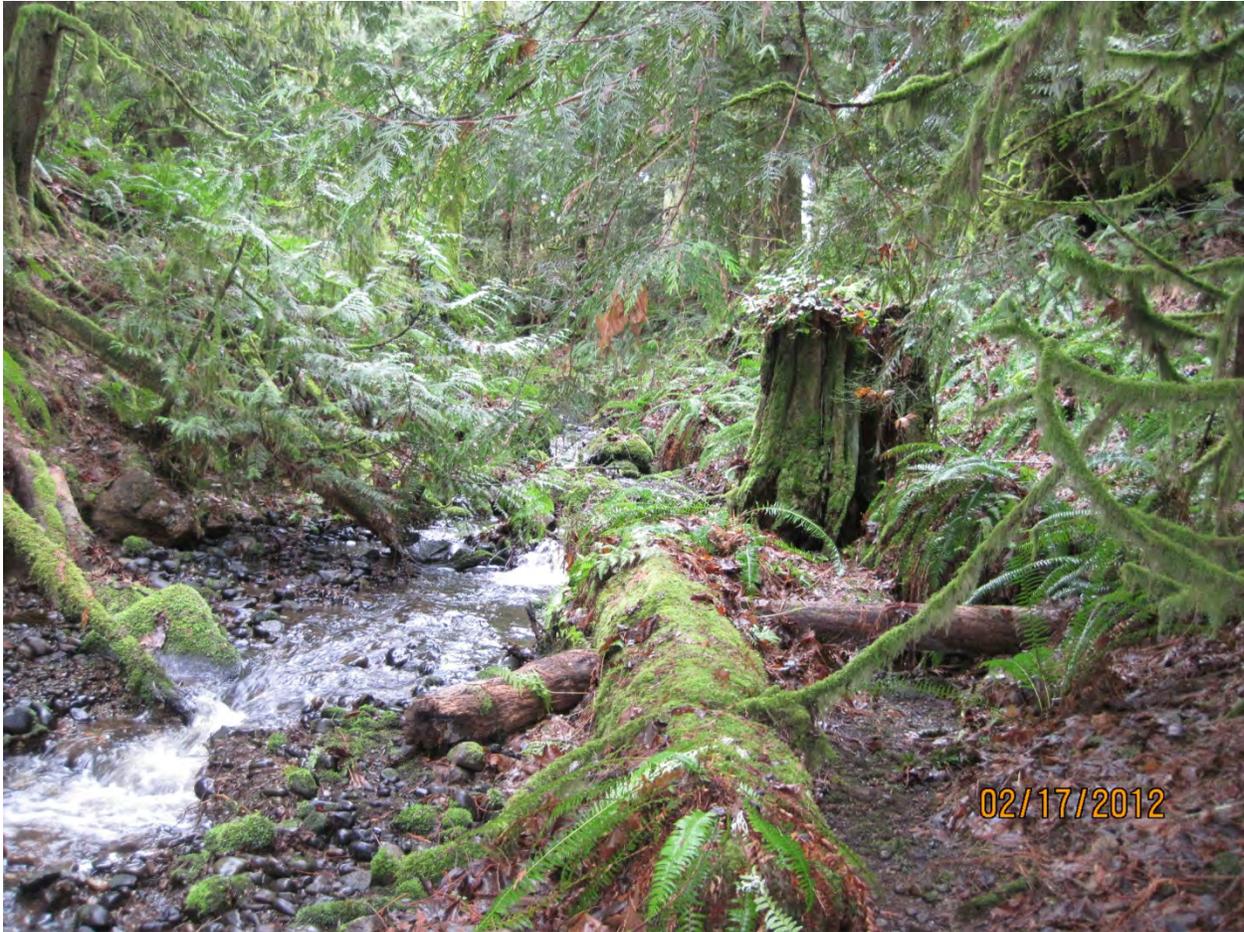
Photo 17. Reach 2 – Ravine reach containing LWD, boulders and dense riparian vegetation. Note 6-foot diameter old growth stump adjacent to stream bed.

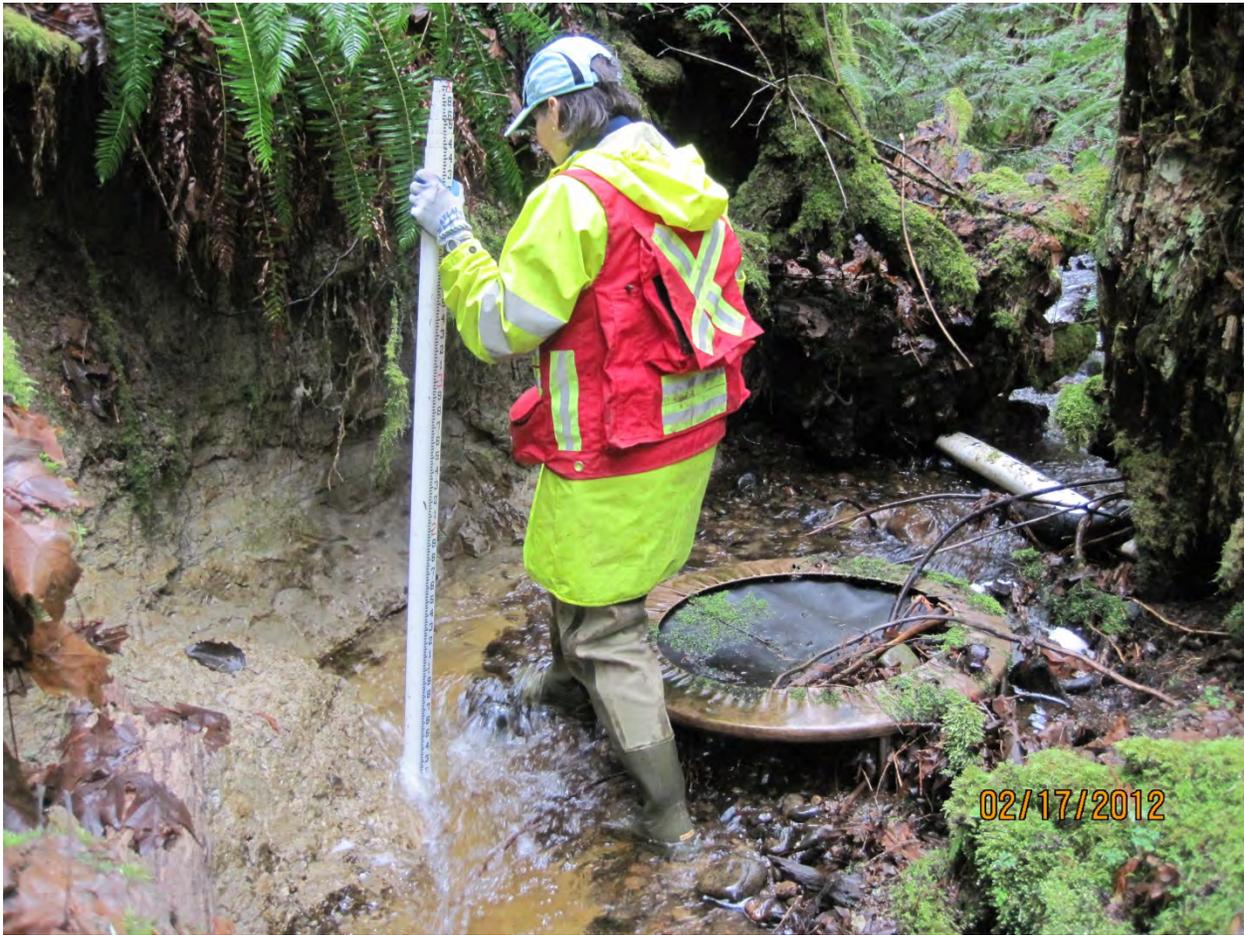
The geology in this reach is mapped as Advance Outwash. In this area Advance Outwash is composed of silt to fine sand sized with minor pebbles (see Photos 18 and 19). The compacted sediments stand in vertical exposures up to 5 feet tall and are exposed in the east bank. Weathered soil and colluvium cover the slopes. The channel bottom is covered in firm sand to cobble sized sediments. The gravel and cobbles steam sediments are sub-rounded to rounded and predominately granites and diorites derived from recessional outwash. A zone or band of granitic boulders, two (2) to three (3) feet in diameter (see Photo 16), form steps in the channel. These have weathered from the overlying Till. In general banks are incised 1.5 feet and undercut about a foot. The gradient flattens above the culvert that forms the northern boundary of the reach. The valley bottom flattens and widens in response to deposition above the culvert. Glacial Till caps the hills on either side of the lower drainage.

Photo 18. Reach 2 – Ravine reach with area of erosion into hard pan, plus debris.

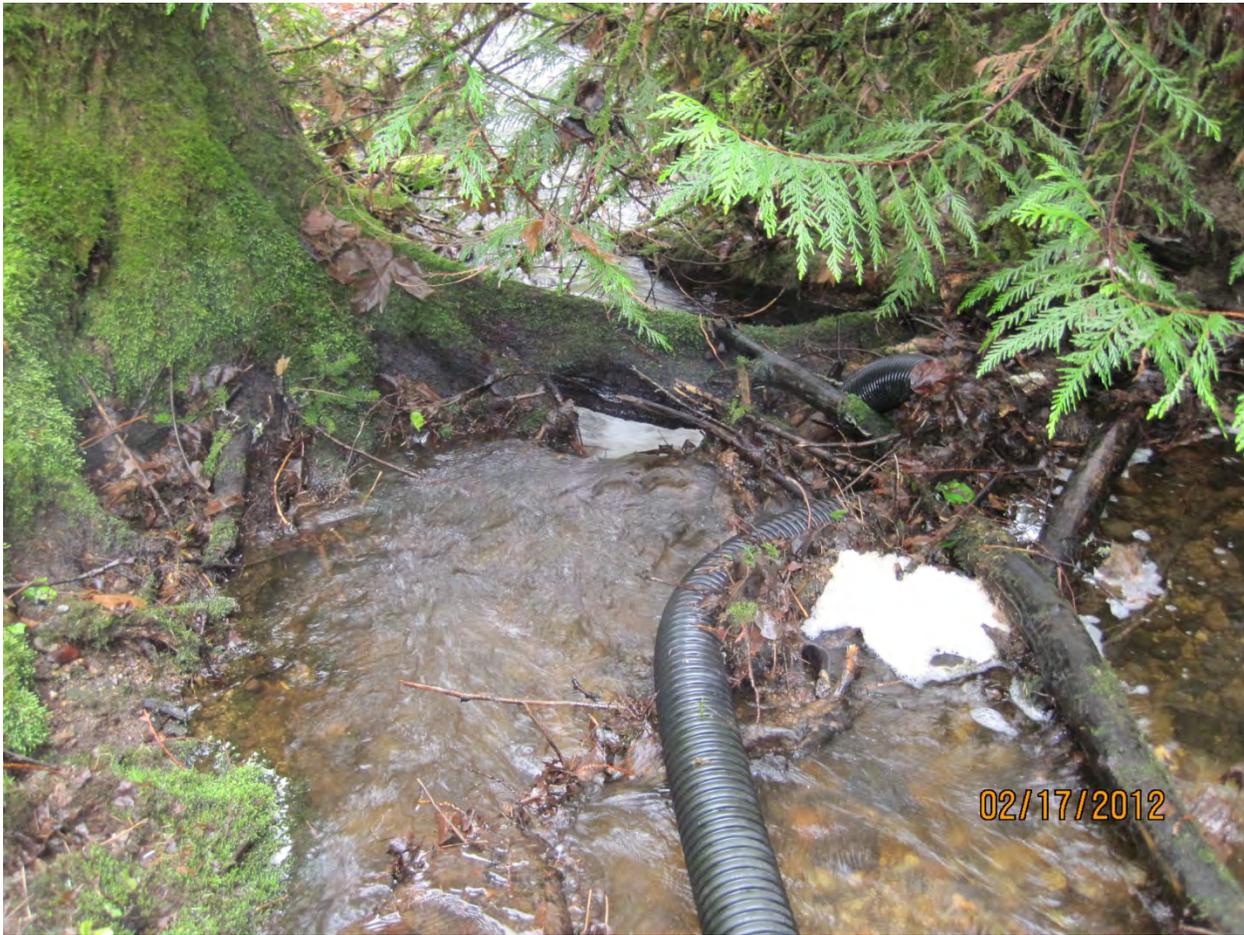
Photo 22. Reach 2 – Close up of tree root caused gravel terrace, drop and plunge pool. Fish passable due to short drop, deep and long plunge pool.

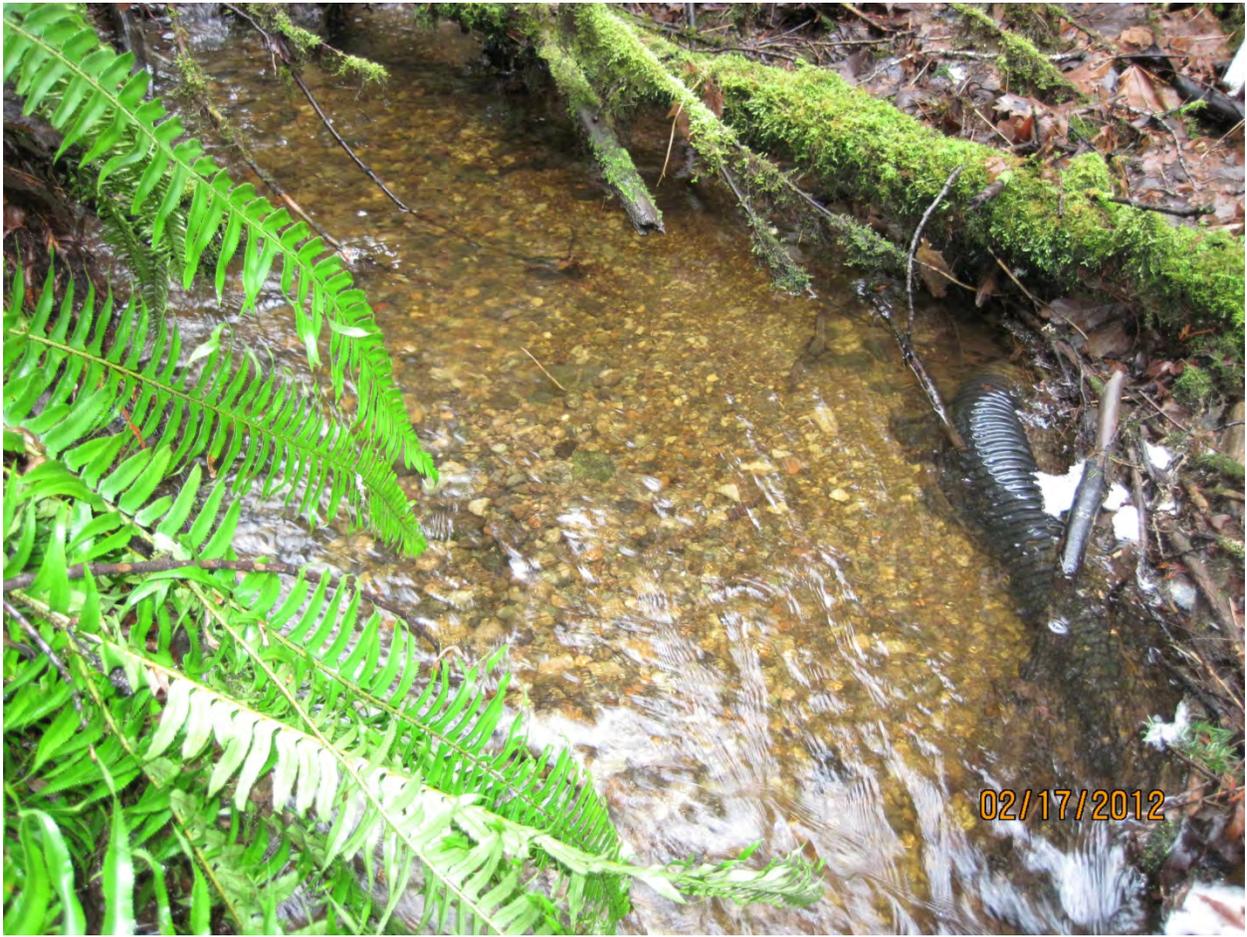
Photo 23. Reach 2 – Close up of good quality salmonid spawning gravel in tree root caused pool.
