Allen Lake Outlet Stream Reconnaissance

December 10, 2012

1.0 Purpose and Scope

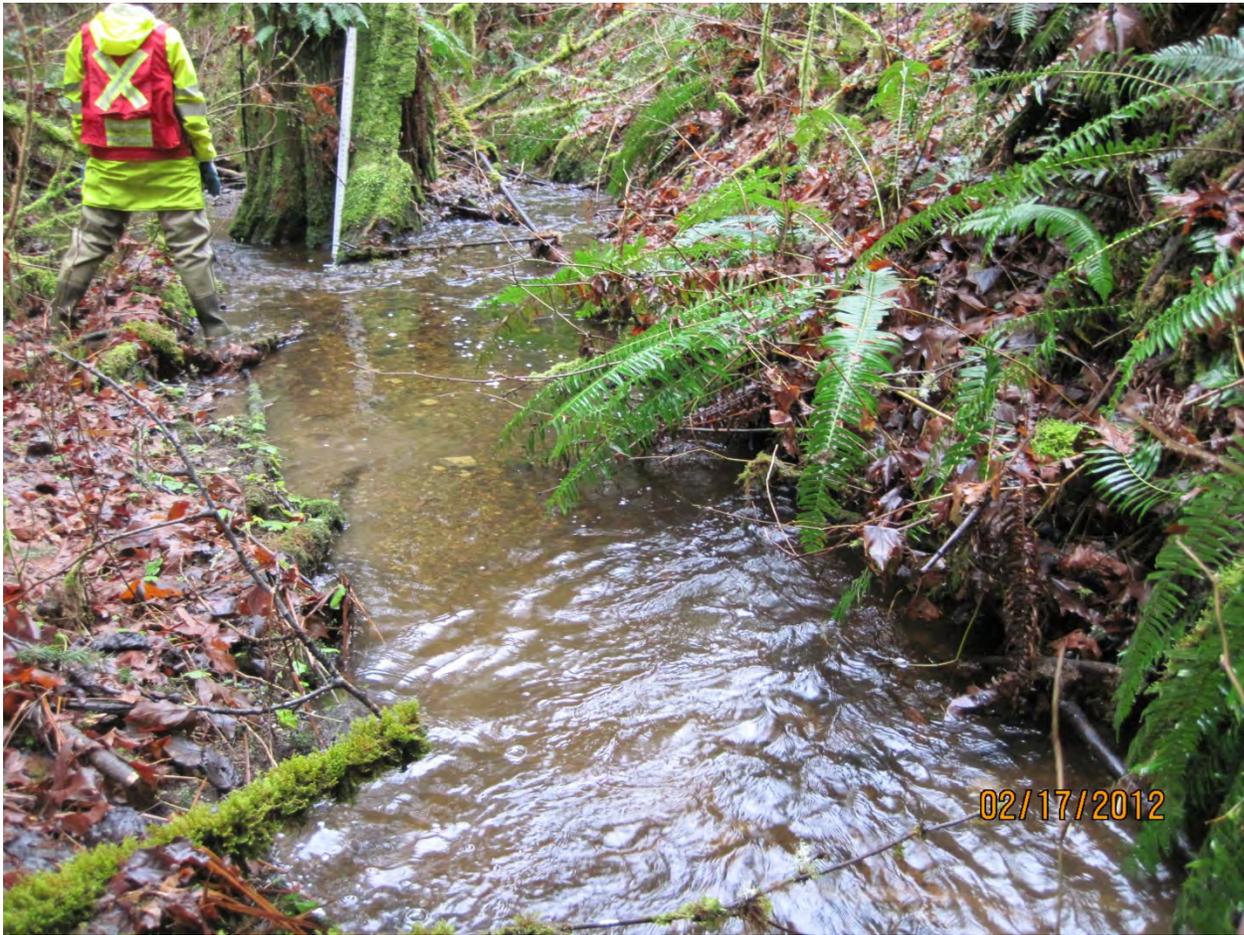
Photo 24. Reach 2 – Old growth stump in channel at grade with creek bed, indicating very little downcutting and erosion of stream bed. Note suitable sized salmonid spawning gravel in pool and tailout. Good spawning habitat for cutthroat trout and coho salmon (if accessible to salmon).

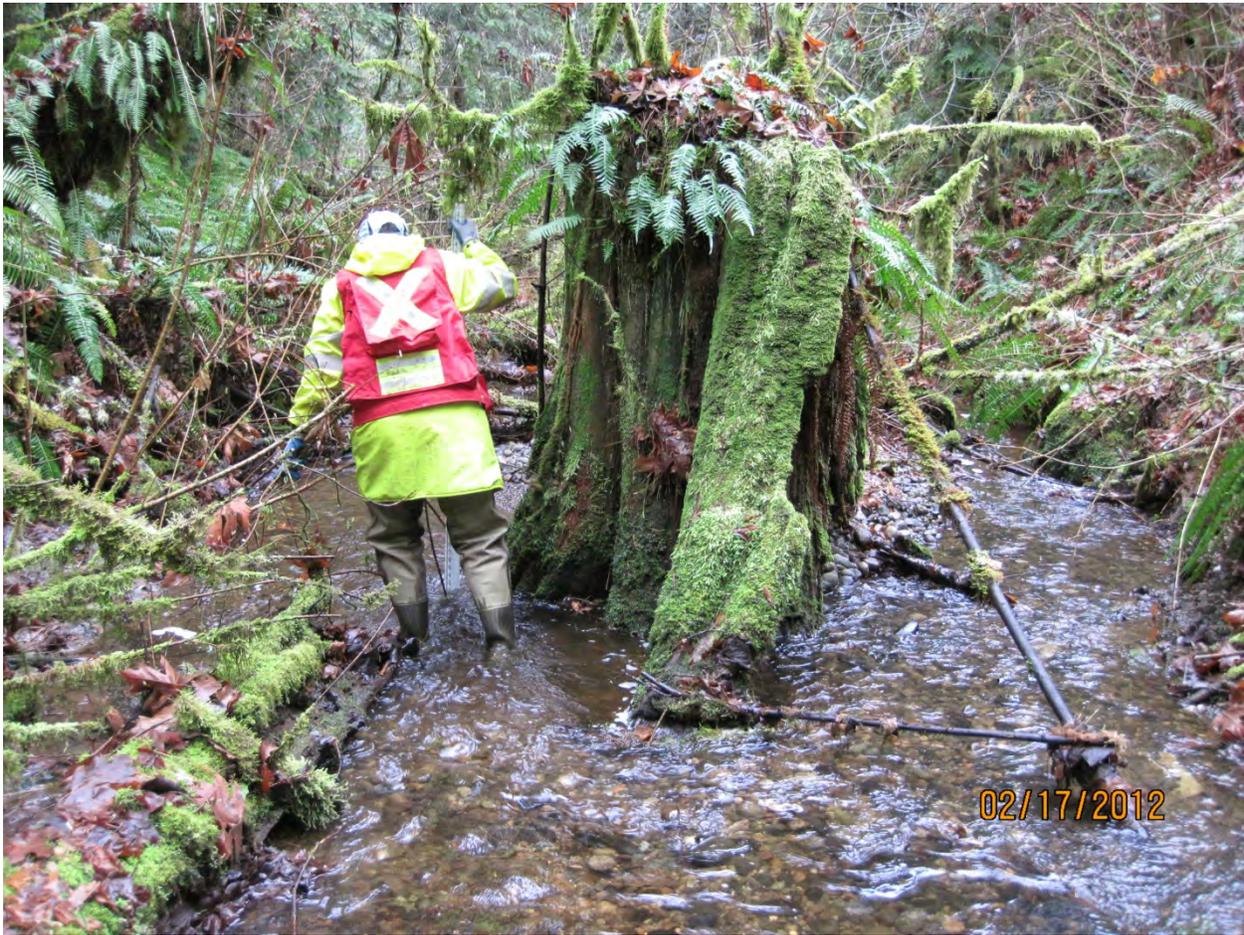
Photo 25. Reach 2 – Large old growth stump in stream channel. Note lack of downcutting and erosion around sides of stump.

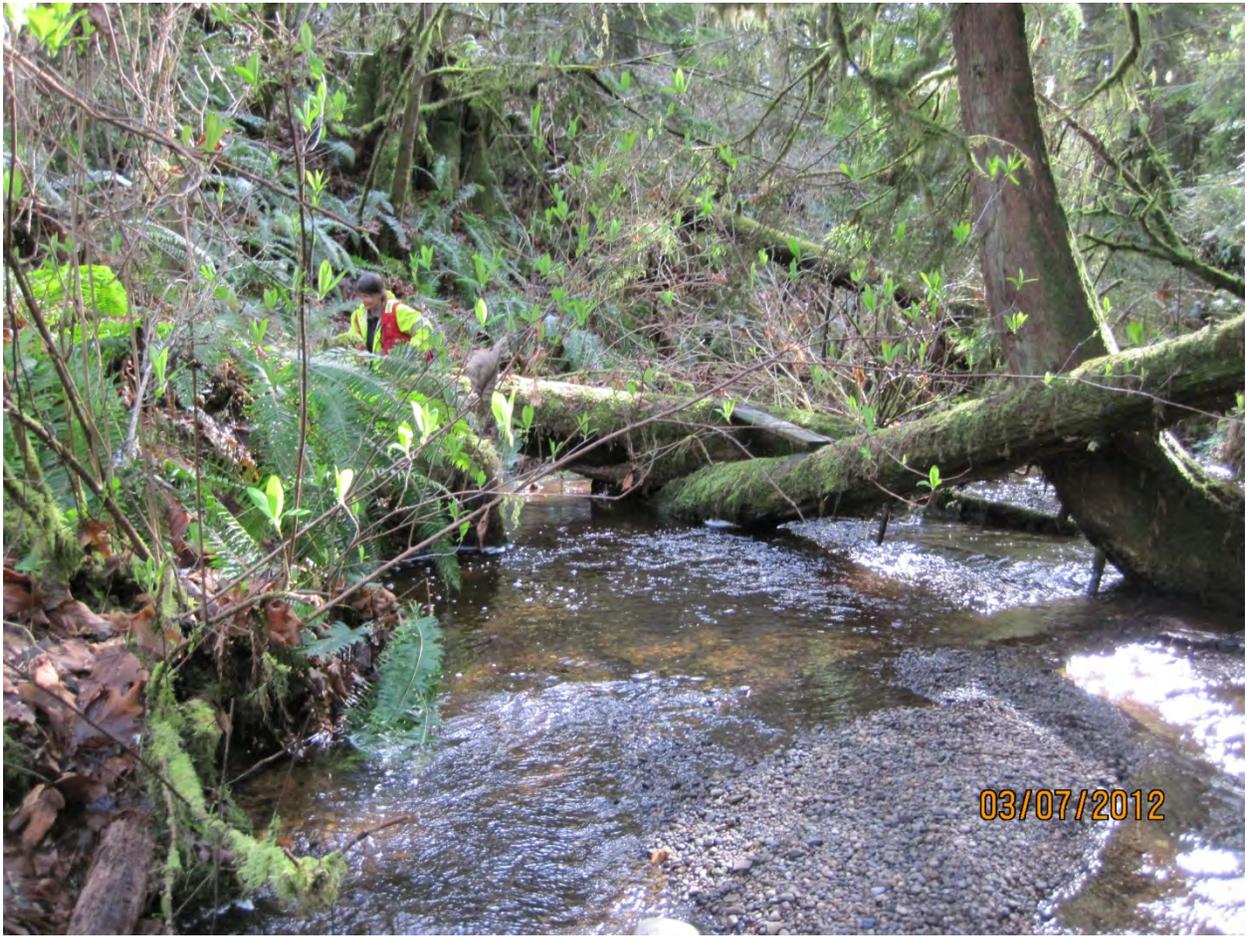
Photo 26. Reach 2 – Downstream end of Reach 2 just upstream of NE 25th private residential driveway crossing. Note excellent pool and riffle habitat with abundant salmonid spawning gravel and high volume of large woody debris providing cover.

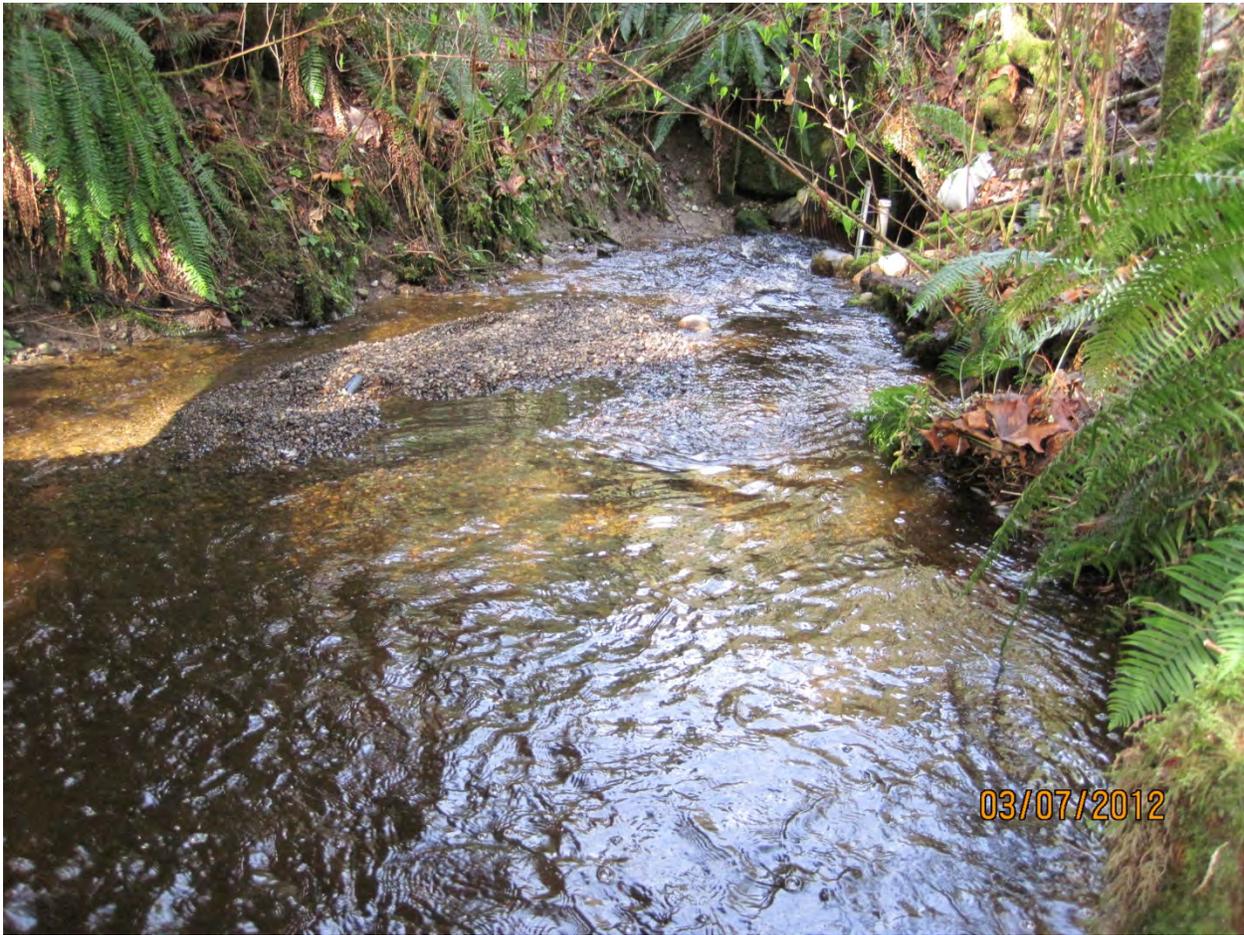
Photo 27. Reach 2 – Lower end of Reach 2 looking downstream at the upstream end of the NE 25th private driveway culvert and King County gauge site. Note the abundant salmonid sized spawning gravel deposits, and excellent spawning riffles. Coho salmon cannot access this spawning habitat due to this impassable culvert.

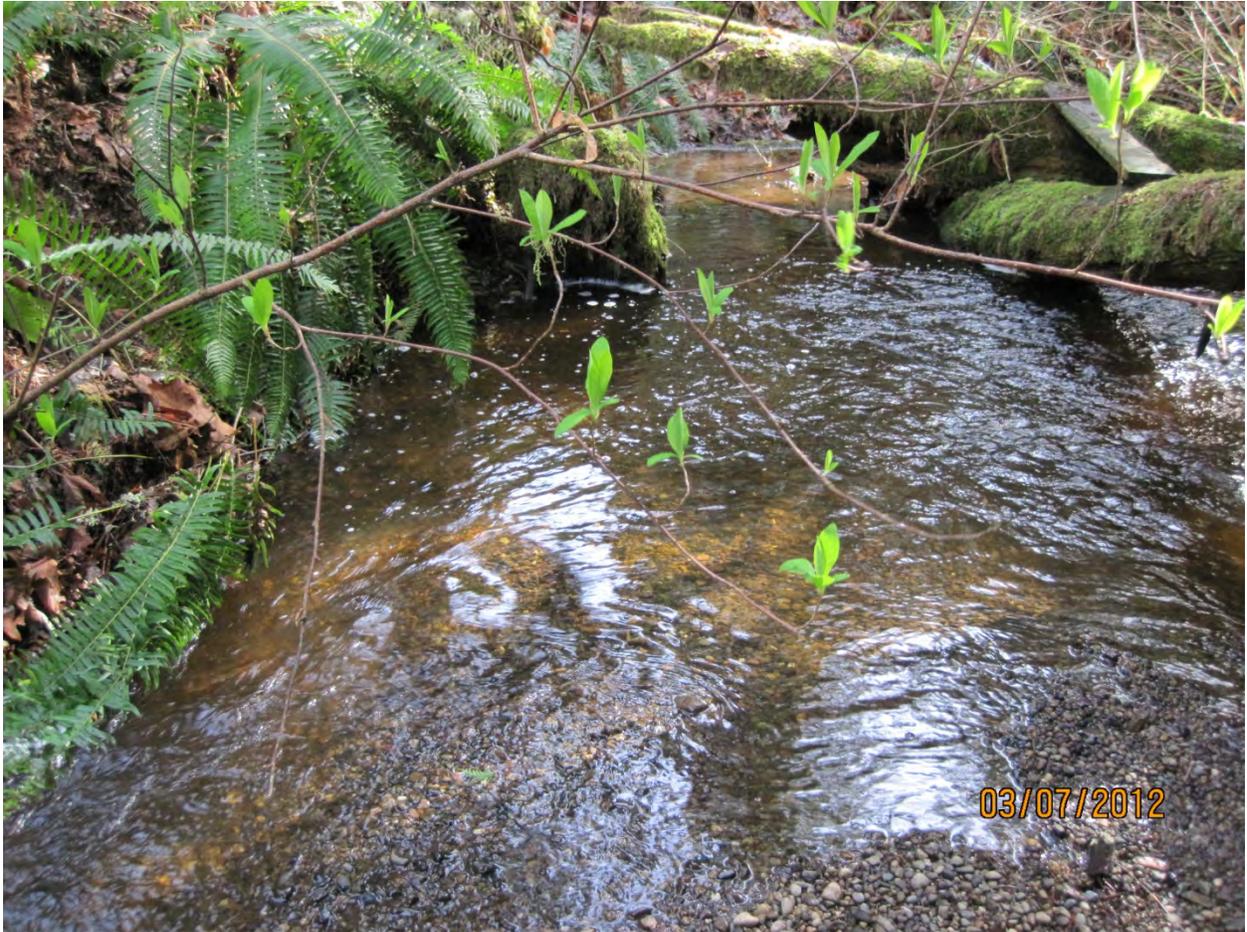
Photo 28. Reach 2 – At the lower end of Reach 2, looking upstream at high quality pool/riffle combination with very good instream and overhead cover created by large woody debris.

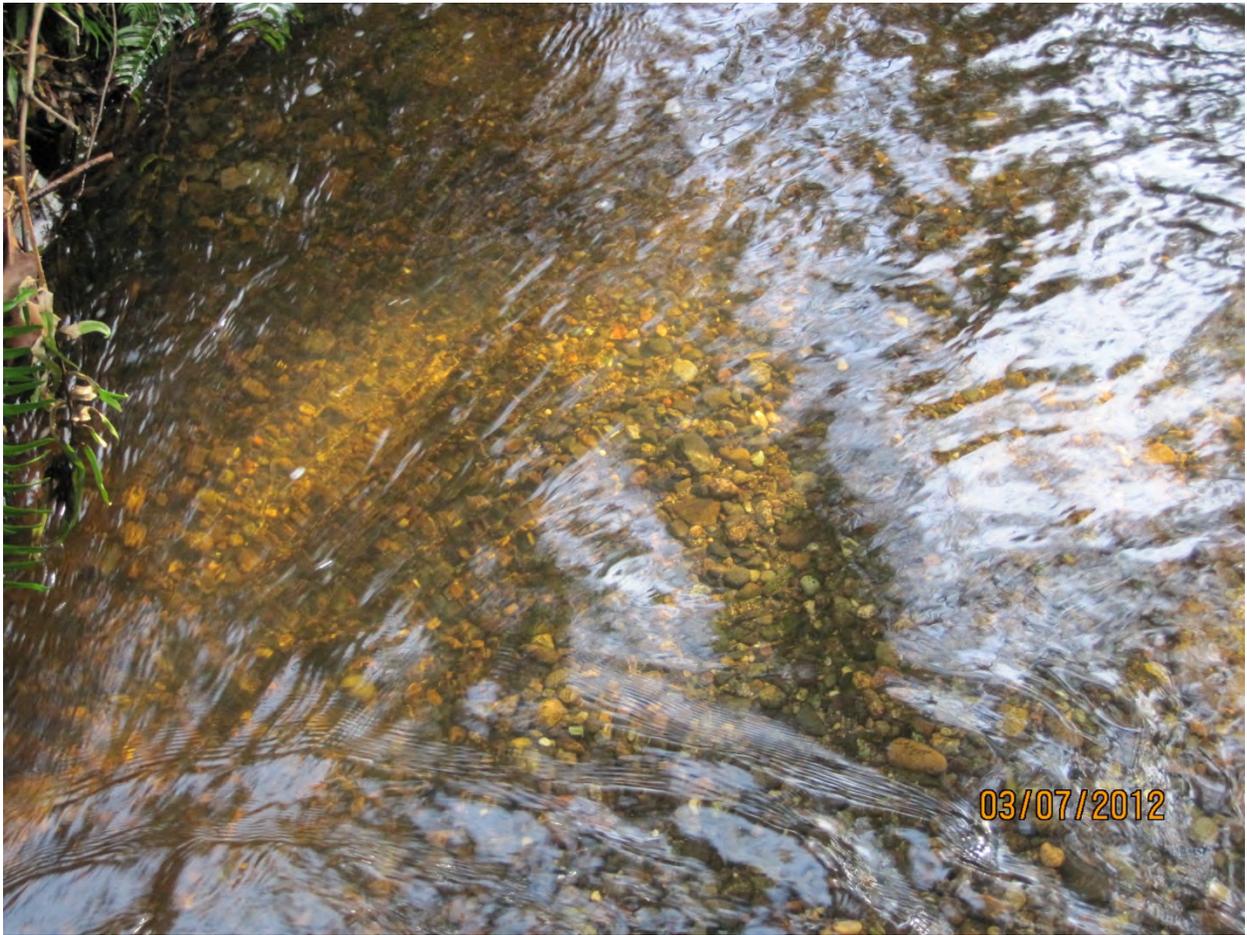
Photo 29. Reach 2 – Excellent spawning habitat suitable for coho salmon and cutthroat trout at lower end of reach 2, just upstream from NE 25th culvert.

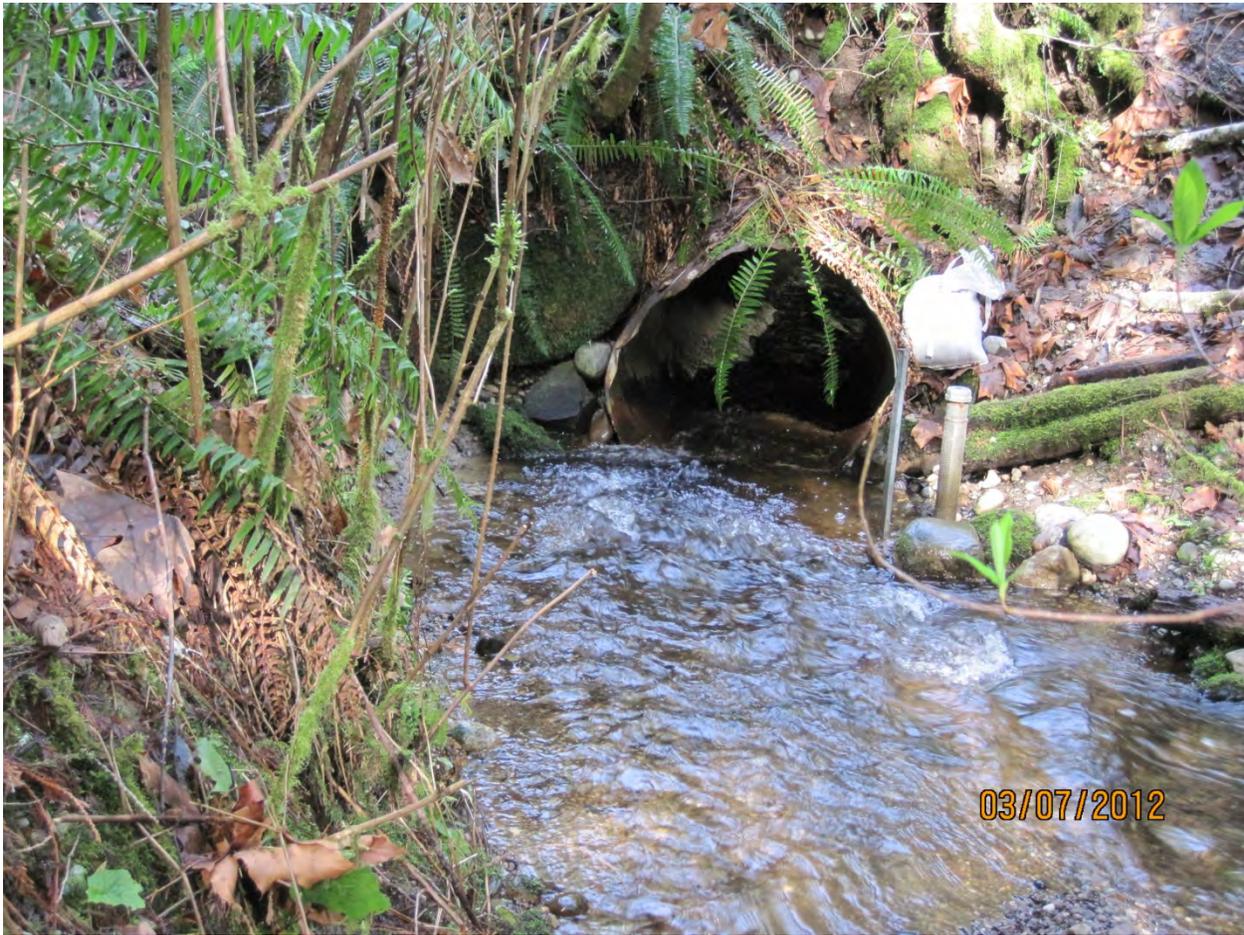
Photo 30. Reach 2 – Downstream end of Reach 2, looking downstream into the 36-inch diameter corrugated metal pipe at NE 25th private residential driveway. The pipe graduates from 36-inch diameter cpm, to 48-inch smooth steel, and then to 54-inch diameter cmp, all within driveway prism. The King County stream flow gauge is on the right, next to pipe. Note partially crushed, rusty, old pipe.

2. Evaluate cost of replacement of the private driveway culvert at NE 25th Street and assist owners in grant application to replace with fish passable crossing. Consider County paid replacement due to 36 inch crushed and rusted pipe section, or entire crossing. Could be very expensive to provide fish passable culvert that meets City and State requirements.

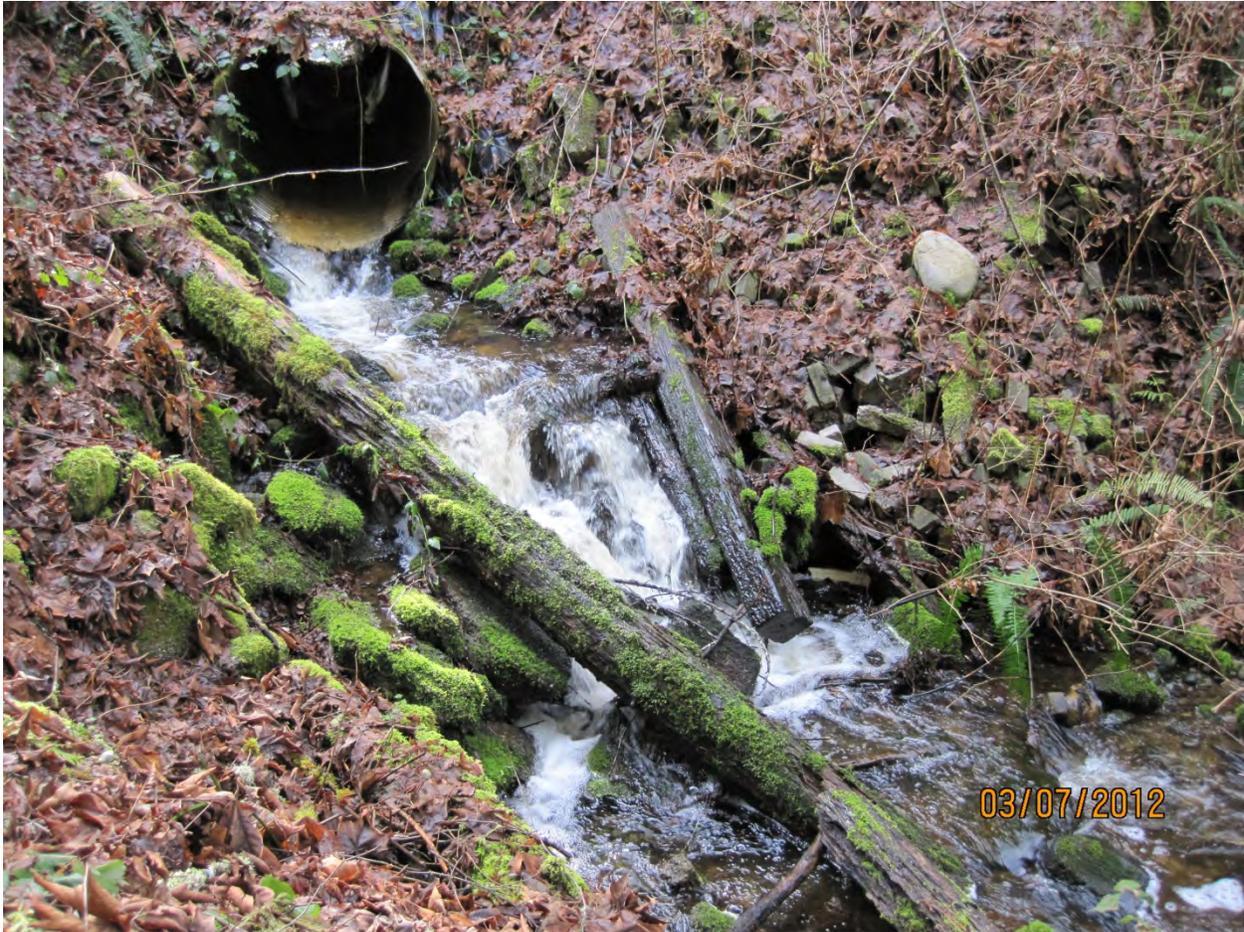
Photo 38. Reach 3 – Fish impassable culvert outlet at NE 25th private driveway. This view looks through pipe, so is slightly different viewpoint than Photo 39.

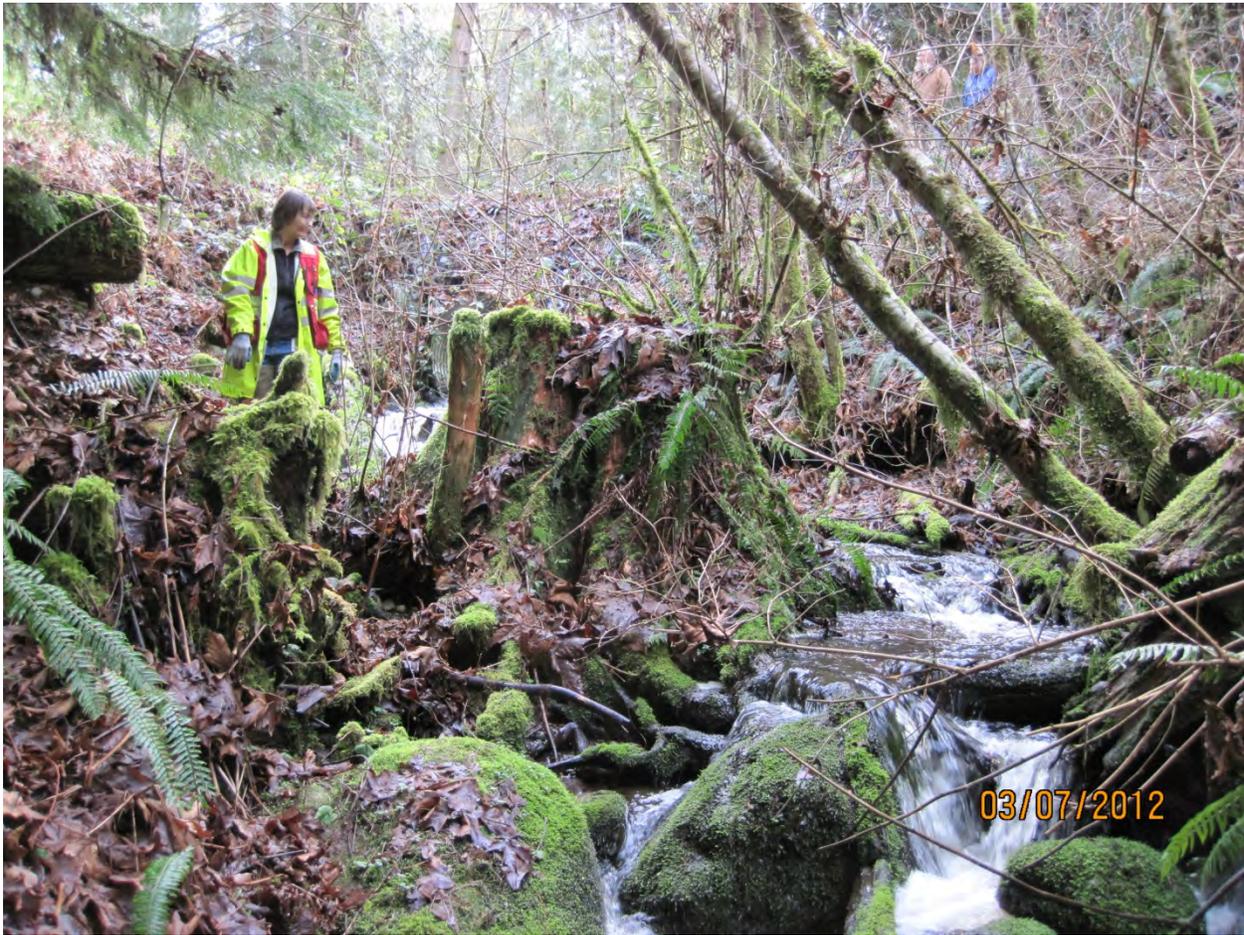
Photo 41. Reach 3 – Just downstream of NE 25th private drive. Note boulder band caused short cascade, determined to be fish passable. Also note large old growth stump at edge of stream channel.

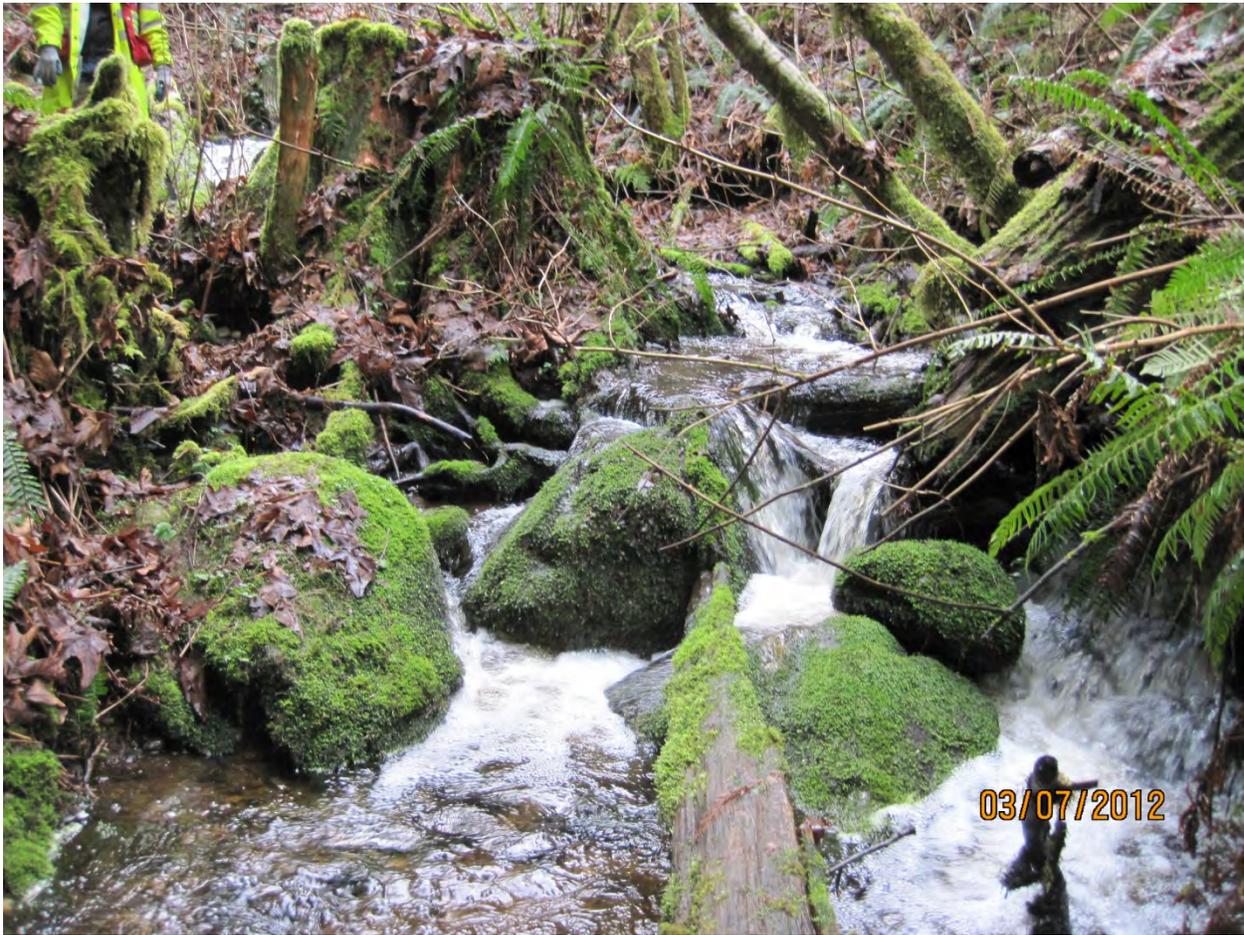
Photo 42. Reach 3 - Fish passable boulder cascade segment just downstream from NE 25th private driveway culvert.

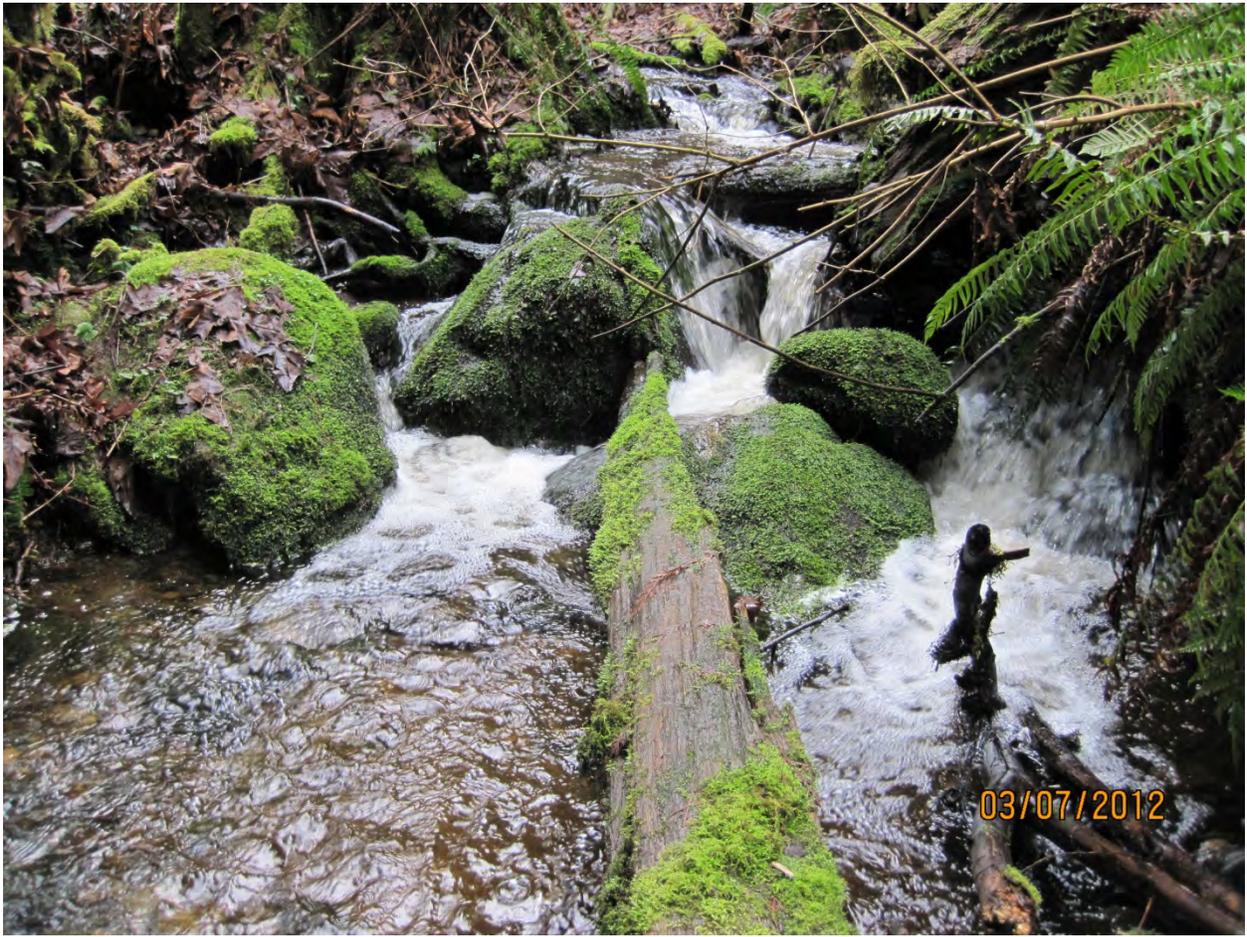
Photo 43. Reach 3 – Downstream end of boulder cascade. Good trout habitat. Good water oxygenation.

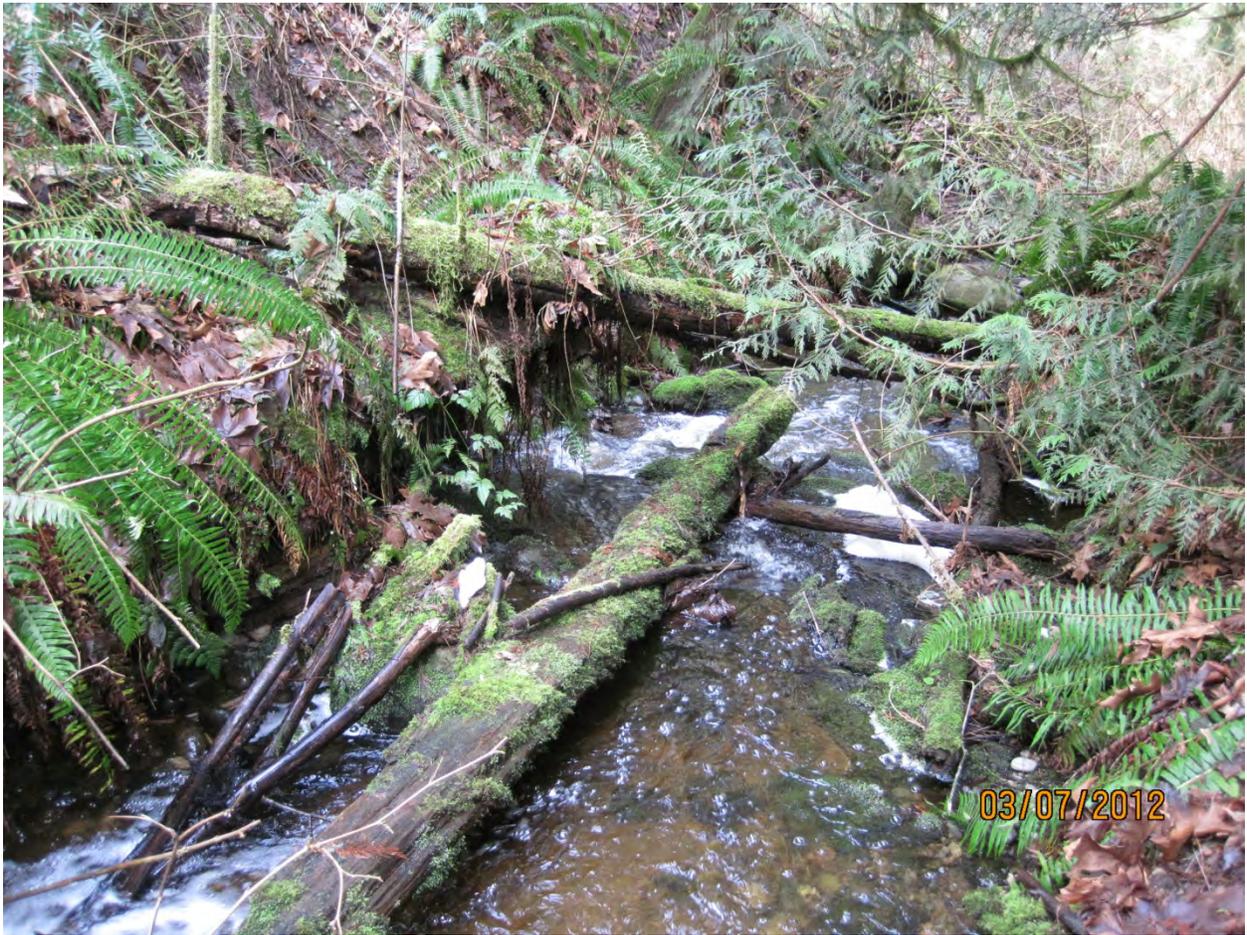
Photo 44. Reach 3 – LWD in channel just downstream of NE 25th private driveway culvert, providing instream and overhead cover for fish.

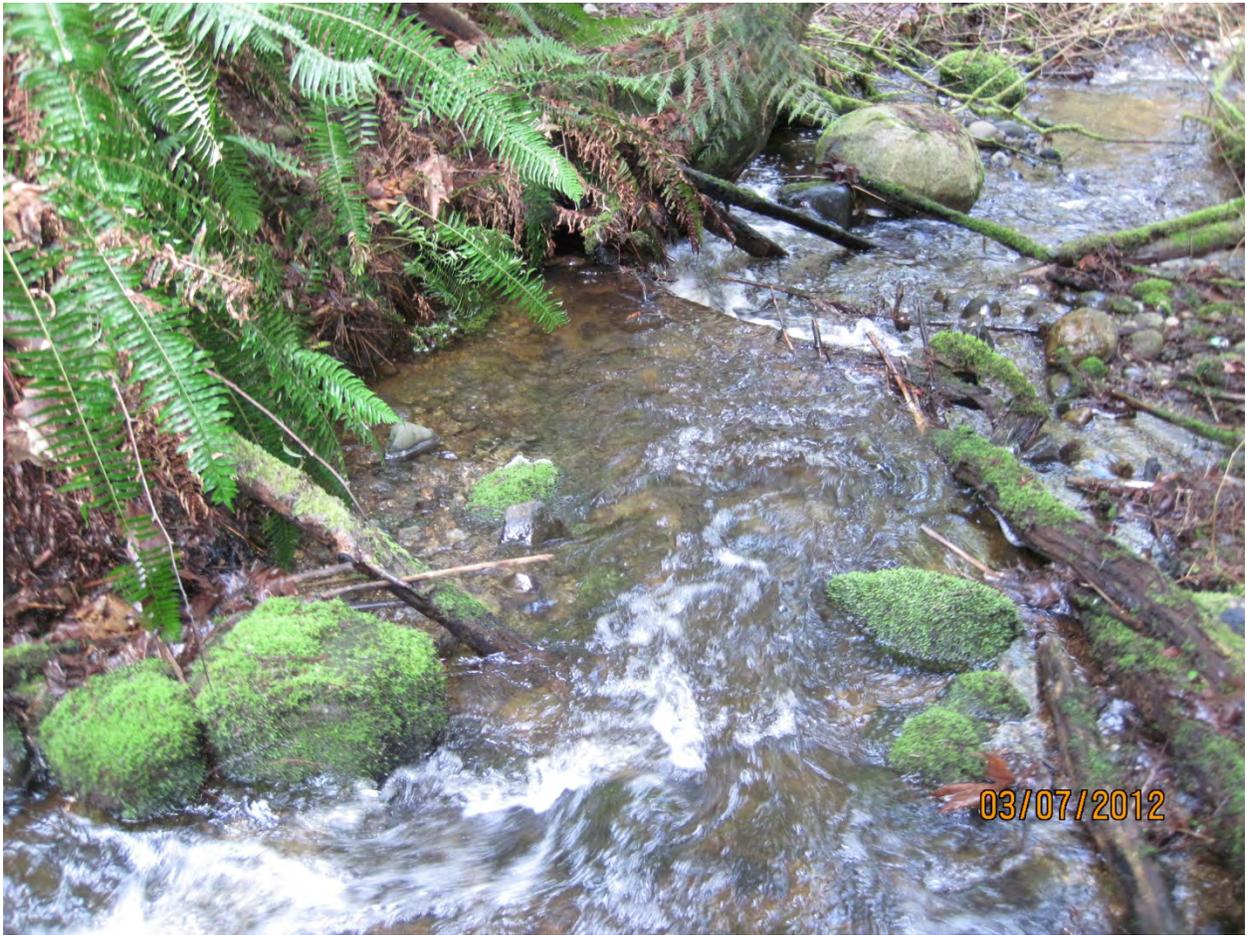
Photo 45. Reach 3 – Downstream end of fish passable boulder cascade segment.

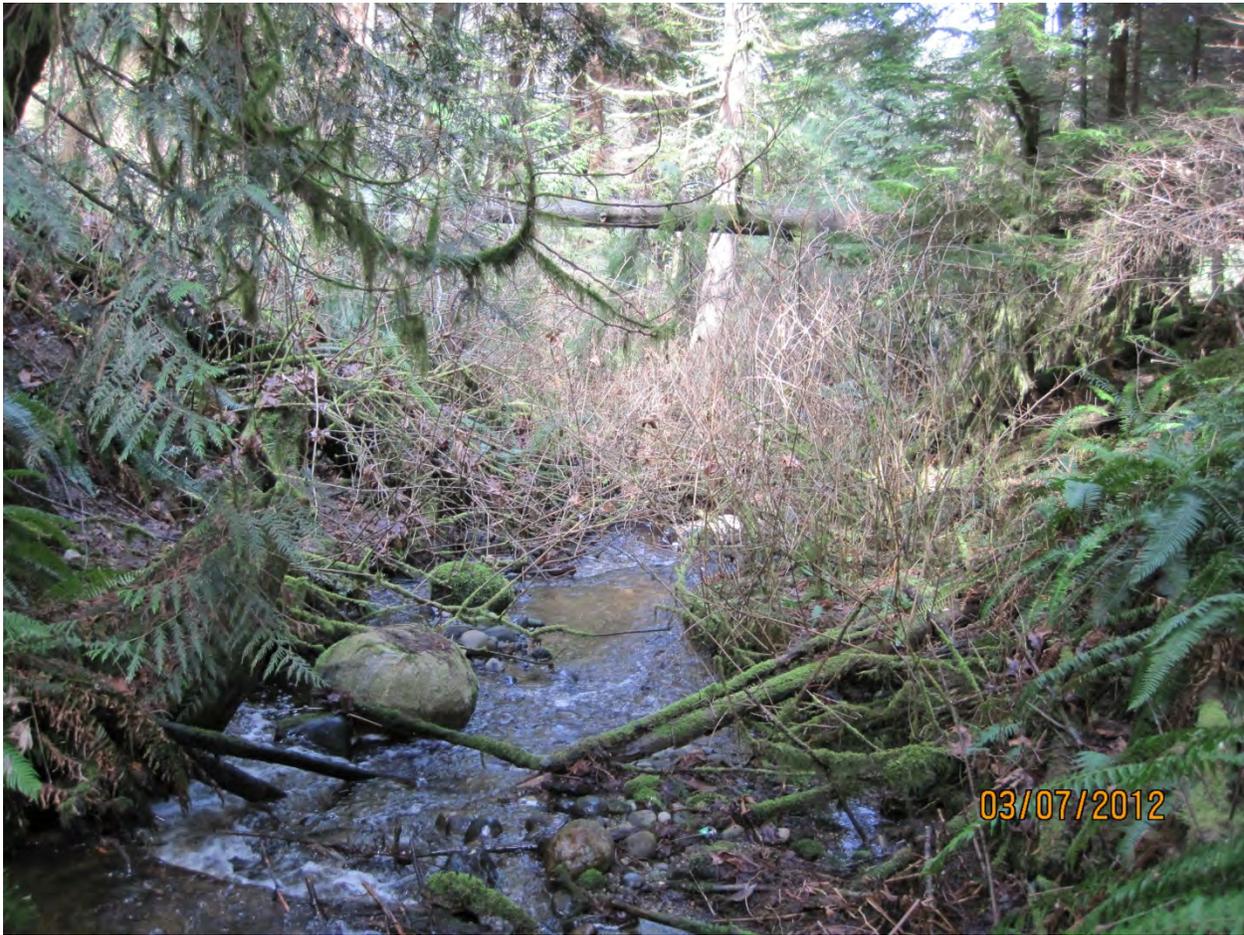
Photo 46. Reach 3 – Transition from boulder cascade to pool/riffle ravine reach at 3% to 5% stream channel gradient. Note heavy shrub layer cover component.

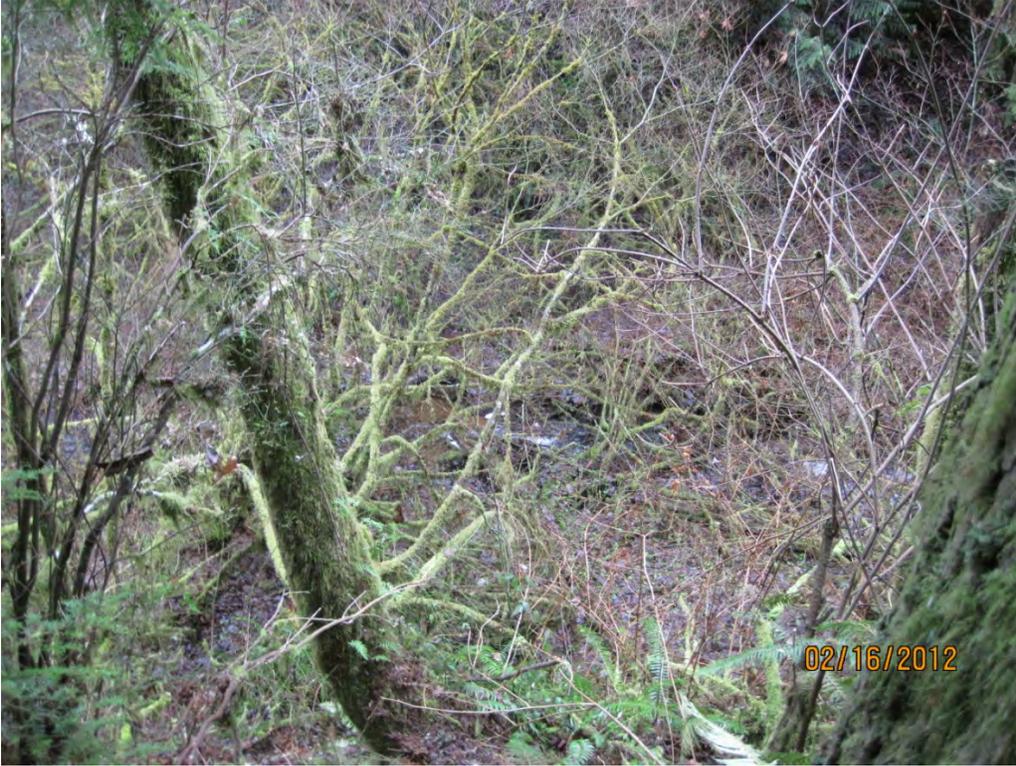
Photo 47. Reach 4 - Deep ravine reach with dense vegetation cover and 3% to 5% stream channel gradient.

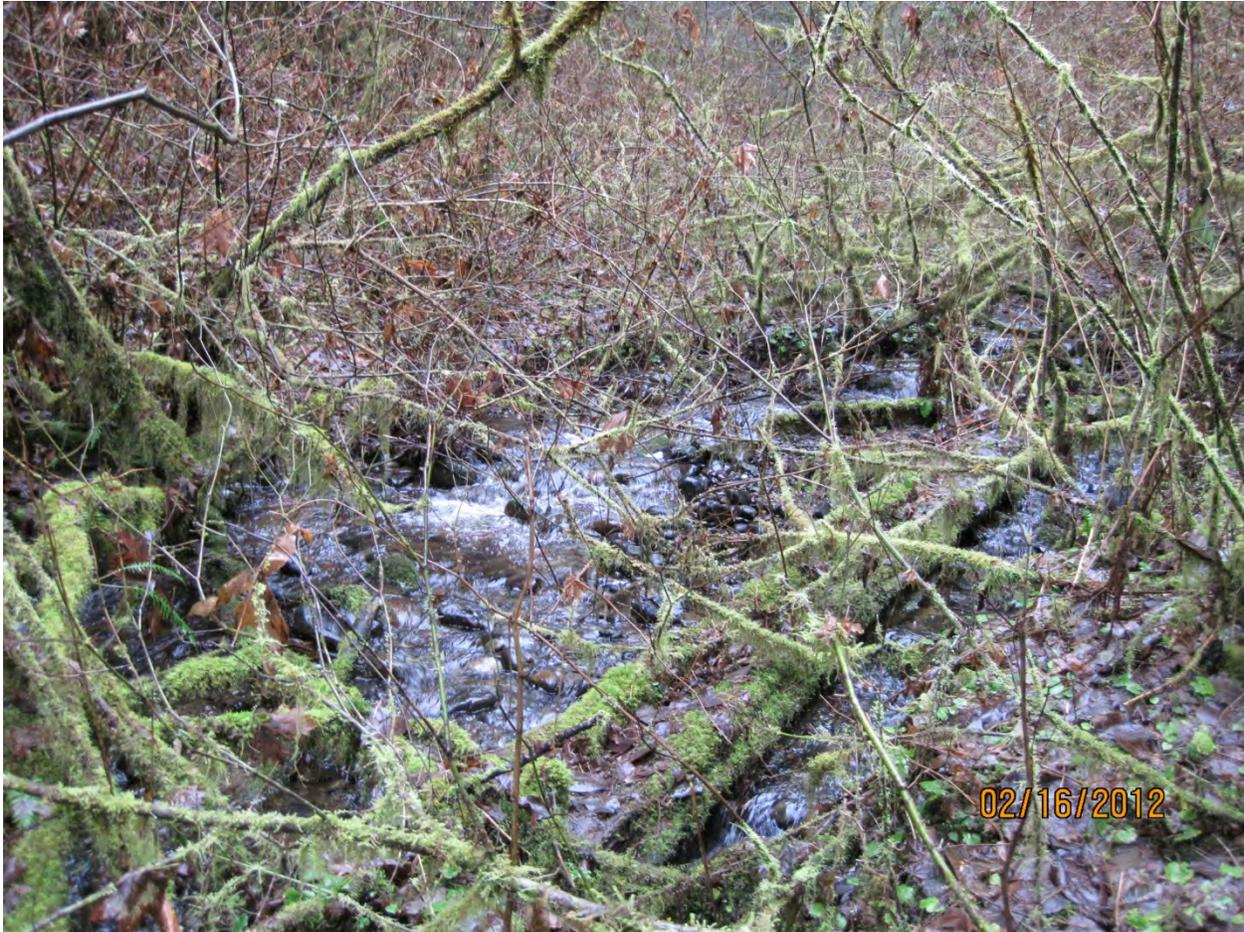
Photo 48. Reach 4 - Pool/riffle section near downstream end of ravine reach. Note LWD, pools, suitable salmonid spawning gravel, instream cover, and natural boulder patch.

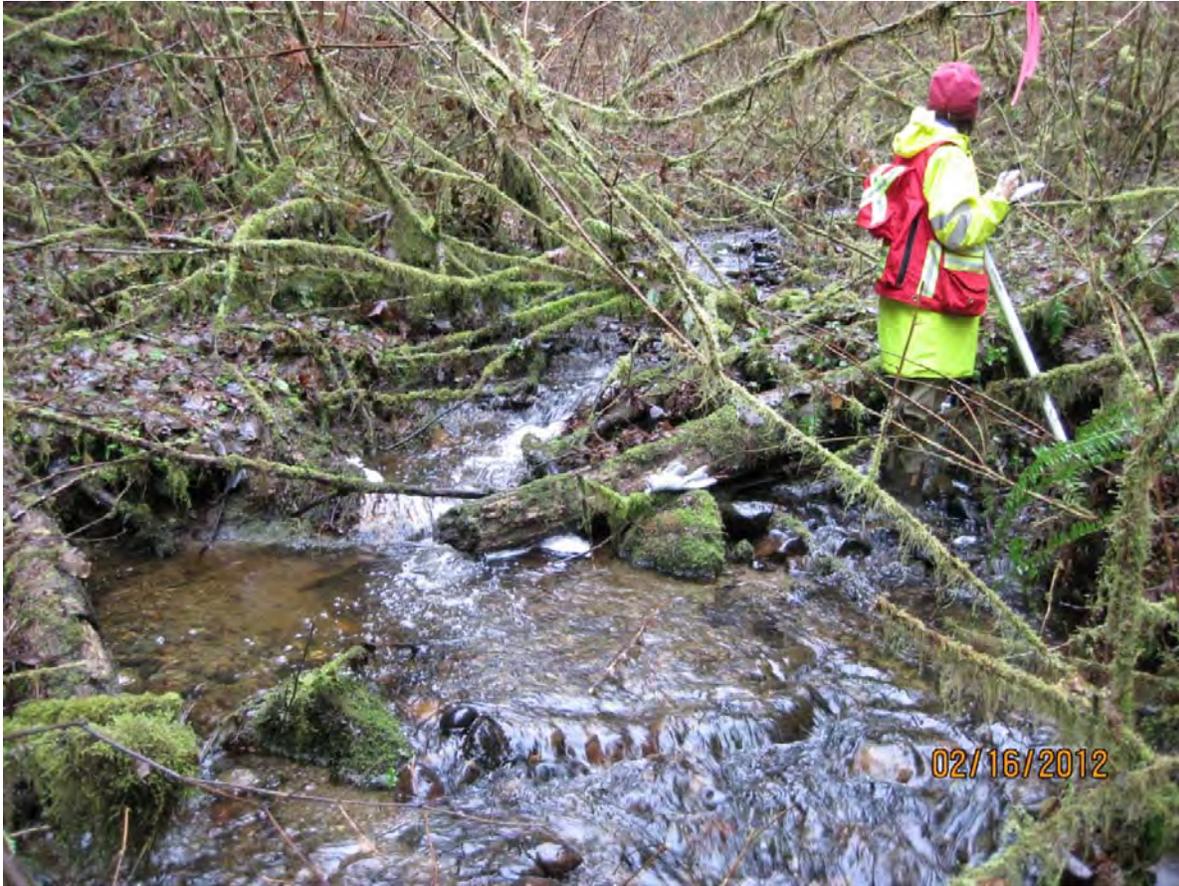
Photo 49. Reach 4 – LWD and boulder created pool and riffle.

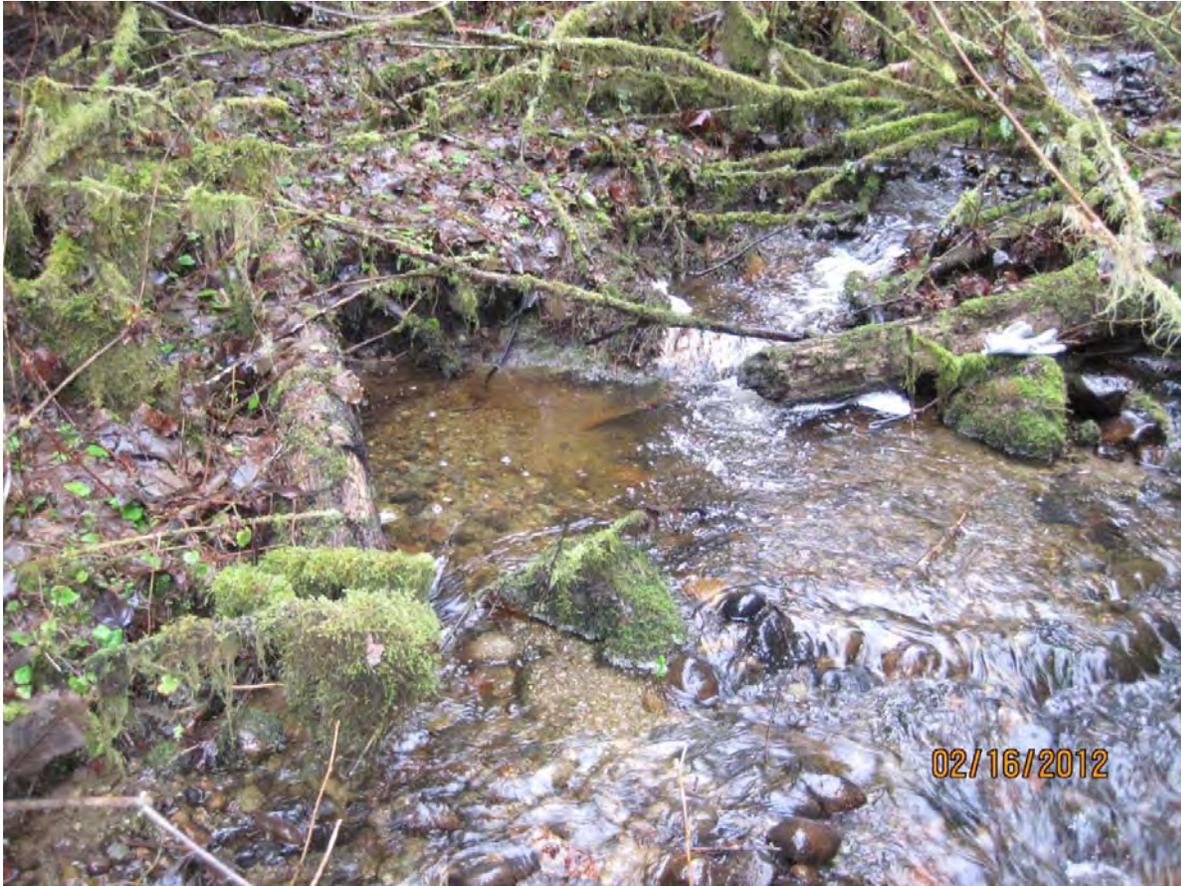
Photo 50. Reach 4 – Pool/riffle complex.

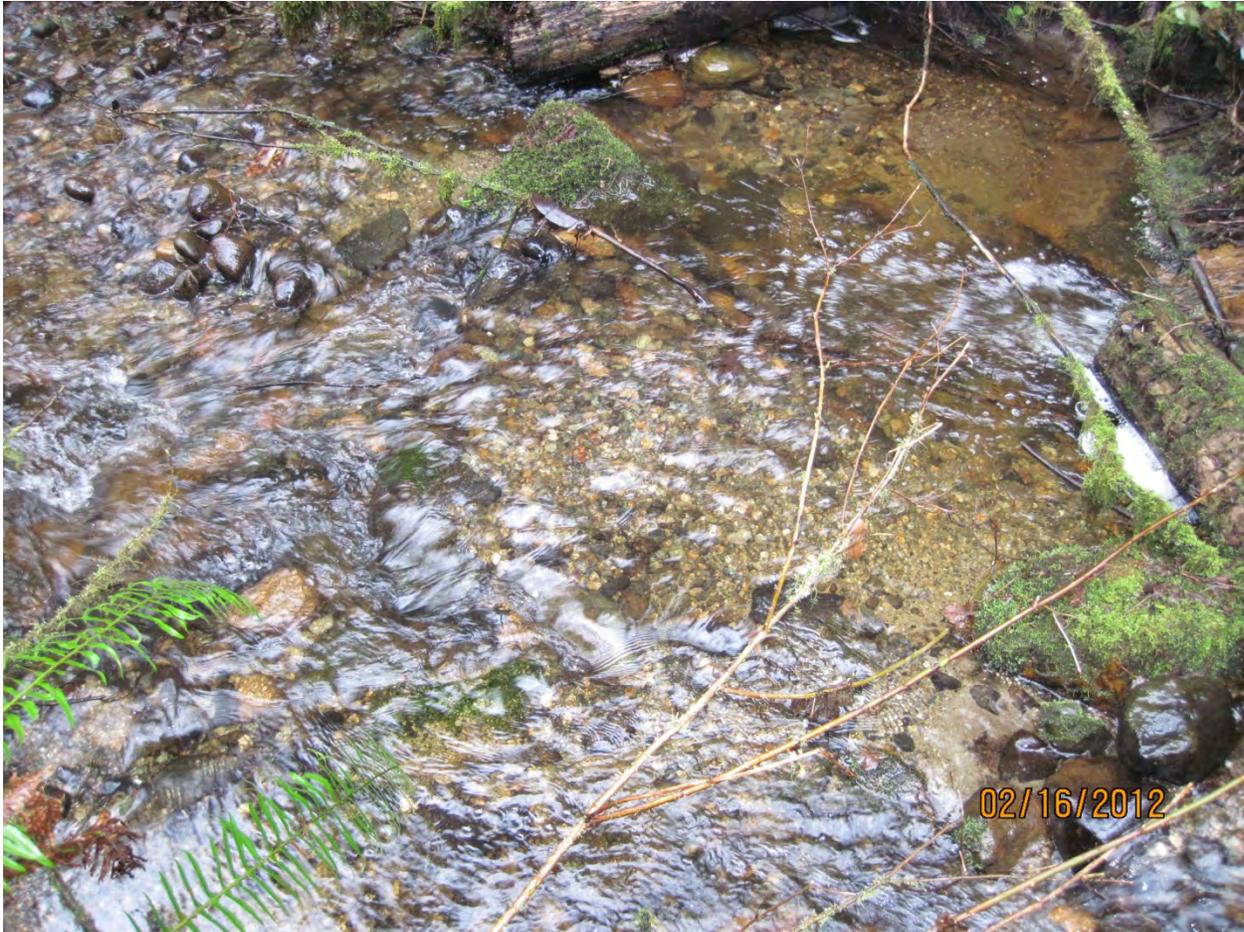
Photo 51. Reach 4 – Cobble and gravel stream bed with suitable cutthroat trout spawning habitat.
