Allen Lake Outlet Stream Reconnaissance

December 10, 2012

1.0 Purpose and Scope

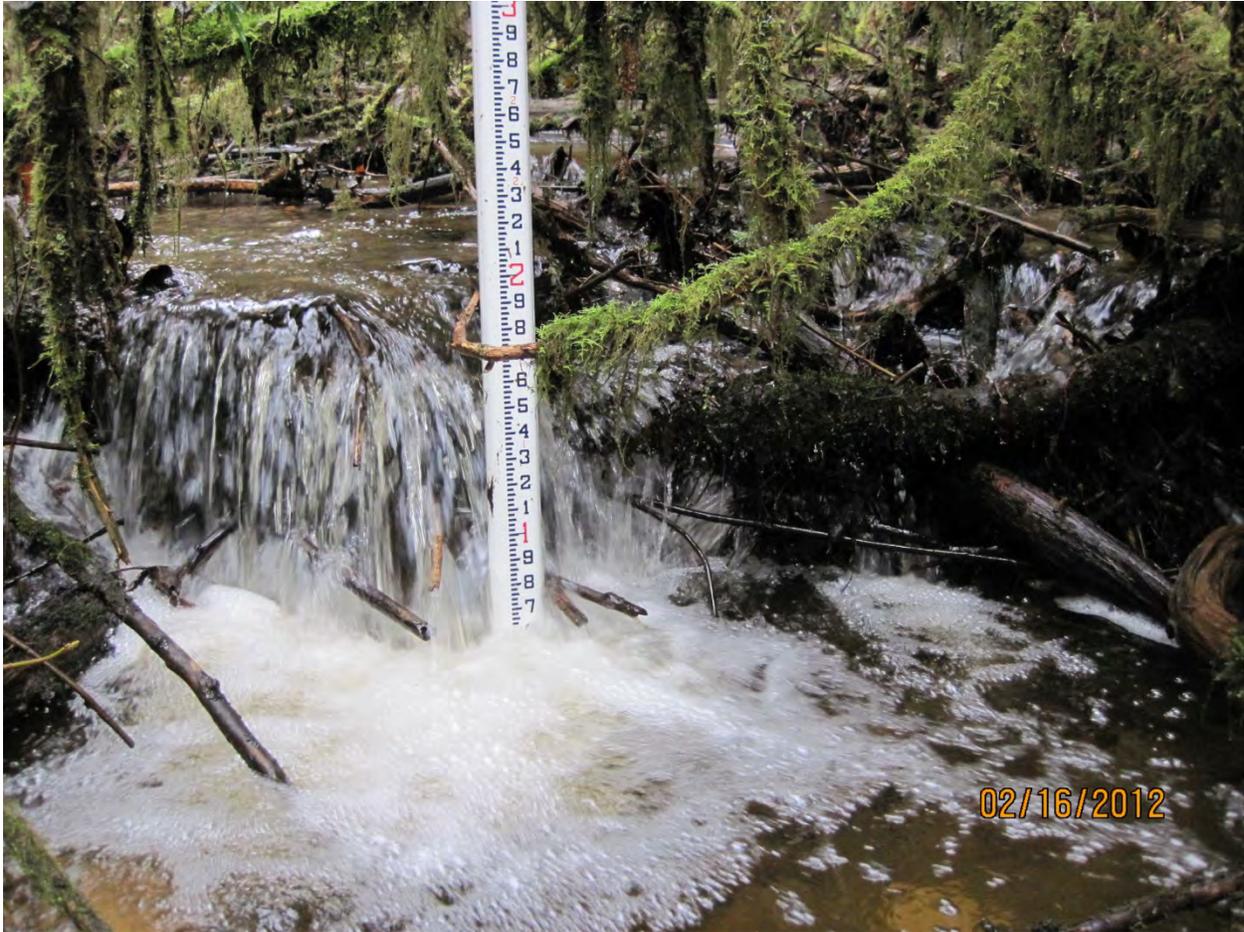
Photo 52. Reach 4 – Temporary small woody debris accumulation creating pool habitat and small sediment terrace. Fish passable. Accumulation fell apart when stepped on due to composition of small sticks, leaves, and small debris.

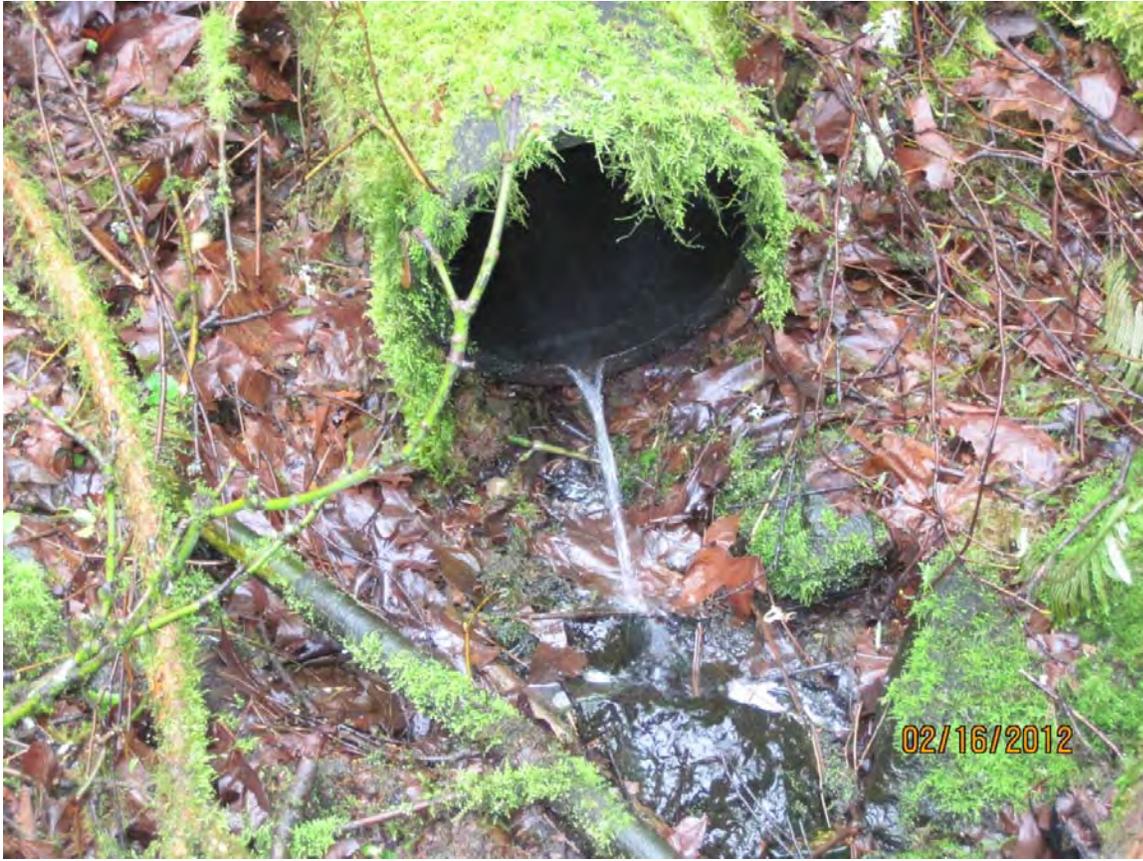
Photo 53. Reach 4 – One of several tightline stormwater runoff pipe outfalls into creek from upland subdivisions located on plateau.

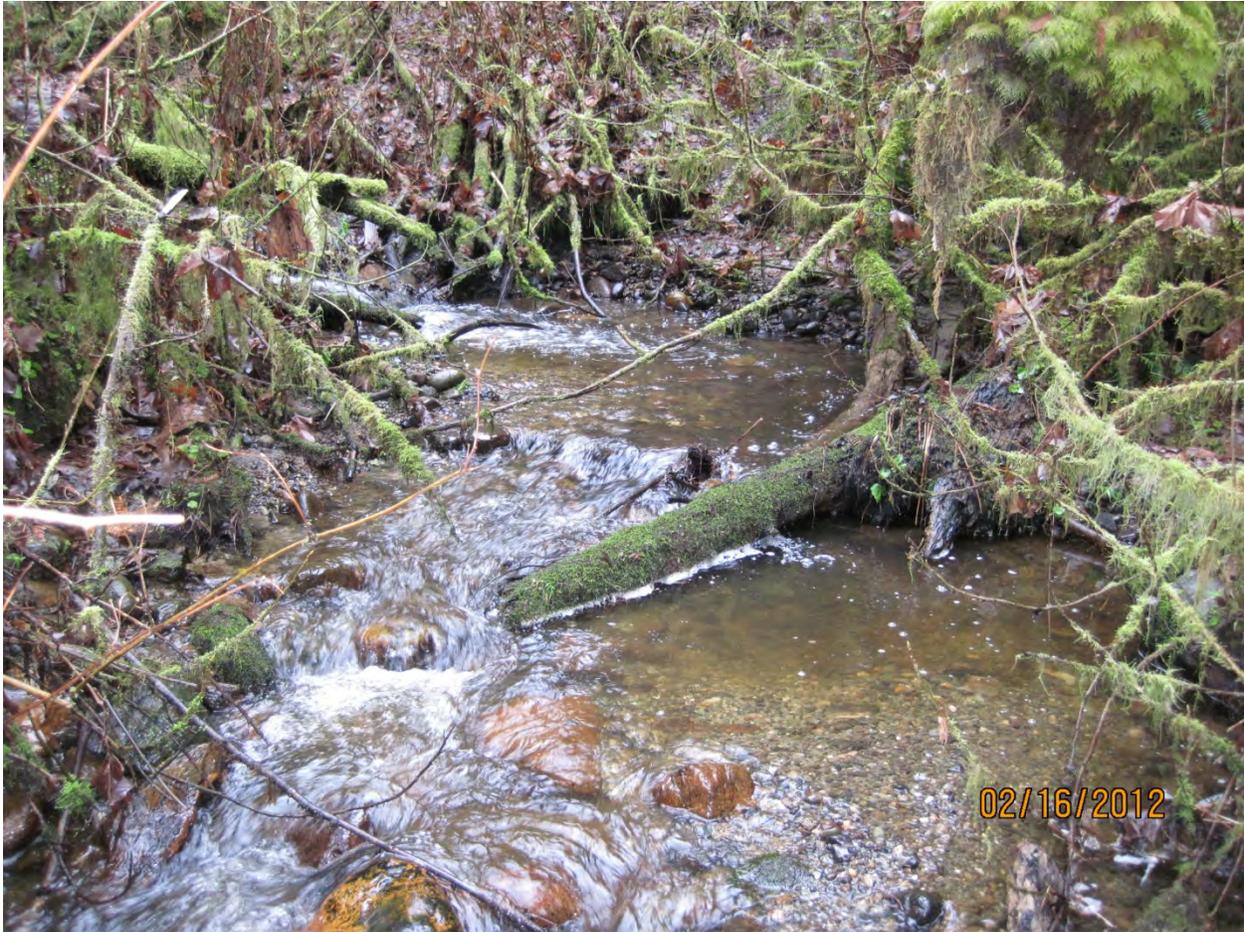
Photo 54. Reach 4 – Pool/riffle habitat in lower end of Reach 4. Note good quality, suitable salmonid spawning gravel. Cobbles provide good aquatic insect substrate and hydraulic refuge for salmonid juveniles.

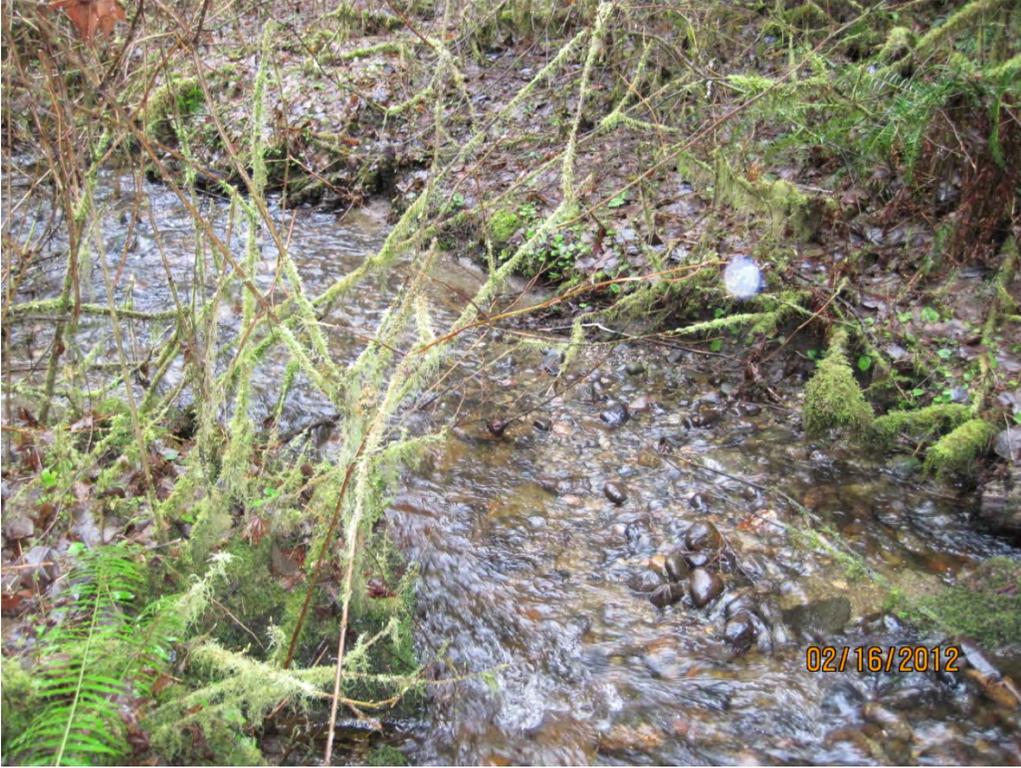
Photo 55. Reach 4 - Gravel bedded stream suitable for salmonid spawning. Year round flow area.

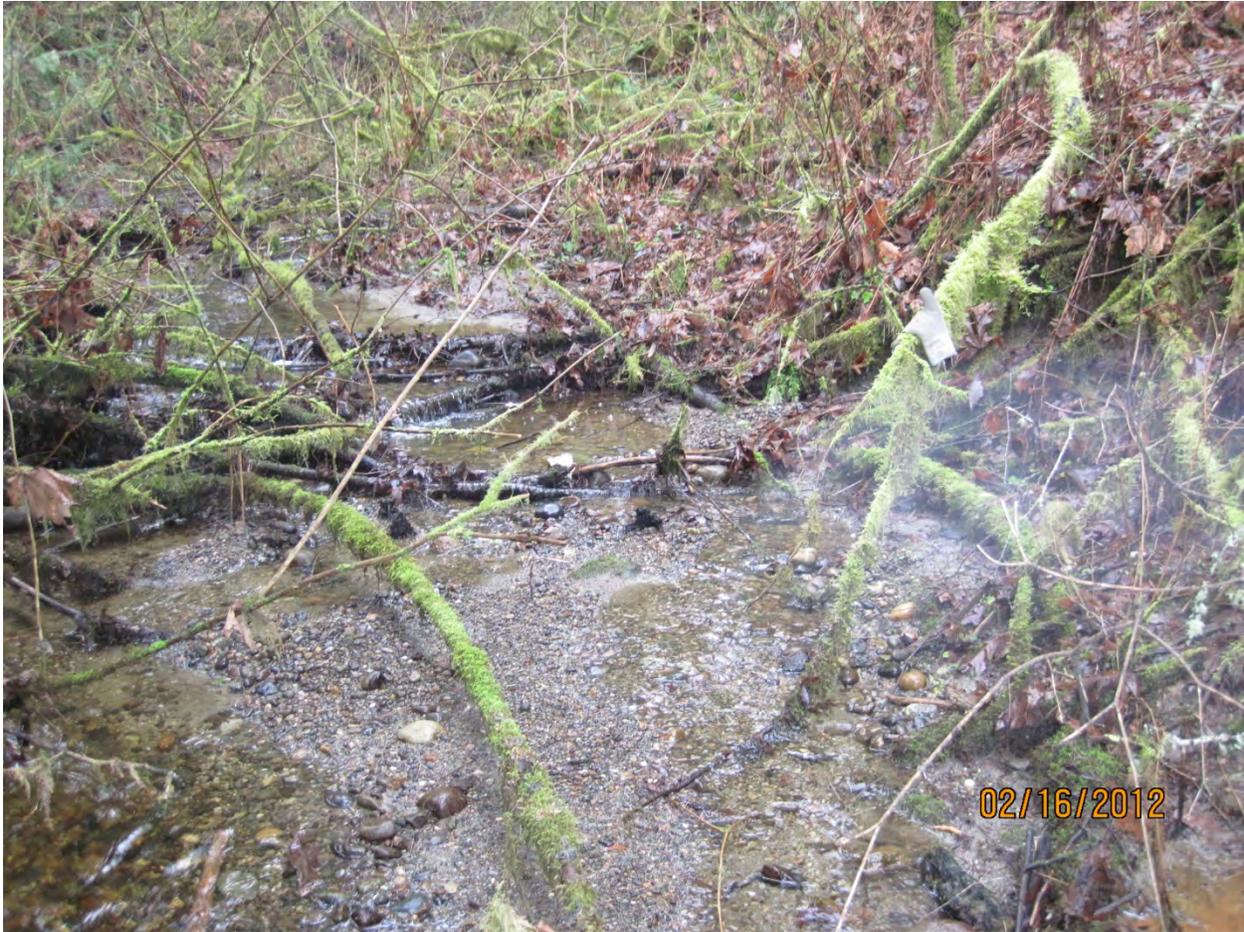
Photo 56. Reach 4 - Near downstream end of reach 4, about 300 feet upstream of Happy Valley Eastside Inc. 70 acre parcel on valley floor.

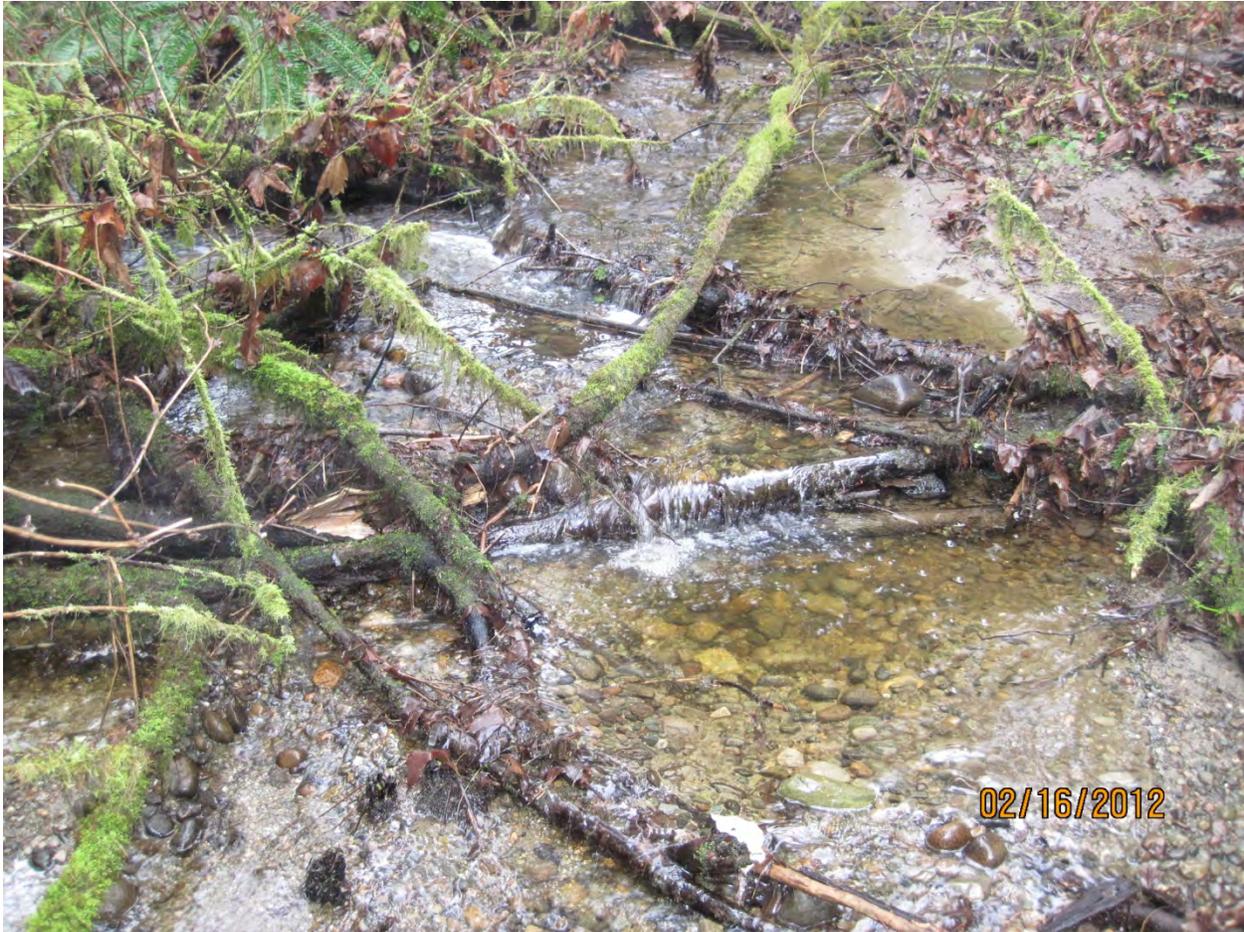
Photo 57. Reach 4 – Lower end of Reach 4 with abundant small woody debris in channel providing pool/riffle habitat and high levels of detritus.

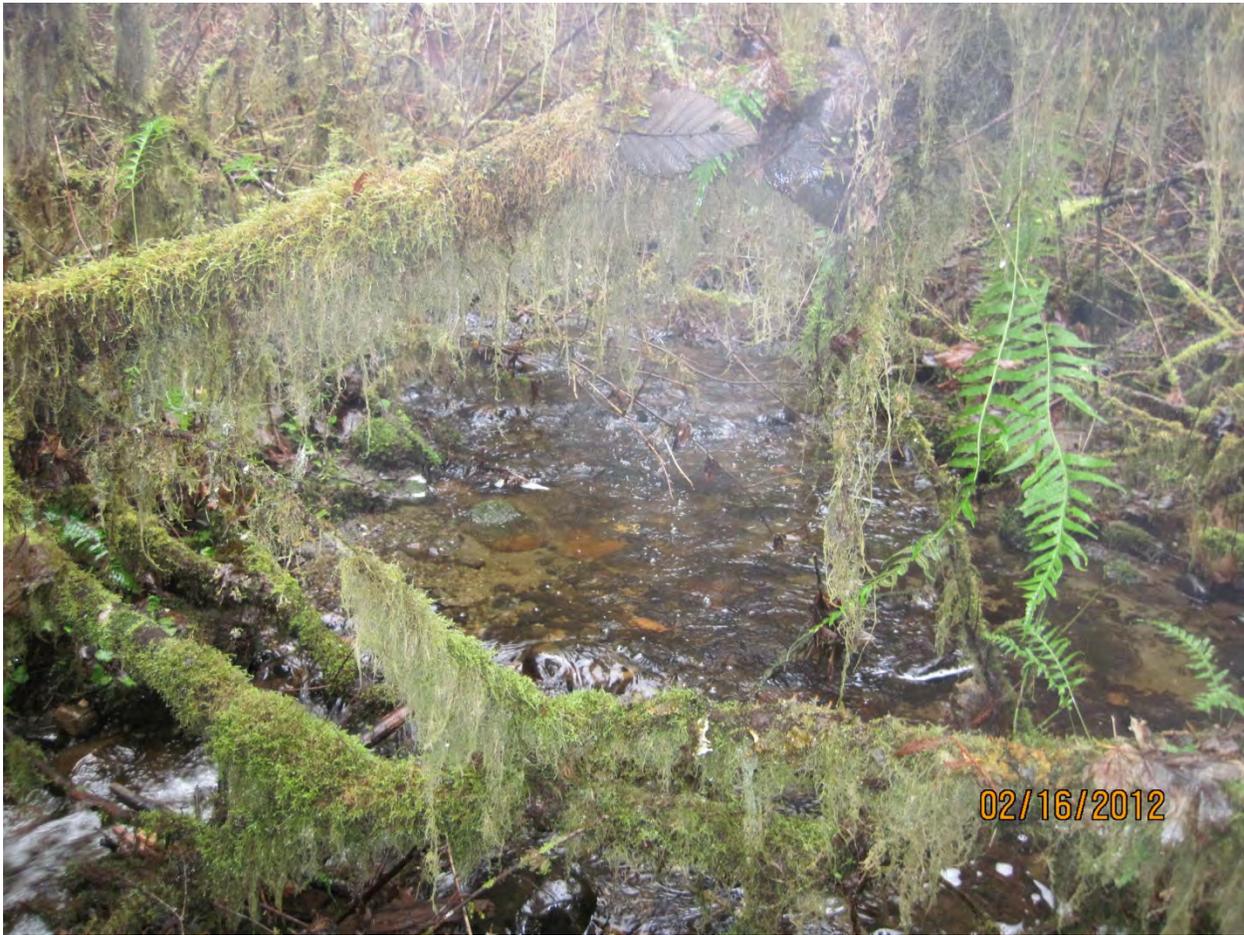
Photo 58. Reach 4 – Lower gradient at downstream end of ravine reach with gravel/cobble bed and very dense overhead vegetation in stream buffer.

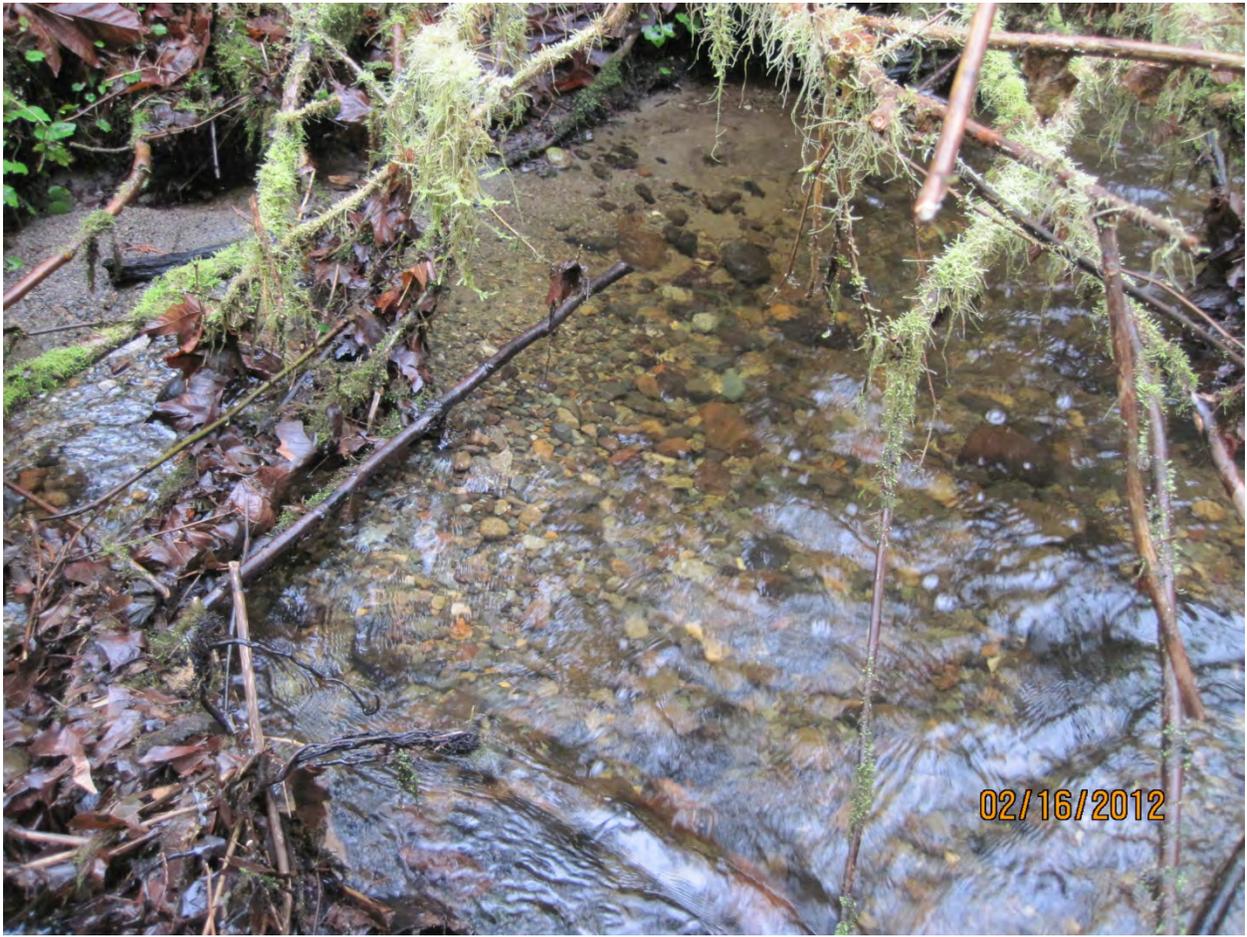
Photo 59. Reach 4 – Downstream end of Reach 4, pool/riffle complex with suitable spawning habitat for salmon and trout.

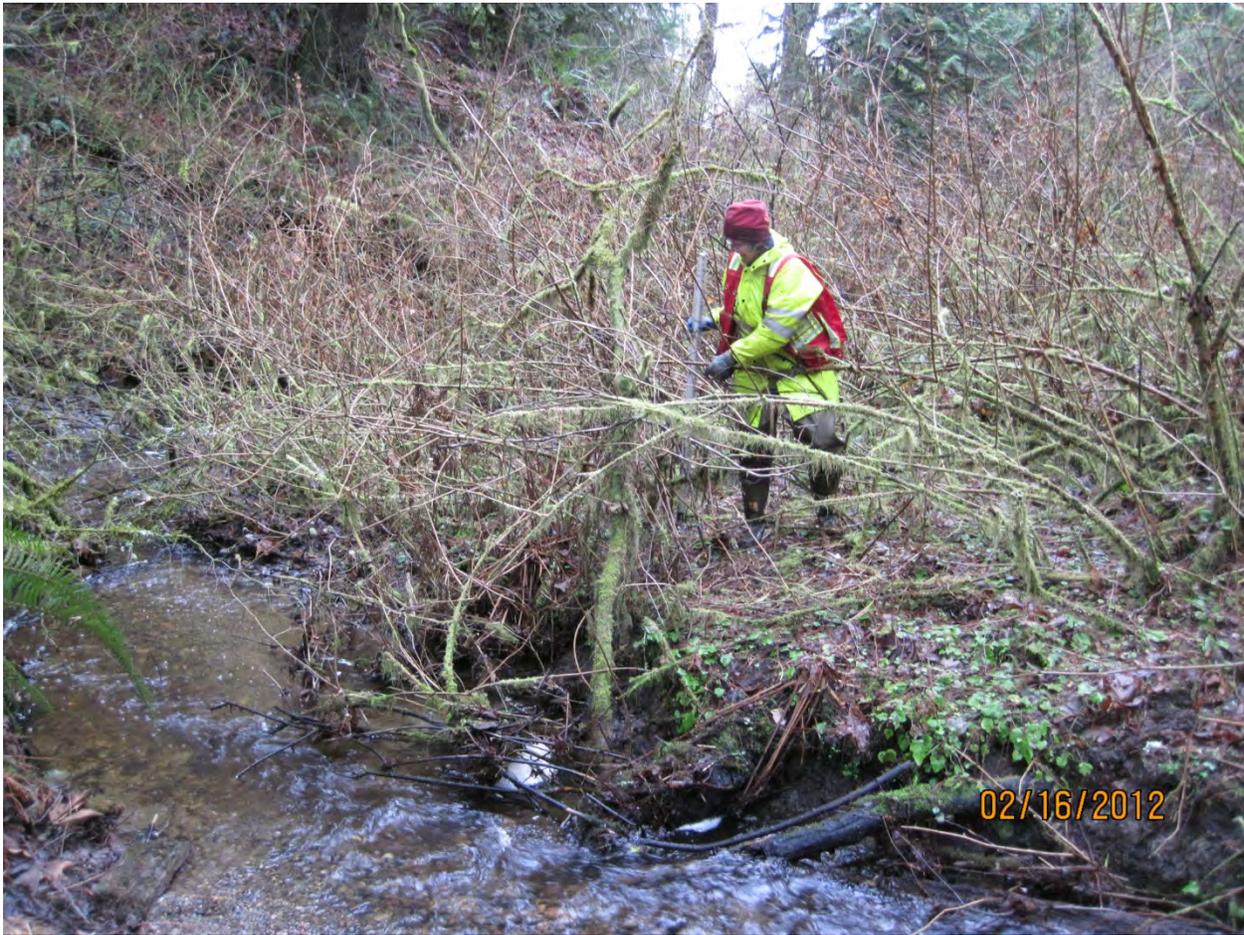
This reach is underlain by alluvial fan deposits overlying Advance Outwash which in turn overlies older non-glacial Olympic interbed deposits. The alluvial fan deposits form benches on either side of the stream (see Photo 60) and are composed of saturated, fine sediment and organic muck. The alluvial fan has formed where the gradient has flattened above the lowest culvert on the drainage. The stream has incised a foot into the sediments. The high organic content suggests that the sediment is associated with the pond failure reported in Reach 3. The log dam failure would have deposited some large amount of the sediment in a single event. The relatively uniform size (age) of the bushes growing on the benches and re-incision of the stream into the sediment is consistent with a single event.

Photo 60. Reach 4 – Near downstream end of ravine reach. Note the abundant shrub buffer layer growing on the broad, soft, saturated sediment terrace. Fine sediment terraces supporting a dense shrub layer were common throughout Reach 4 on one or both banks.

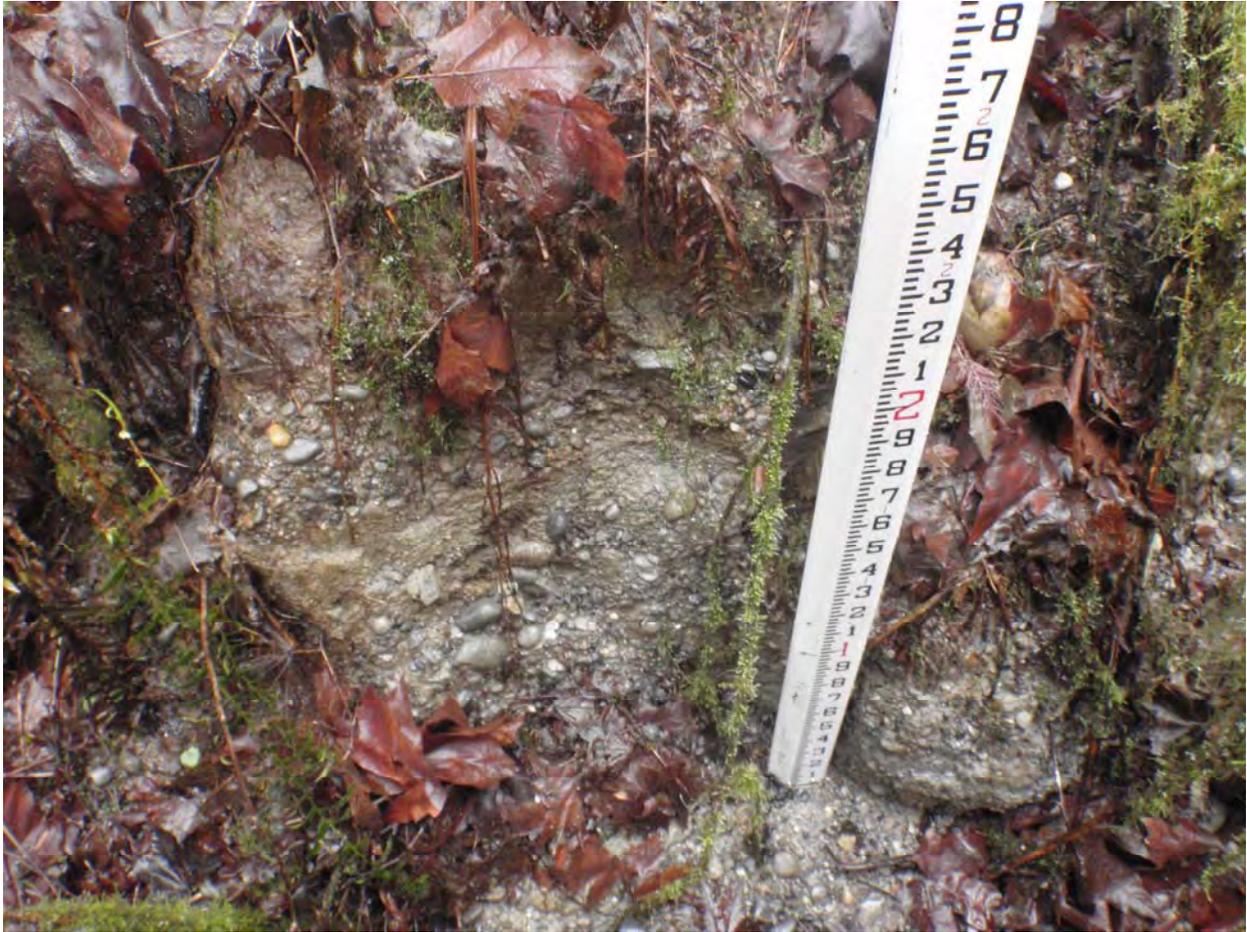
Photo 61. Reach 4 – Near downstream end of ravine reach. Advance Outwash.

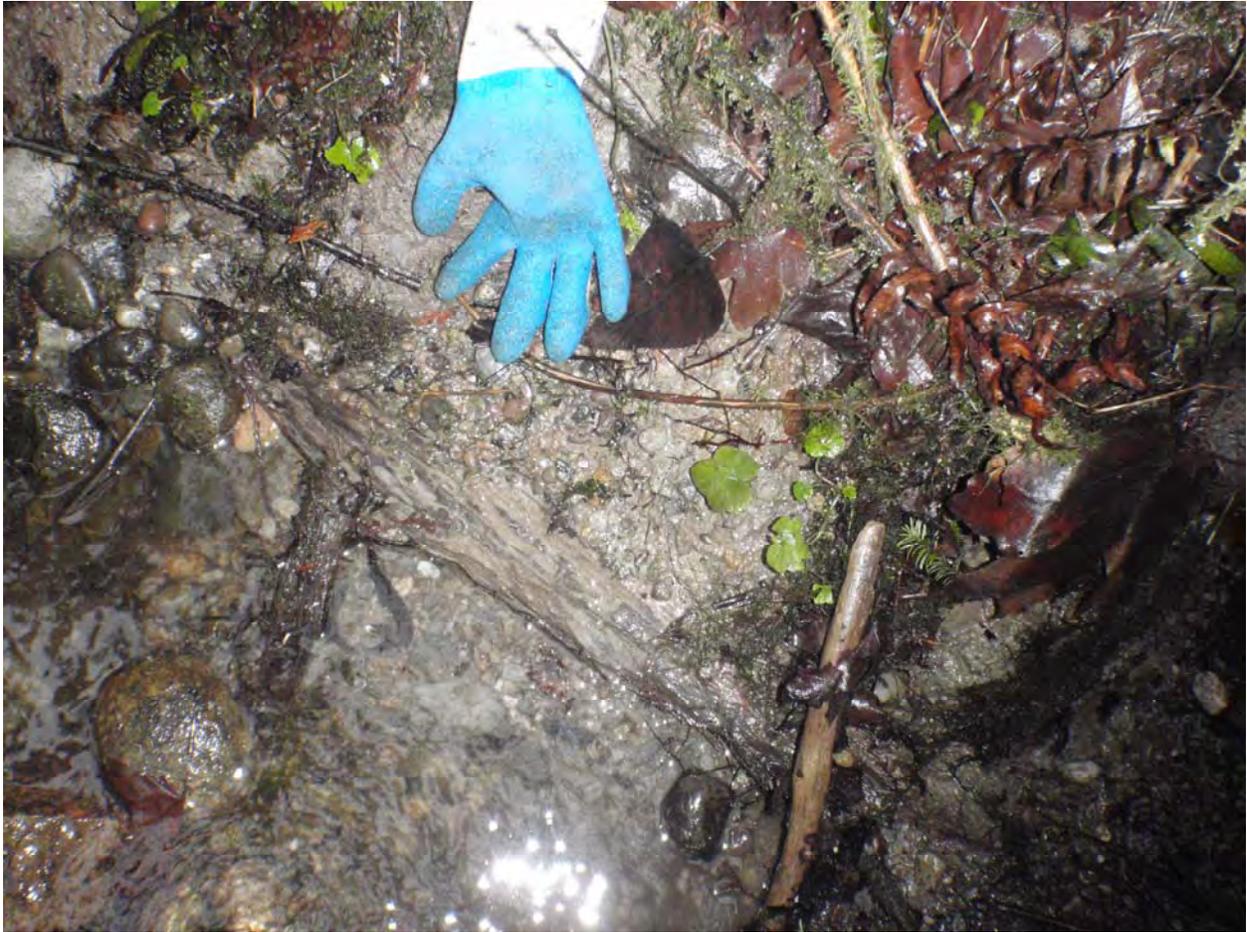
Olympic interbed deposits underlay the Advance Outwash and are composed of laminated silt to clay sized sediments and are visible in the lower section of the reach (see Photo 64). Large fragments of buried wood are occasionally exposed by erosion (see Photo 62). Slopes above the stream are covered by colluvium. Shallow soil slips and landslides are present on the inner slopes of the drainage (see Photo 64). Groundwater seepage was noted at the contact between the Olympic interbeds and colluvium in several areas (see photo 63).

Photo 62. Reach 4 – Advance Outwash with wood fragment.

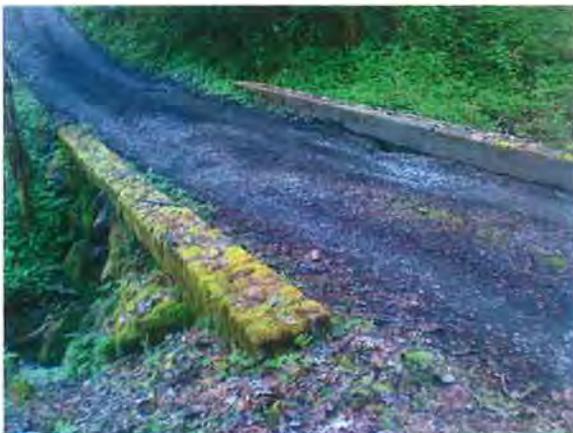
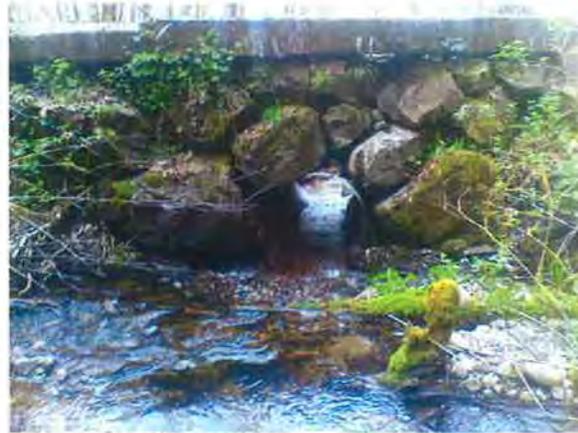
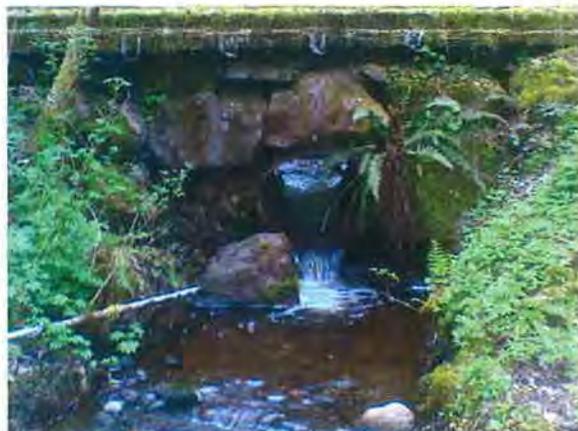
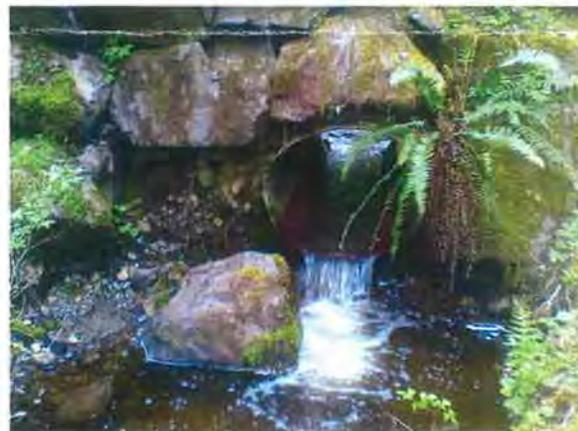
- 11) On the outlet side, one of the boulders has rolled out.
- 12) This is the first year that water is flowing through the gravel on the inlet side and flowing underneath the culvert. Repairs need to be made to seal the inlet side.

- 13) Small repairs have been made to the top of the bridge with concrete. More are needed.
