South Park Bridge Replacement Offsite Analysis Field Inspection

A field inspection analysis was performed on December 31, 2008 for the South Park Bridge Replacement project. The inspection was conducted with the intent of evaluating one mile upstream and downstream of the proposed project to determine the conditions of the existing drainage patterns and discharge locations. The investigation was conducted keeping in mind how the proposed improvements could potentially impact the existing drainage patterns and conditions. The field visit was performed to meet and exceed the requirements established in the King County Surface Water Design Manual (2005, page 1-21, section 1.2.2). Due to fencing, security barriers, and lack of permission to cross private properties, the shoreline was not walked the full mile up and downstream of the project vicinity. Visual inspection of the shoreline and outfalls were performed from the limited area open for pedestrian access, up on the bridge, and from vantage points across the waterway to the opposite shoreline. Photographs were taken to document field observations and findings. Where access was available adjacent to the waterway, the area was walk

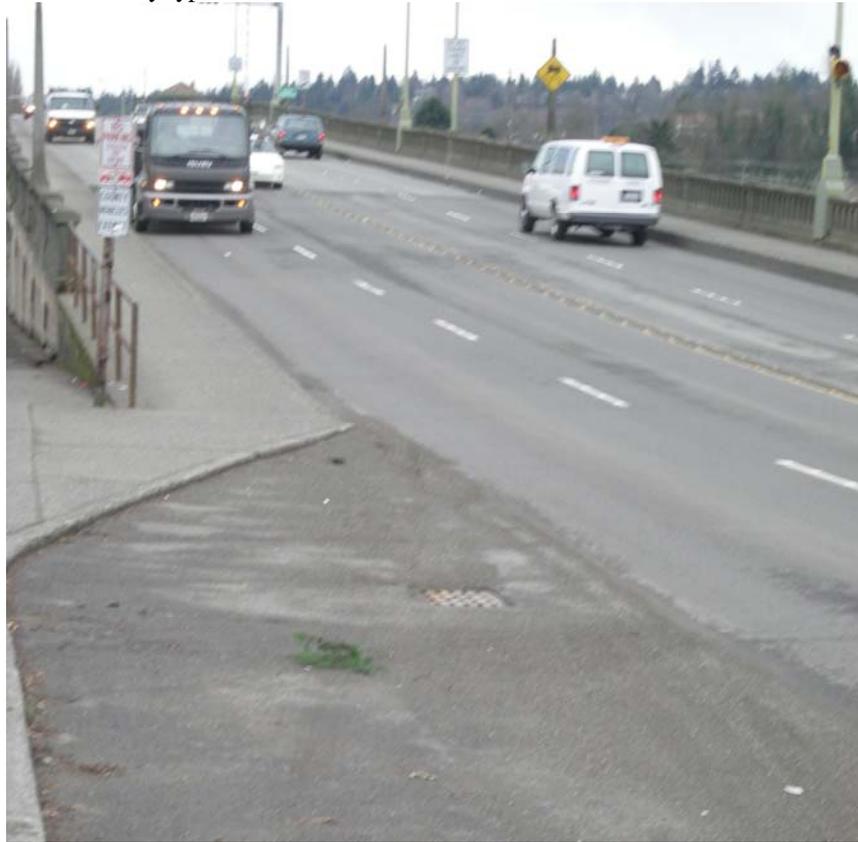
- 67) This is a picture looking south toward the waterway from the existing northeast side of the bridge. The curb line is higher than the roadway and drains toward the flow line at the edge of traveled way. The roadway typical section forms a “W” in this area.
