King County Green Roof Case Study Report

February 2006

Paladino & Company, Inc.

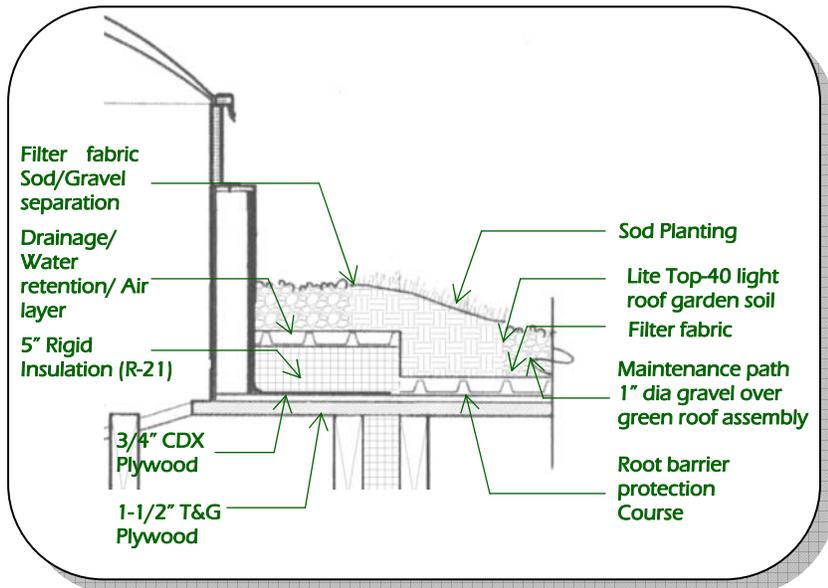
Green Roof Cross Section & Details

based on gravity flow and is inadequate at certain places resulting in drying in those patches. However, the roof overall appears to be on target for establishment.

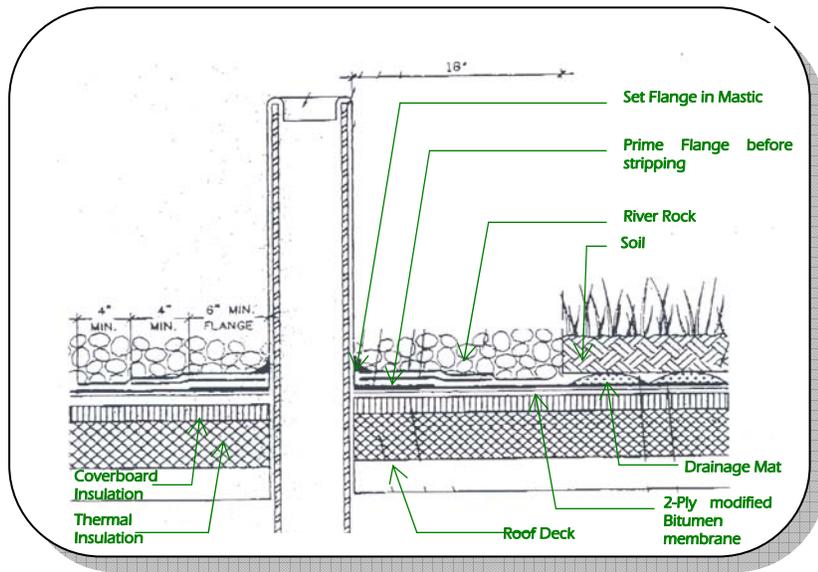
Green Roof Cross Section & Details

The plant failure happened several months after the roof was installed. The plants died in circular patches that grew larger until all plantings died. Currently, no remediation measures are being implemented and the majority of plants are dead.
