# **Saltwater Intrusion and Infiltration into the King County Wastewater System**

**March 2011**

**King County**

Department of  
Natural Resources and Parks  
**Wastewater Treatment Division**

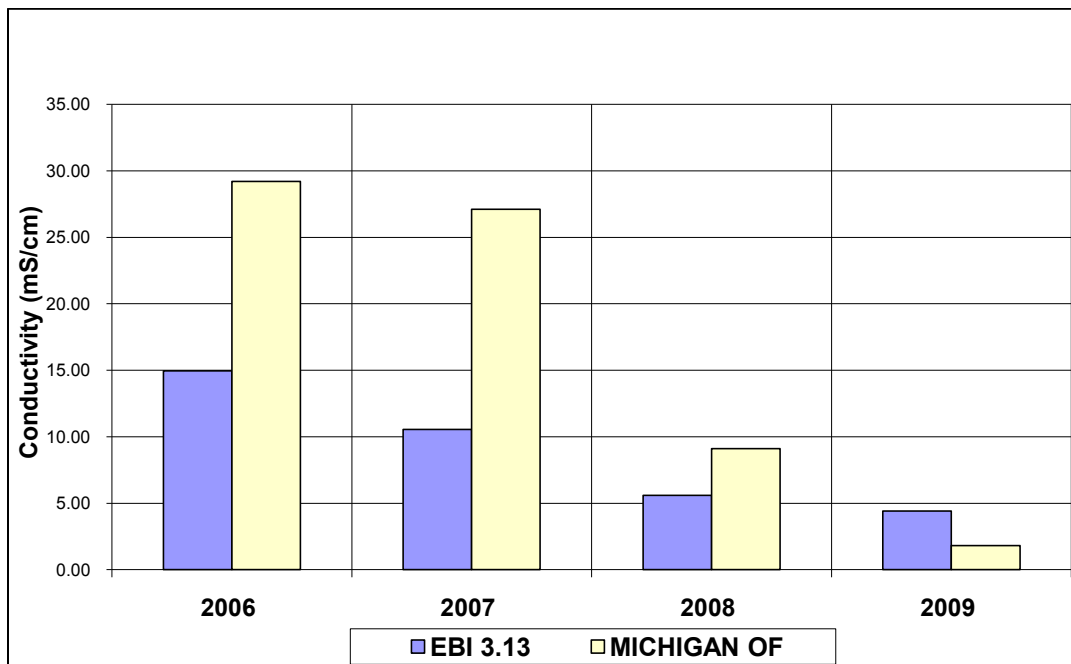
Further investigation found that several large cracks and fill-portholes inside of the outfall structure were leaking during high tides.<sup>5</sup> These leaks were sealed via grout injection in 2009 through a work-order contract. After completion of these repairs, the average peak conductivity at the outfall dropped to 1.76 mS/cm, almost 95 percent lower than the average peak conductivity measured in 2007 (Figure 8). (The 2009 average peak conductivity shown in Figure 8 for MH 13 is similar to that of 2008 because the monitoring was done before grout injection.)

**Figure 8. Decrease in Conductivity at Outfall and Downstream Manhole after Gate Replacement and Grouting at South Michigan Outfall**

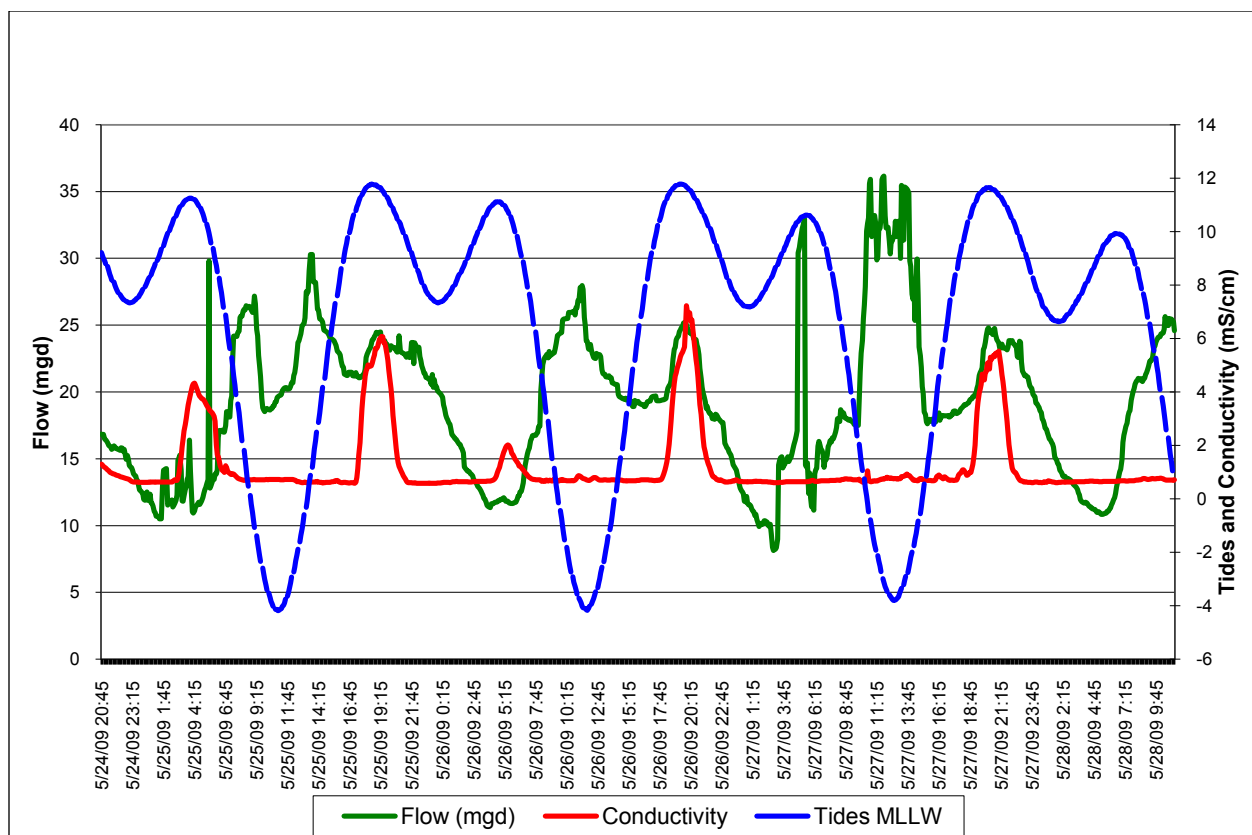
- **Between Hanford Street and Lander Street Outfall/Lander Street Regulator Stations.** One manhole (W10-146) halfway between the two stations was monitored. Average peak conductivity was 11.54 mS/cm.
- **At and near Lander Street Outfall and Lander Street Regulator Stations.** Two SPU manholes (SEA 50-186 and SEA 50-184) were monitored near the Lander Street Outfall Station. Average peak conductivities at these manholes were 31.02 and 32.01 mS/cm. The Lander Street Regulator Station and a location (W10-144) on EBI Section 5 just downstream of the station (also monitored for flow) showed average peak conductivities of 22.04 and 11.18 mS/cm, respectively. All measurements were taken in 2008. Figure 12 shows the relationship between tide, flow, and conductivity at this downstream location. Both flow and conductivity increase with high tides over 11 feet.

**Figure 12. The Immediate Impact of High Tides Just Downstream from the Lander Street Regulator Station, May 24–28, 2009**

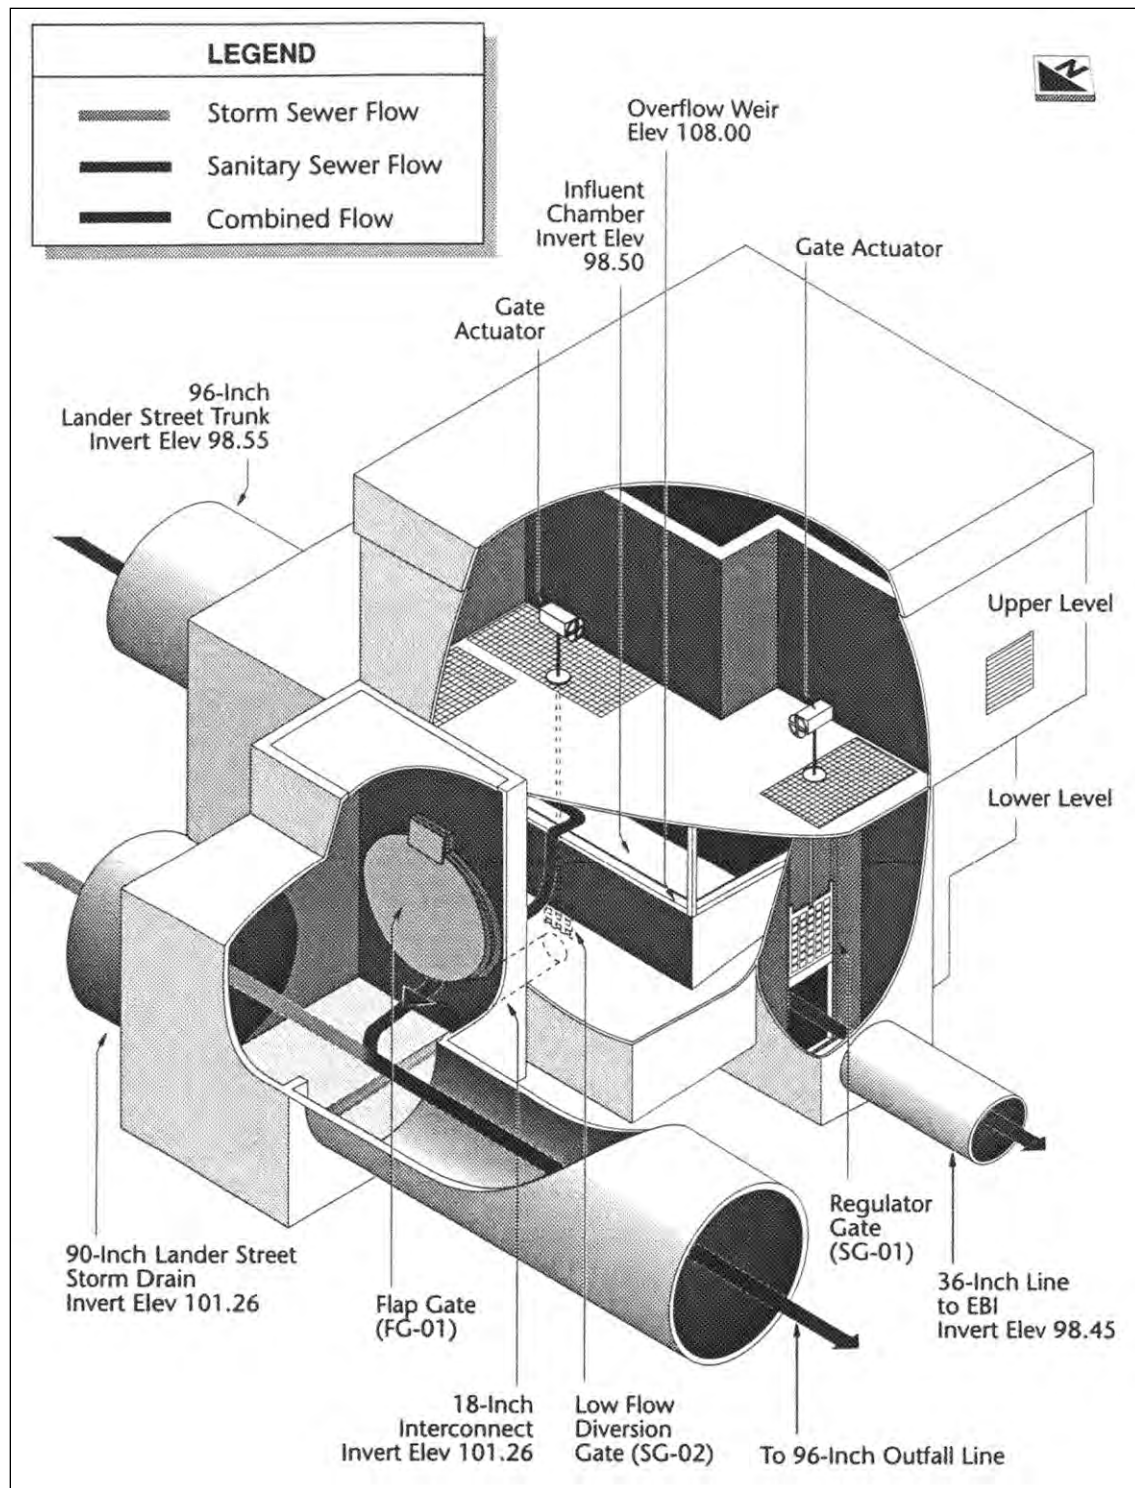
**Figure 13. Gates in the Lander Street Regulator Station**

Salt water is entering the overflow structure inside the Lander Street Regulator Station through a defective flap and low flow diversion gates (FG-01 and SG-02, shown in Figure 13) and then spilling into the conveyance system just prior to the first downstream manhole on EBI Section 5. The salt water enters the outfall line at high tides and then into the 90-inch-diameter Lander Street Storm Drain that runs through the station. The gate in the Lander Street Outfall Station is permanently open, allowing water to flow in both directions (Figure 15). The bypass gate, designed to move the first flush of stormwater into the EBI, is permanently closed. The height of the interconnect pipe between the storm drain and the regulator station overflow is only 1.26 feet. This pipe and the overflow structure fill daily with salt water (Figure 15). Barnacles can be found inside the storm drain and on the outer walls of the Lander Street Regulator Station.

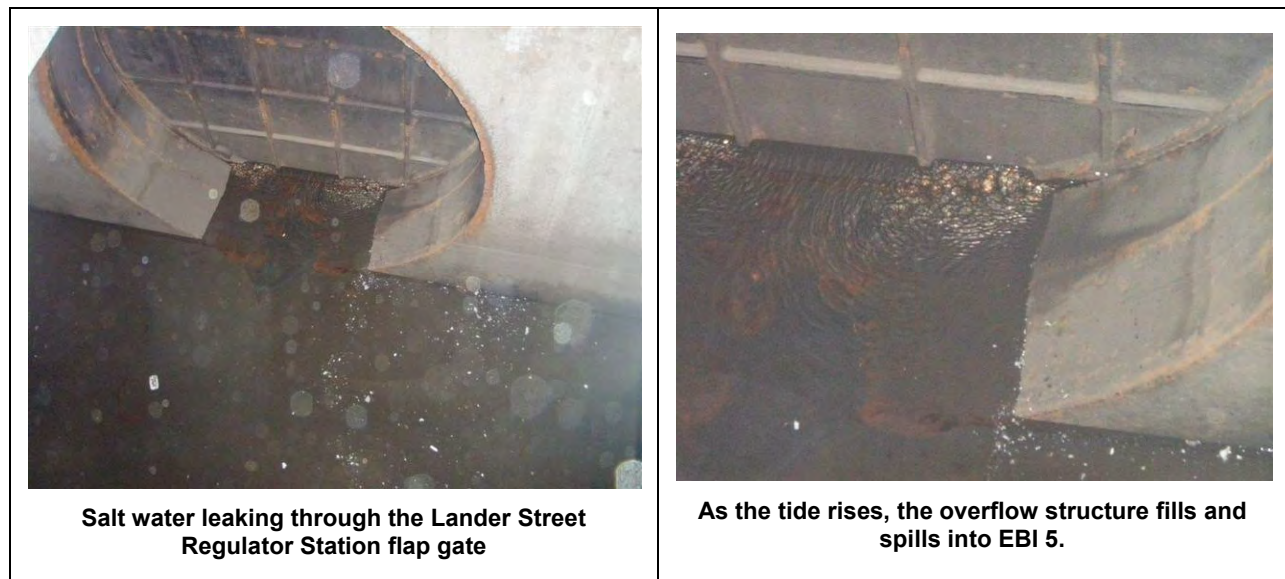
**Figure 15. Salt Water Entering and Leaving the Lander Street Regulator Station**

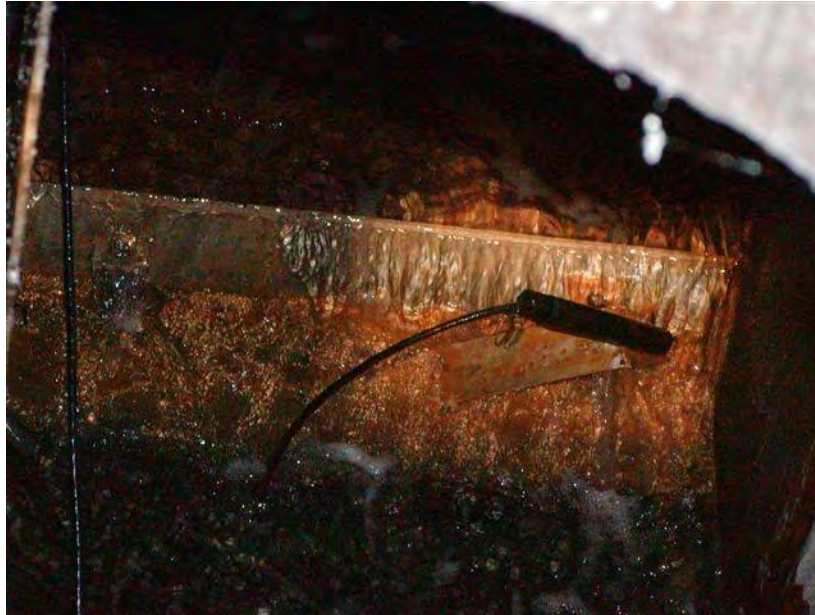
- **Near Washington Street.** Three SPU facilities near Washington Street under the viaduct were monitored. Two manholes (SEA 43-49 and SEA W10-210A) registered average peak conductivities of 11.20 and 10.63 mS/cm. The average peak conductivity at SPU's Washington Street Diversion Structure was 14.65 mS/cm. During monitoring, salt water was seen entering through the structure's overflow gate (Figure 17).

**Figure 17. Salt Water Entering SPU's Washington Street Diversion Structure Overflow Gate on the Downtown Seattle Waterfront**

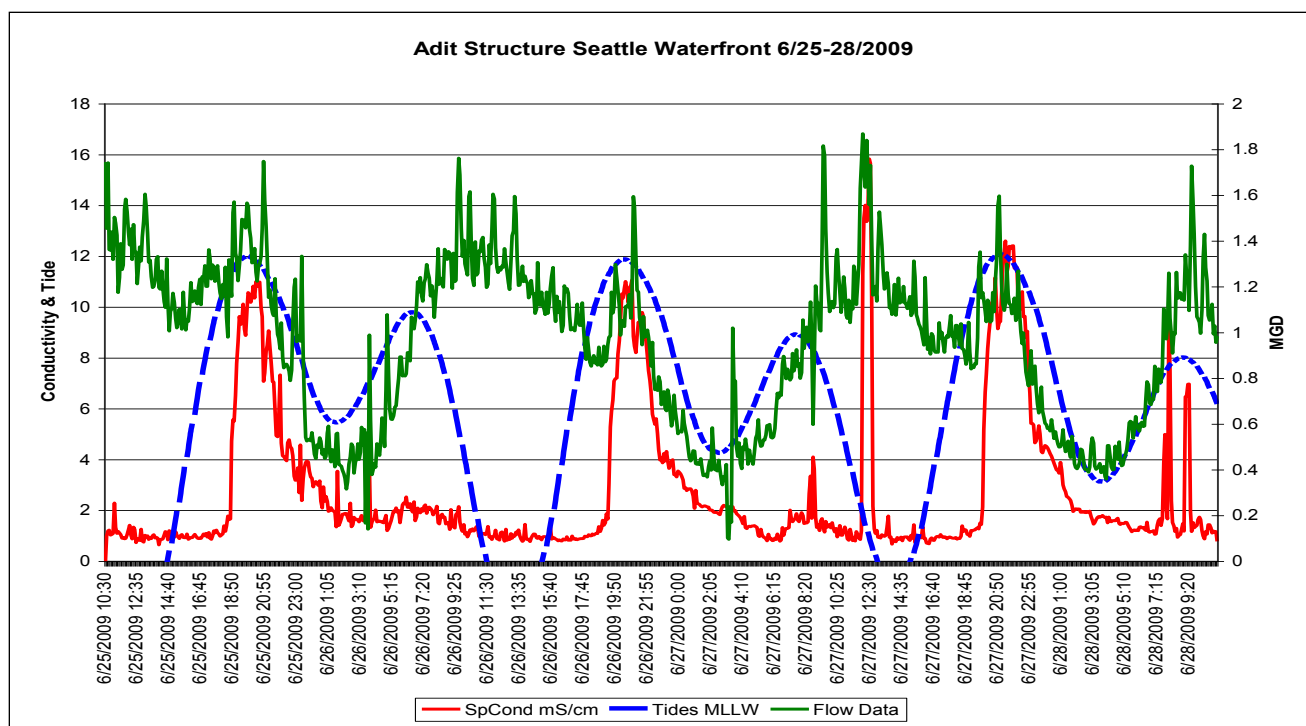
- **At the Adit Structure.** The King County Adit Structure, near the Pike Street Hillclimb, collects wastewater from almost all of the central waterfront basins before sending them into EBI Section 6. The structure receives flows from SPU's University Street Overflow Gate (elevation 6.7 feet) and the Madison Street Overflow Gate (elevation 8.3 feet). It showed an average peak conductivity of 24.38 mS/cm. Flow was monitored at the structure. The flows entering the Adit structure were usually 60 to 90 percent salt water during high tides; the structure would surcharge at times and invalidate the flow data. The average inflow of salt water was about 1.0 mgd; the peak flow was 1.9 mgd. Figure 18 shows the relationships of flow, tide, and conductivity at the Adit Structure.

**Figure 18. Relationship of Flow, Tide, and Conductivity at Downtown Adit Structure, June 25–28, 2009**

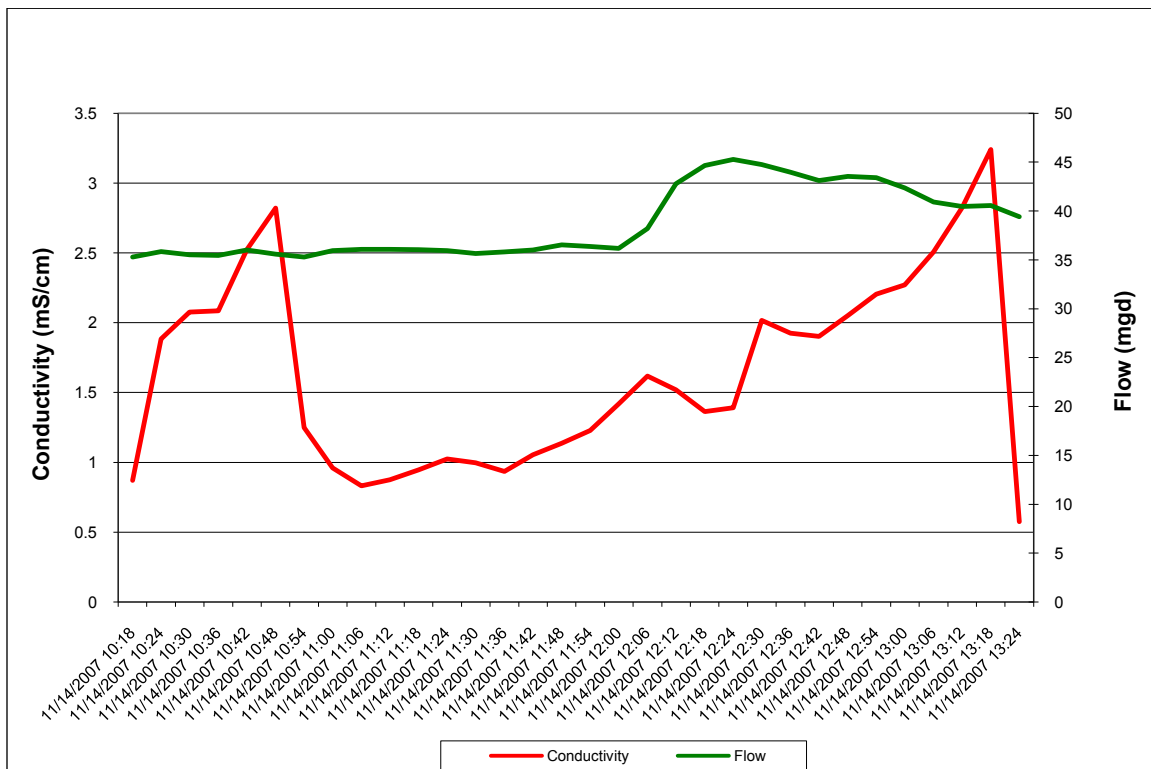
- Interbay Pump Station.** The average peak conductivity at the Interbay Pump Station was 6.01 mS/cm. Figure 22 shows a peak of 3.24 mS/cm and a flow of 42 mgd recorded on November 14, 2007, at the station. Given that the conductivity of Elliott Bay is around 32 mS/cm, the percentage of salt water in the wastewater flows at this peak would be almost 10 percent and the average volume of saltwater would be 4.2 mgd. The average conductivity over the three-hour period shown in Figure 22 is 2.0 mS/cm (6 percent solution of salt water) and the average pump flow is 40 mgd, which amounts to an estimated 2.5 mgd of salt water pumped through the station.

A peak of 8.78 mS/cm in 2008 and a peak of 12.96 mS/cm in 2009 occurred during monitoring at the Interbay Pump Station. A conductivity of 8.78 mS/cm indicates 27 percent salt water in flows at Interbay, which equates to 10.8 mgd of salt water in a 40-mgd daily average flow during the high tide cycle. The salt water is coming both from EBI 7 and the South Magnolia Trunk.

**Figure 22. Relationship of Flow and Conductivity at Interbay Pump Station, November 14, 2007**

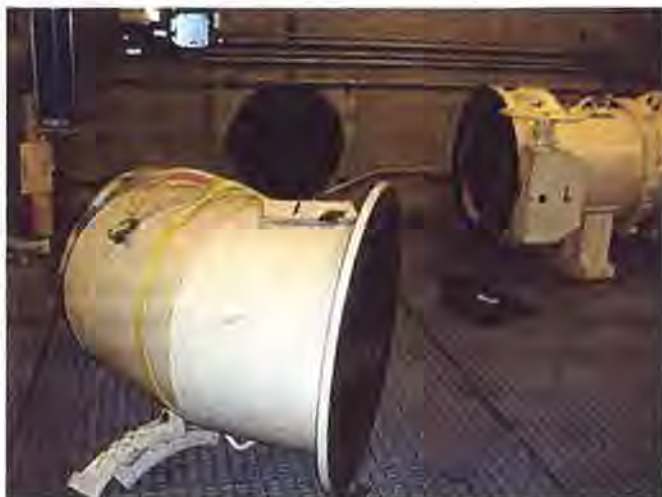
**Figure 1**

Figure 1 shows an elbow that was removed in May of 2003 from the RAS line of the West Point facility. Of the three elbows inspected, this showed the least damage. There were, however, pits and coating blisters present.

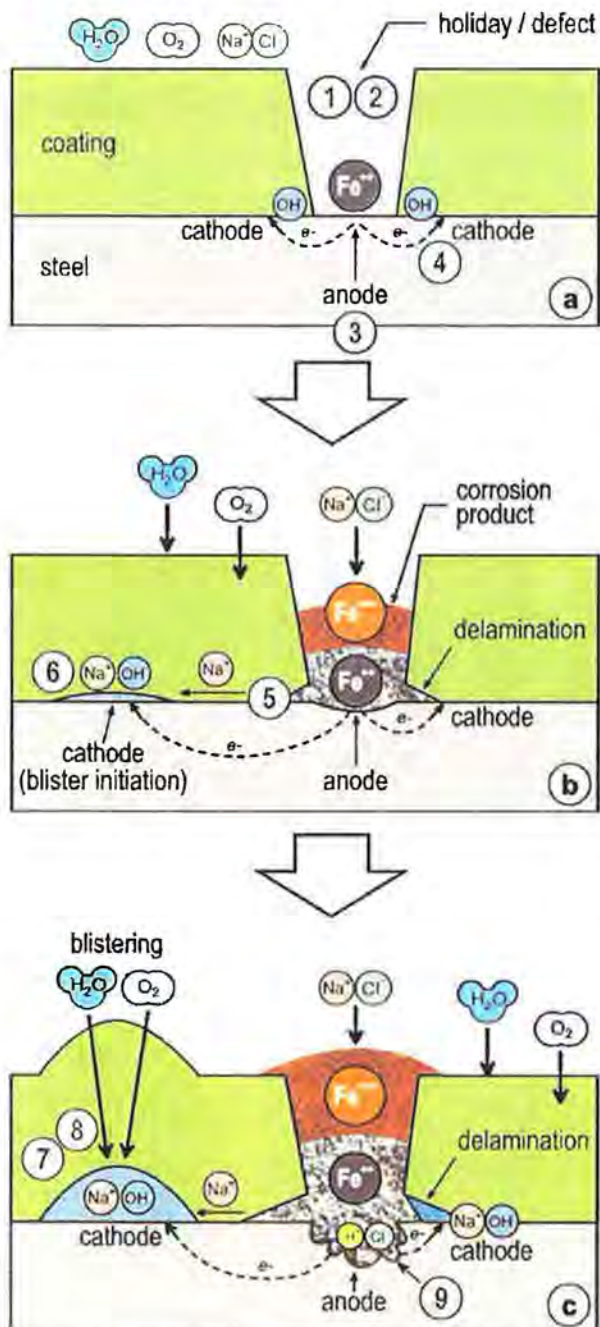
Figure 7 shows coating degradation that occurs as the result of a coating defect. This figure and discussion follows a model developed by staff at the National Institute of Standards and Technology (NIST)<sup>6</sup>.

In Figure 7a, step 1 is the formation of the coating defect and step 2 is the transport of water and other reactants, such as oxygen and chloride ions, to the metal surface. Steps 3 and 4 are the formation of the anode (corrosion site) and cathode(s).

In Figure 7b, note that the cathodic reaction is not benign. Here the sodium ion is part of a hydrolysis reaction:

This leads to delamination of the coating.

Sodium ions diffuse along the metal-coating interface, step 5, and initiate blisters at a distance, step 6. This alkaline solution then creates an osmotic pressure gradient (7) the main force behind step 8, blister growth.

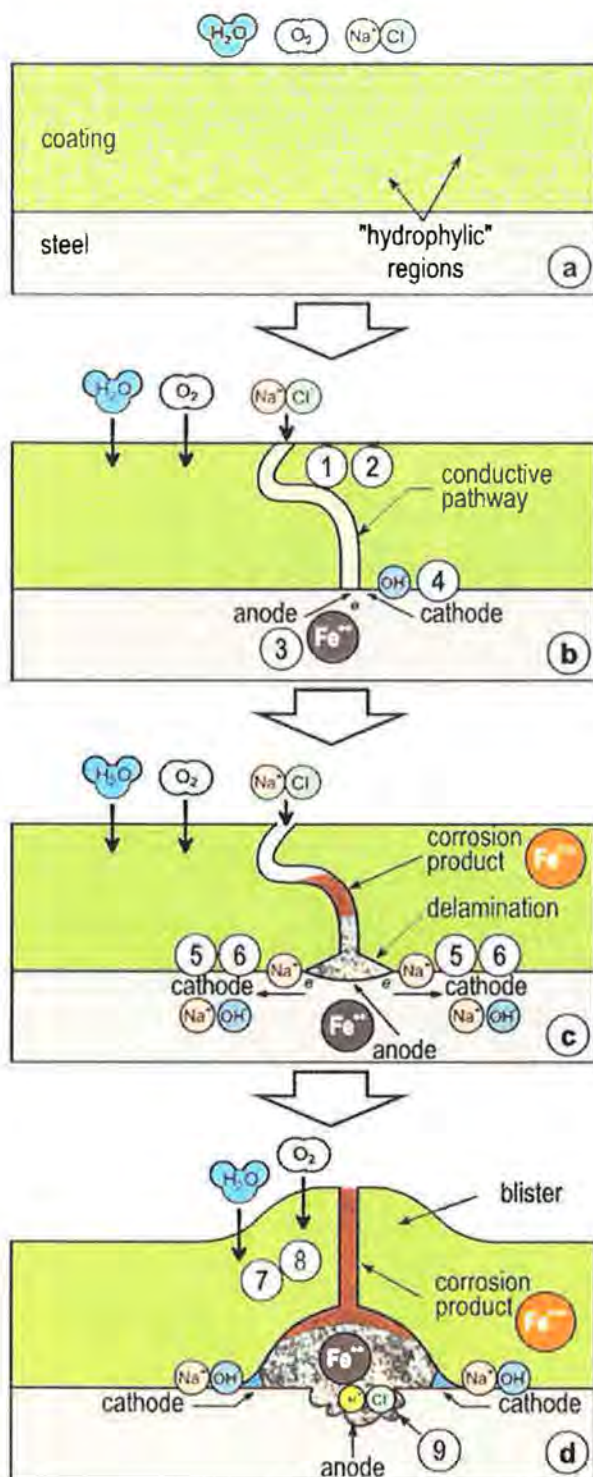
Figure 8 shows the NIST model for coating degradation without a defect. In 8a, the hydrophilic regions are areas with low molecular weight materials that have relatively little cross-linking. As such they can take up water and ions and are subject to hydrolysis. Films made of epoxy, phenolic and phthalate resins show these types of areas.

The hydrolysis and dissolution of the hydrophilic regions eventually lead to the formation of pathways through the coating to the steel surface, see step 1, Figure 8b. As in the case of coatings with a defect, water and reactants reach the steel, step 2; leading to the formation of anodes and cathodes, steps 3 and 4 respectively.

In Figure 8c, again the small and mobile sodium ion diffuses along the steel-coating interface in step 5. Through hydrolysis, step 6, alkaline solutions develop. This leads to delamination of coating adjacent to the conductive pathway.

In Figure 8d, step 7, the alkaline pools generate osmotic pressure gradients that transport water to the reaction site. This inflow of water and expansion due to the formation of corrosion products causes swelling and blister formation in step 8.

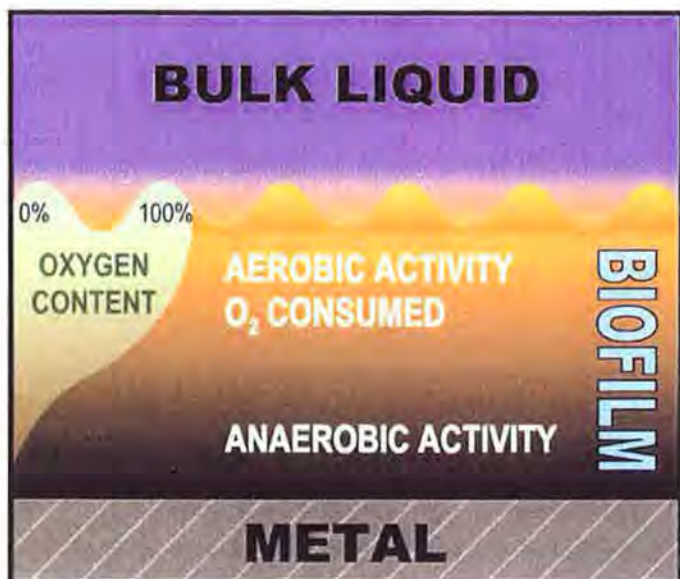
Figure 9 shows a simplified schematic of a biofilm. To the left in the figure is a stylized graph of the oxygen concentration in the biofilm. Note that the concentration is highest near the surface and drops with depth. At the bulk liquid interface, note that the dominate metabolic pathway is aerobic while at the metal surface it is anaerobic. Traditional pitting activity, as is shown in Figures 6-8, can provide iron in solution that iron bacteria can metabolize. As with chloride complexes, this process helps move reaction products from the active site and accelerates corrosion.

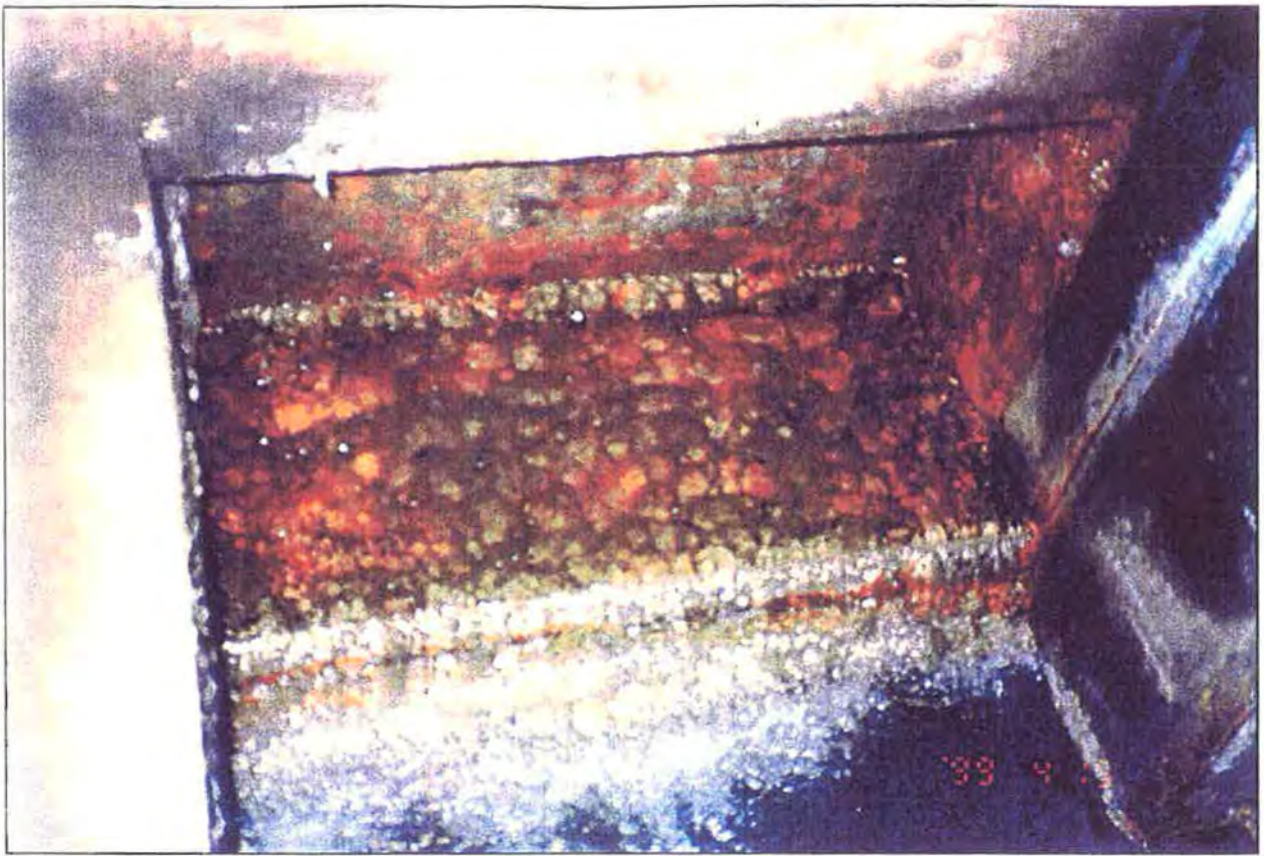
University Street Gate

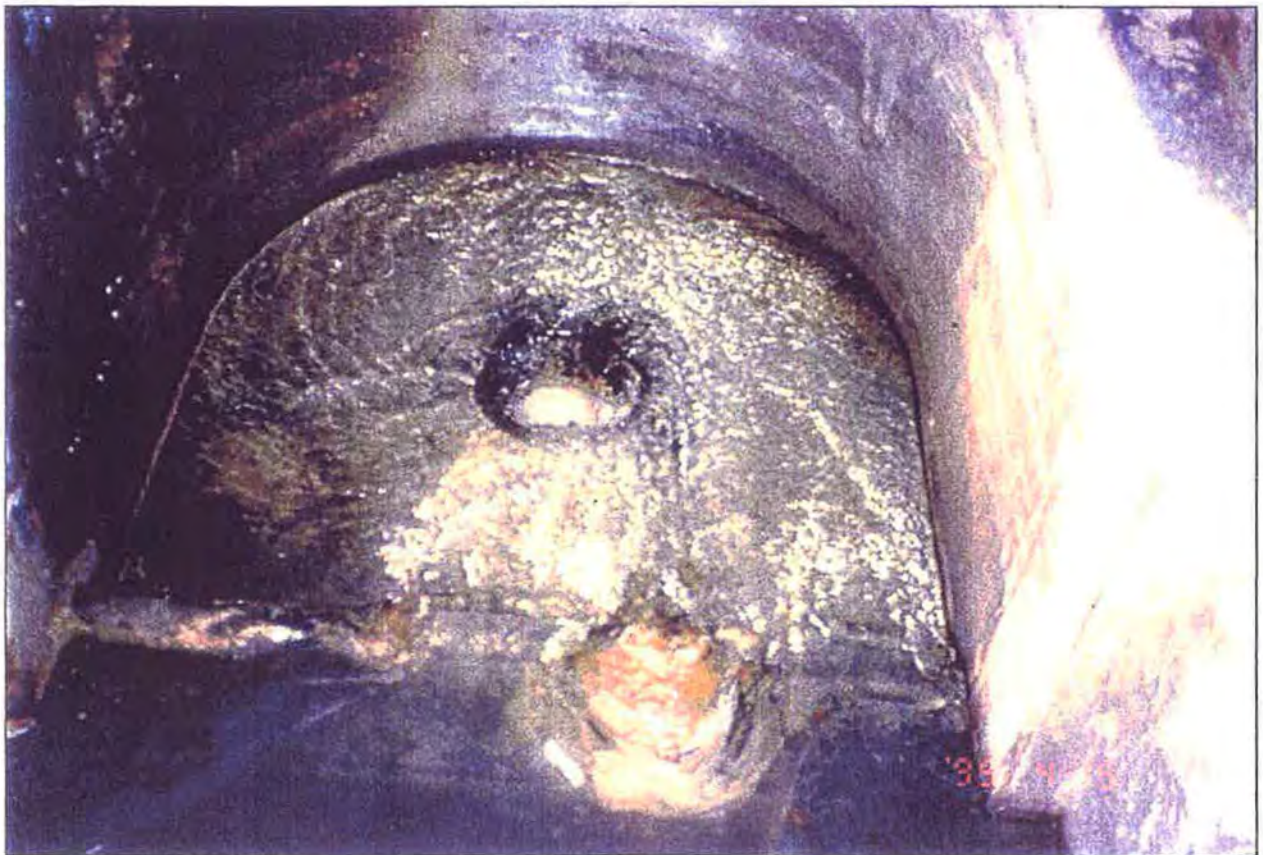
University Street Vortex

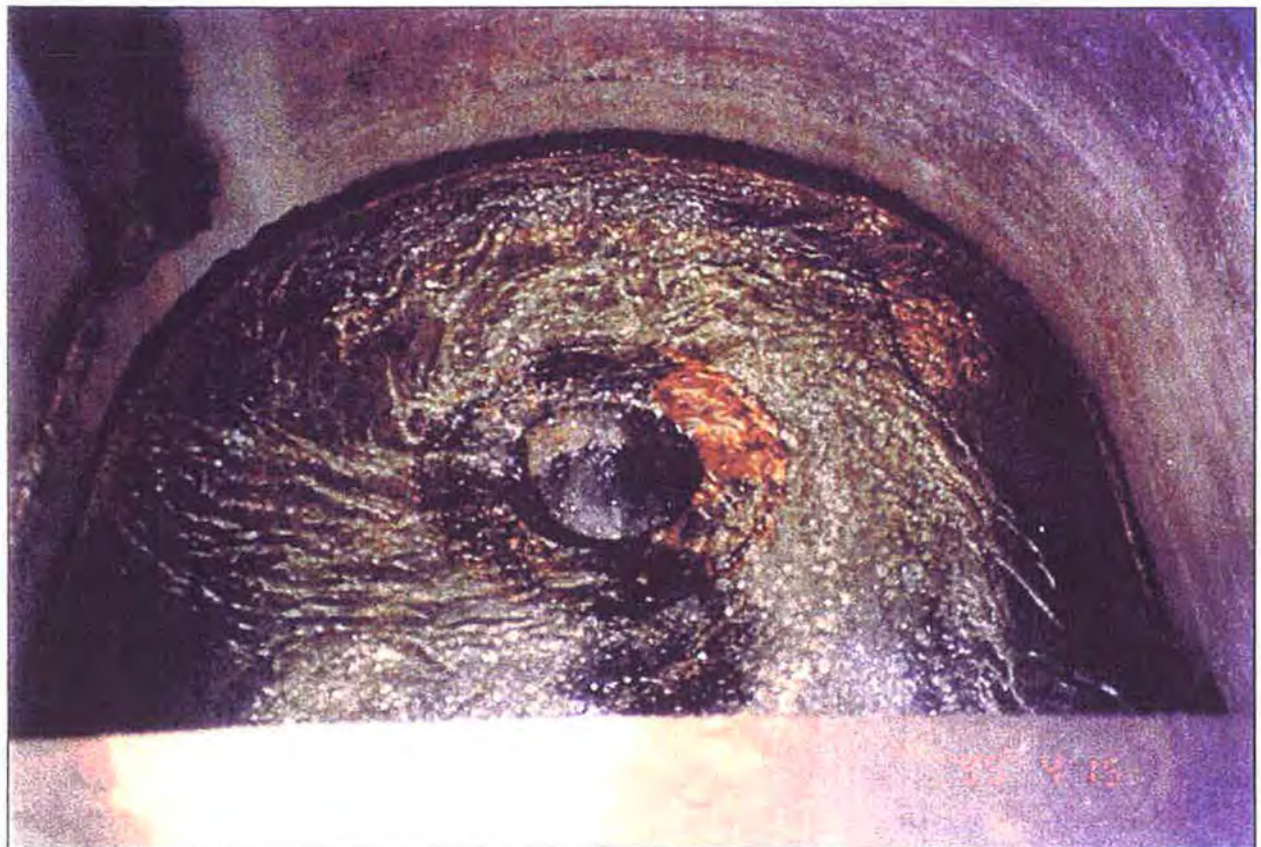
Vine Street Vortex

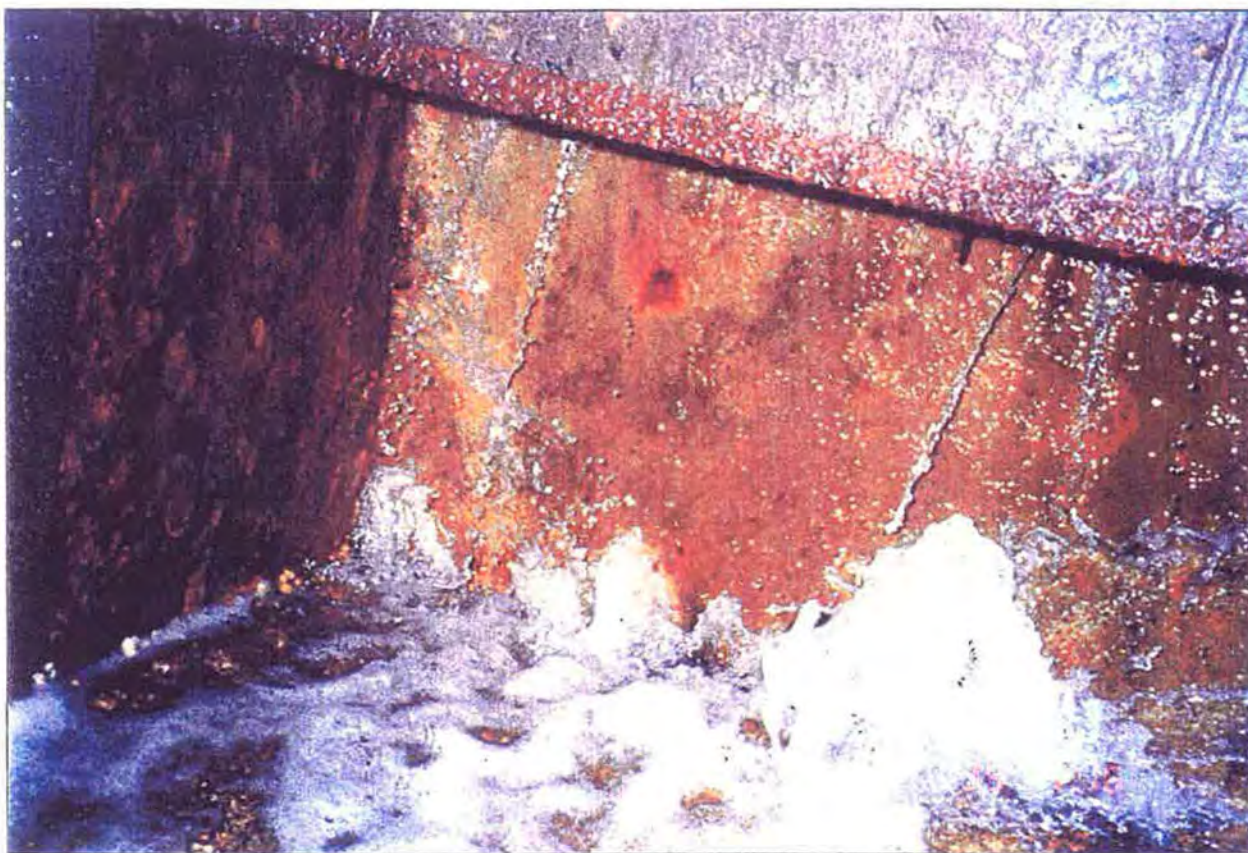
Washington Street Gate view 1

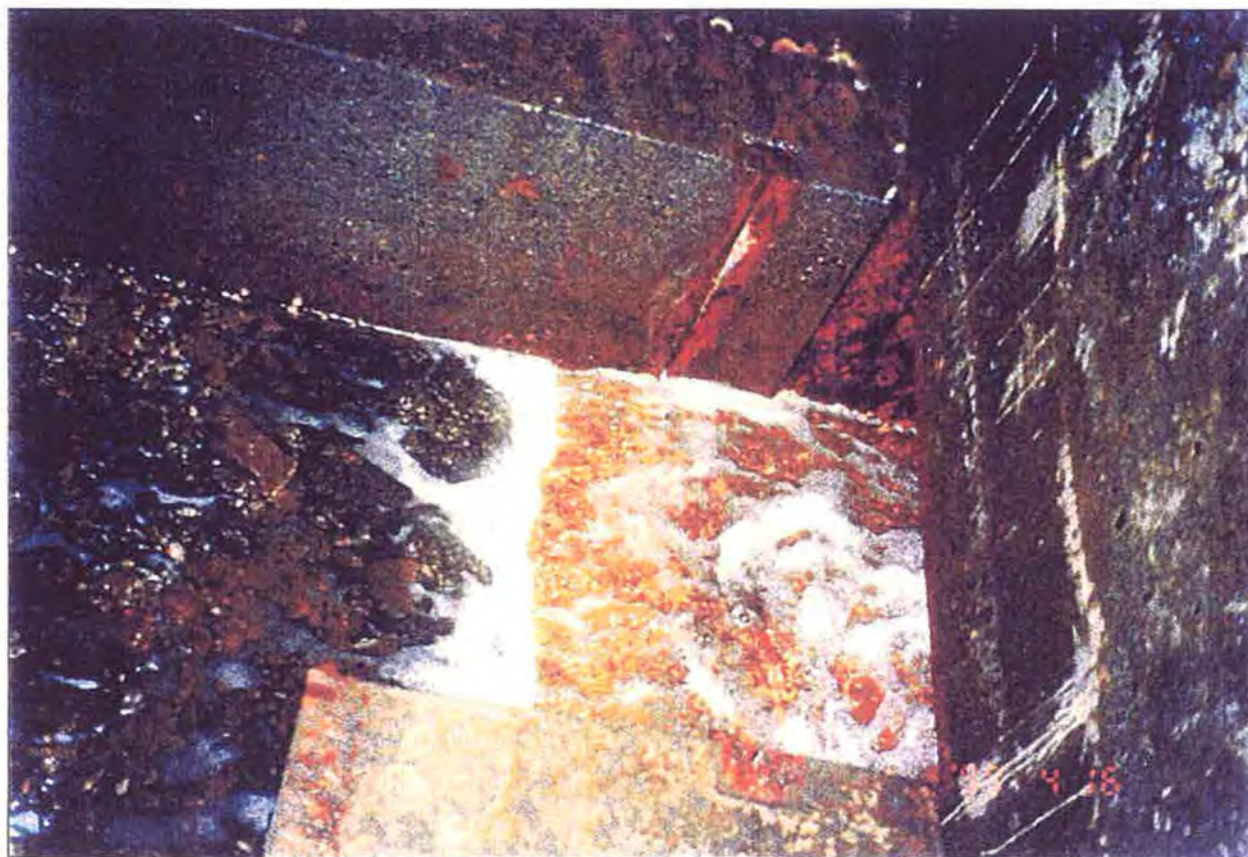
Washington Street Gate view 2
