Subject: Seattle Metro Final Design Engineering For The Carkeek
Transfer/CSO Facilities Project
North Beach Force Main Inspection Report

Reference: Municipality of Metropolitan Seattle
Final Design Engineering
Carkeek Transfer/CSO Facilities Project
(4359.01/1 and 4359.16/1)

Subject: North Beach Force Main
Excavation and Evaluation - Task 561

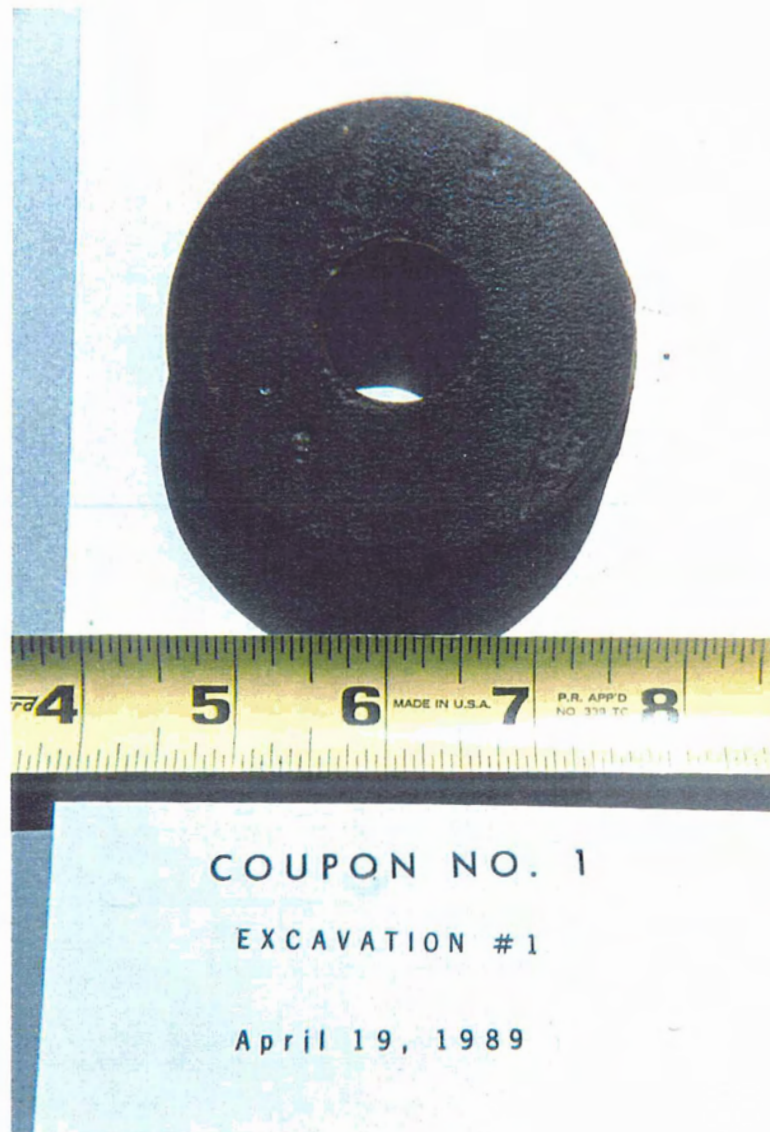
PICTURE NO. 25

The exterior surfaces of Coupons Nos. 1 and 3 (removed from the force main at Excavations Nos. 1 and 3 respectively) appeared to be in very good condition, with a thin film of tightly adhering graphitization and no pitting evident. Coupon No. 2 (removed from Excavation No. 2), however, showed some pitting activity.

Close-up of exterior surface of Coupon No. 1 as removed from Excavation No. 1 on the North End Force Main, before cleaning.

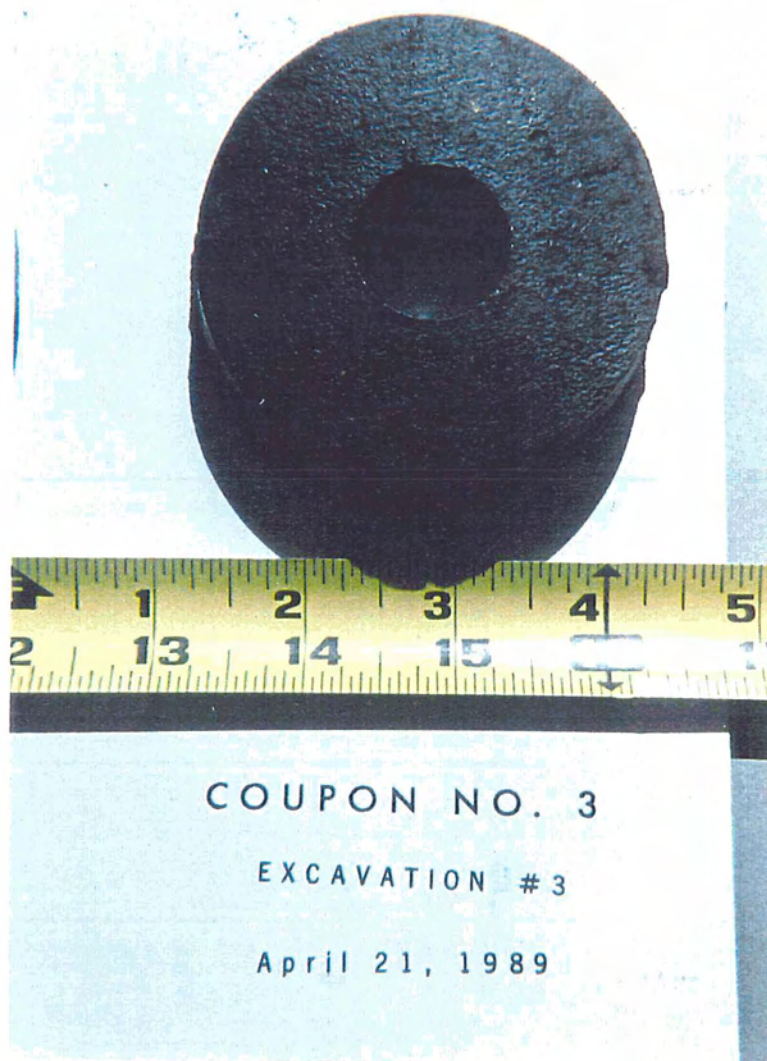
PICTURE NO. 27

Close-up of exterior surface of Coupon No. 3 removed from the North Beach Force Main at Excavation No. 3, before cleaning.

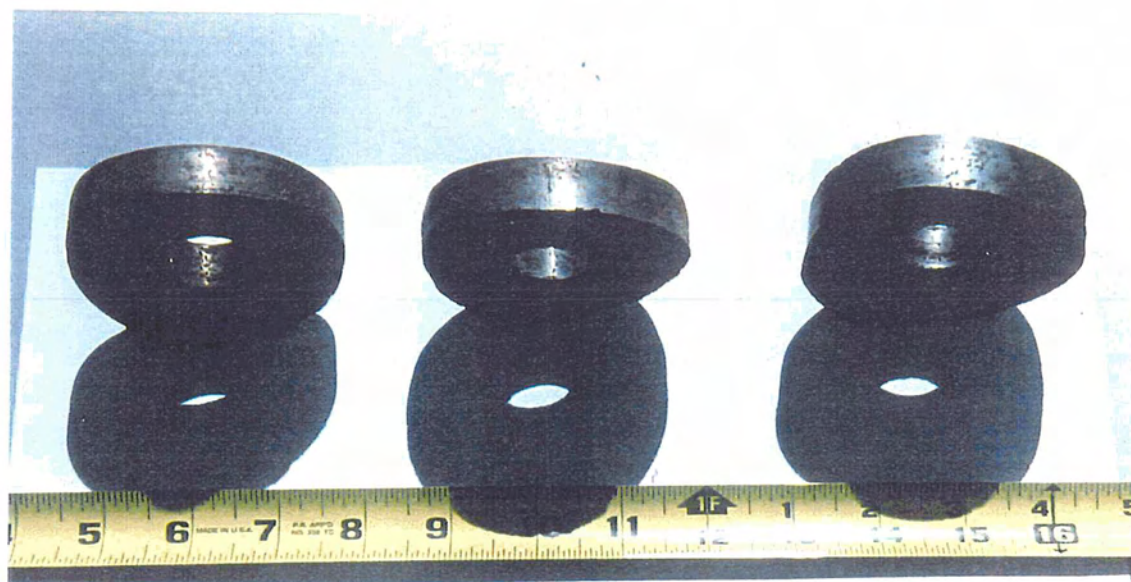
Coupons removed from the North Beach Force Main showing the pipe wall thickness. The average thicknesses were measured as follows:

Coupon No. 1	=	623 mils (Ø.623")
Coupon No. 2	=	648 mils (Ø.648")
Coupon NO. 3	=	701 mils (Ø.701")

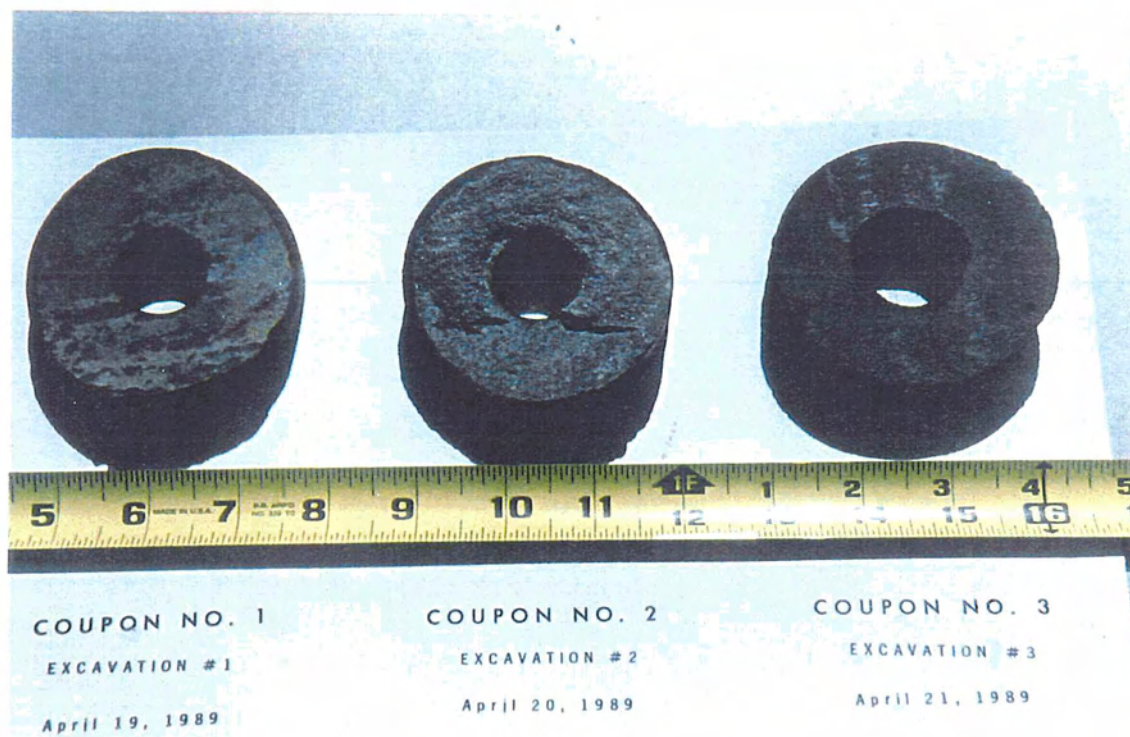
PICTURE NO. 29

Interior surfaces of coupons removed from the North Beach Force Main, before cleaning.

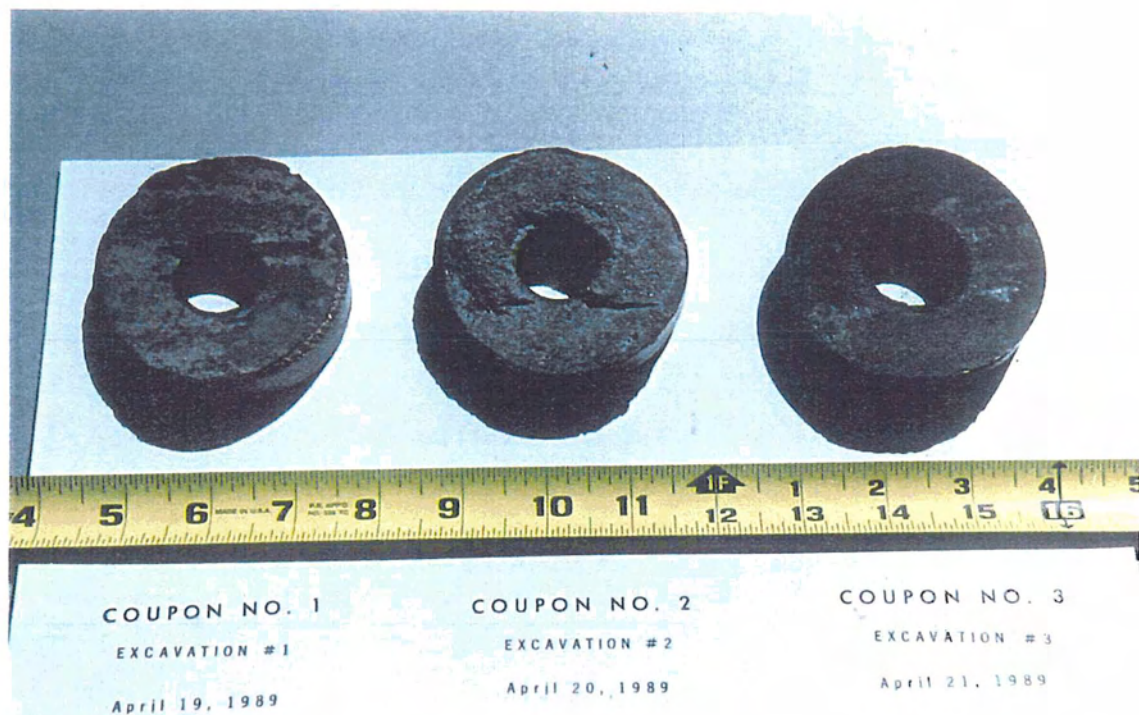
PICTURE NO. 43

Interior surfaces of the coupons removed from the North Beach Force Main, after lightly cleaning with a power driven wire brush to remove scale and debris.

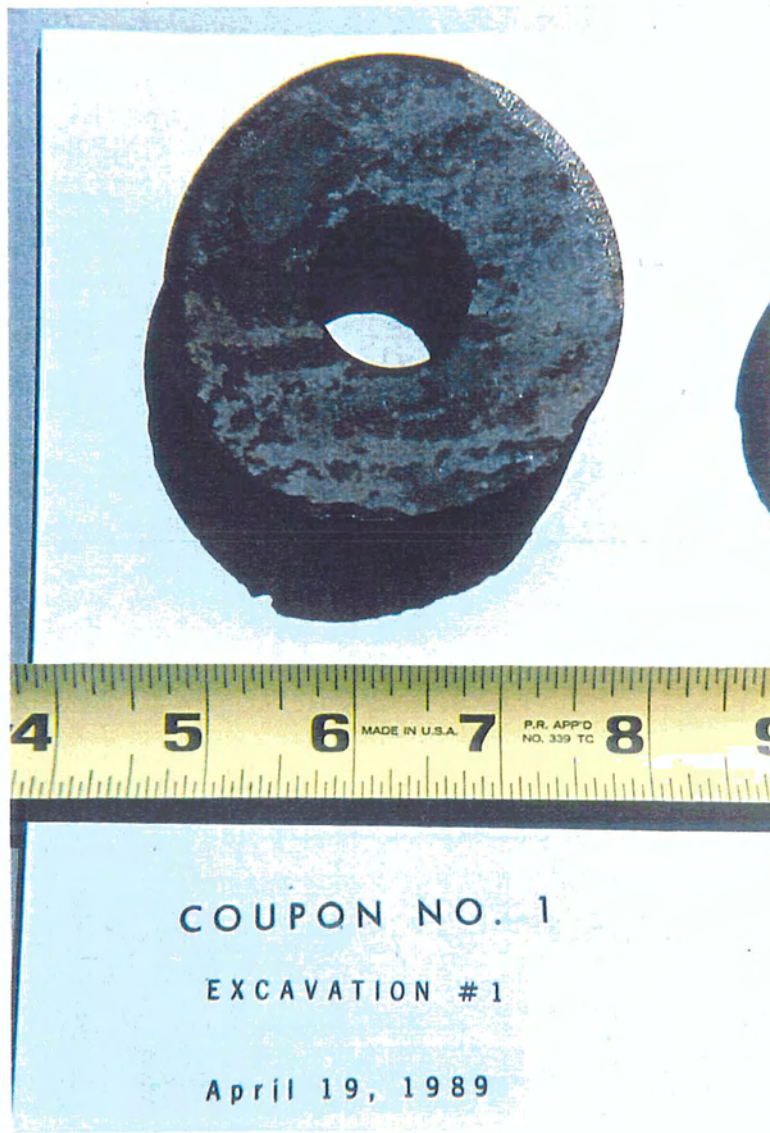
PICTURE NO. 44

Close-up of the interior surface of Coupon No. 1 removed from the North Beach Force Main at Excavation No. 1, after cleaning lightly with a power driven wire brush to remove scale and debris. Note the thin layer of cement mortar lining on the interior surface.

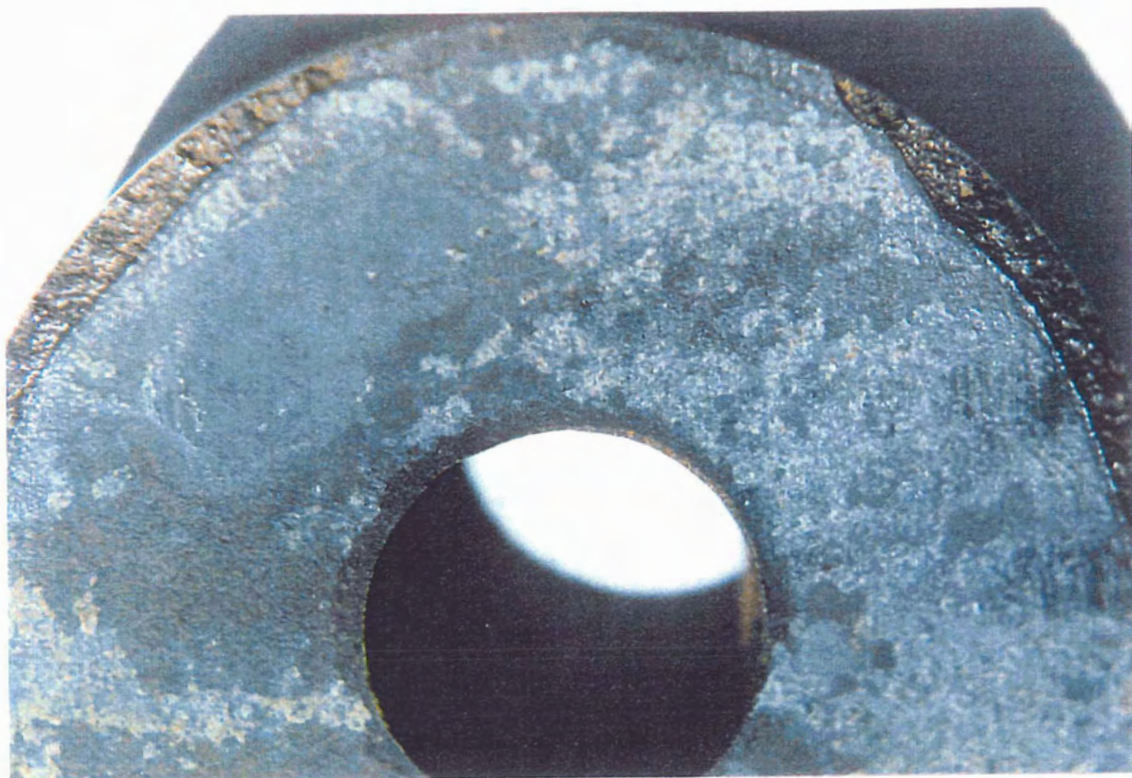
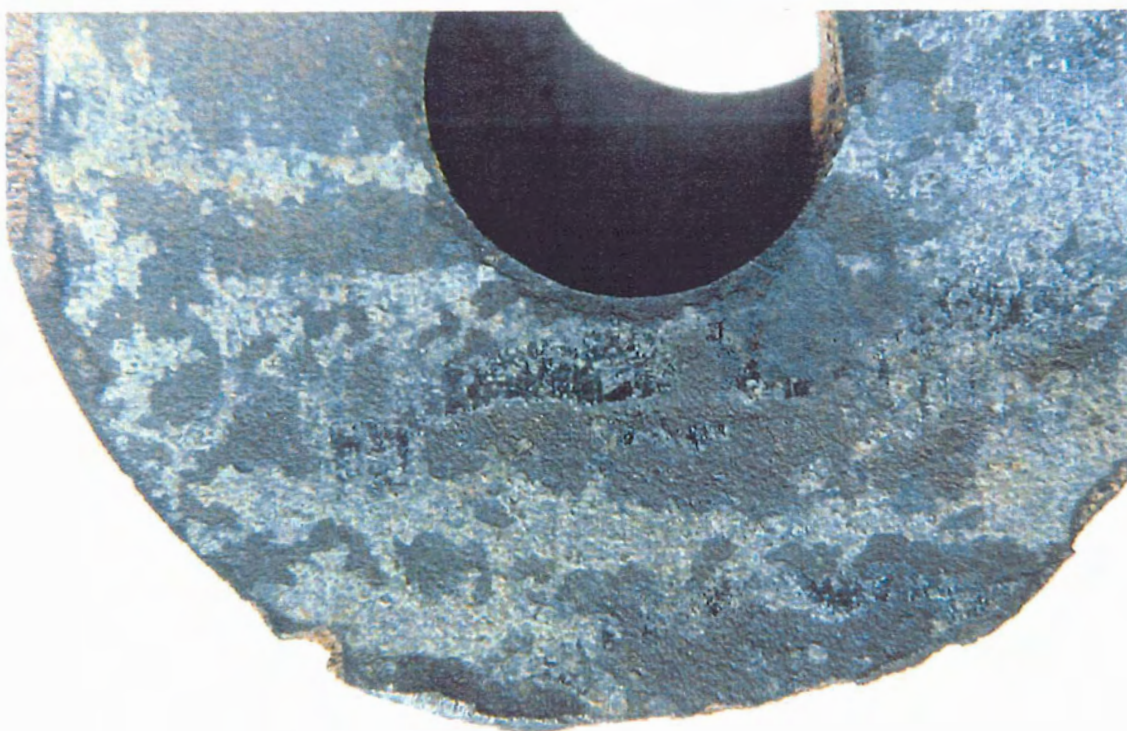
PICTURES NOS. 46 and 47

Enlargements of the interior surface of Coupon No. 1 removed from the North Beach Force Main at Excavation No. 1, after lightly cleaning. The thin layer of cement mortar lining is quite evident.

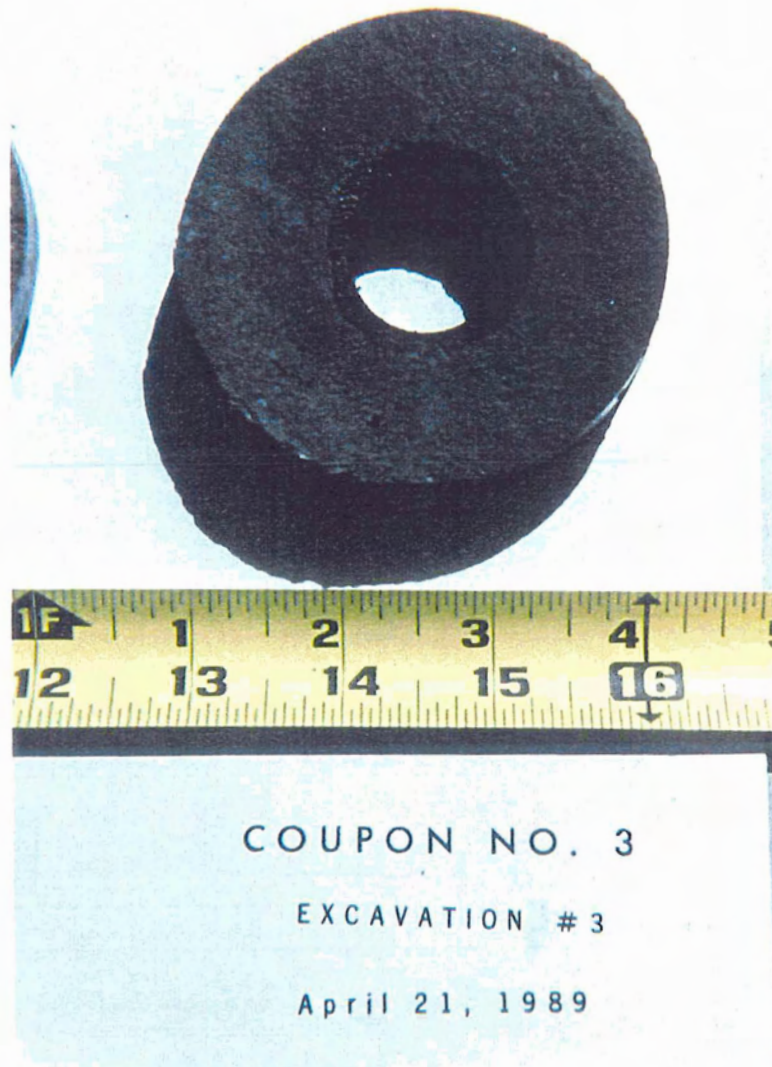
PICTURE NO. 52

Close-up of the interior surface of Coupon No. 3 removed from the North Beach Force Main at Excavation No. 3, after cleaning lightly with a power driven wire brush to remove scale and debris.

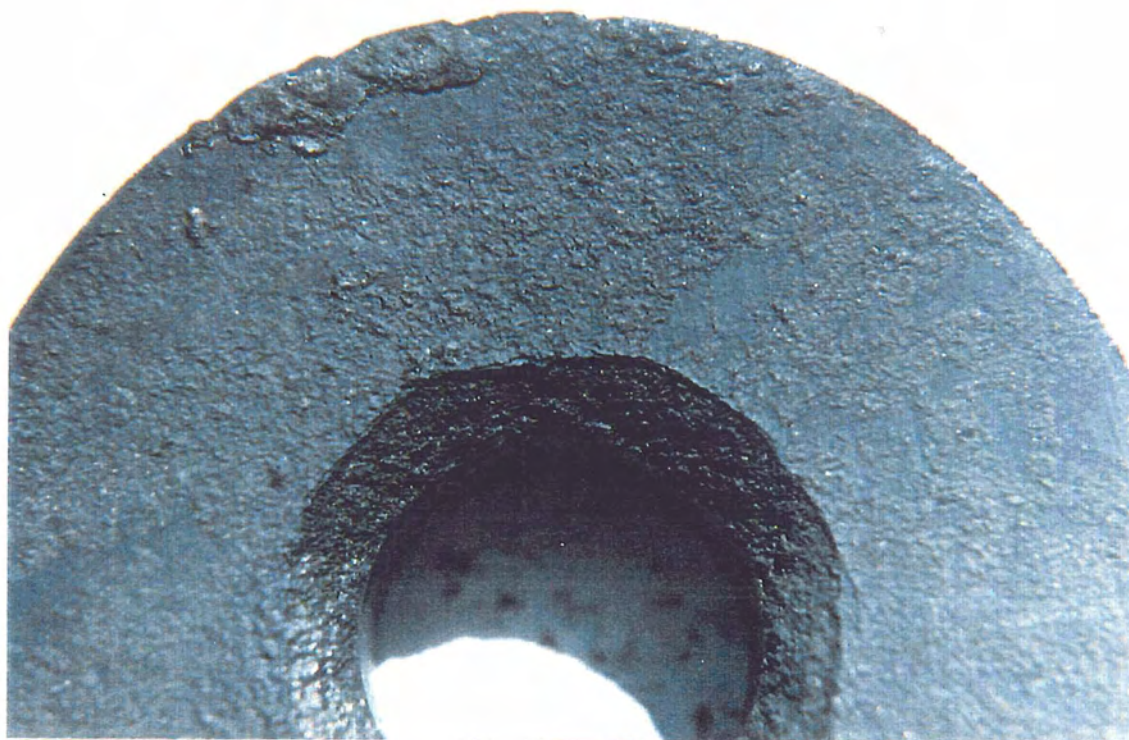
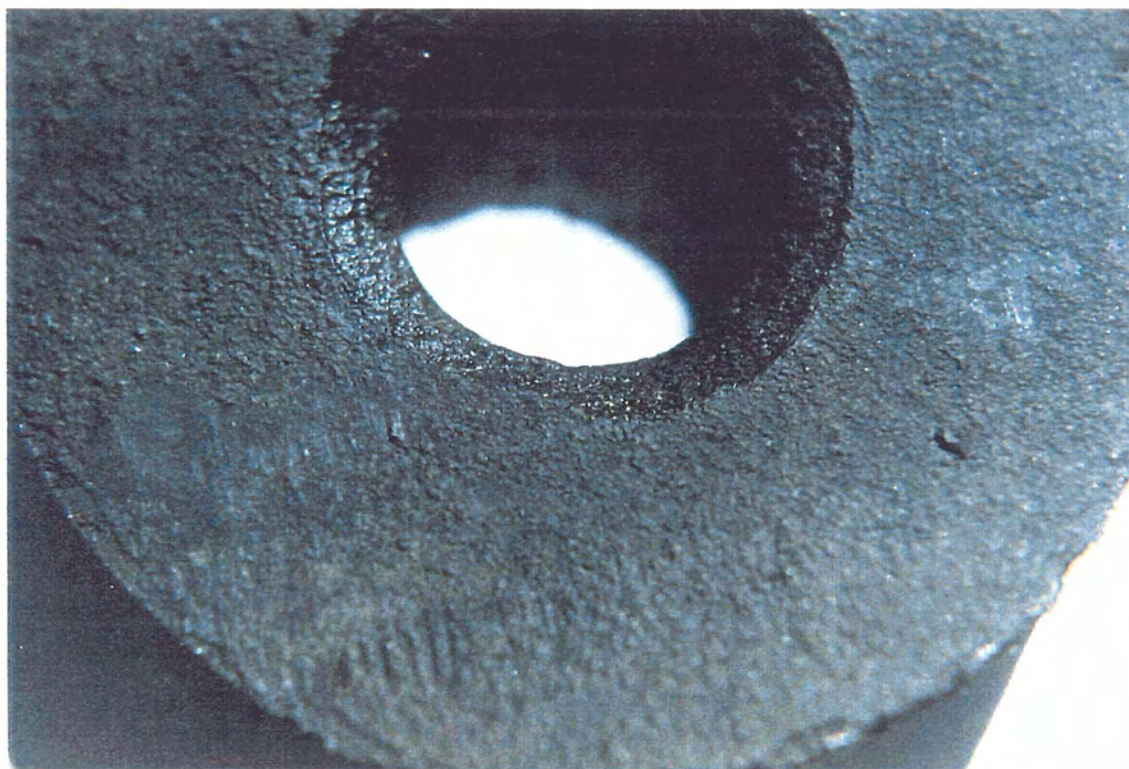
PICTURES NOS. 54 and 55

Enlargements of the interior surface of Coupon No. 3 removed from the North Beach Force Main at Excavation NO. 3, after lightly cleaning.

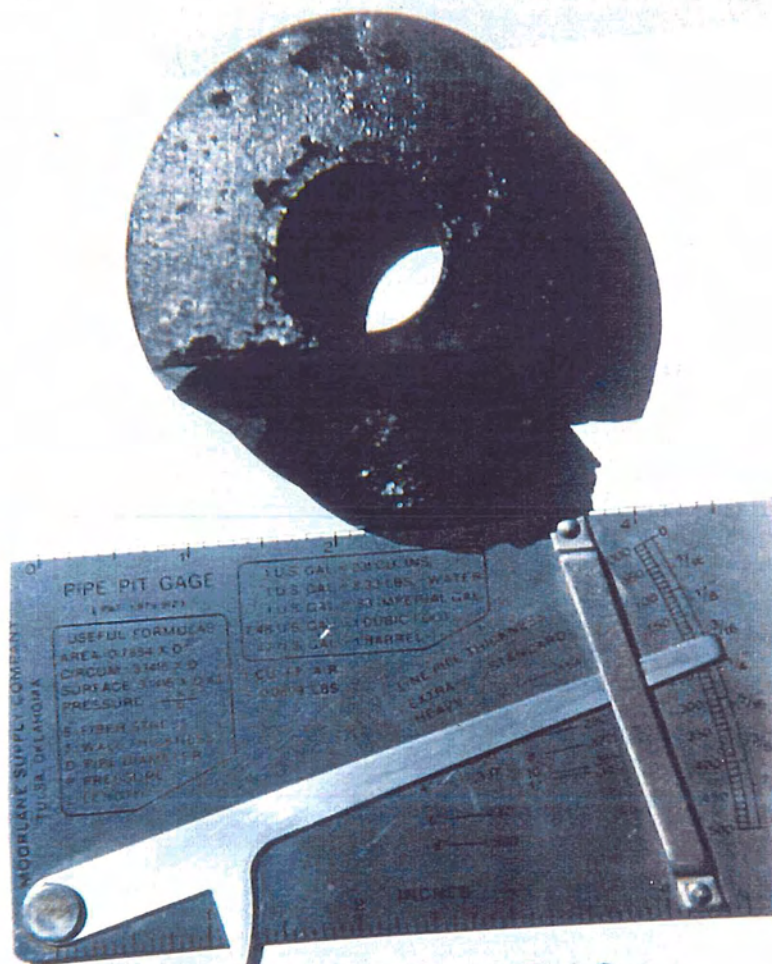
PICTURE NO. 56

Coupon No. 2 as sectioned by SCAN TECH, INC. for wall thickness measurements and metallurgical testing. Sectioning was done across a deep pit in the exterior surface of the coupon -- see the following pictures Nos. 57 and 58.

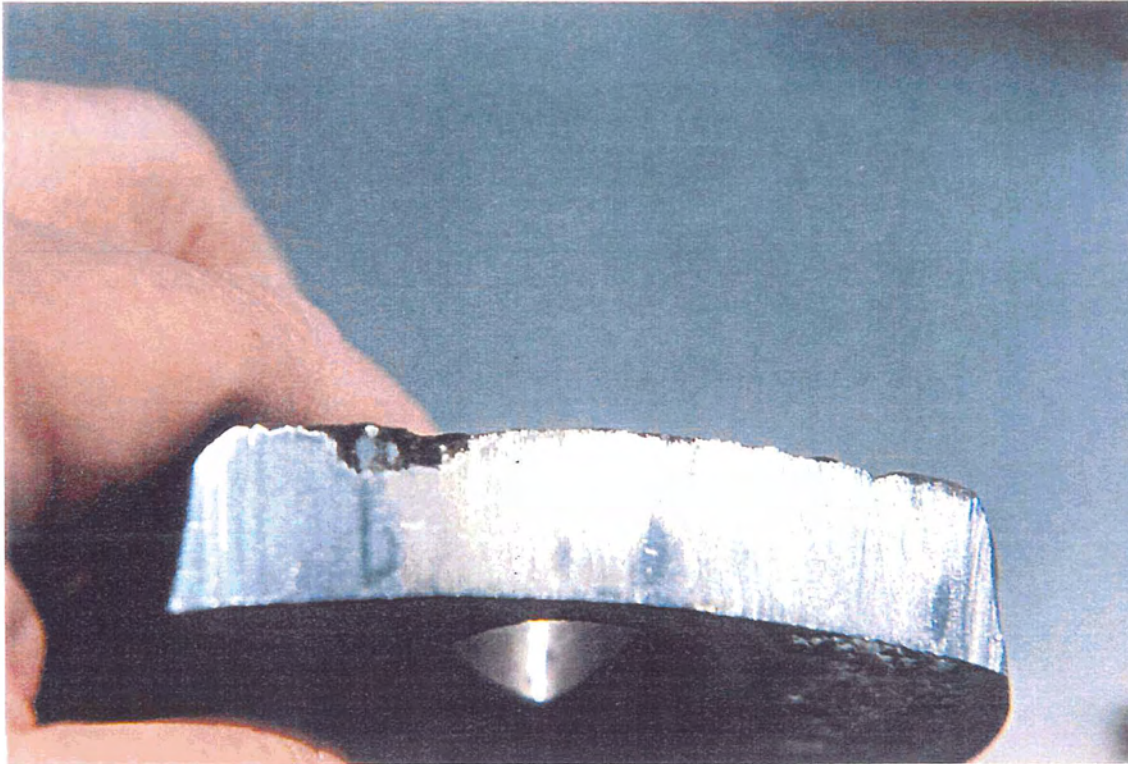
PICTURE NO. 57

Based on the evaluation made of the three coupons removed from the force main, and using the rather deep pitting found in Coupon No. 2 as a "worst case" situation, it has been estimated that the force main could operate for another 31 years before complete penetration of the pipe wall occurs, resulting in a leak.

Large section of Coupon No. 2 showing cut across deep pit. The pit depth was measured at $\emptyset.22''$, with the thickness of the pipe wall remaining beneath the pit measured at $\emptyset.44''$. The pit area was filled with tightly adhering graphitization.

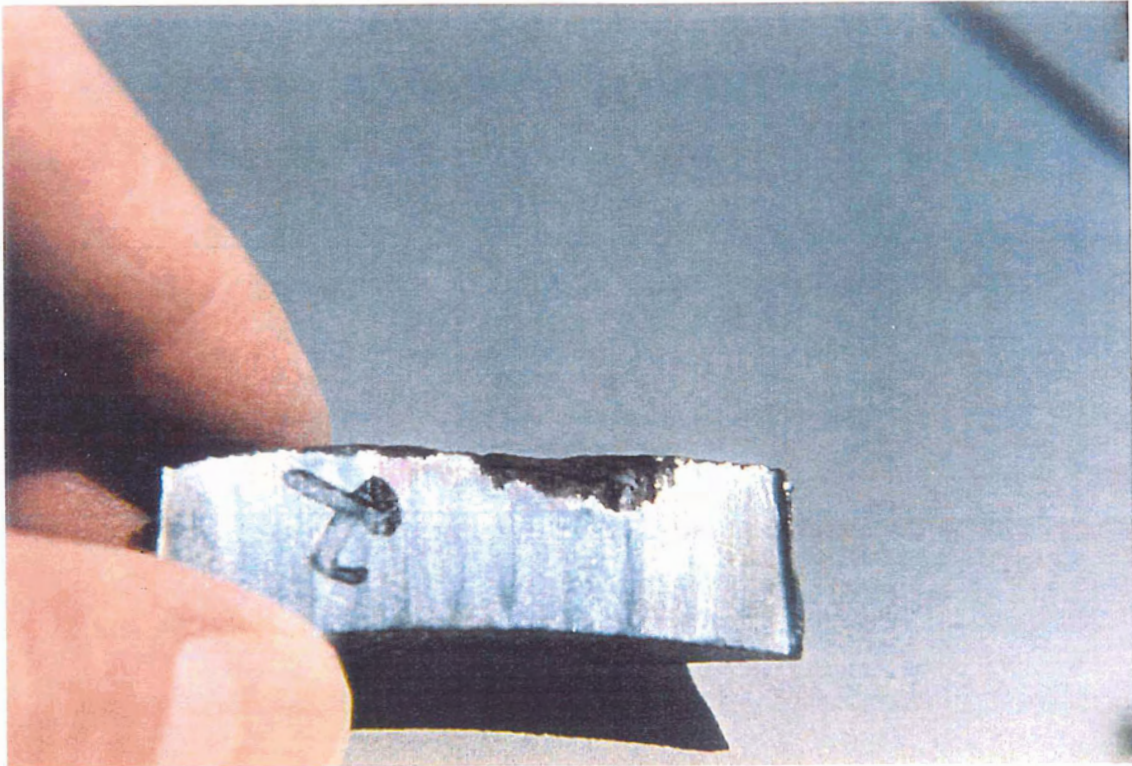
PICTURE NO. 58

Small section of Coupon No. 2 showing cut across deep pit. The pit depth was measured at 0.22", with the thickness of the pipe wall remaining beneath the pit measured at 0.44". The pit area was filled with tightly adhering graphitization.
