**South Fork Snoqualmie River
Levee Repair and Reconstruction Plan**

**South Fork Snoqualmie River
Levee Characterization Report
River Mile 2.0 – 5.9**

June 2014

Tetra Tech

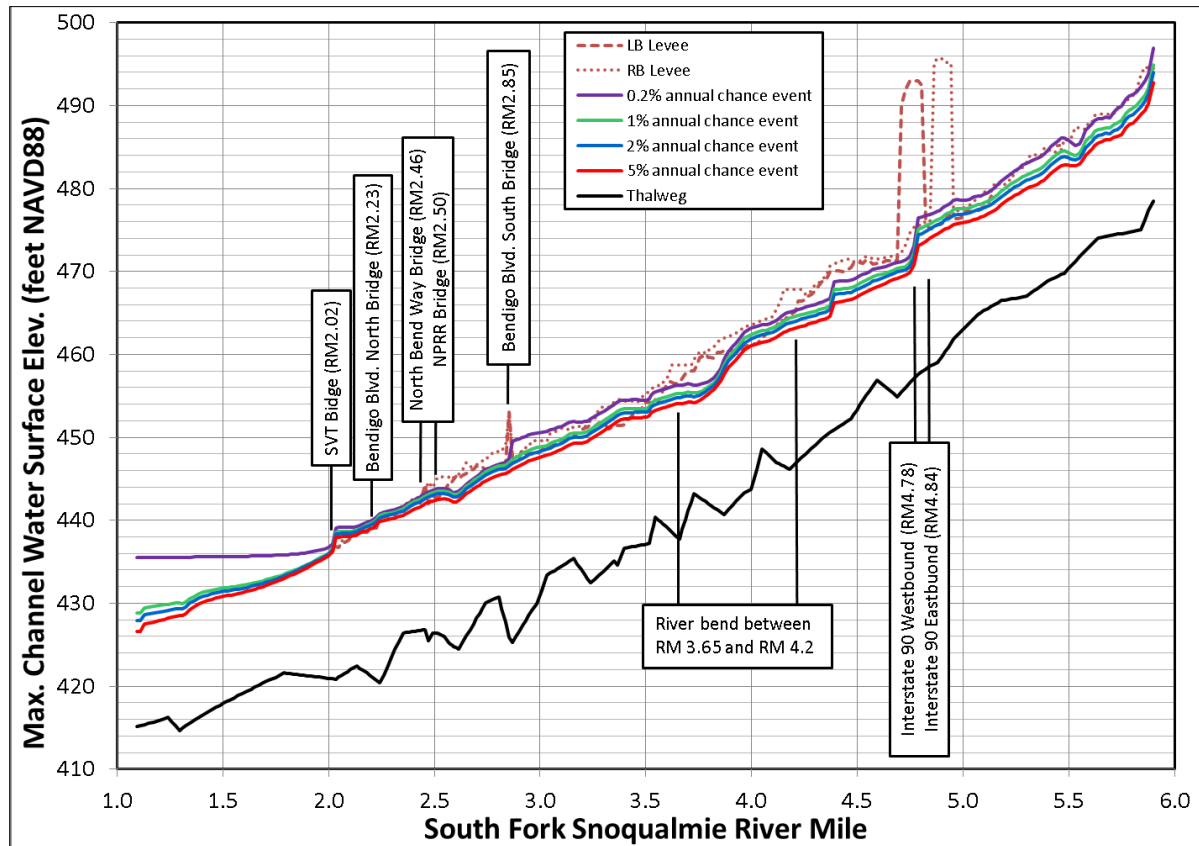
Figure 2-10. Maximum Channel Water Surface Profiles from FLO-2D Model for South Fork Snoqualmie River—Existing Conditions

Figure 2-10 shows the longitudinal water surface, thalweg and right and left bank levee height profiles of the South Fork Snoqualmie River for the four flood events. The most significant head loss (drop in water surface elevation) due to instream structures occurs at the Snoqualmie Valley Trail Bridge and at the Interstate 90 Bridges for all simulated events. Significant head loss also occurs at the Bendigo Boulevard South Bridge for the 0.2-percent-annual-chance flood conditions only. Figure 2-10 also shows significant head loss between RM 3.75 and RM 4.00 that is due to the sinuosity of the channel alignment and the high main channel velocities in this vicinity.

As seen in Figure 2-10, the existing Bendigo Boulevard South bridge and the adjacent abutments result in a significant increase in upstream water surface elevation for the 0.2-percent-annual-chance flood event. For flood events of lesser magnitude, the increase is less significant. This is due to the fact that the bridge opening is predicted to be surcharged (i.e. the upstream water surface elevation is greater than the low chord of the bridge opening) for the 0.2-percent-annual-chance flood event. Further discussion of the Bendigo Boulevard Bridge is provided in a section below discussing bridge hydraulics.

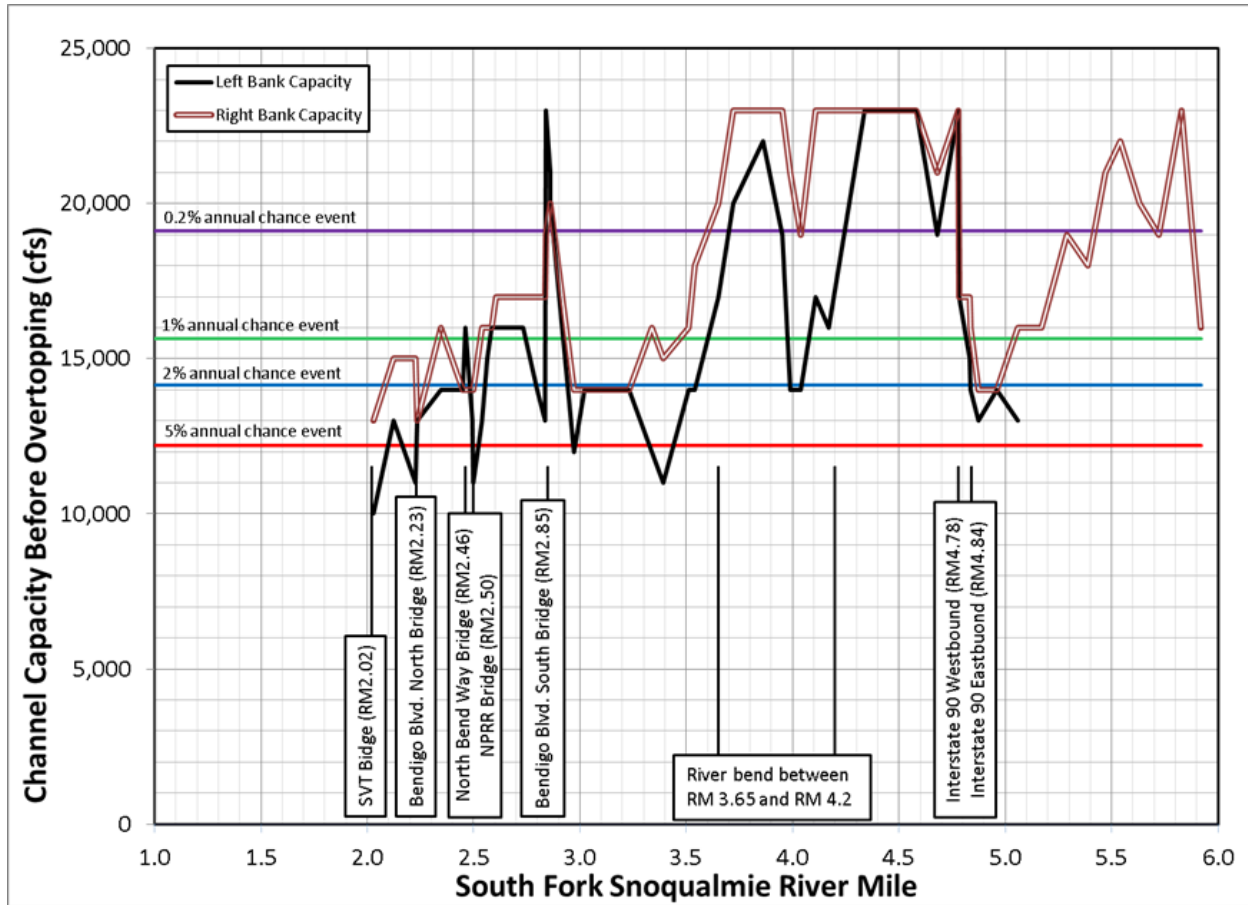
Figure 2-12. Levee Capacity without Overtopping—Existing Conditions

Figure 2-12 shows the estimated capacity of the left and right bank levees for the South Fork Snoqualmie River within the study limits. This figure shows that backwater from the bridge structures reduce the capacity of the levee system upstream of all road crossings. The backwater effect at Snoqualmie Valley Trail, North Bend Way, and Bendigo Boulevard South reduce the levee capacity to less than the 5-percent-annual-chance-event flow of 12,190 cfs. Additional documentation of the capacity of the levee is found in Appendix A.

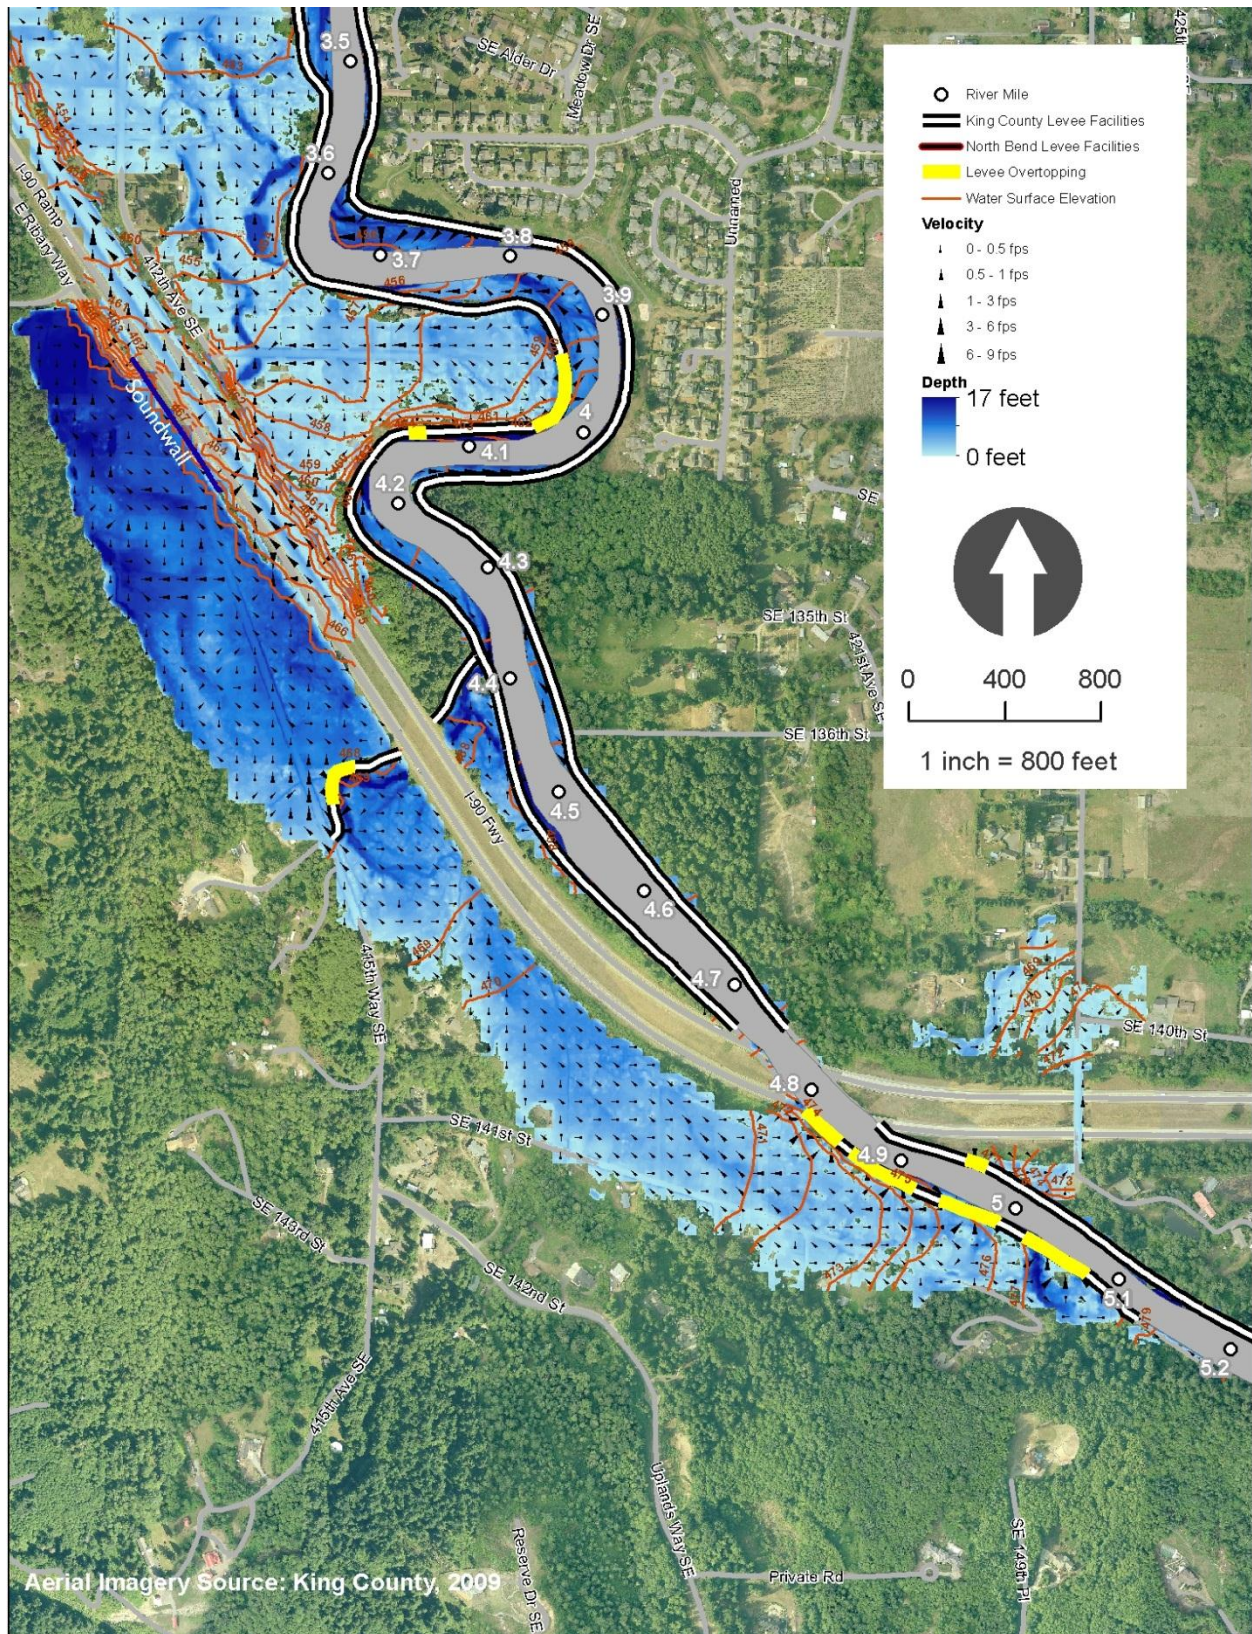
Figure 2-13. Floodplain Inundation RM 4.85 to RM 5.9, Including Clough Creek Floodplain; 1-Percent-Annual-Chance Flood Event

The most upstream location on the left bank levee system that overtops and contributes to flooding in the left overbank is immediately upstream of the Interstate 90 bridges, between RM 4.9 and RM 5.1. Figure 2-13 shows a detail of the floodplain inundation in this area for the 1-percent-annual-chance flood event.

The Interstate 90 roadway embankment is predicted to overtop for the 1- and 0.2-percent-annual-chance flood event when the accumulated floodwater volume fills the low-lying depression adjacent to the embankment. Overtopping of the Interstate 90 roadway embankment is a function of the volume of accumulated floodwater, and not just the magnitude of the peak flow rate in the South Fork Snoqualmie River.

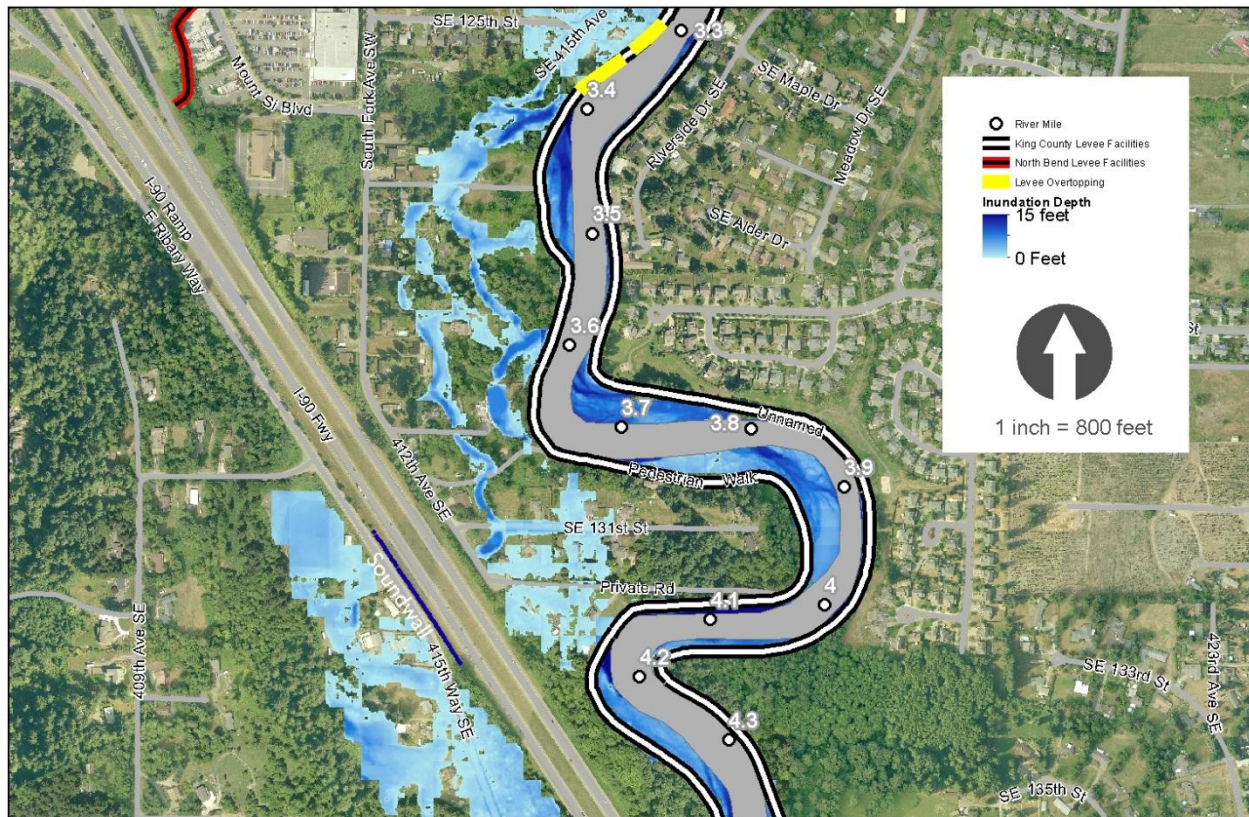
Figure 2-15. Floodplain Inundation Due to Seepage at RM 4.2 for the 5-Percent-Annual-Chance Event

The most upstream overtopping in this section is predicted during the 2-percent-annual-chance flood event at the inside of the sharp river bend at about RM 4.0. However, seepage through the levee during flood events potentially inundates the area during the 5-percent-annual-chance event. Floodplain inundation due to seepage at this location is shown on Figure 2-15. Maximum depth in the area between Mt. Si Boulevard and Interstate 90 (RM 3.4 to RM 4.85) ranges from 0 to 2 feet for the 5-percent-annual-chance event and from 2 to 5 feet for the 0.2-percent-annual-chance event. Because of seepage through the levee, property and road flooding occurs for all events. The predicted number of flooded properties increases from 12 for the 5-percent-annual-chance event to nearly 40 for the 0.2-percent-annual-chance event. More frequent flooding is predicted at SE 131st Street and several private drives during the 5-percent-annual-chance event. Floodplain inundation extends to 412th Avenue SE during the 2-percent-annual-chance event.

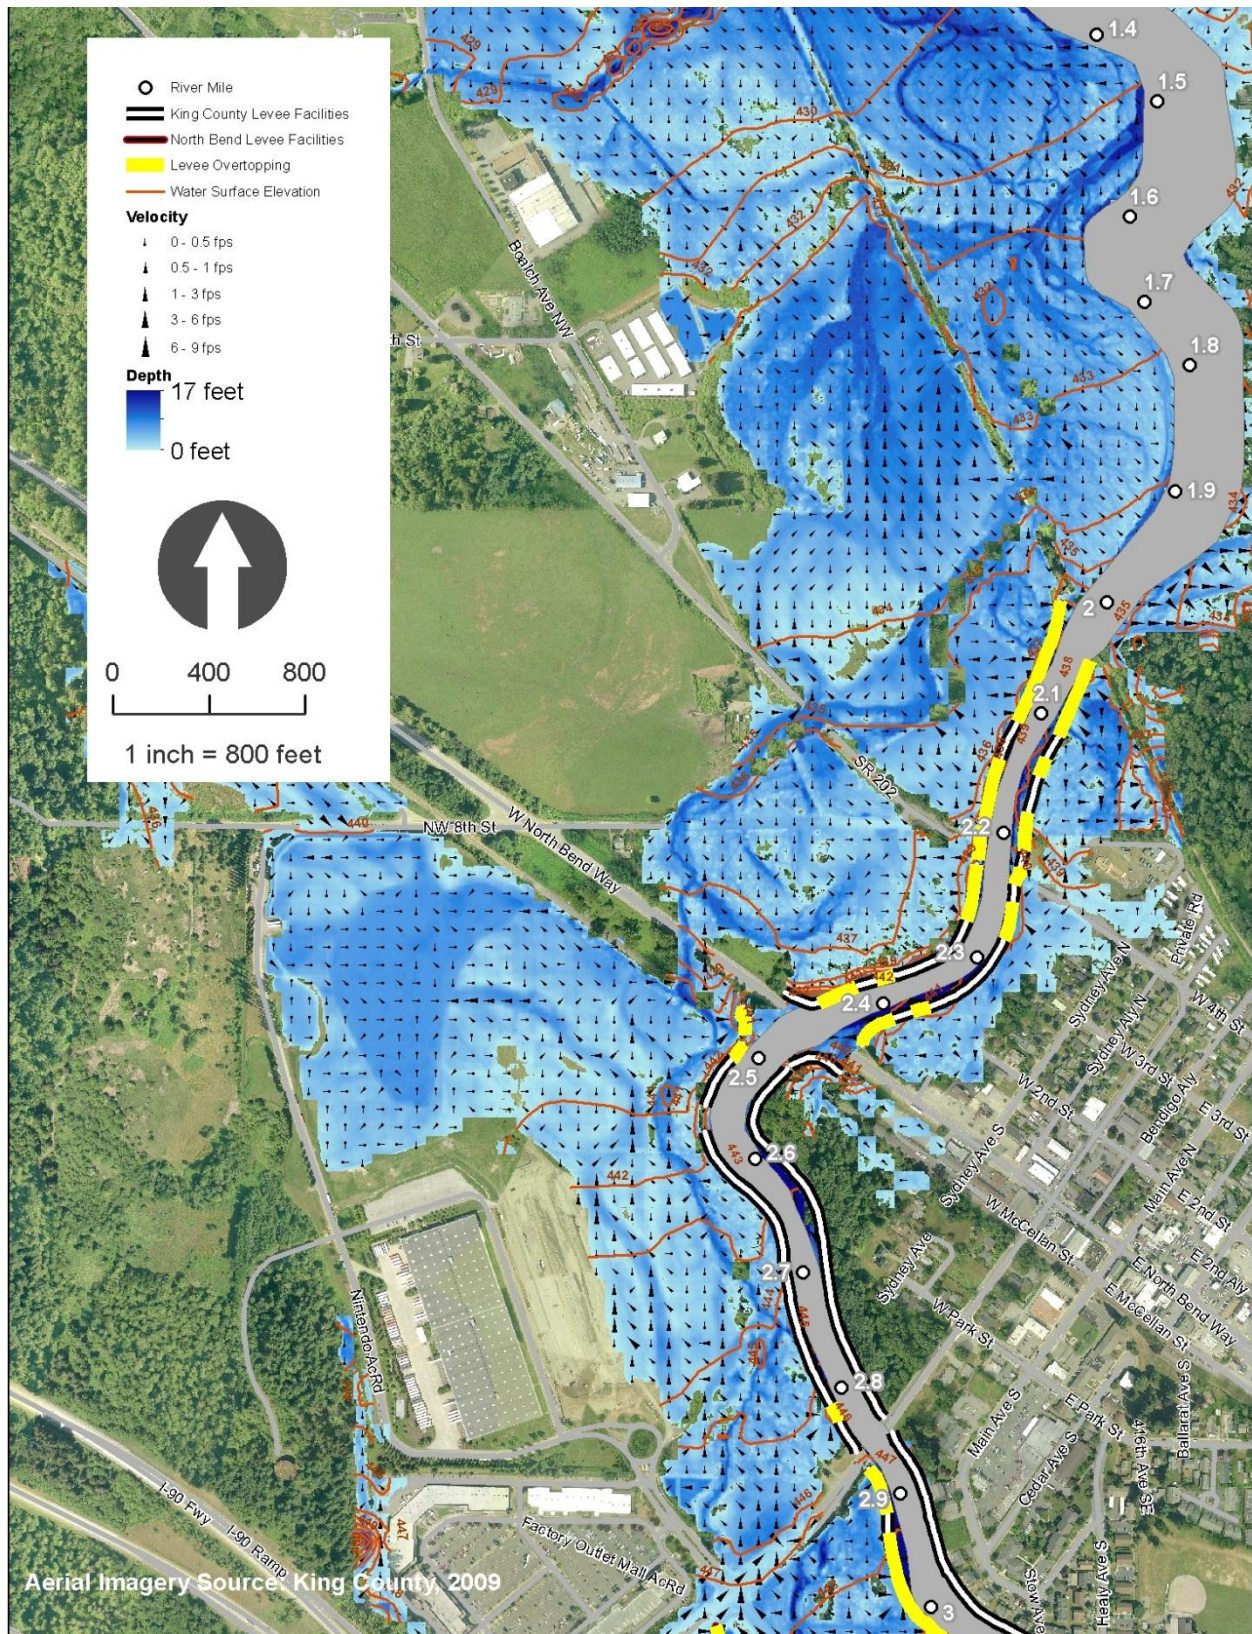
Figure 2-16. Floodplain Inundation RM 2.0 to RM 2.85; 1-Percent-Annual-Chance Flood Event

Maximum flood depth between the Snoqualmie Valley Trail and Bendigo Boulevard South (RM 2.0 to RM 2.85) ranges from 0 to 2 feet for the 5-percent-annual-chance event and from 2 to 6 feet for the 0.2-percent-annual-chance event. The low-lying area near Snoqualmie Valley Trail is predicted to be inundated due to overtopping of the South Fork Snoqualmie River left bank levee near RM 2.1 during the 5-percent-annual-chance flood event. The area north of Bendigo Boulevard South and South Fork Avenue SW also floods during this event due to overtopping of Bendigo Boulevard South.

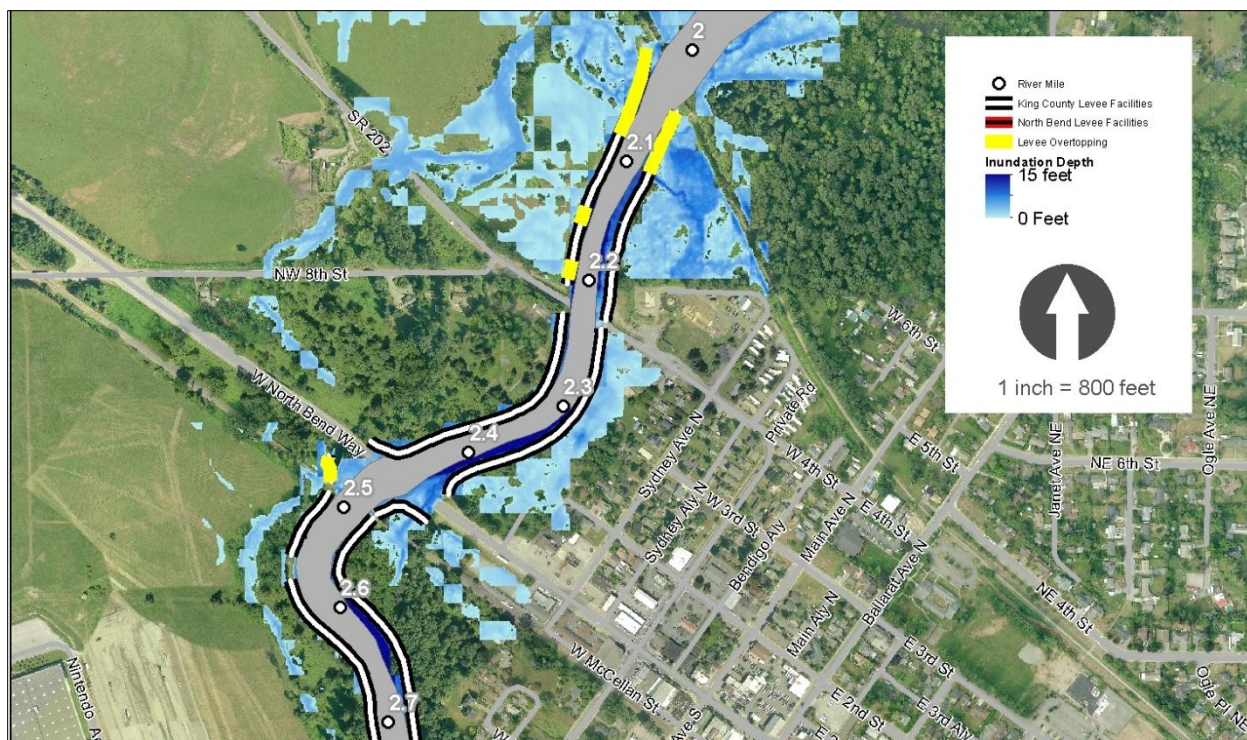
Figure 2-17. Floodplain Inundation Due to Seepage at RM 2.4 for the 5-Percent-Annual-Chance Event

For the 5- and 2-percent-annual-chance peak flood events, the only predicted sources of flood flows on the right bank floodplain are levee overtopping at the downstream end of the leveed reach, between West North Bend Way and the Snoqualmie Valley Trail (RM 2.0 to RM 2.1), and levee seepage at RM 2.27 and RM 2.47. River flows for the 5-percent-annual-chance flood event are predicted to be completely contained within the right bank levee system upstream of this location. Inundation due to seepage in this area is shown on Figure 2-17.

Maximum flood depths in the right overbank area are predicted to range from 1 to 4 feet for the 5-percent-annual-chance flood event and 2 to 5 feet for the 1- and 0.2-percent-annual-chance flood event. Peak flood flow velocity is less than 1 foot per second up to the 1-percent-annual-chance flood event but increases to greater than 2 feet per second for the 0.2-percent-annual-chance flood event. Predicted peak flood depth due to levee seepage at RM 2.27 and RM 2.47 is 1 foot for the 5-percent-annual-chance flood event.

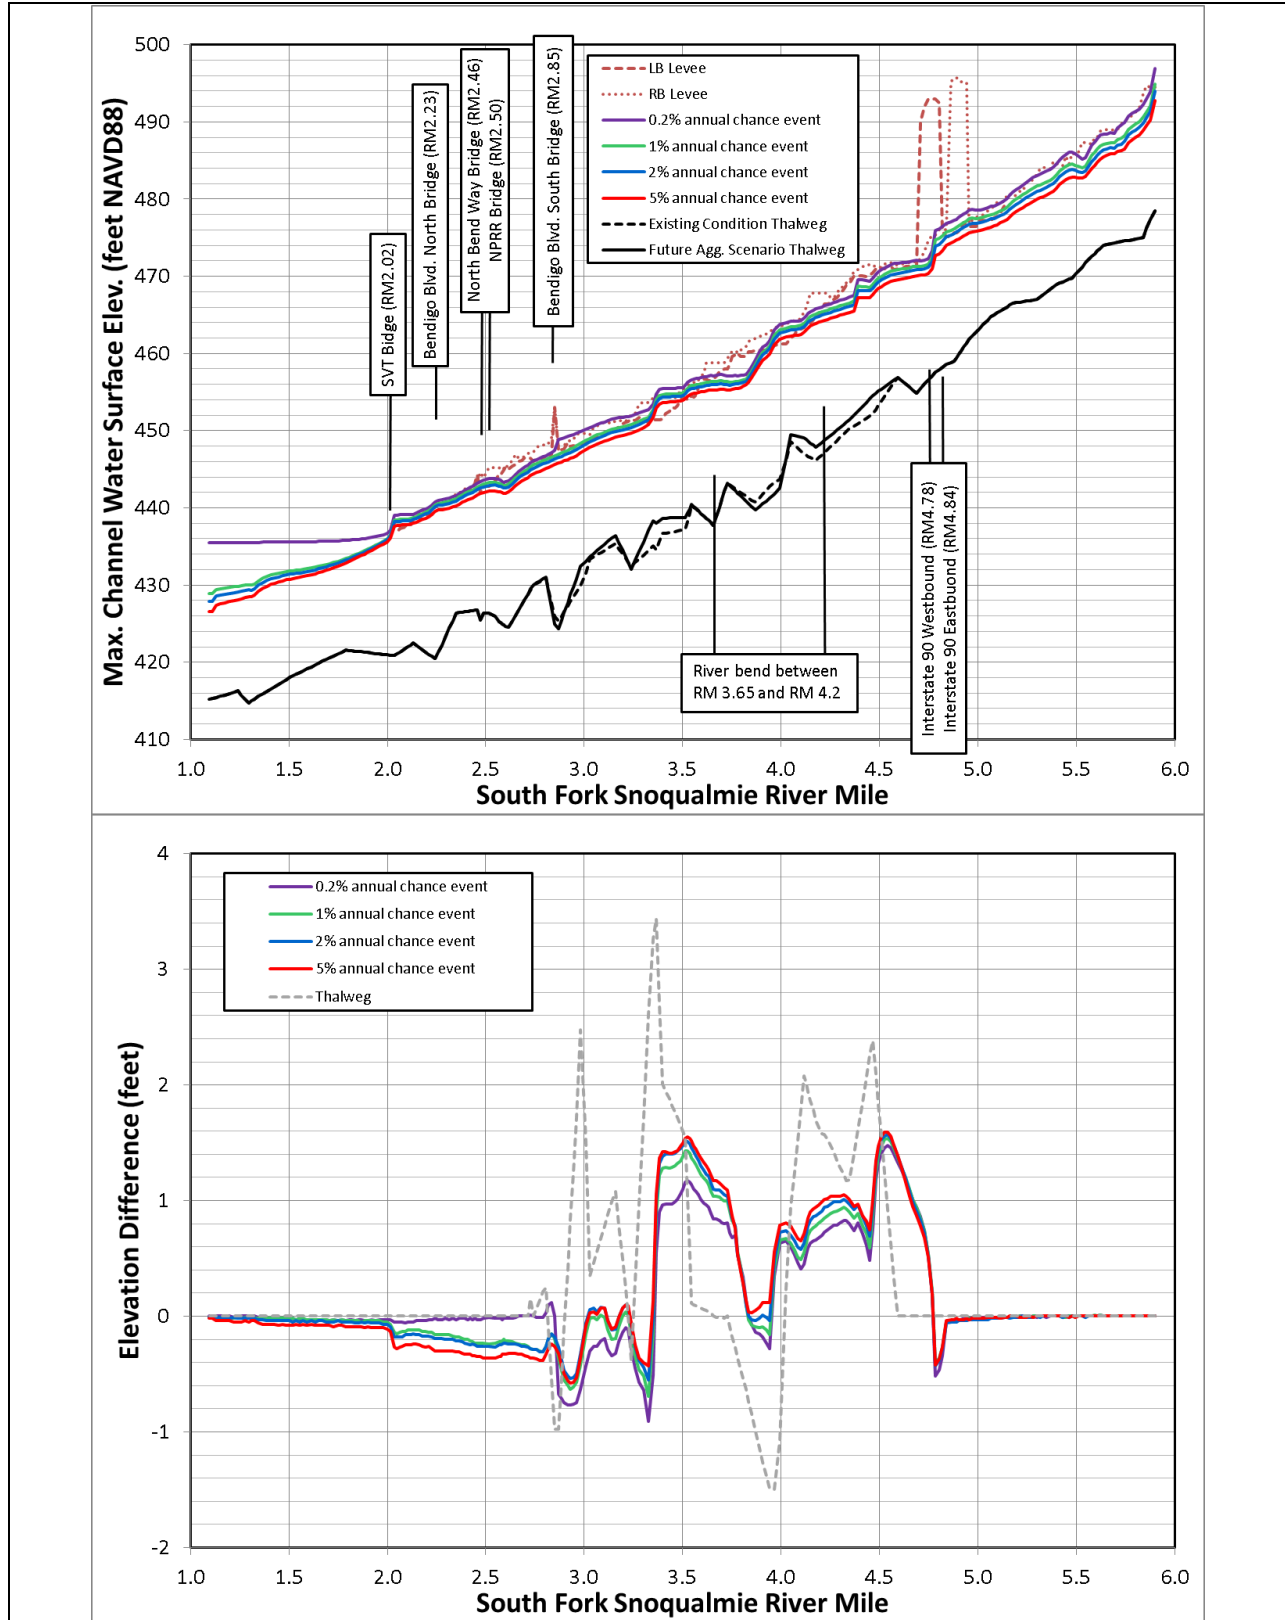
Figure 2-18. South Fork Snoqualmie River Thalweg and Predicted Maximum Water Surface Profiles—Future Aggradation Scenario (top) and Difference Between Future and Existing Scenarios (bottom)

A modeling scenario was developed to represent future sediment aggradation in the South Fork Snoqualmie River in the study area if no improvements are implemented. This scenario assumes that channel changes and sediment trends observed over the past 14 to 17 years will continue at a similar rate over a future 30-year period. The amount of sediment aggradation is based on information on past channel changes, ongoing channel monitoring performed by King County between RM 2.85 and 4.46, and channel cross-section surveys conducted since 1992 (King County, 2012). The effect of gravel aggradation on the river hydraulics is unknown outside this reach. The analysis of the future aggradation scenario considered only local physical adjustments to the South Fork Snoqualmie River channel in the study area; it did not consider changes to the hydrologic flow regime or widespread land use conversion in the watershed. This aggradation scenario assumed gravel deposition up to 3 feet between RM 2.74 and RM 4.58, with a localized scour section near RM 4.0 (see Figure 2-18).

Figure 2-18 shows the South Fork Snoqualmie River thalweg, right and left bank levee height profiles, and longitudinal water surface for the four design flood events. This figure shows that, for the future aggradation scenario, water surface elevations increase for all flood events upstream of RM 3.40, as a direct result of the changes in the thalweg profile. The greatest increase is associated with the 5-percent-annual-chance peak flood event, with slightly smaller increases for the 2- and 1-percent-annual-chance peak flood events. The increase in water surface elevations predicted for the 0.2-percent-annual-chance flood event is even smaller because a larger proportion of the floodwaters overtop at upstream locations and much of the flood flow is already being conveyed in the floodplain.

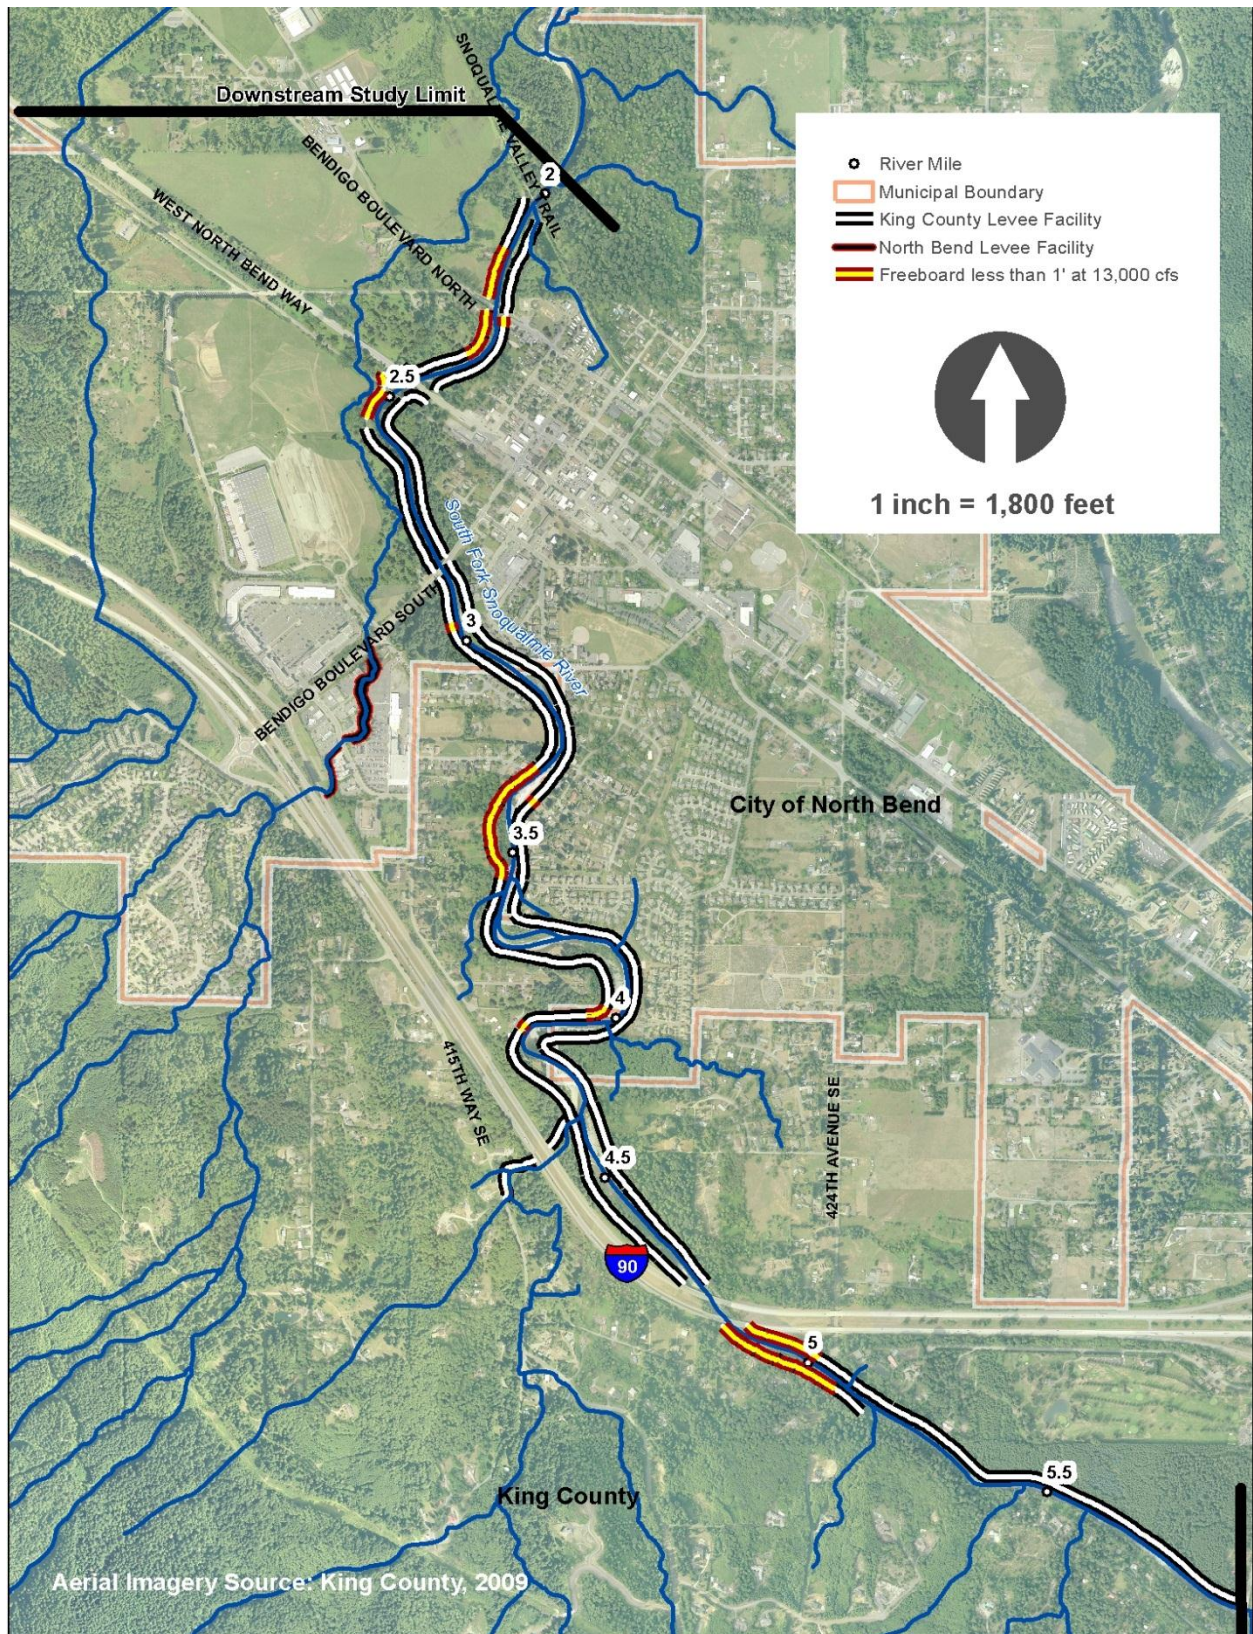
Figure 2-19. Freeboard Less than 1' for 13,000 cfs—Future Aggradation Scenario

Levee freeboard was also evaluated for the future aggradation scenario to identify locations where freeboard is less than the original design criteria of 1 foot for a 13,000 cfs design flow rate without overtopping. Figure 2-19 shows a similar trend compared to existing conditions with most of the right bank levee system having 1 foot or more of freeboard for a significant portion of the right bank with insufficient freeboard at only 5 percent of the length (920 feet). The length of levee with insufficient freeboard was greater on the left bank with 29 percent (4,325 feet) of levee with freeboard less than 1 foot. Compared to existing conditions, the length of right bank levee with insufficient freeboard was only 70 feet longer for the future aggradation scenario. On the left bank, the length of levee with freeboard less than 1 foot increased by 995 feet. The levee freeboard evaluation is documented in Appendix A.

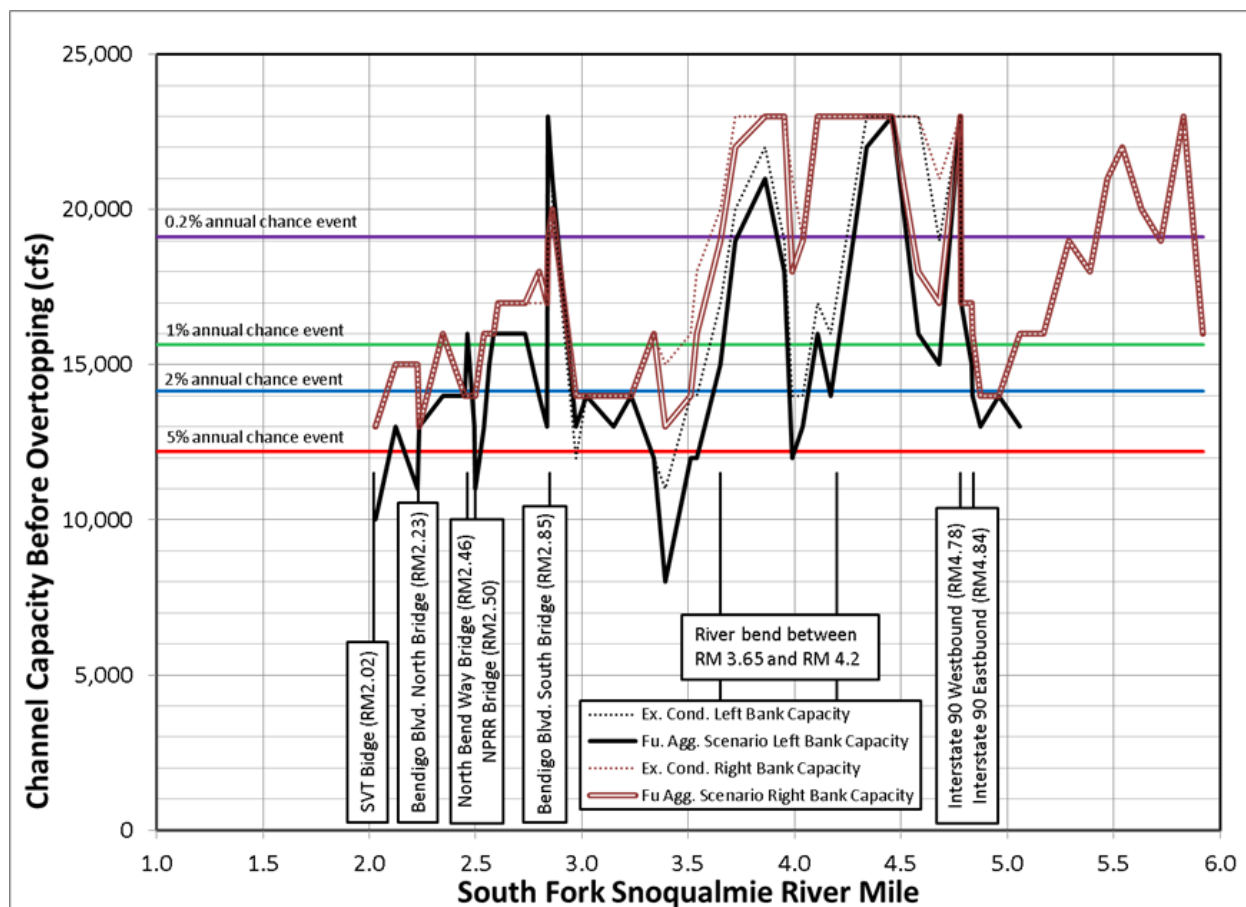
Figure 2-20. Levee Capacity without Overtopping—Future Aggradation Scenario

Levee capacity for the South Fork Snoqualmie River was evaluated using the process outlined for existing conditions (See Section 2.2.3) Similar to existing conditions, the right bank levee system is able to convey higher stream flow rates before overtopping compared to the left bank levee. The left bank levee has insufficient capacity to convey the 5-percent-annual-chance-event for 15% (2,360 feet) of the length of the levee whereas the right bank has adequate capacity to convey the same event for the entire length of levee. Compared to existing conditions, the length of the left bank levee system with sufficient capacity to convey the 5% annual-chance-event is reduced by 340 feet. For the 1-percent-annual-chance event, the left bank has adequate capacity over 35 percent (5,500 feet) of the length compared to the right bank which has the capacity to convey the same event for over 70 percent (14,210 feet) of the length. For the left bank, the length of levee capable of conveying the 1-percent-annual-chance event is reduced by almost 1,800 feet compared to existing conditions.

Figure 2-20 shows the flow capacity for left and right bank levee system for the South Fork Snoqualmie River. Similar to existing conditions, this figure shows that backwater from the bridge structures reduces the capacity of the levee system upstream of all road crossings. However, gravel deposition in the aggradation reach (RM 2.7 to 4.6) significantly reduces the capacity near RM 4.0 to less than the peak flow for the 5-percent-annual chance event (12,190 cfs). For existing conditions, the capacity is about equal to the 2-percent-annual chance peak flood event of 14,160 cfs.

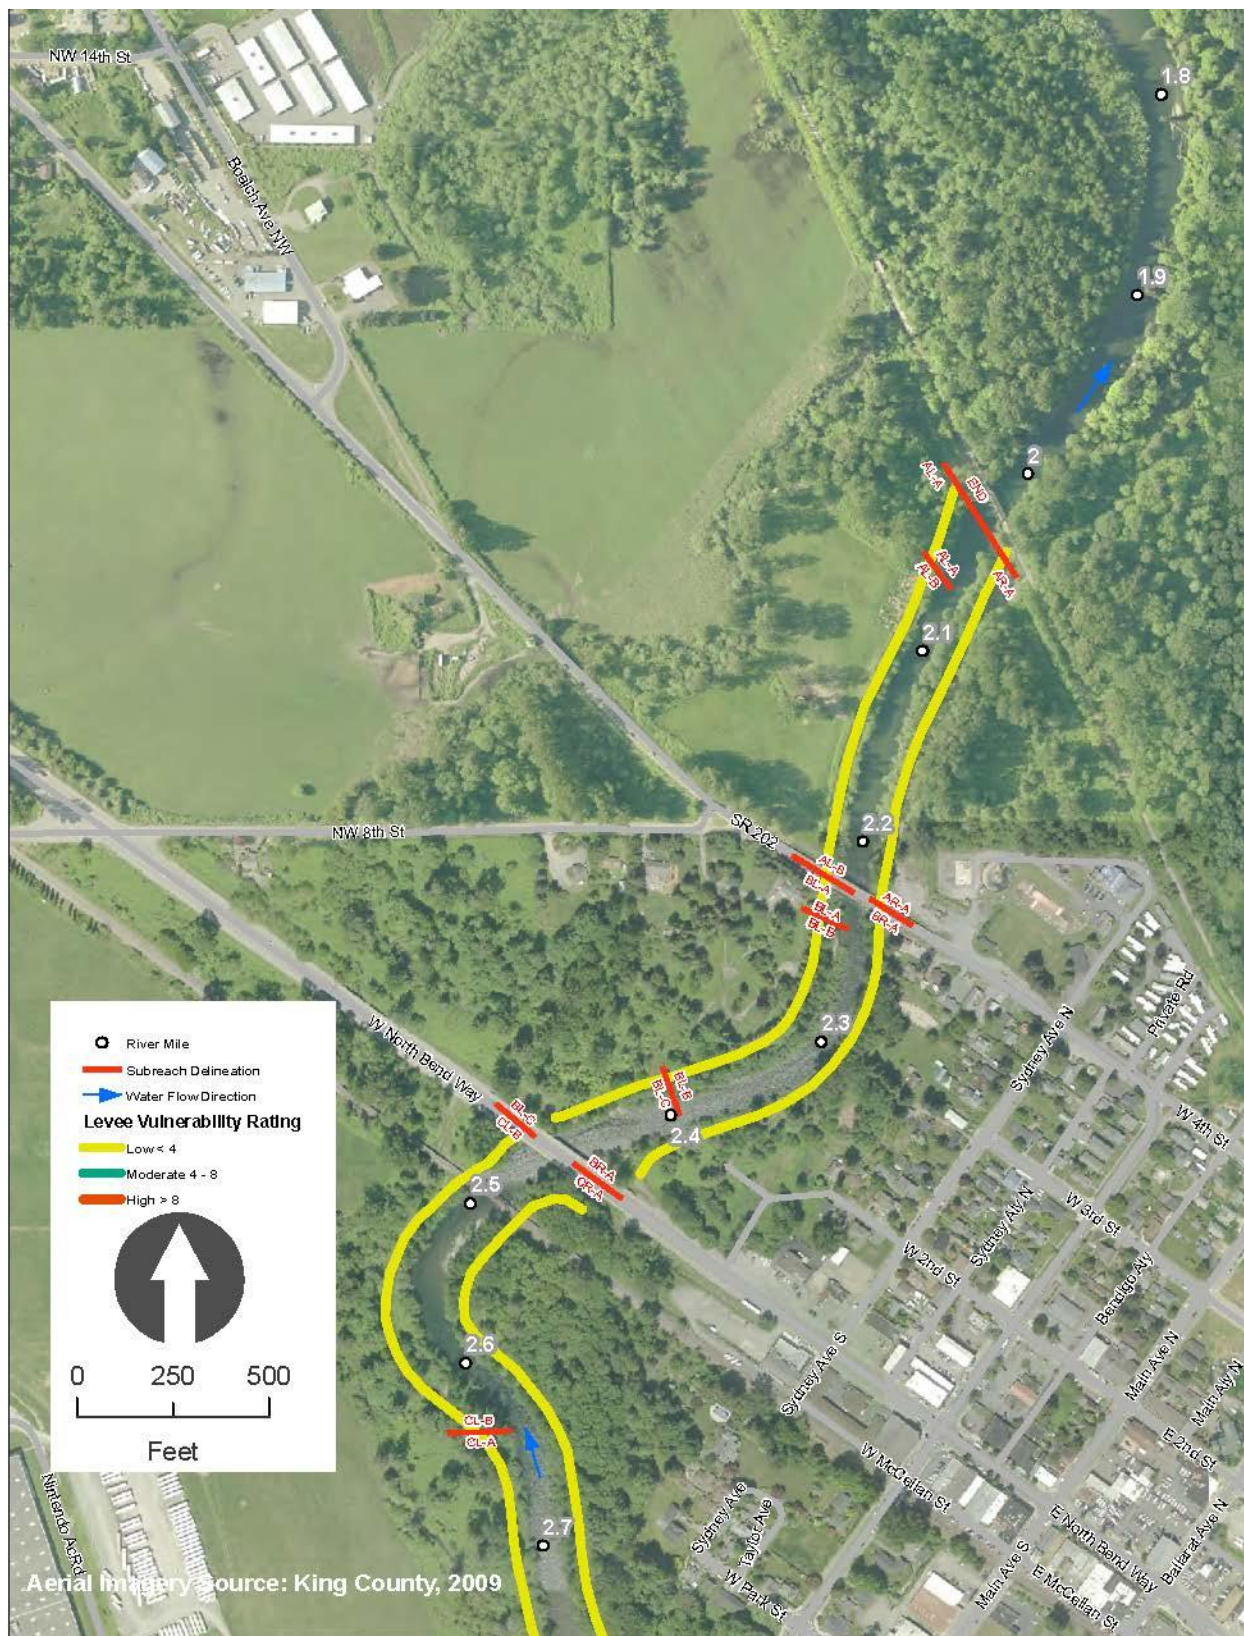
Figure 3-1. Levee Vulnerability Rating, RM 2.0 to RM 2.7

The vulnerability value was obtained by multiplying the ratings for the levee height, crest width and riverside slope. A vulnerability value less than 4 indicates a levee section with low vulnerability. A value between 4 and 8 indicates moderate vulnerability. A value greater than 8 indicates high vulnerability. Levee vulnerability is shown graphically in Figures 3-1 to 3-4.

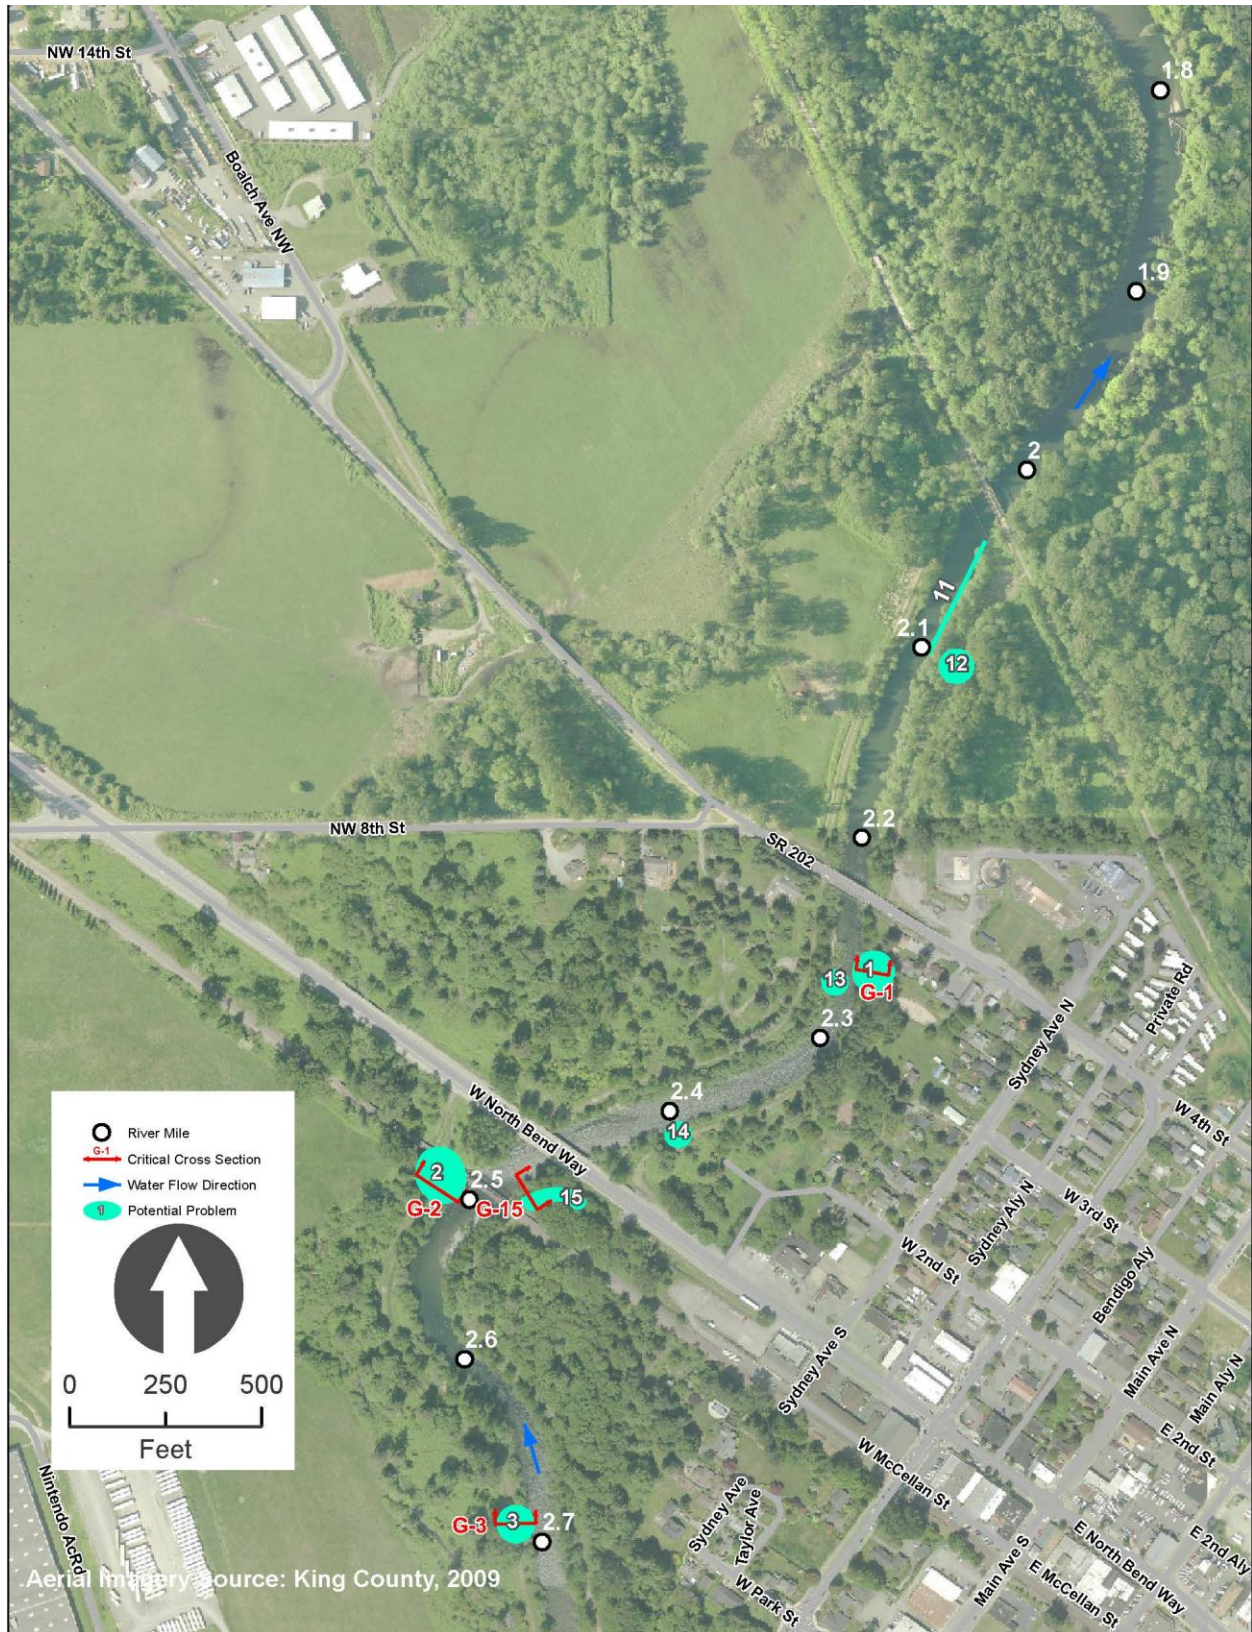
Figure 3-5. Potential Geotechnical Problem and Critical Section Locations RM 2.0 to RM 2.7

The remaining 20 problems selected for a higher level of evaluation include 11 potential seepage or piping problems (combined with erosion, depression, or steep slopes) and nine steep slope or bank erosion problems. The geotechnical and hydrogeological problem locations of the top 20 are shown in Figures 3-5 through 3-8.

Following the determination of potential geotechnical and hydrogeologic problem ratings, the project team and King County selected seven critical sections for additional stability and seepage analyses. Potential problems with a likelihood of failure rating of 7 or greater were selected as critical sections. Five of the sections are on the left bank and two are on the right bank. Critical section locations are listed in Table 3-5; locations are also shown in Figures 3-5 through Figure 3-8. The levee height of the critical sections as measured from the landside toe is typically 4 to 5 feet, with the exception of locations G-3 and G-23 which are 8 and 10 feet high, respectively. Levee crest widths vary from 15 feet at locations G-1 and G-23 to greater than 20 feet at the other locations. Riverside slope inclinations are severe (steeper than 1.5H:1V) at locations G-3, G-5, G-15, and G-23, and moderate (1.5 -2H:1V) at the remaining locations.

TABLE 3-5 CRITICAL SECTION LOCATIONS		
Location ID	River Bank	River Mile
G-1	Right	2.27
G-2	Left	2.51
G-3	Left	2.70
G-5	Left	3.10
G-8	Left	4.18
G-15	Right	2.47
G-23	Left	4.5 to 4.6
