**South Fork Snoqualmie River
Levee Repair and Reconstruction Plan**

**South Fork Snoqualmie River
Levee Characterization Report
River Mile 2.0 – 5.9**

June 2014

Tetra Tech

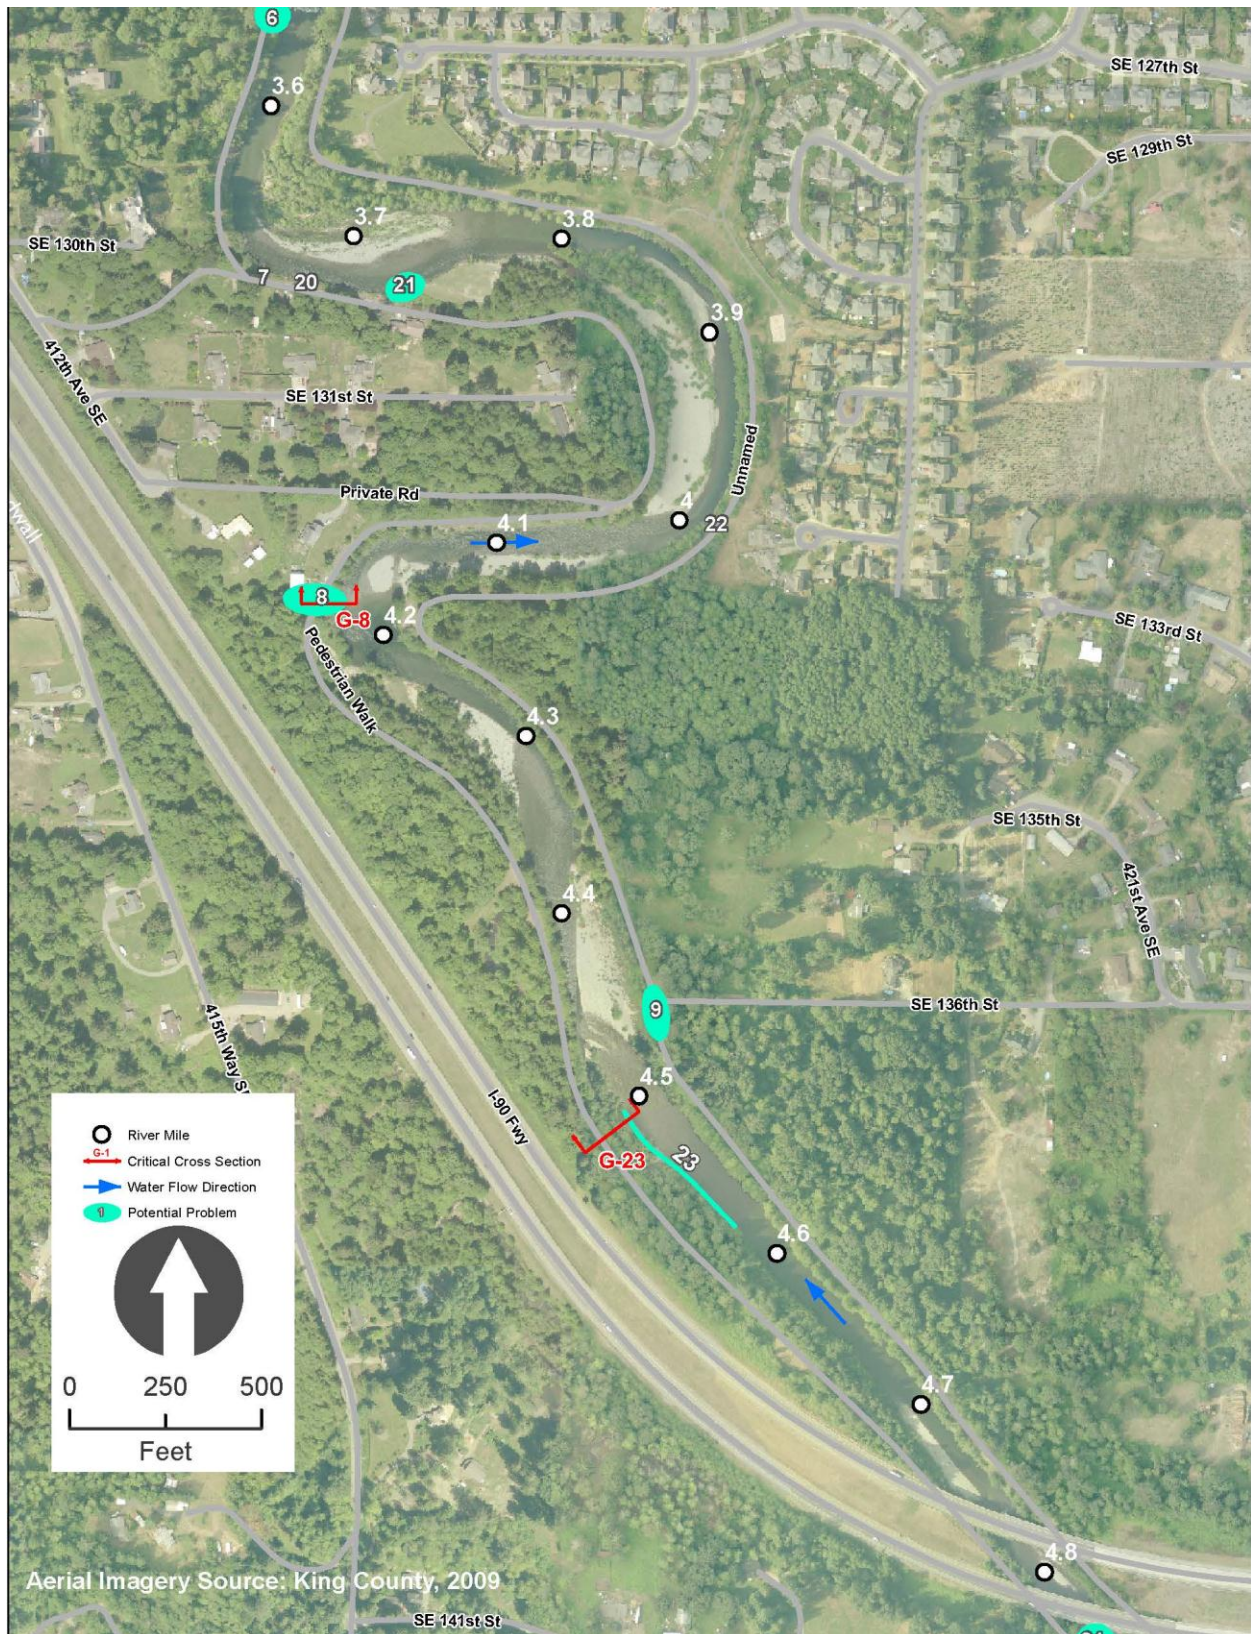
Figure 3-7. Potential Geotechnical Problem and Critical Section Locations RM 3.6 to RM 4.8

The remaining 20 problems selected for a higher level of evaluation include 11 potential seepage or piping problems (combined with erosion, depression, or steep slopes) and nine steep slope or bank erosion problems. The geotechnical and hydrogeological problem locations of the top 20 are shown in Figures 3-5 through 3-8.

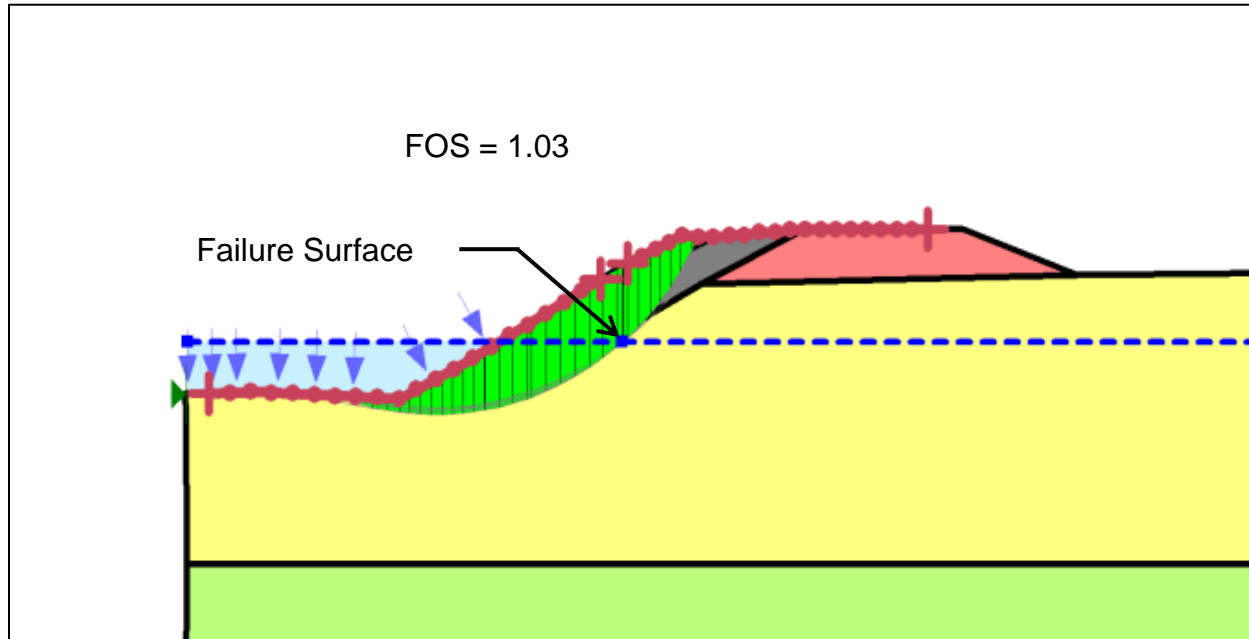
The results of the seismic analyses show the failure surfaces are typically on the riverside slope, extending from the toe of the slope upward and exiting on the riverside slope or at the levee crest. For example, Figures 3-22 and 3-23 show the failure surfaces analyzed for location G-1 for the seismic case. Figure 3-22 represents the case where the riprap is assumed to be equal to the design thickness, and Figure 3-23 shows the failure surface if a 5-foot thickness of riprap were constructed on the slope. The thickness of the failed soil mass varies from about 3 to 5 feet for the seismic analyses. Detailed figures showing the results for each critical section location and analysis case are provided in Appendix C.

Figure 3-23. Location G-1, Seismic Results for 5-foot Thickness of Riprap, Factor of Safety = 1.03

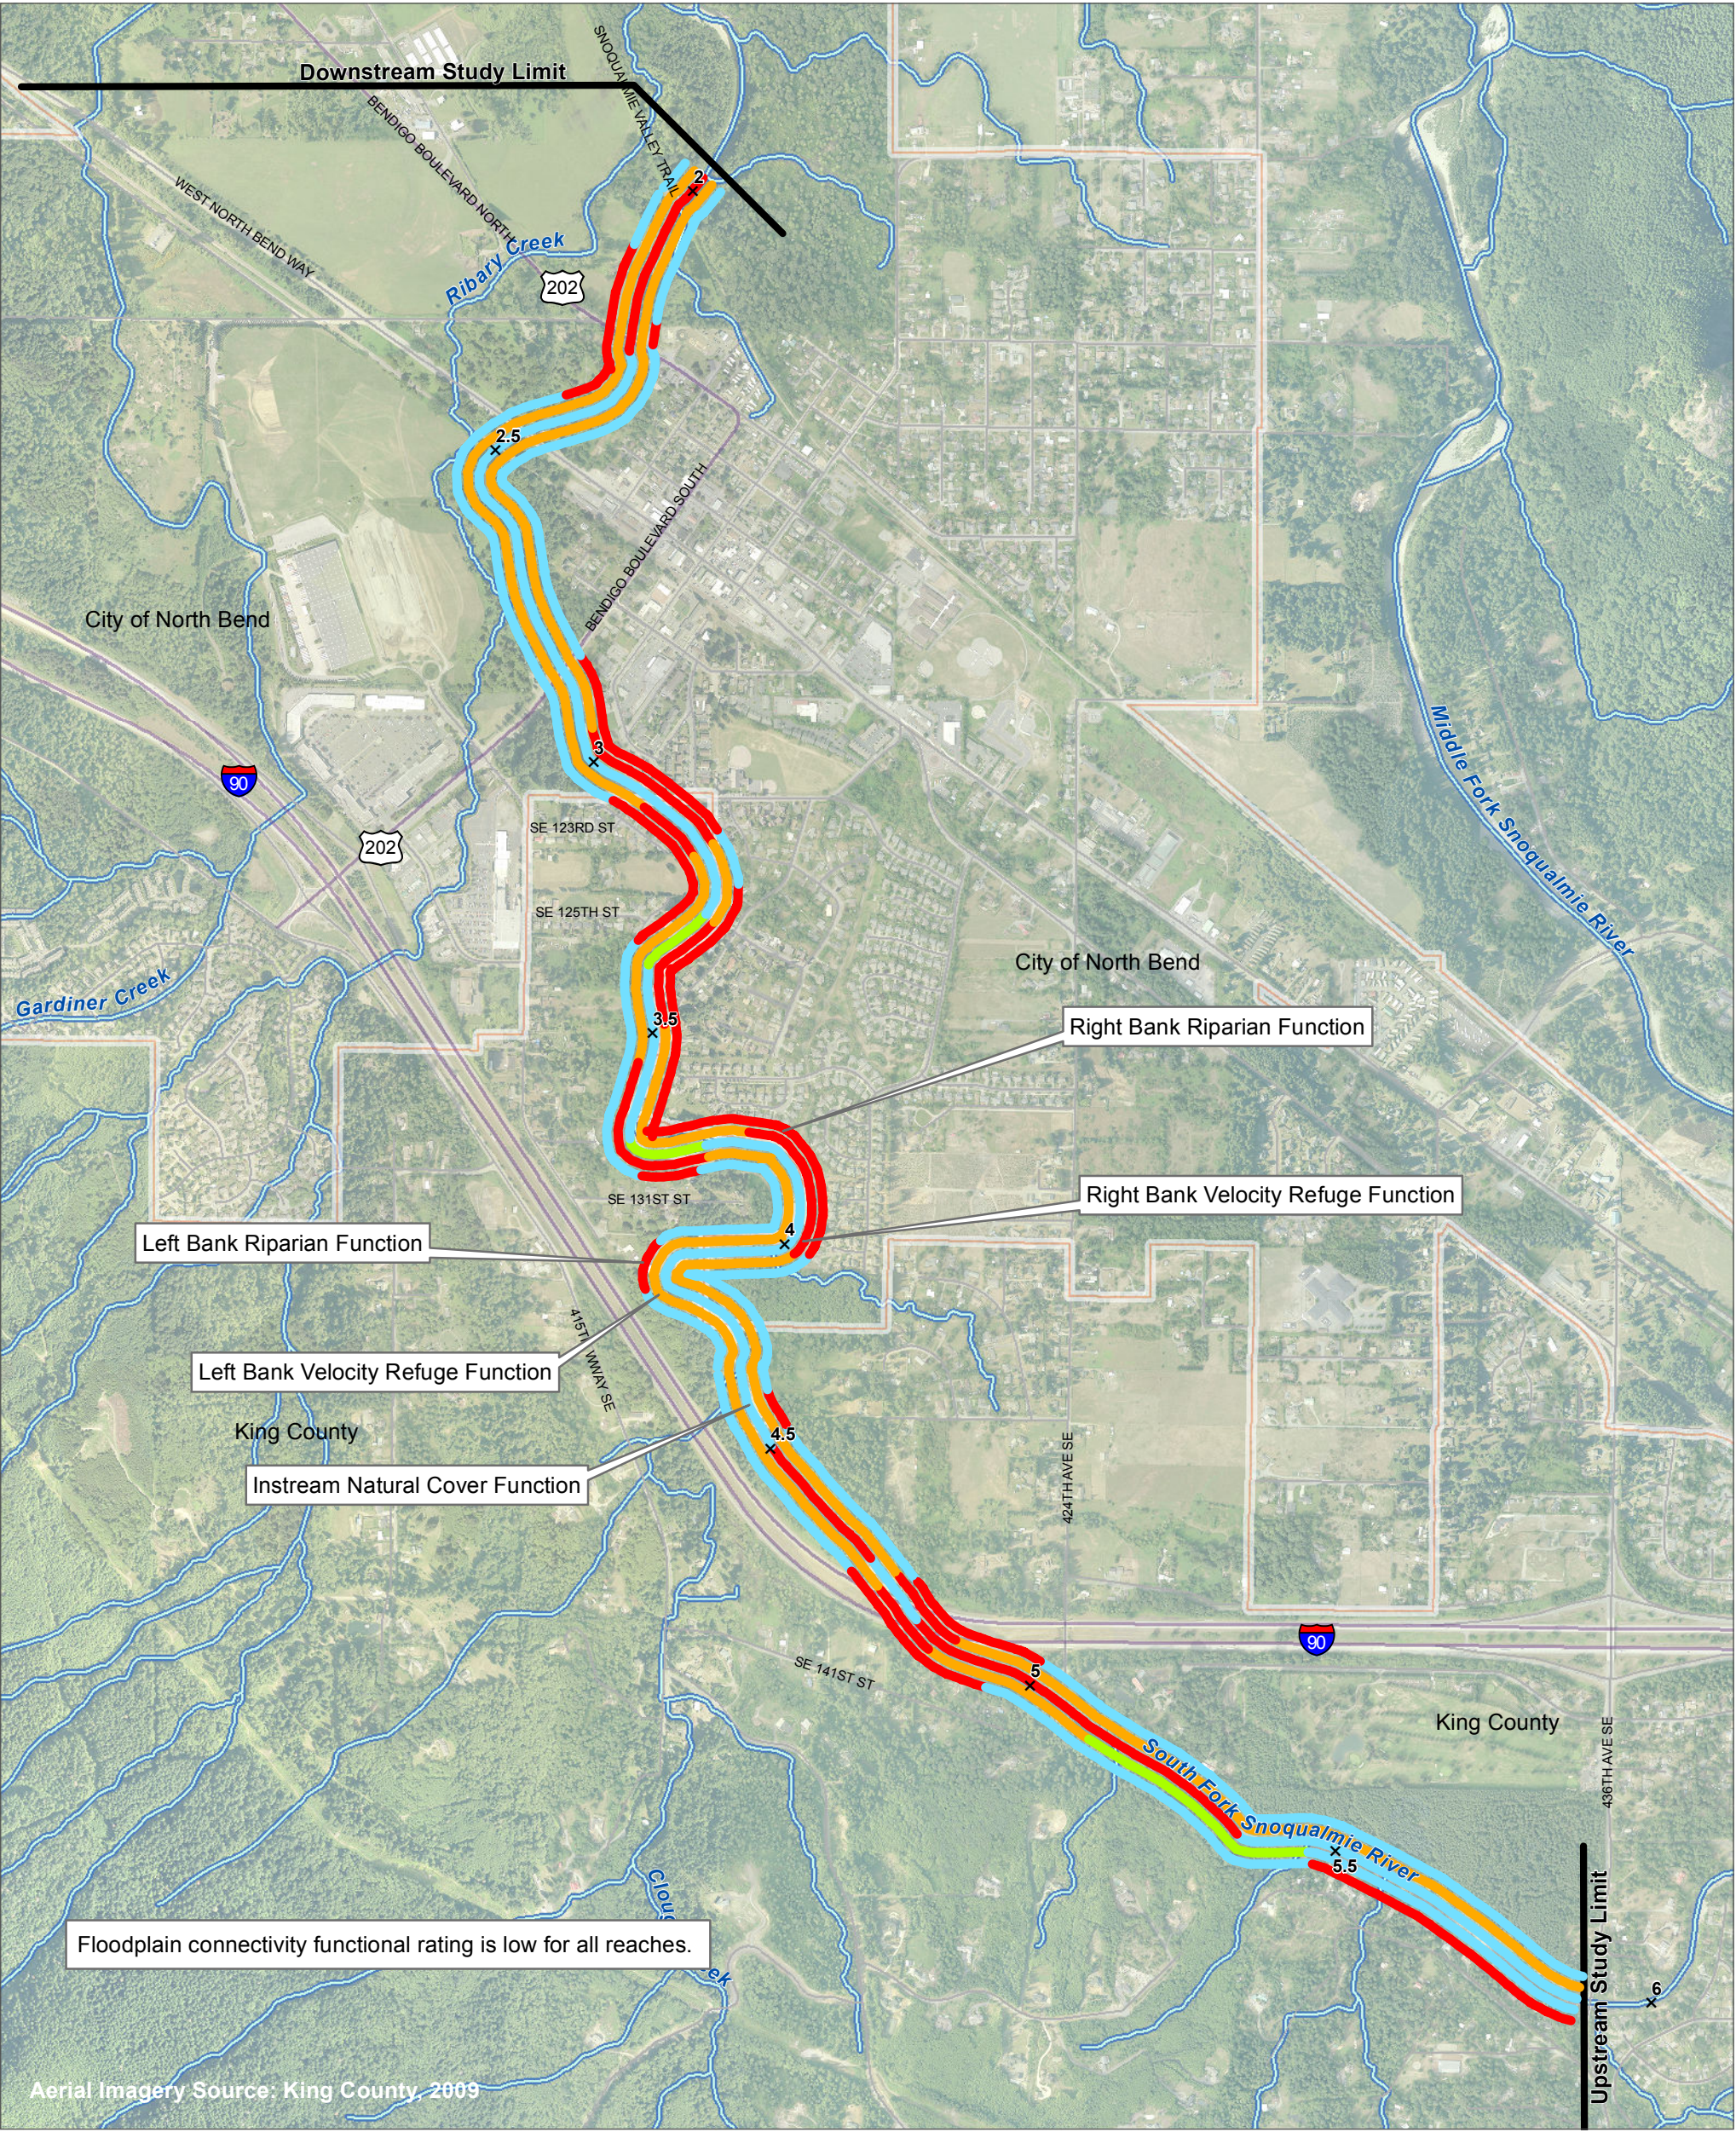
The entire study area has stream banks that are confined by levees, with the exception of the left bank from RM 5.1 to 5.9, which has a natural slope. Much of the streambank along levees has scattered areas of shrubs and small trees and was rated with low functions, but may have some functions because of mature shrubs and small trees growing on the levees. These vegetated areas provide only minimal refuge during higher flows, although they may provide more refuge than streambank sections with emergent vegetation, small shrubs, and riprap, which provide no substantial refuge from high flows.

Figure 4-4. Ecological Function
South Fork Snoqualmie River Levee Characterization Report, RM 2.0 - 5.9

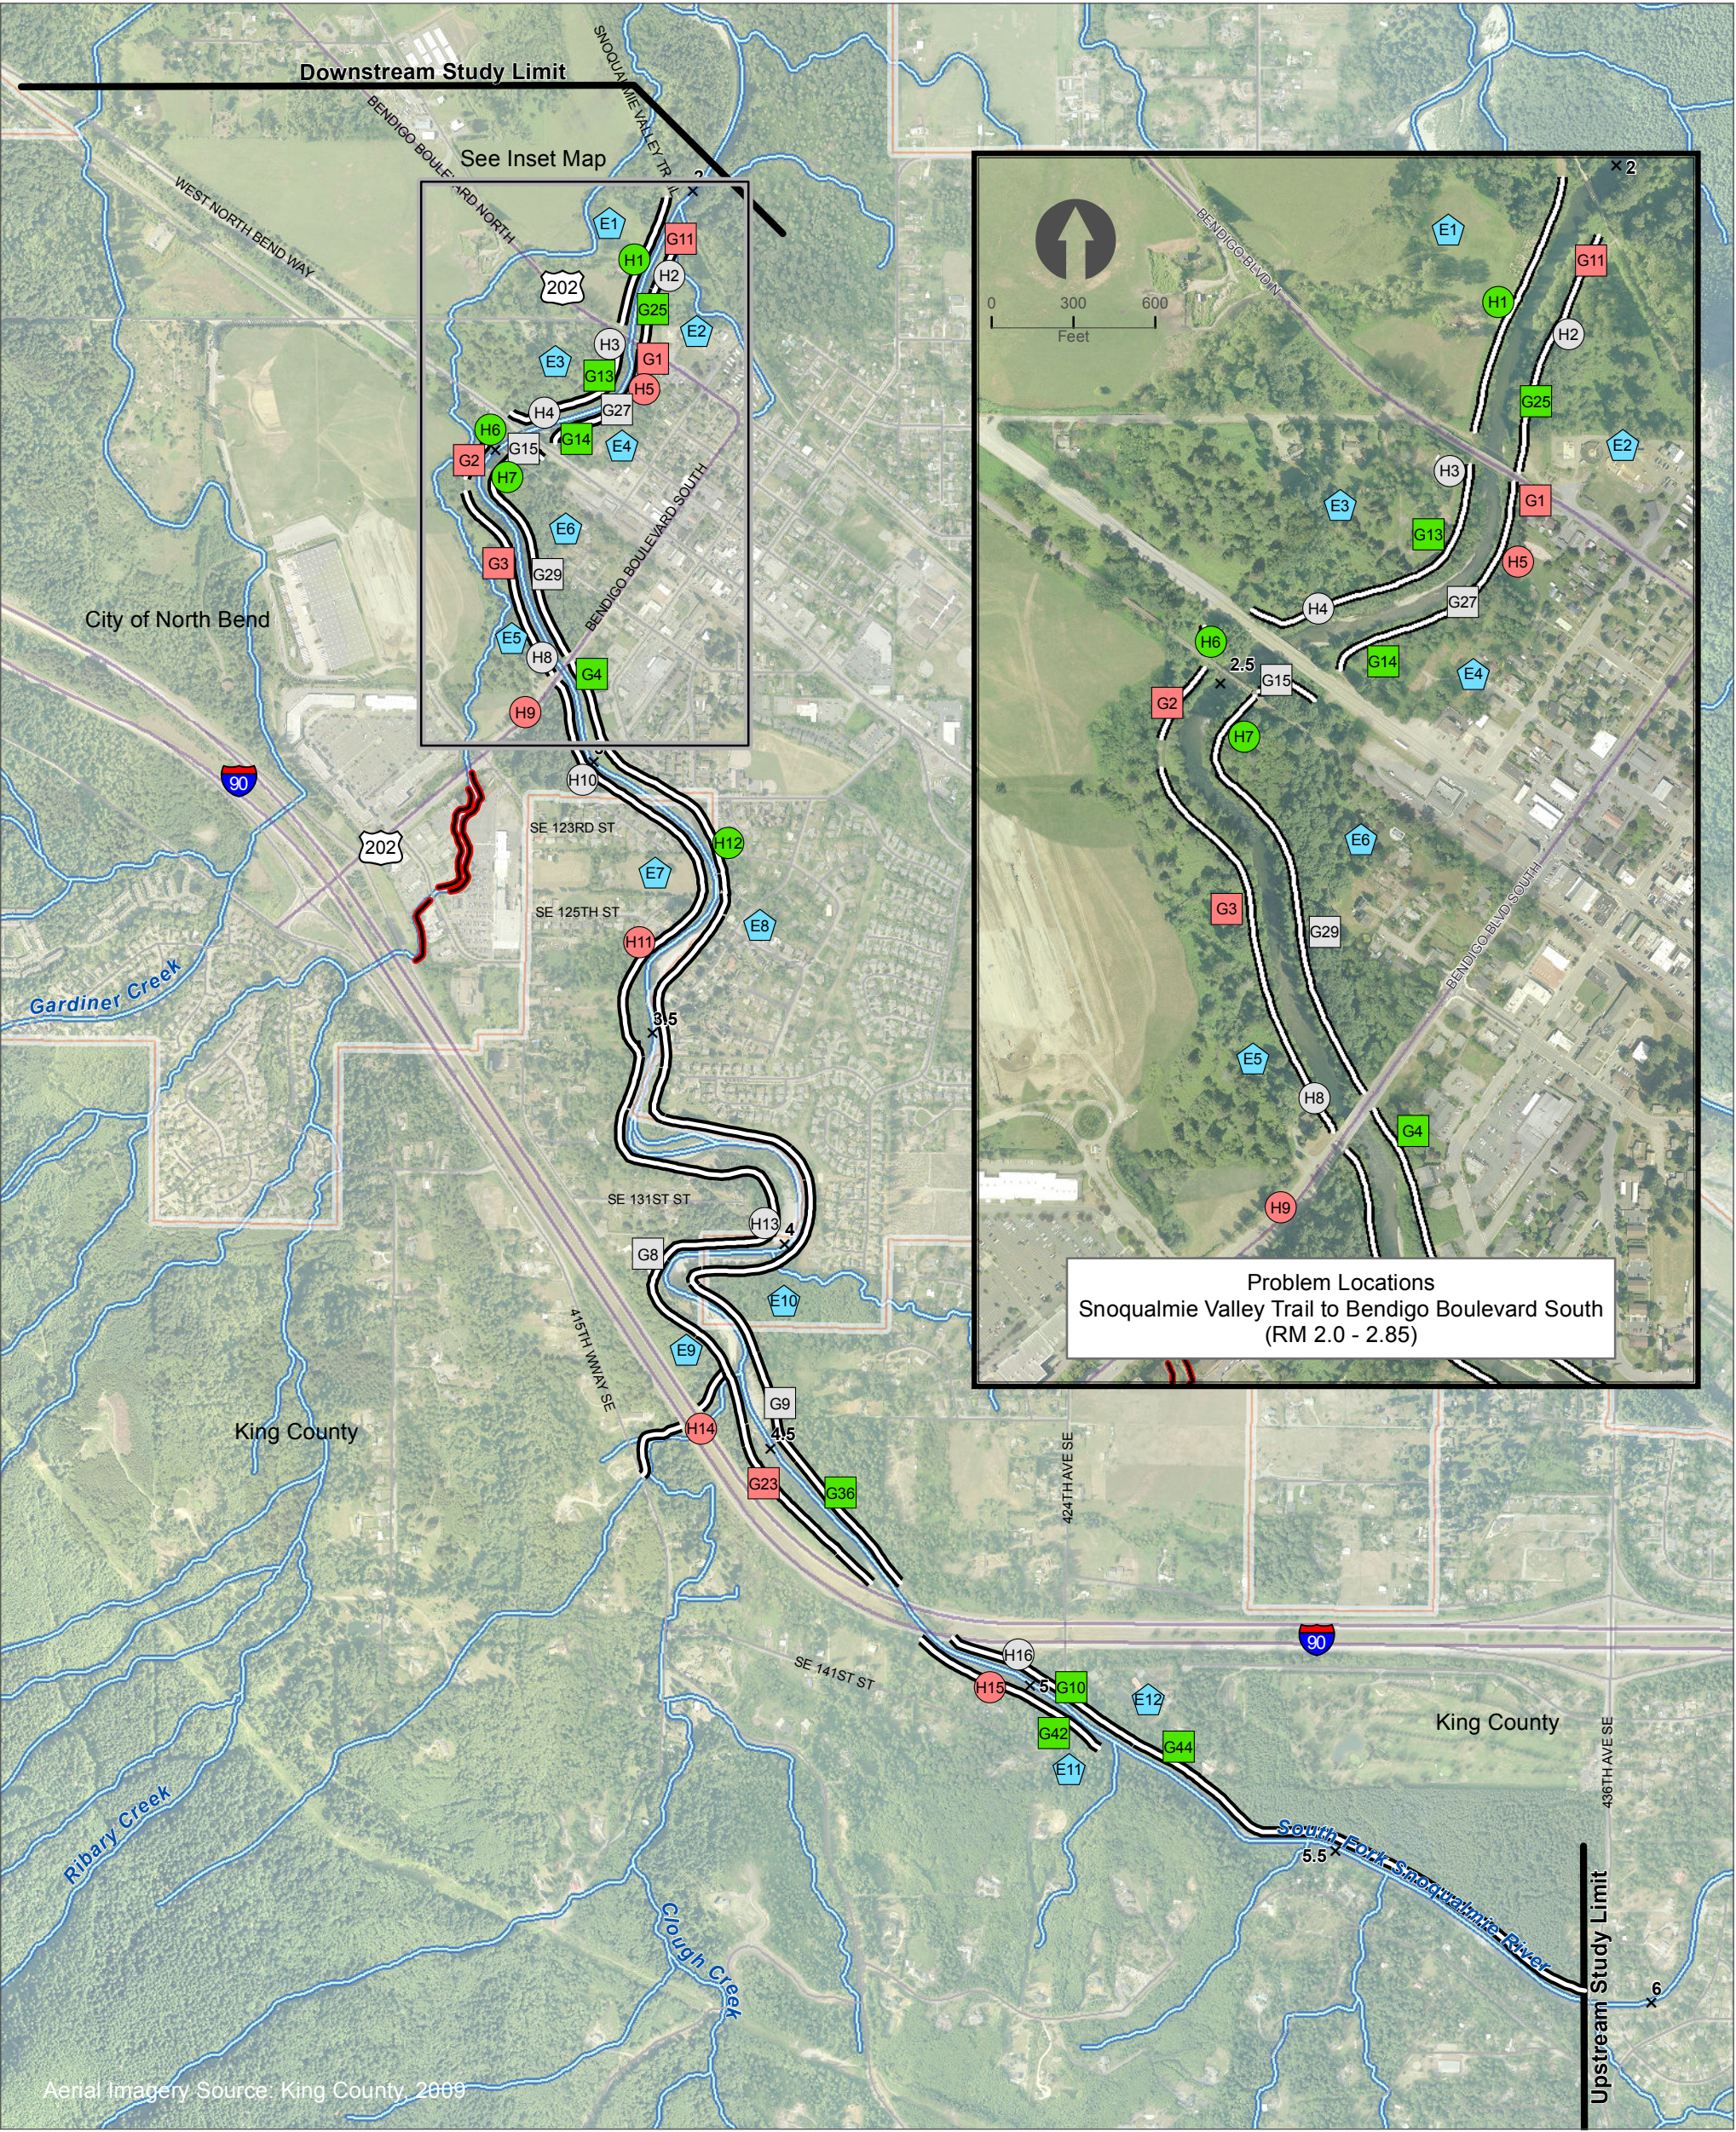
Each of the identified problems documented in the previous chapters have been compiled in Table 5-1 shown below. This table describes the problems and lists potential consequences of failure. Problems are grouped by reaches generally defined by road crossings. Locations of the problems are shown in Figure 5-1.

Figure 5-1. Hydraulic, Geotechnical, and Ecological Problem Areas
South Fork Snoqualmie River Levee Characterization Report
