# **2012 Post Construction Monitoring Report King County Multiple Stormwater Facility Retrofits**

**DOE Stormwater Retrofit Grant  
Grant Agreement Number G1100216**

November 30, 2012

2012 Post Construction Monitoring Report  
King County Multiple Stormwater Retrofits

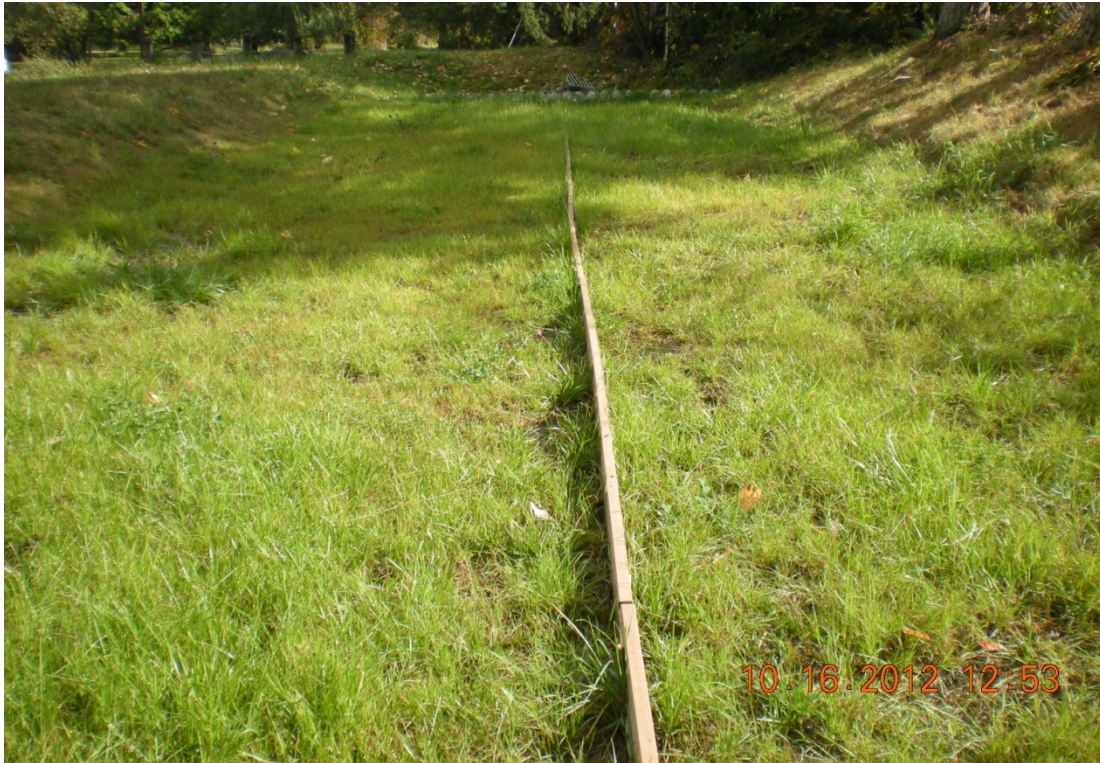
Webster Lake Estates Tract G

Webster Lake Estates Tract G.

The bioswale was regraded and reseeded with a grass seed mix in Table 6.3.1.C of the 2009 King County Surface Water Design Manual. Plant survival is over 80%. The first half of the swale shows close to a 100% survival rate for bioswale grass and coverage. The final half shows bioswale grass survival and cover of about 70%. No rills or eroded channels were observed in the graded swale channel bottom. It is expected that the swale grass in the final half of the cell will fill in as precipitation increases and the swale experiences more flow. No further action is recommended.

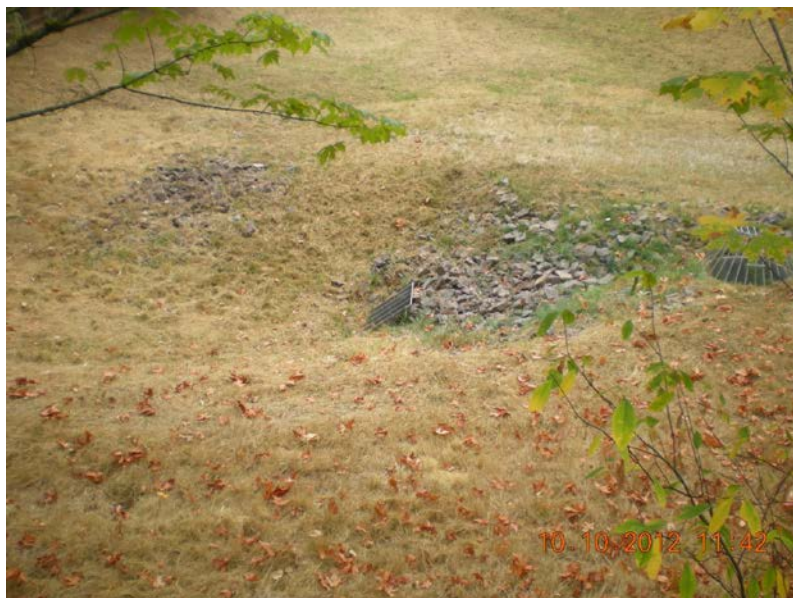
Vigorous growth can be seen across site, emergency overflow has not yet been utilized.

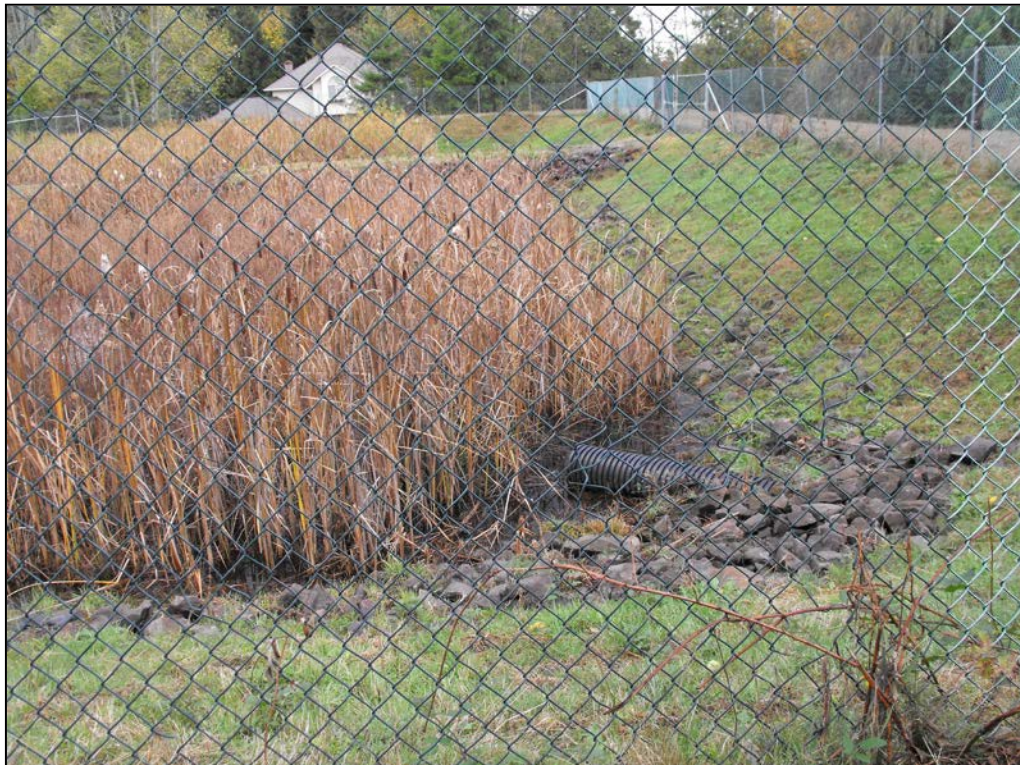
Park Avenue Picture 3: Pond Outlet

No significant storm event has occurred since this facility has been retrofitted. No further actions are recommended.

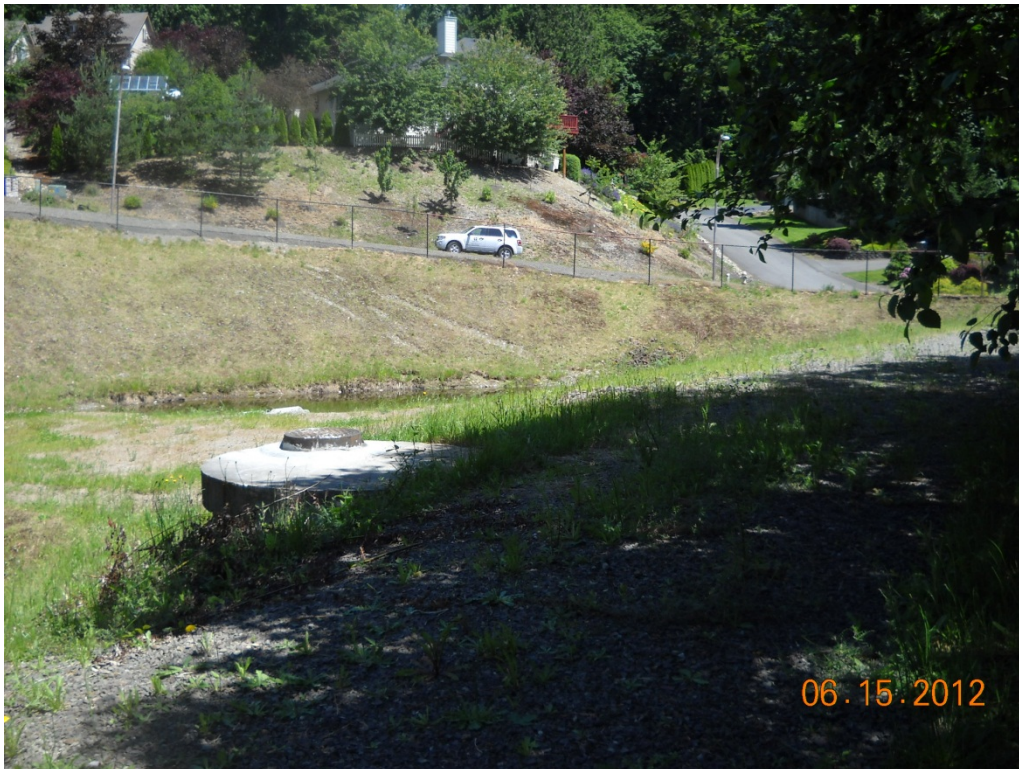
Quail Creek No. 2 and 3 View of head end of pond, from southwest.
