King County District Court Site LID Retrofit Project

Preliminary Pre-Engineering Design Report

Basin Study:	Miller-Walker Basin Stormwater Retrofit Planning Study
Site Name:	King County District Court Site
Site Location:	Burien, Washington
Site Number:	KC-47 (for reference in Implementation Plan Report)
Basin Partners:	King County; Cities of Burien, Normandy Park, and SeaTac; the Port of Seattle, and the Washington State Department of Transportation

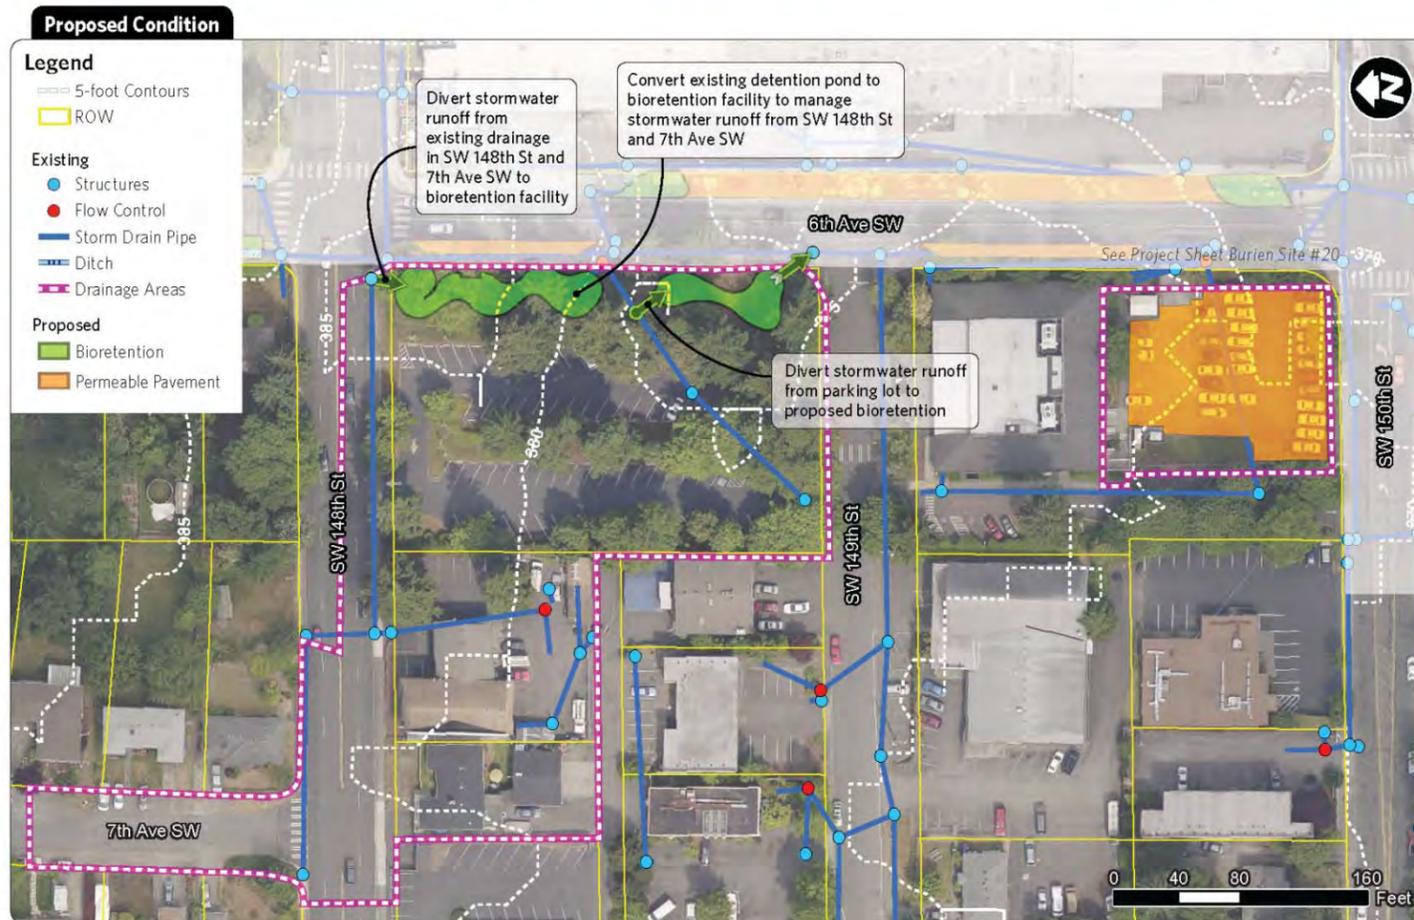
PROJECT STUDY AREA: KING COUNTY SITE #47
KING COUNTY DISTRICT COURT
(601 SW 149TH ST & 14905 6TH AVE SW)

LID Typology: Bioretention, Permeable Pavement, Additional Flow Control	Planning-Level Construction Cost Range	
Receiving Water: Miller Creek	Low end: \$524,000	
Site Priority Rank: #6	Middle: \$747,907	
	High end: \$1,122,000	
Description		
This project would modify an existing detention pond to accommodate additional stormwater runoff diverted from SW 148th Street and incorporate bioretention into the facility to provide enhanced stormwater treatment for the tributary drainage area. The project would also replace the existing impervious Police parking lot (south of the King County Courthouse) with permeable pavement to provide flow control. Both sites currently drain to Ambaum Pond through flow control structures and an oil water separator.		
Opportunities	Constraints	
<ul style="list-style-type: none"> Convert an existing flow control facility into bioretention Provide enhanced water quality treatment and flow control for stormwater runoff diverted from SW 148th St Provide very good educational opportunities near the parking lot north of the King County District Courthouse Deep infiltration feasibility is good based on preliminary soil testing and could be used to infiltrate site stormwater runoff 	<ul style="list-style-type: none"> Many large trees on site would need to be protected in place A flow splitter may be required to control the amount of stormwater to be divert from the SW 148th Street drainage system to the modified pond.

Drainage Area (SF)	Pollutant Load Reduction	Hydrology
Roof: 7,300	Copper (Lbs/yr): 0.10	Avg. Annual Vol. Infiltrated (ac-ft/yr): 6.41
Sidewalk: 7,500	Fecal Coliform (MPN in billions/yr): 0	Subbasin M-11:
Parking: 51,645	Nitrogen (Lbs/yr): 4.65	2-yr Peak Flow Reduction: 10%
Roadway: 26,930	Phosphorus (Lbs/yr): 0.95	High Pulse Count Reduction (Avg # High Pulses/yr): 5%
Pervious: 29,775	Suspended Solids (Lbs/yr): 564.67	High Pulse Count Reduction (Avg High Pulse Count Range/yr): 2%
Total: 123,150 SF	Zinc (Lbs/yr): 0.83	B-IBI Increase: 16.6to 17.3 (4%)

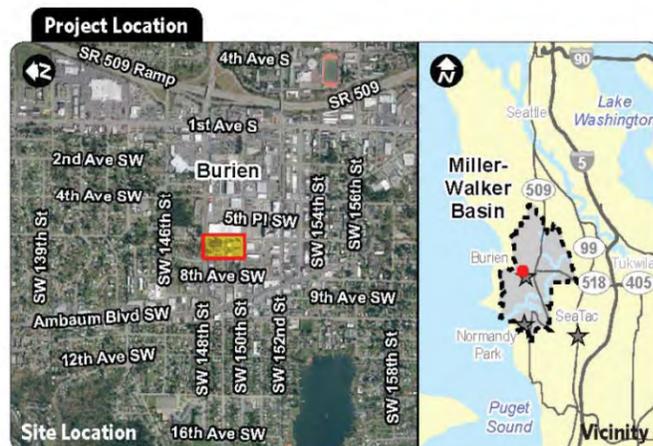
Figure 2 Proposed Project Improvements

- Replace approximately 0.253 acres of existing impervious parking lot on the south side of the King County District Courthouse with permeable pavement, which includes replacing the existing curb around the perimeter of the parking lot. The permeable pavement will manage stormwater runoff from the 0.333-acre tributary area (0.253 acres of permeable pavement with 0.08 acres of run-on).

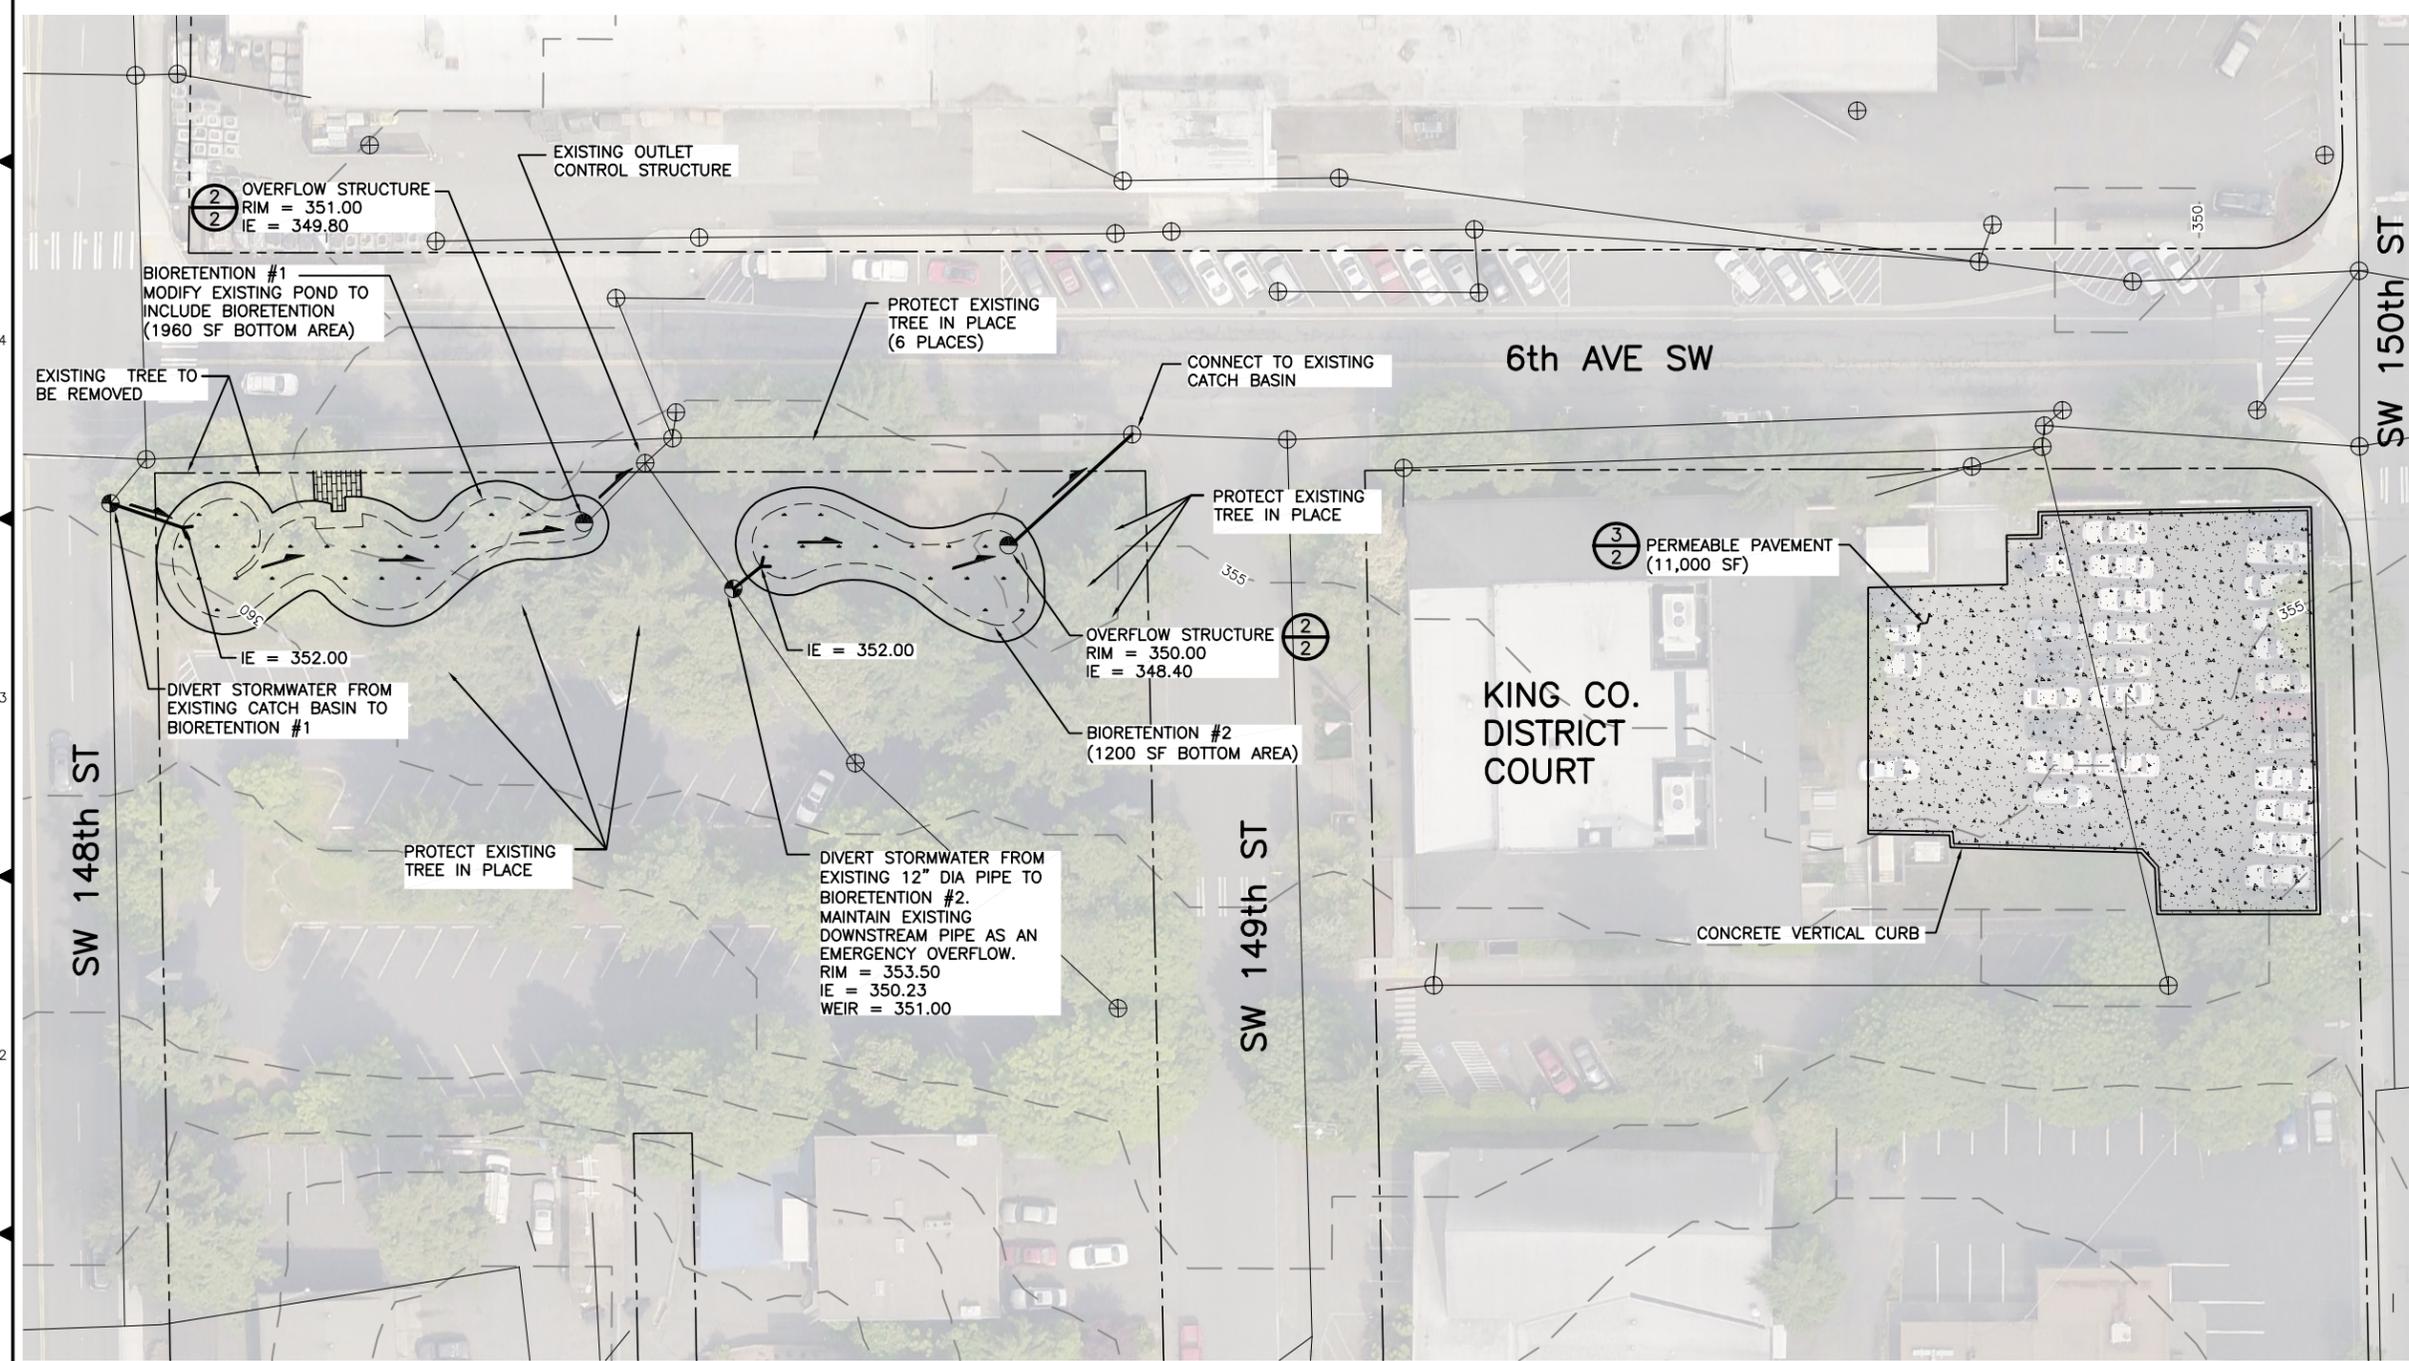
DEPARTMENT OF NATURAL RESOURCES & PARKS
 WATER AND LAND RESOURCES DIVISION
 MILLER-WALKER BASIN STORMWATER RETROFIT
 PROJECT KC-47
 KING COUNTY DISTRICT COURT
 STORMWATER RETROFIT
 CONCEPTUAL SITE LAYOUT

1. DRAINAGE STRUCTURE AND PIPE ELEVATION INFORMATION IS BASED ON AS-BUILT DRAWINGS TO BE CONFIRMED DURING PRELIMINARY DESIGN.
2. DRAINAGE STRUCTURE AND PIPE LOCATIONS SHOWN ON PLANS ARE BASED ON CITY OF BURIEN'S GIS DATA TO BE CONFIRMED DURING PRELIMINARY DESIGN.

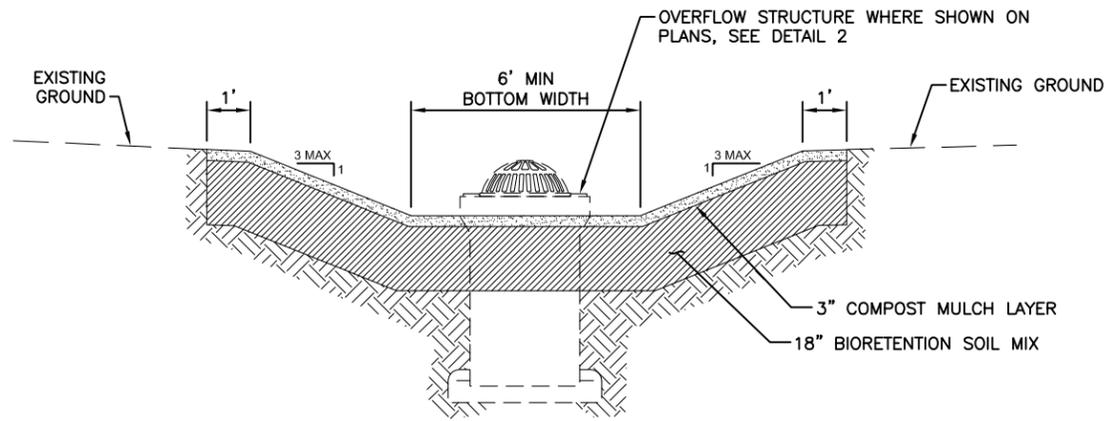
**TYPICAL BIORETENTION
CROSS SECTION**

DETAIL 1
NTS TYP

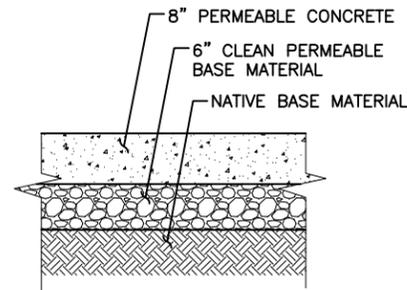
**TYPICAL PERMEABLE CONCRETE
CROSS SECTION**

DETAIL 3
NTS

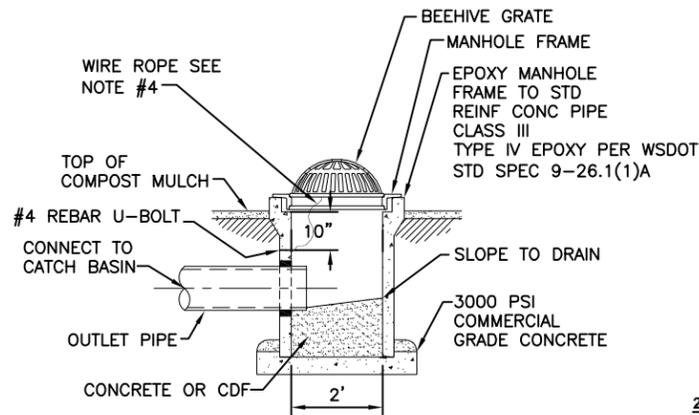
**OVERFLOW STRUCTURE
DETAIL 2**

1. SECURE GRATE IN PLACE WITH 54-INCHES OF WIRE ROPE. LOOP ENDS OF WIRE ROPE AROUND U-BOLT AND GRATE. CRIMP EACH END OF WIRE ROPE WITH 3" OVERLAP.
2. DRILL 2" DEEP HOLES INTO PIPE AND EPOXY #4 REBAR U-BOLT (2"x4") IN HOLES.
3. GRATE TO BE CAST IRON, ASTM A48 CL30.
4. WIRE ROPE TO BE 1/8" - 3/16" STAINLESS STEEL, 7 STRANDS OF 19 WIRES.

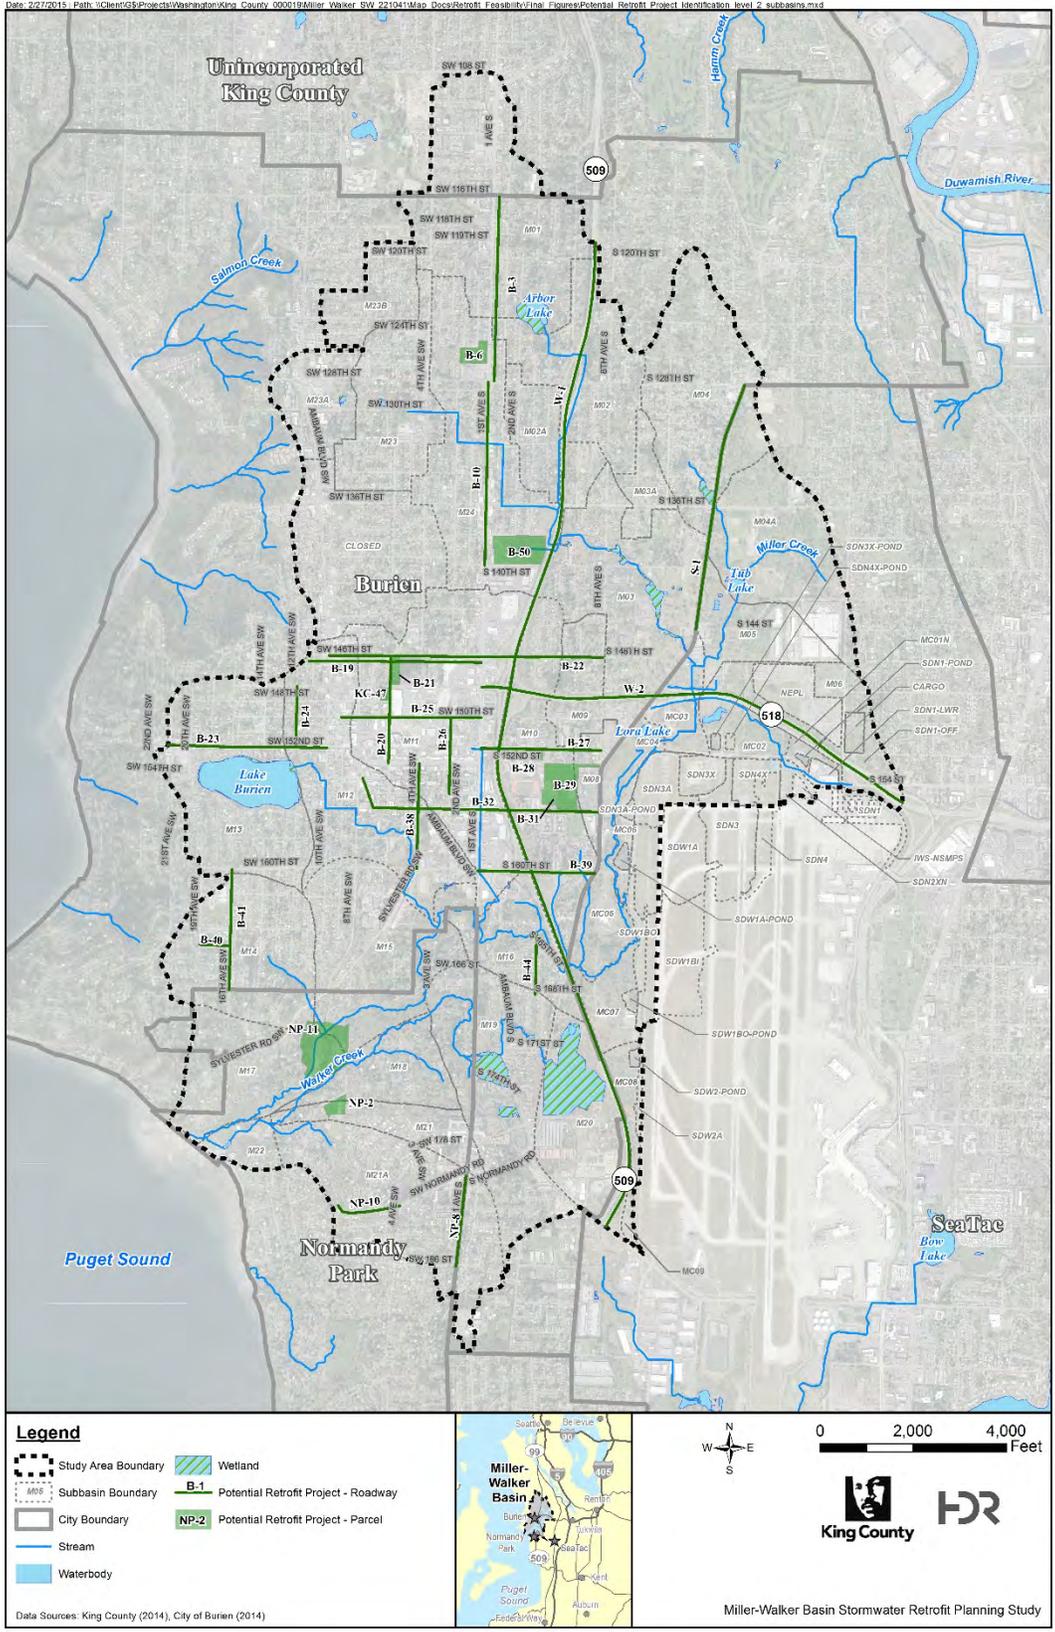
Figure 1 – Locations of Top 30 Stormwater Retrofit Projects

The locations of the proposed 30 stormwater retrofit projects are shown in Figure 1. This is a planning-level analysis with estimates of tributary area and infiltration footprint for each project determined from available Geographic Information System (GIS) data and windshield field surveys. Many of the projects span across model subbasin boundaries, which required delineating separate tributary areas for each subbasin that the project was located in. A summary of each project showing the type(s) of GSI, the tributary area captured by each type of GSI, and the area of each type of facility proposed is shown in Table 1.

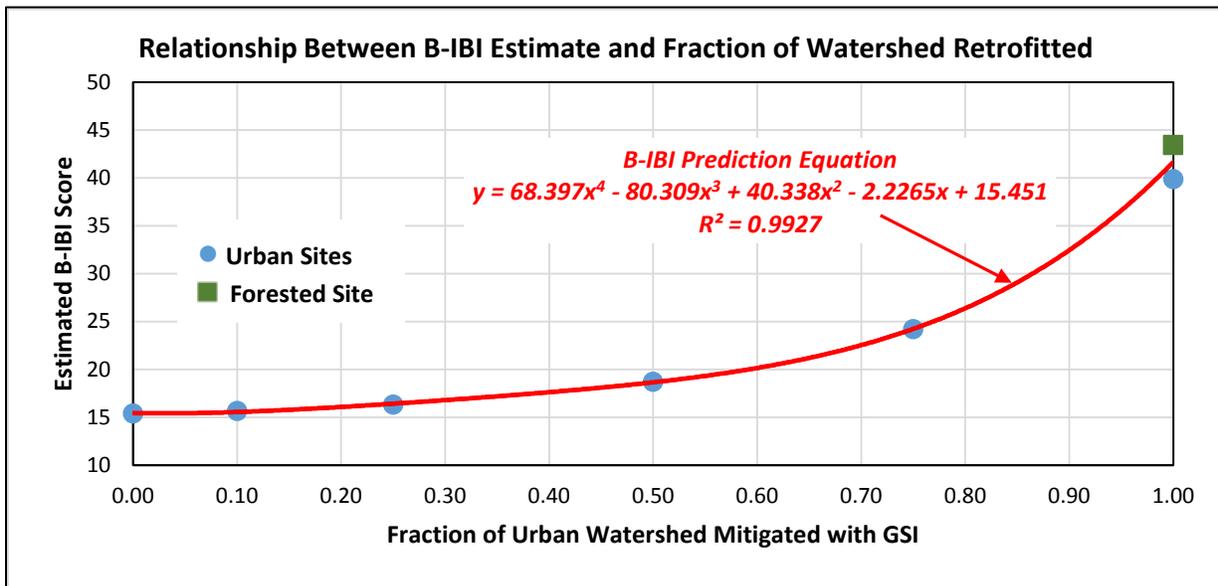
Figure 2 – Relationship Between Predicted B-IBI Score and Fraction of Watershed Retrofit with GSI

Test Site	Fraction of Site Mitigated by GSI	Predicted B-IBI Score
1. Urban	0.00	15
2. Urban	0.10	16
3. Urban	0.25	16
4. Urban	0.50	19
5. Urban	0.75	24
6. Urban	1.00	40
7. Forest	N/A	43

An example application of the regression equation is as follows. A GSI project is proposed for a subbasin that currently has 50-percent of the urban area mitigated with GSI. Using the B-IBI prediction equation in Figure 2, the estimated B-IBI score for current conditions would be 18.7. With the proposed project, the subbasin would have 60-percent of the total area mitigated with GSI and the predicted B-IBI score would be 20.2 or a 1.5 point increase in B-IBI score.

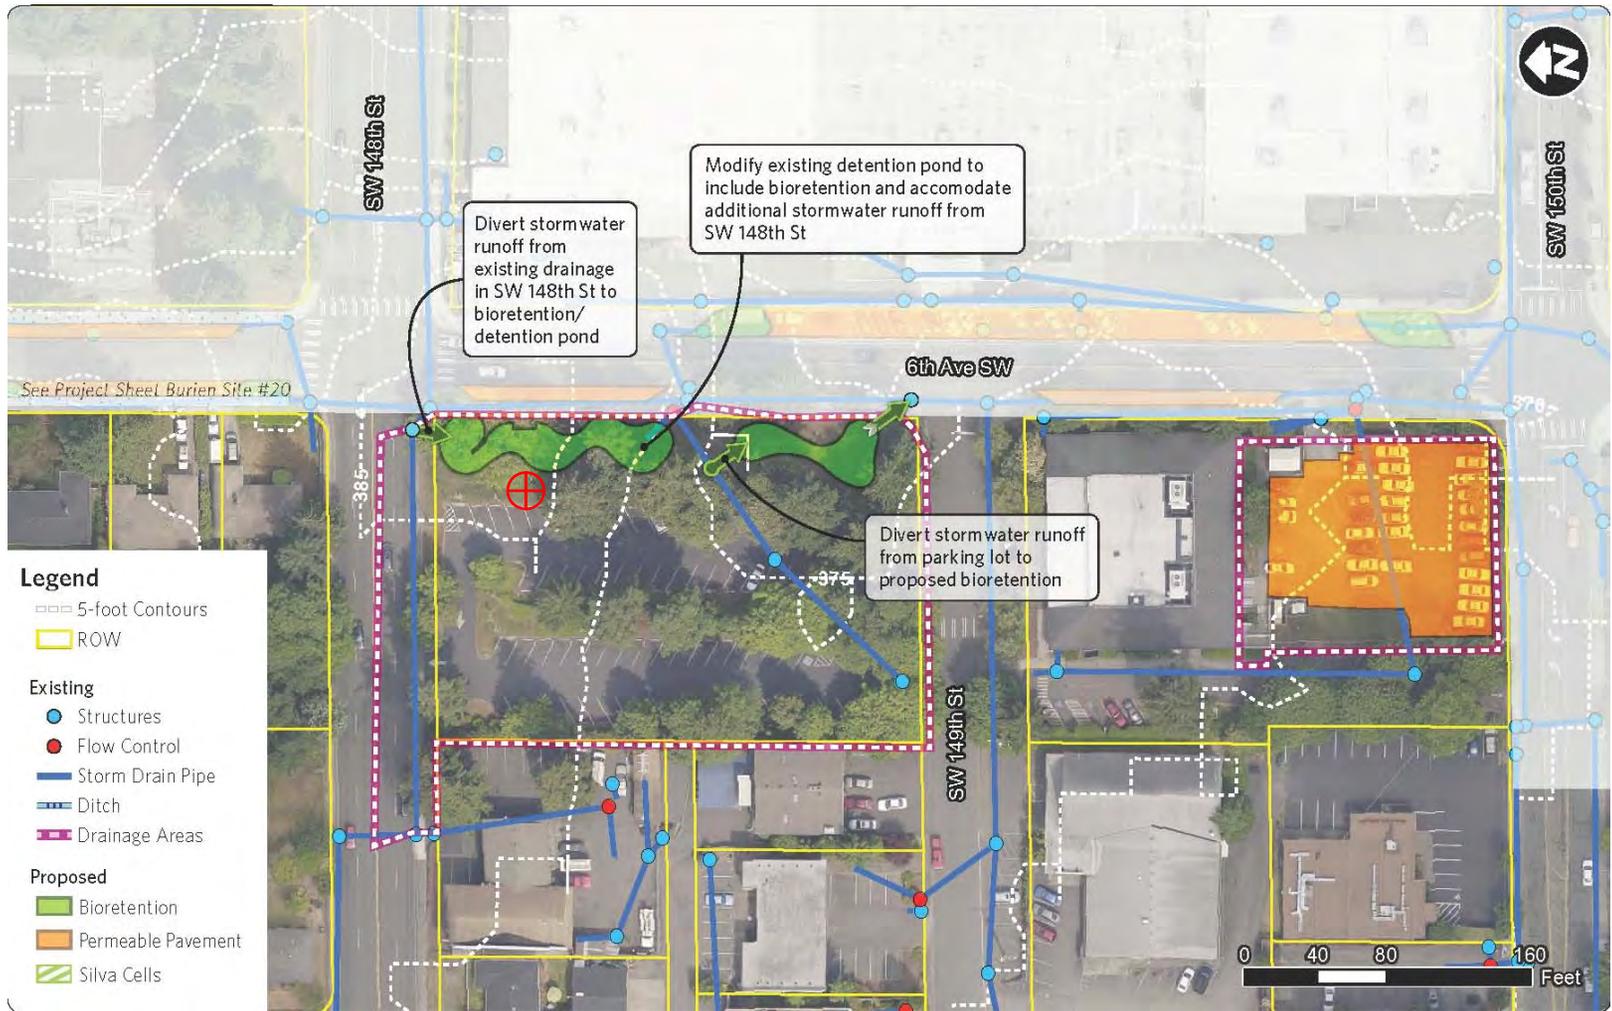
Figure adapted from HDR Engineering (KC-47 Project Sheet.pdf)

⊕ Vector boring V-6

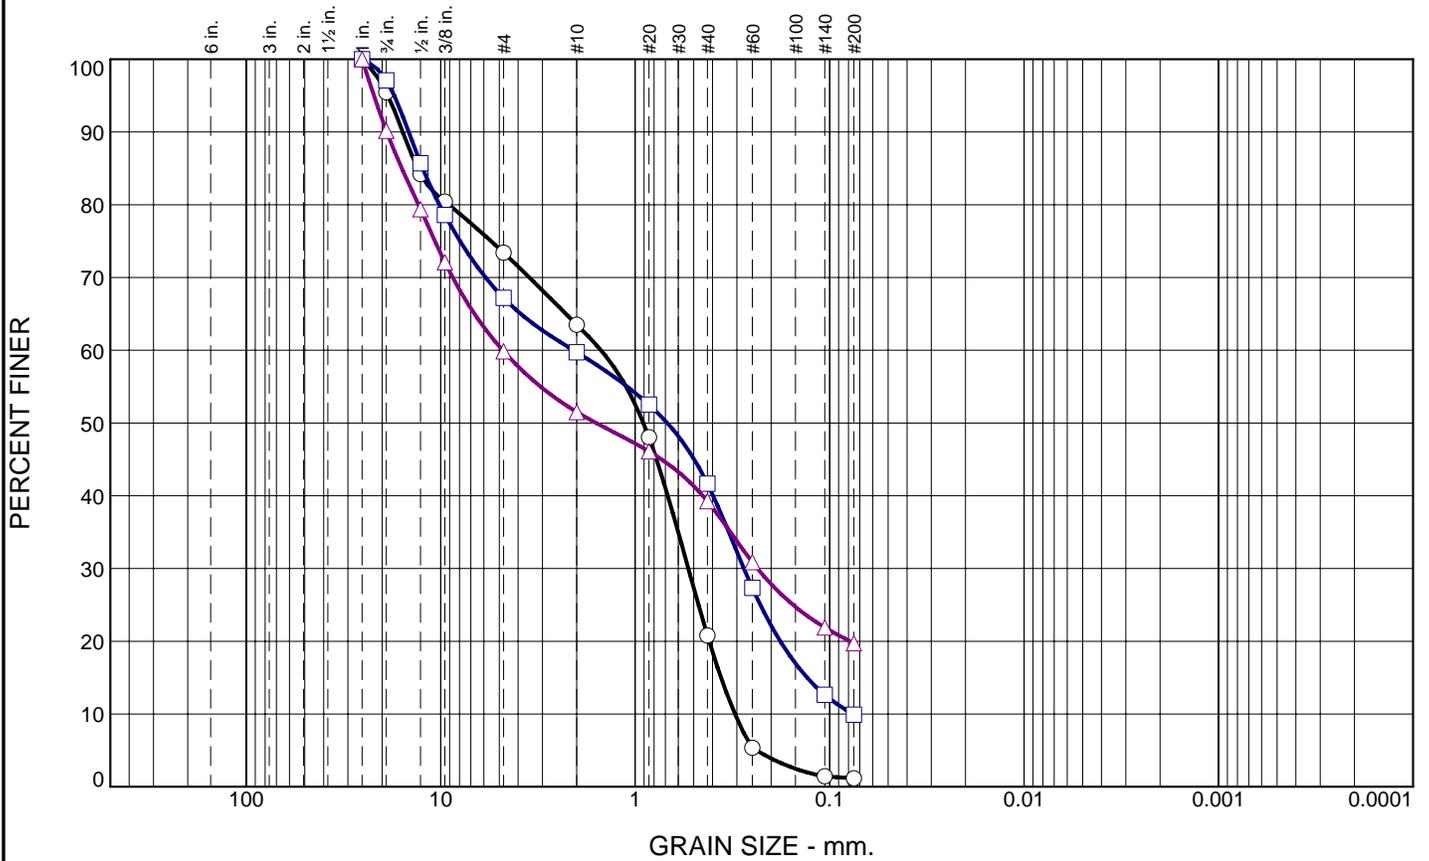
Particle Size Distribution Report

+3"	% GRAVEL	% SAND	% SILT	% CLAY	USCS	AASHTO	PL	LL
○	0.0	26.6	72.2		1.2	SP			
□	0.0	32.8	57.3		9.9	SP-SM	A-1-b	NP	NV
△	0.0	40.1	40.2		19.7	SM	A-1-b	NP	NV

SIEVE inches size	PERCENT FINER		
	○	□	△
1	100.0	100.0	100.0
.75	95.5	97.1	90.2
.5	84.2	85.7	79.4
.375	80.4	78.6	72.1
GRAIN SIZE			
D ₆₀	1.4997	2.0780	4.8009
D ₃₀	0.5330	0.2762	0.2352
D ₁₀	0.3069	0.0760	
COEFFICIENTS			
C _c	0.62	0.48	
C _u	4.89	27.36

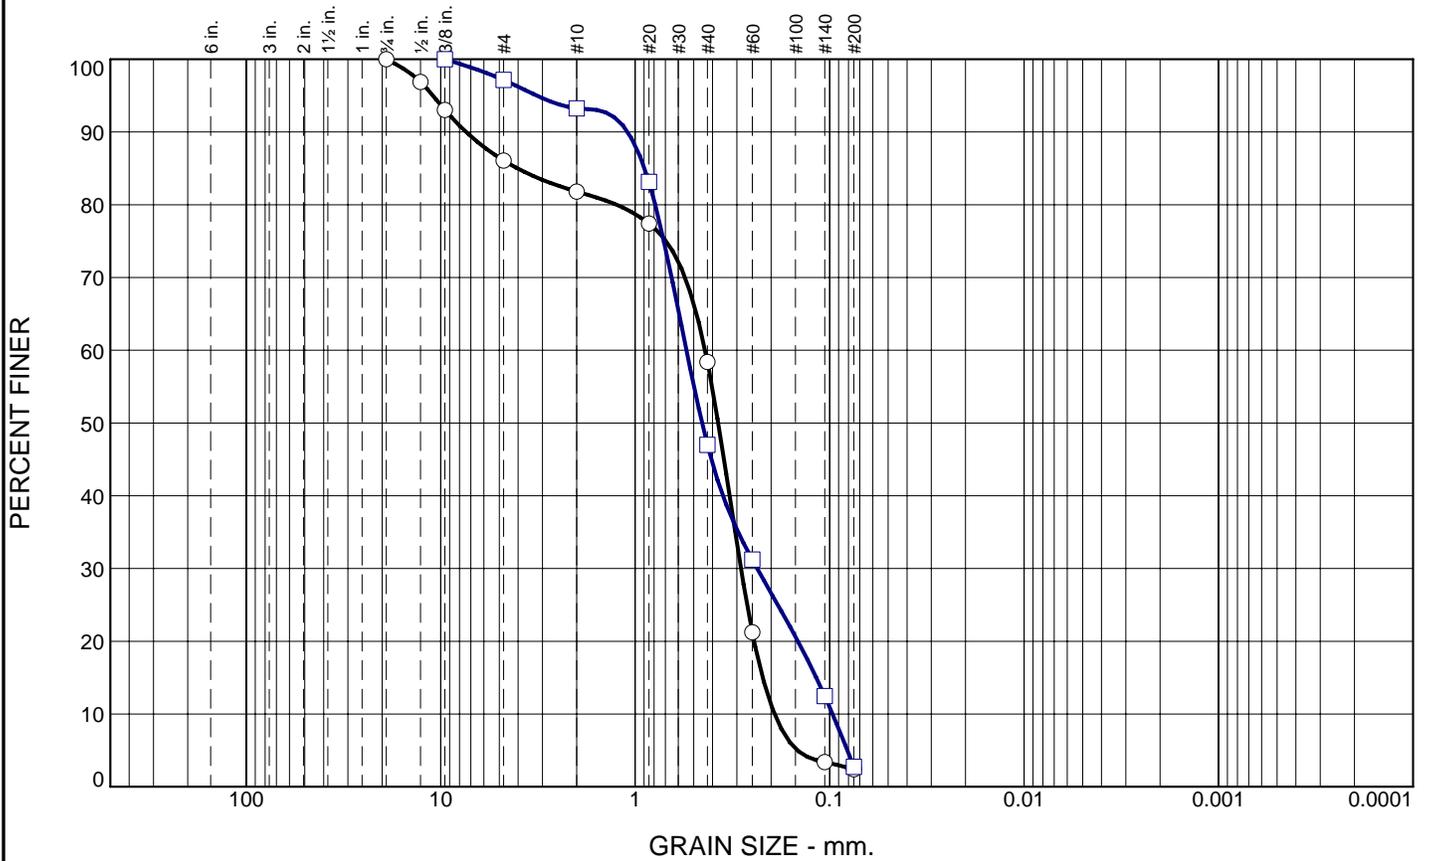
Particle Size Distribution Report

+3"	% GRAVEL	% SAND	% SILT	% CLAY	USCS	AASHTO	PL	LL
○	0.0	13.9	83.7		2.4	SP			
□	0.0	2.9	94.4		2.7	SP

SIEVE inches size	PERCENT FINER	
	○	□
.75	100.0	
.5	96.9	
.375	93.0	100.0
GRAIN SIZE		
D ₆₀	0.4371	0.5451
D ₃₀	0.2858	0.2357
D ₁₀	0.1920	0.0966
COEFFICIENTS		
C _c	0.97	1.05
C _u	2.28	5.64

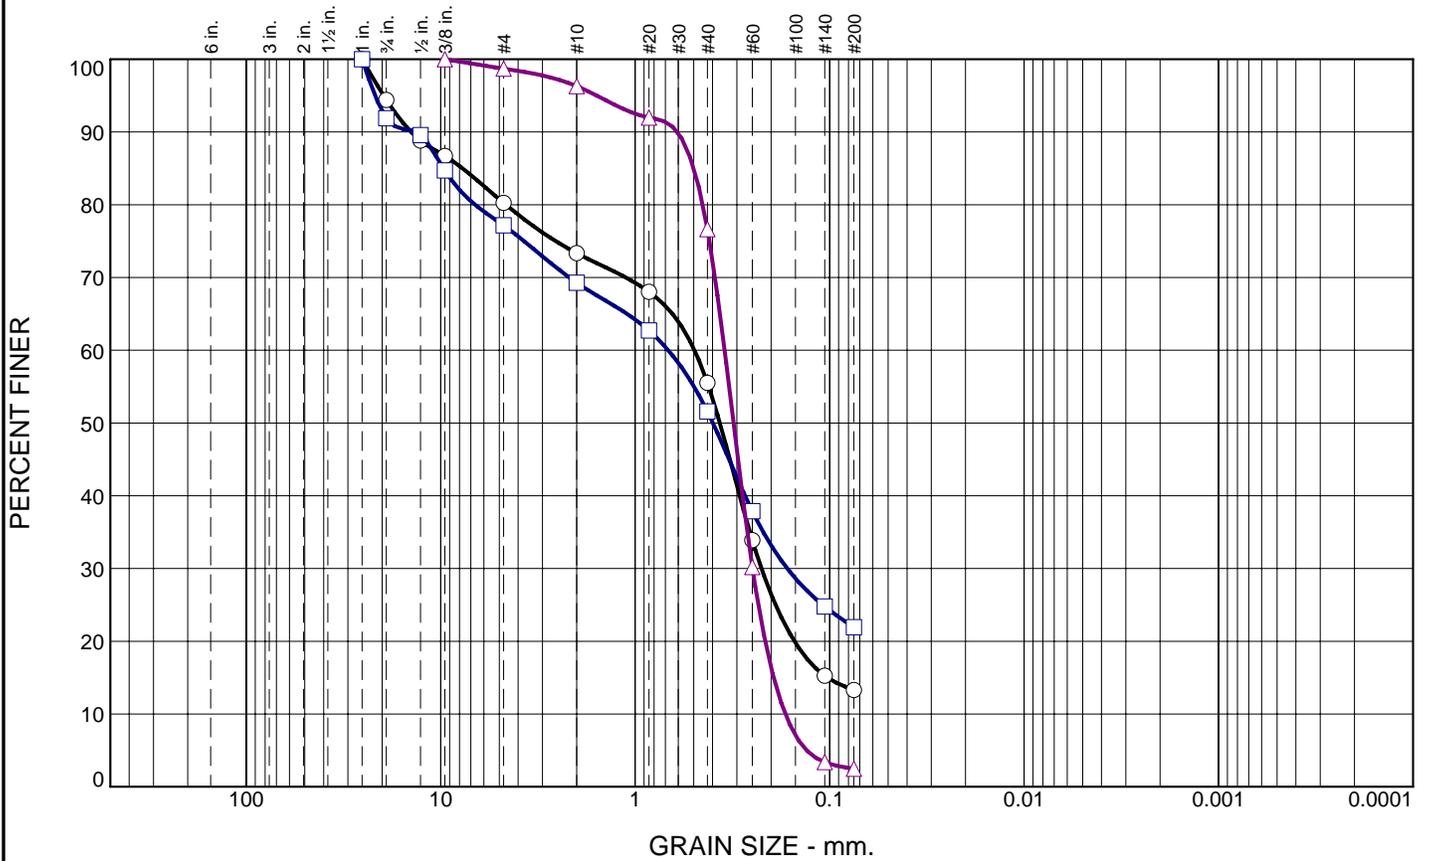
Particle Size Distribution Report

+3"	% GRAVEL	% SAND	% SILT	% CLAY	USCS	AASHTO	PL	LL
○	0.0	19.7	67.0	13.3		SM	A-2-4(0)	NP	NV
□	0.0	22.8	55.3	21.9		SM	A-2-4(0)	NP	NV
△	0.0	1.3	96.2	2.5		SP

SIEVE inches size	PERCENT FINER		
	○	□	△
1	100.0	100.0	
.75	94.4	91.9	
.5	88.8	89.6	
.375	86.7	84.7	100.0
GRAIN SIZE			
D ₆₀	0.4953	0.6755	0.3467
D ₃₀	0.2242	0.1652	0.2494
D ₁₀			0.1691
COEFFICIENTS			
C _c			1.06
C _u			2.05
