Determining the Effects of Vegetation on Levee Structural Integrity on the Green River in King County, Washington

Final Report

September 26, 2014

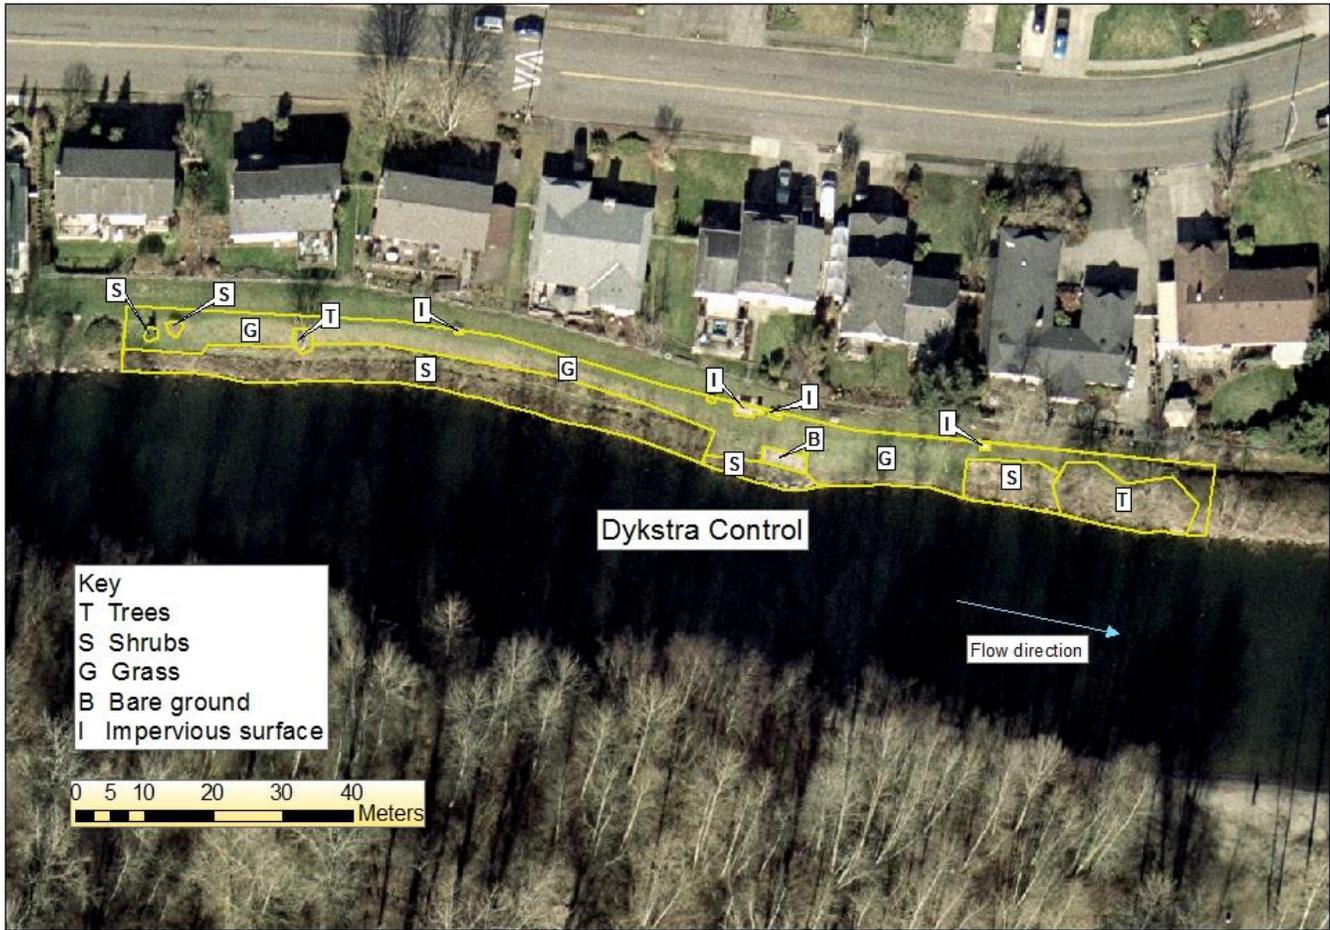
Figure 4. Example of vegetation classification polygons

Natural color aerial photographs taken on February 19, 2006 were digitized and orthorectified by King County prior to the start of this research project. Vegetation analysis was completed using this photo series at a scale of 1 inch equals 100 feet. In each study site, the upstream and downstream extent of the repair was measured to get the total length. A file was created by a King County GIS Specialist for the edge of water of the Green River and imported into the map layer. Then a polygon was created at each location using the edge of water as the riverside boundary and the length of the repair as the upper and lower boundaries. The fourth boundary of the polygon was placed on the middle of the crest of the levee determined through aerial photographic interpretation (see Figure 4).

Within each polygon, percent cover was calculated for each of five basic land cover categories selected for this study: trees, shrubs, grass, impervious surfaces, bare ground (Fig 4). Trees were differentiated from shrubs based on height, where trees were anything that appeared to be over five meters tall. In instances where it was difficult to distinguish height, first return LiDAR data acquired in 2002 was used to help with the land cover determination. Vegetation categories could not be broken down into native or non-native species due to the inability to distinguish this from aerial photographs. The impervious surfaces category included building footprint, roads, parking lots, and levee or revetment crown (if paved). The bare ground category consisted of bare exposed earth.

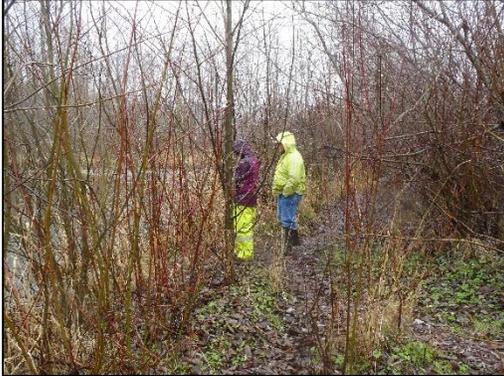
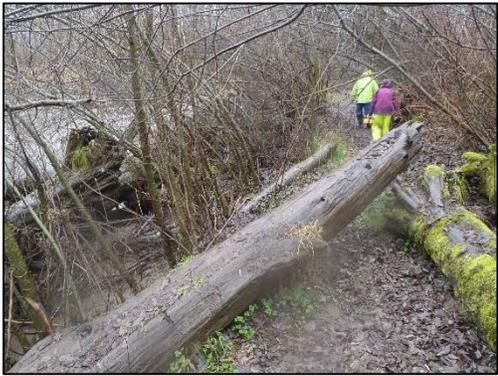
Figure 5 - Fenster levee 2004 Repair – photos taken January 7, 2013

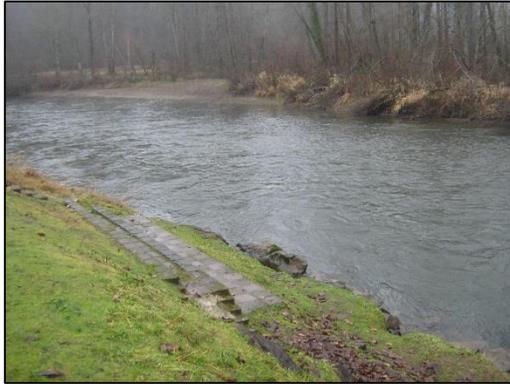
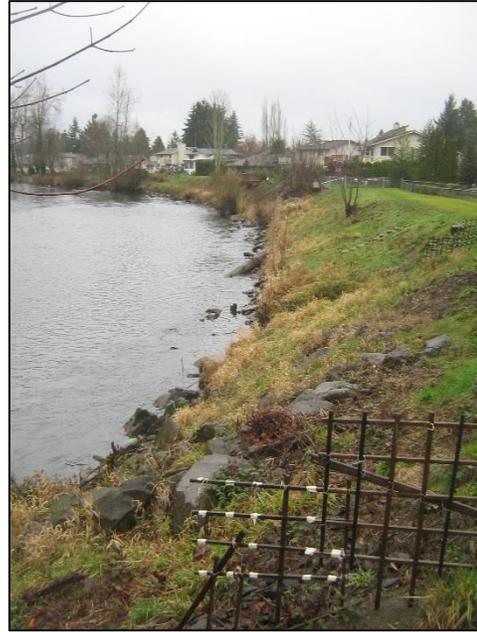
Figure 6 - Dykstra levee repair 1995 – photos taken on January 7, 2013
