**TECHNICAL INFORMATION
REPORT**

**BURKE GILMAN TRAIL
RECONSTRUCTION**

90% Submittal

August 27, 2007

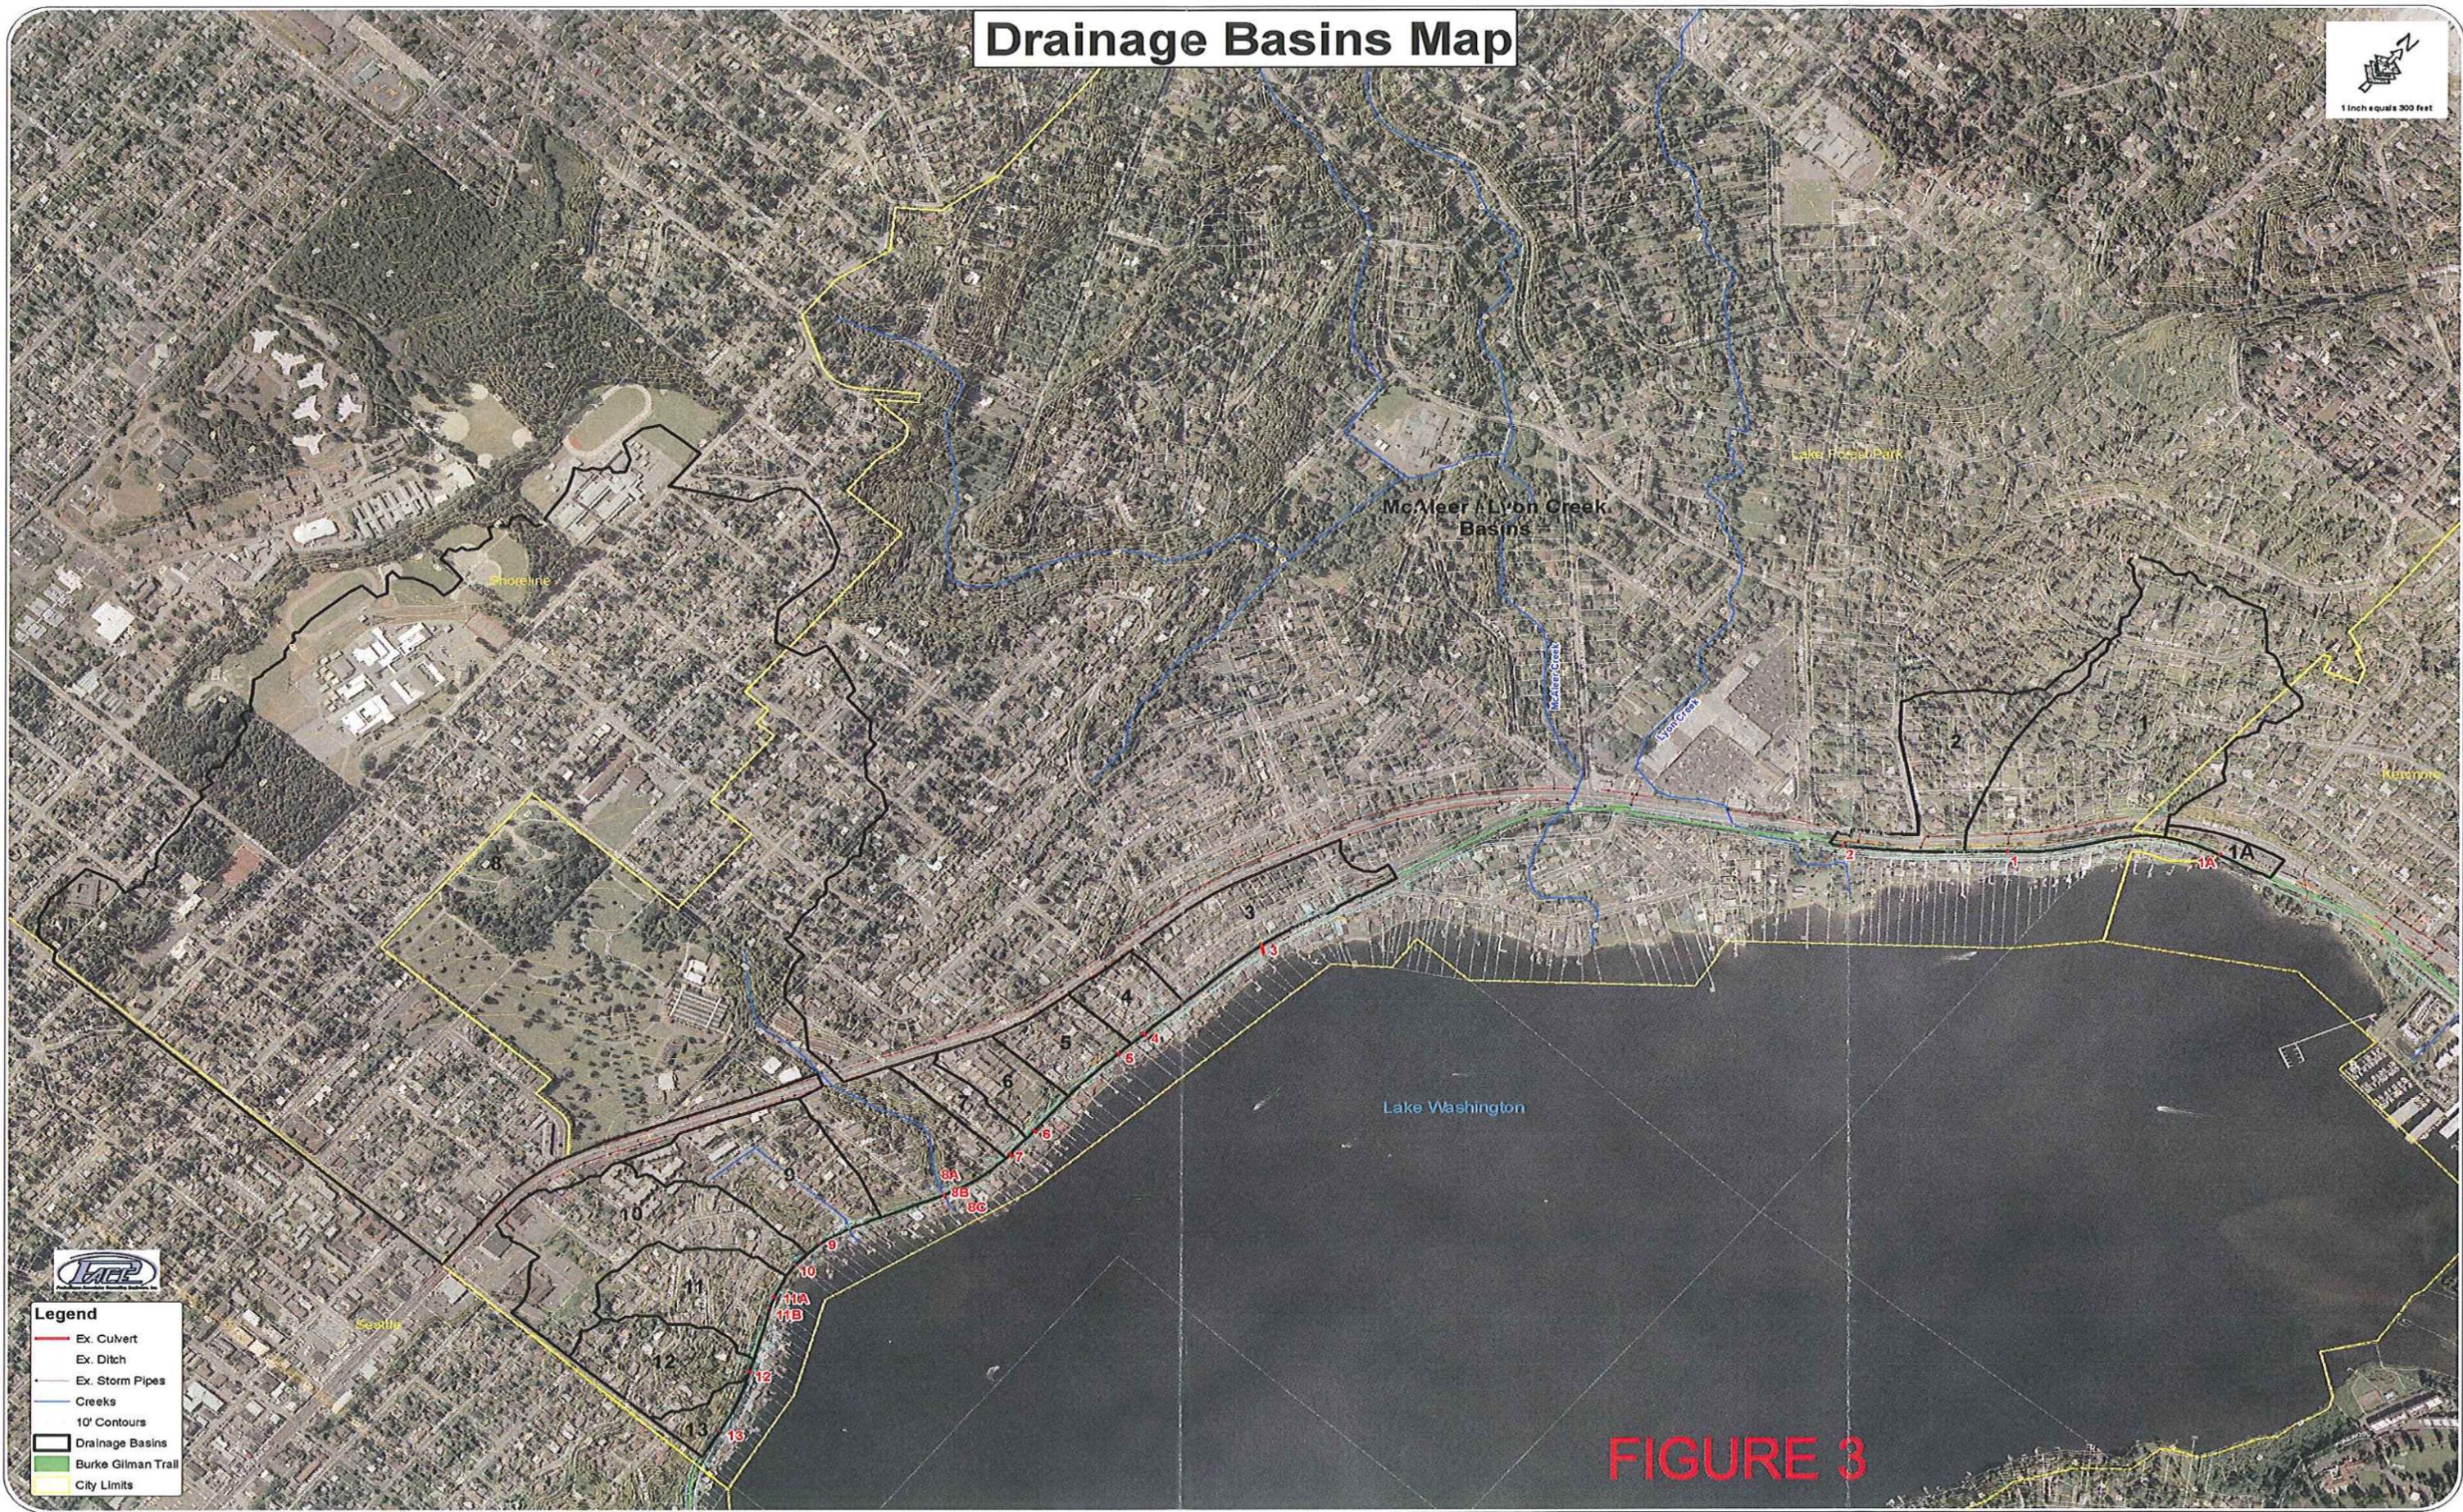
FIGURE 3

Drainage Basins Map

1 inch equals 300 feet

The 2.2-mile stretch of trail is located on an old railroad grade that runs parallel to the shore of Lake Washington. The project area is entirely contained within the City of Lake Forest Park and starts at 145th and extends northerly and easterly along the shoreline to Tracy Owen Station (Log Boom Park) at the City boundary with Kenmore. The site spans several sections including 10, 11, and 15 of Township 26N, Range 04 East. For general location, see Figure 2: Site Location. The study area for the downstream analysis is shown in Figure 3: Drainage Basins.

The existing site hydrology is described in detail in Appendix B of this report, within the April 17, 2005 Drainage Analysis. In all, 13 drainage basins draining to culvert crossings were identified. (Basin 1a shown in the April 17th 2005 Report is north of the improvements and outside of the project limits.) Some basins are drained by more than one culvert, and therefore there are fewer basins than culvert crossings. See Figure 3, Drainage Basins Map for overall basin and culvert identification. The culverts are also numbered on the civil plans using the associated sub-basin as the base culvert number.

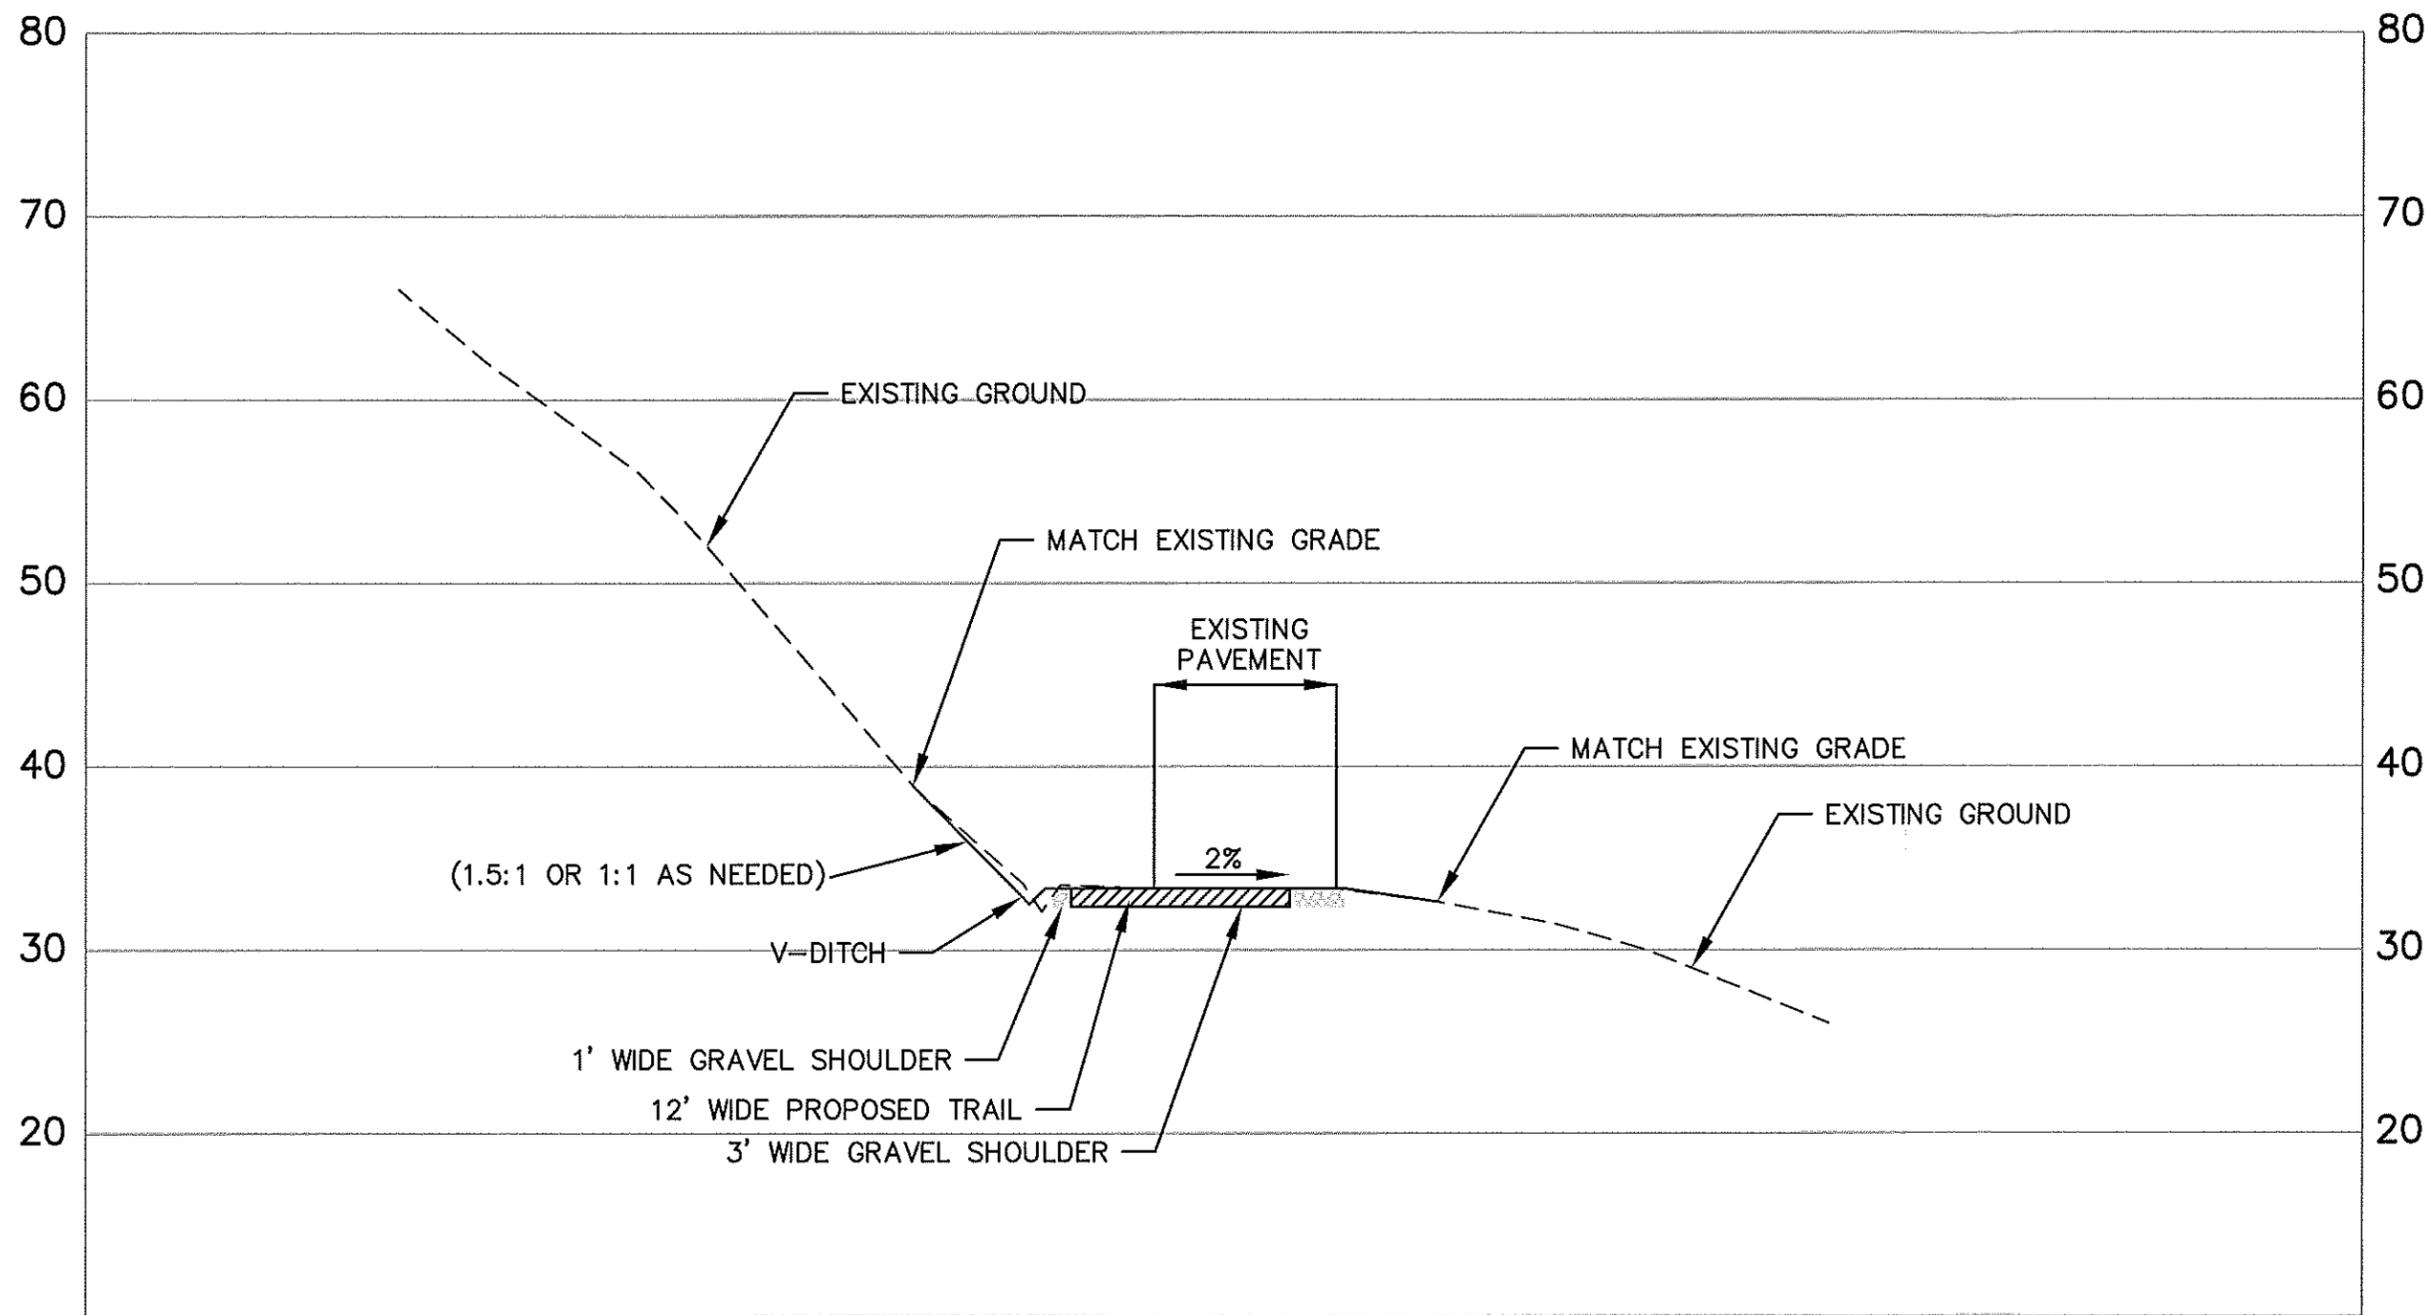
JOB NUMBER
06601.00
 DWG NO. SECTIONS
 SHEET **FIG 4**

**BURKE-GILMAN TRAIL
 REDEVELOPMENT**
 FIGURE 4 - TYPICAL TRAIL SECTION
 WITH V-DITCH

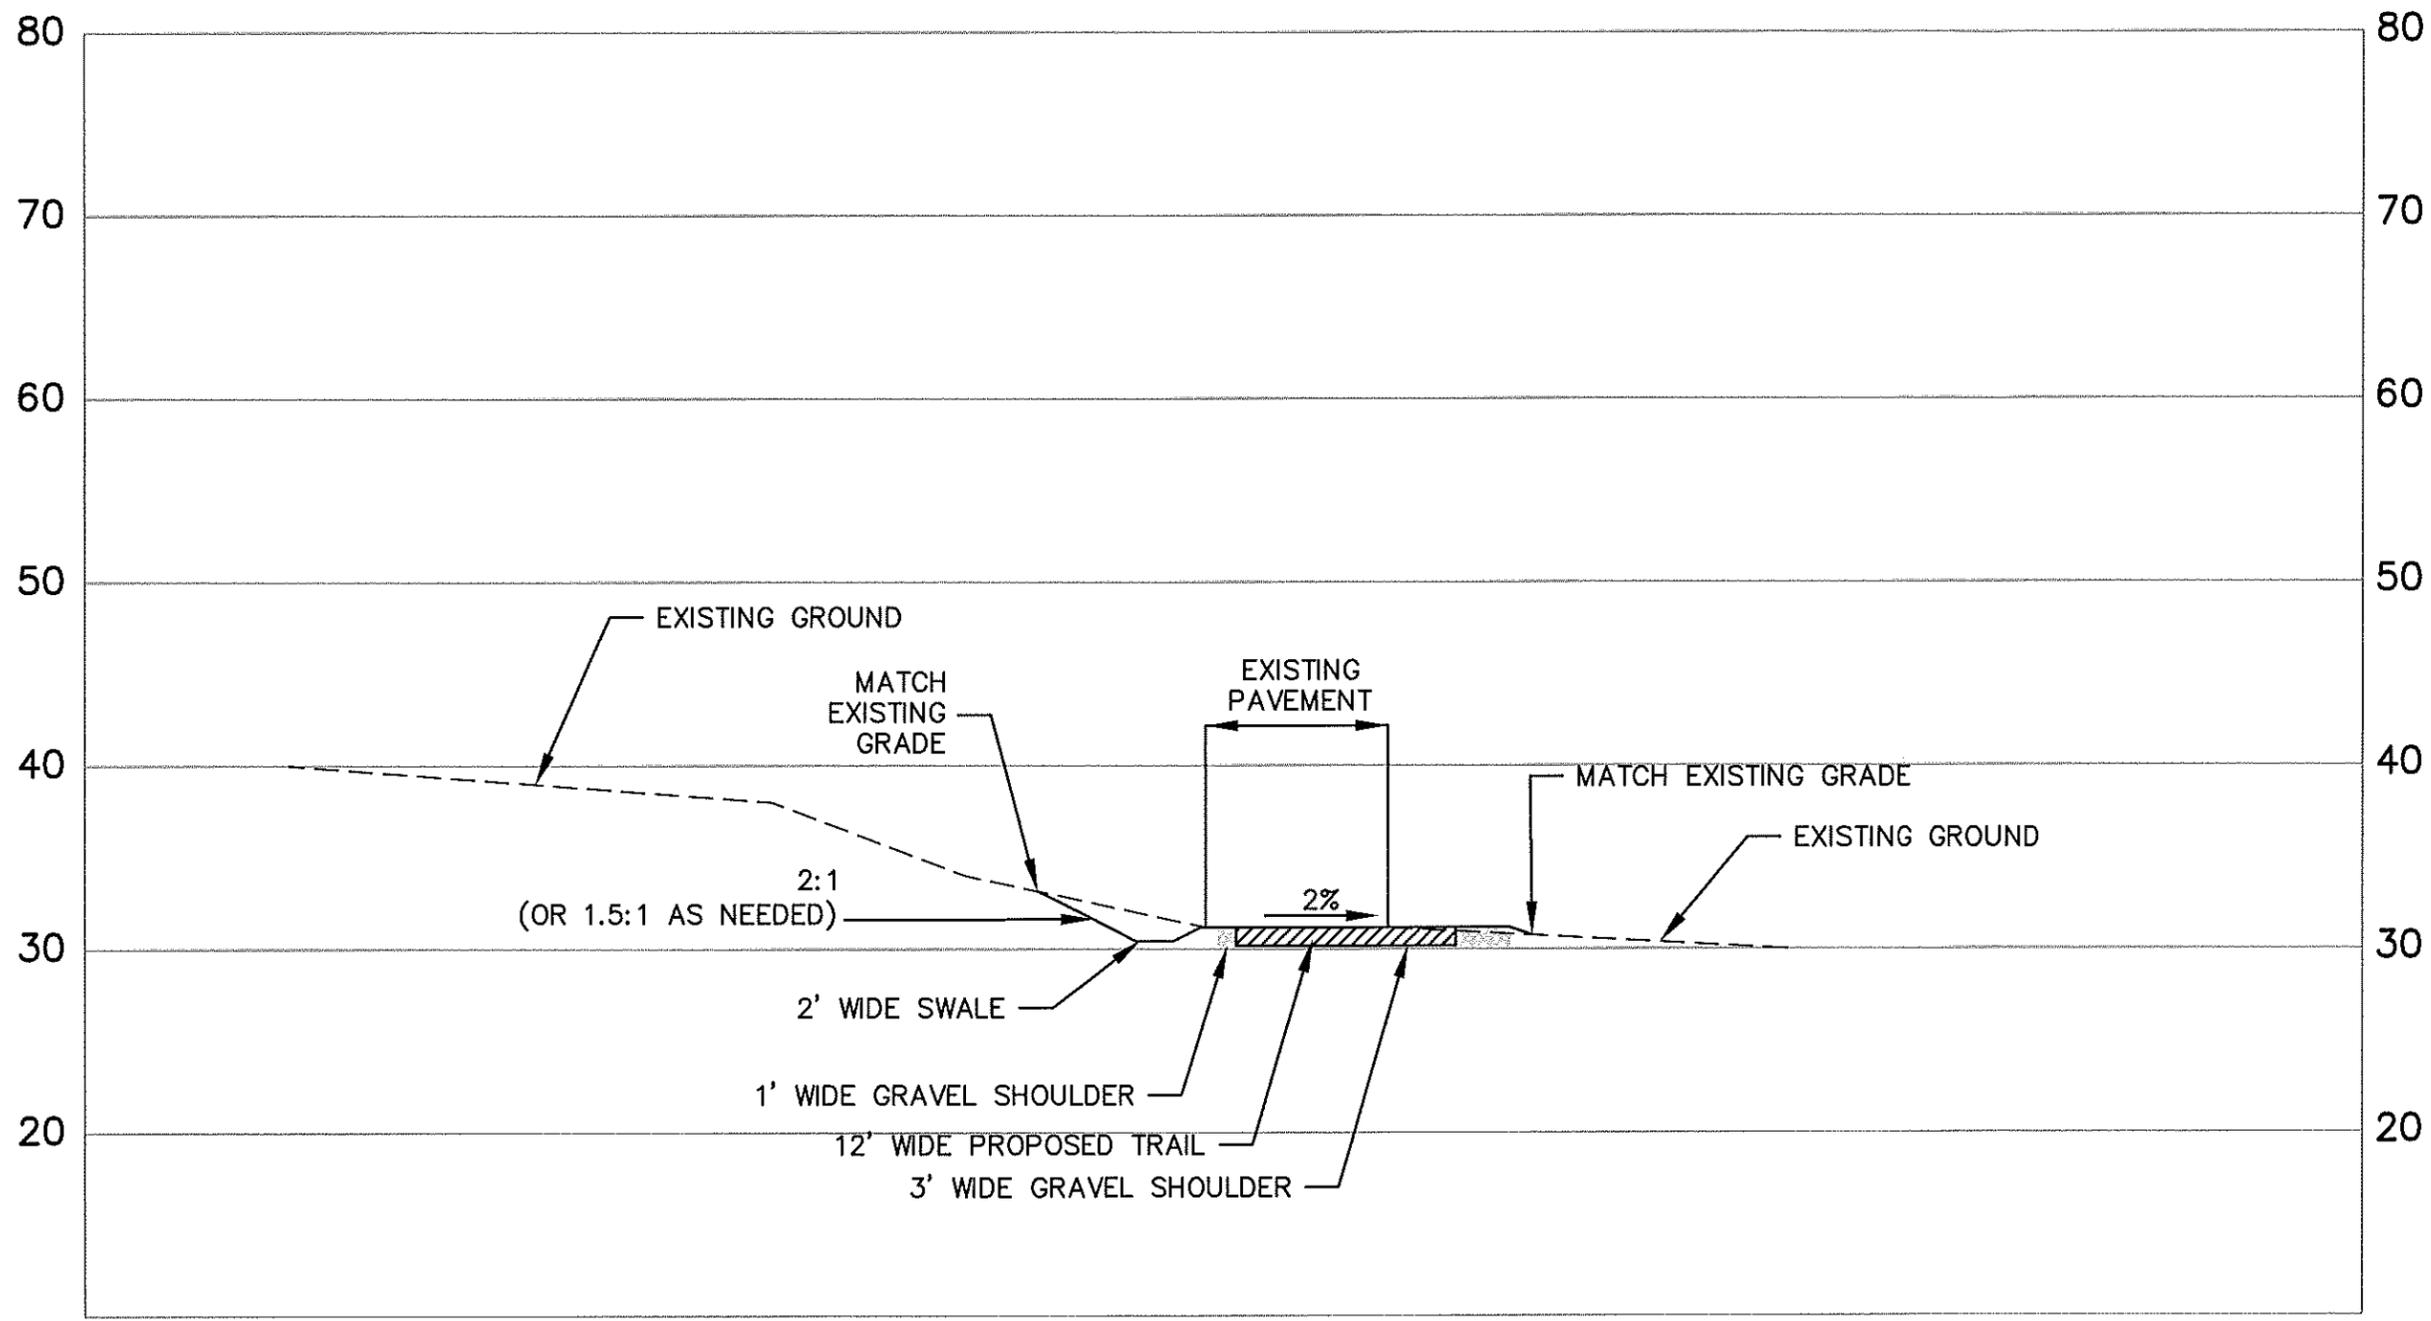
JOB NUMBER
06601.00
 DWG NO. SECTIONS
 SHEET **FIG 5**

**BURKE-GILMAN TRAIL
 REDEVELOPMENT**
 FIGURE 5 - TYPICAL TRAIL SECTION
 WITH TRAPEZOIDAL DITCH

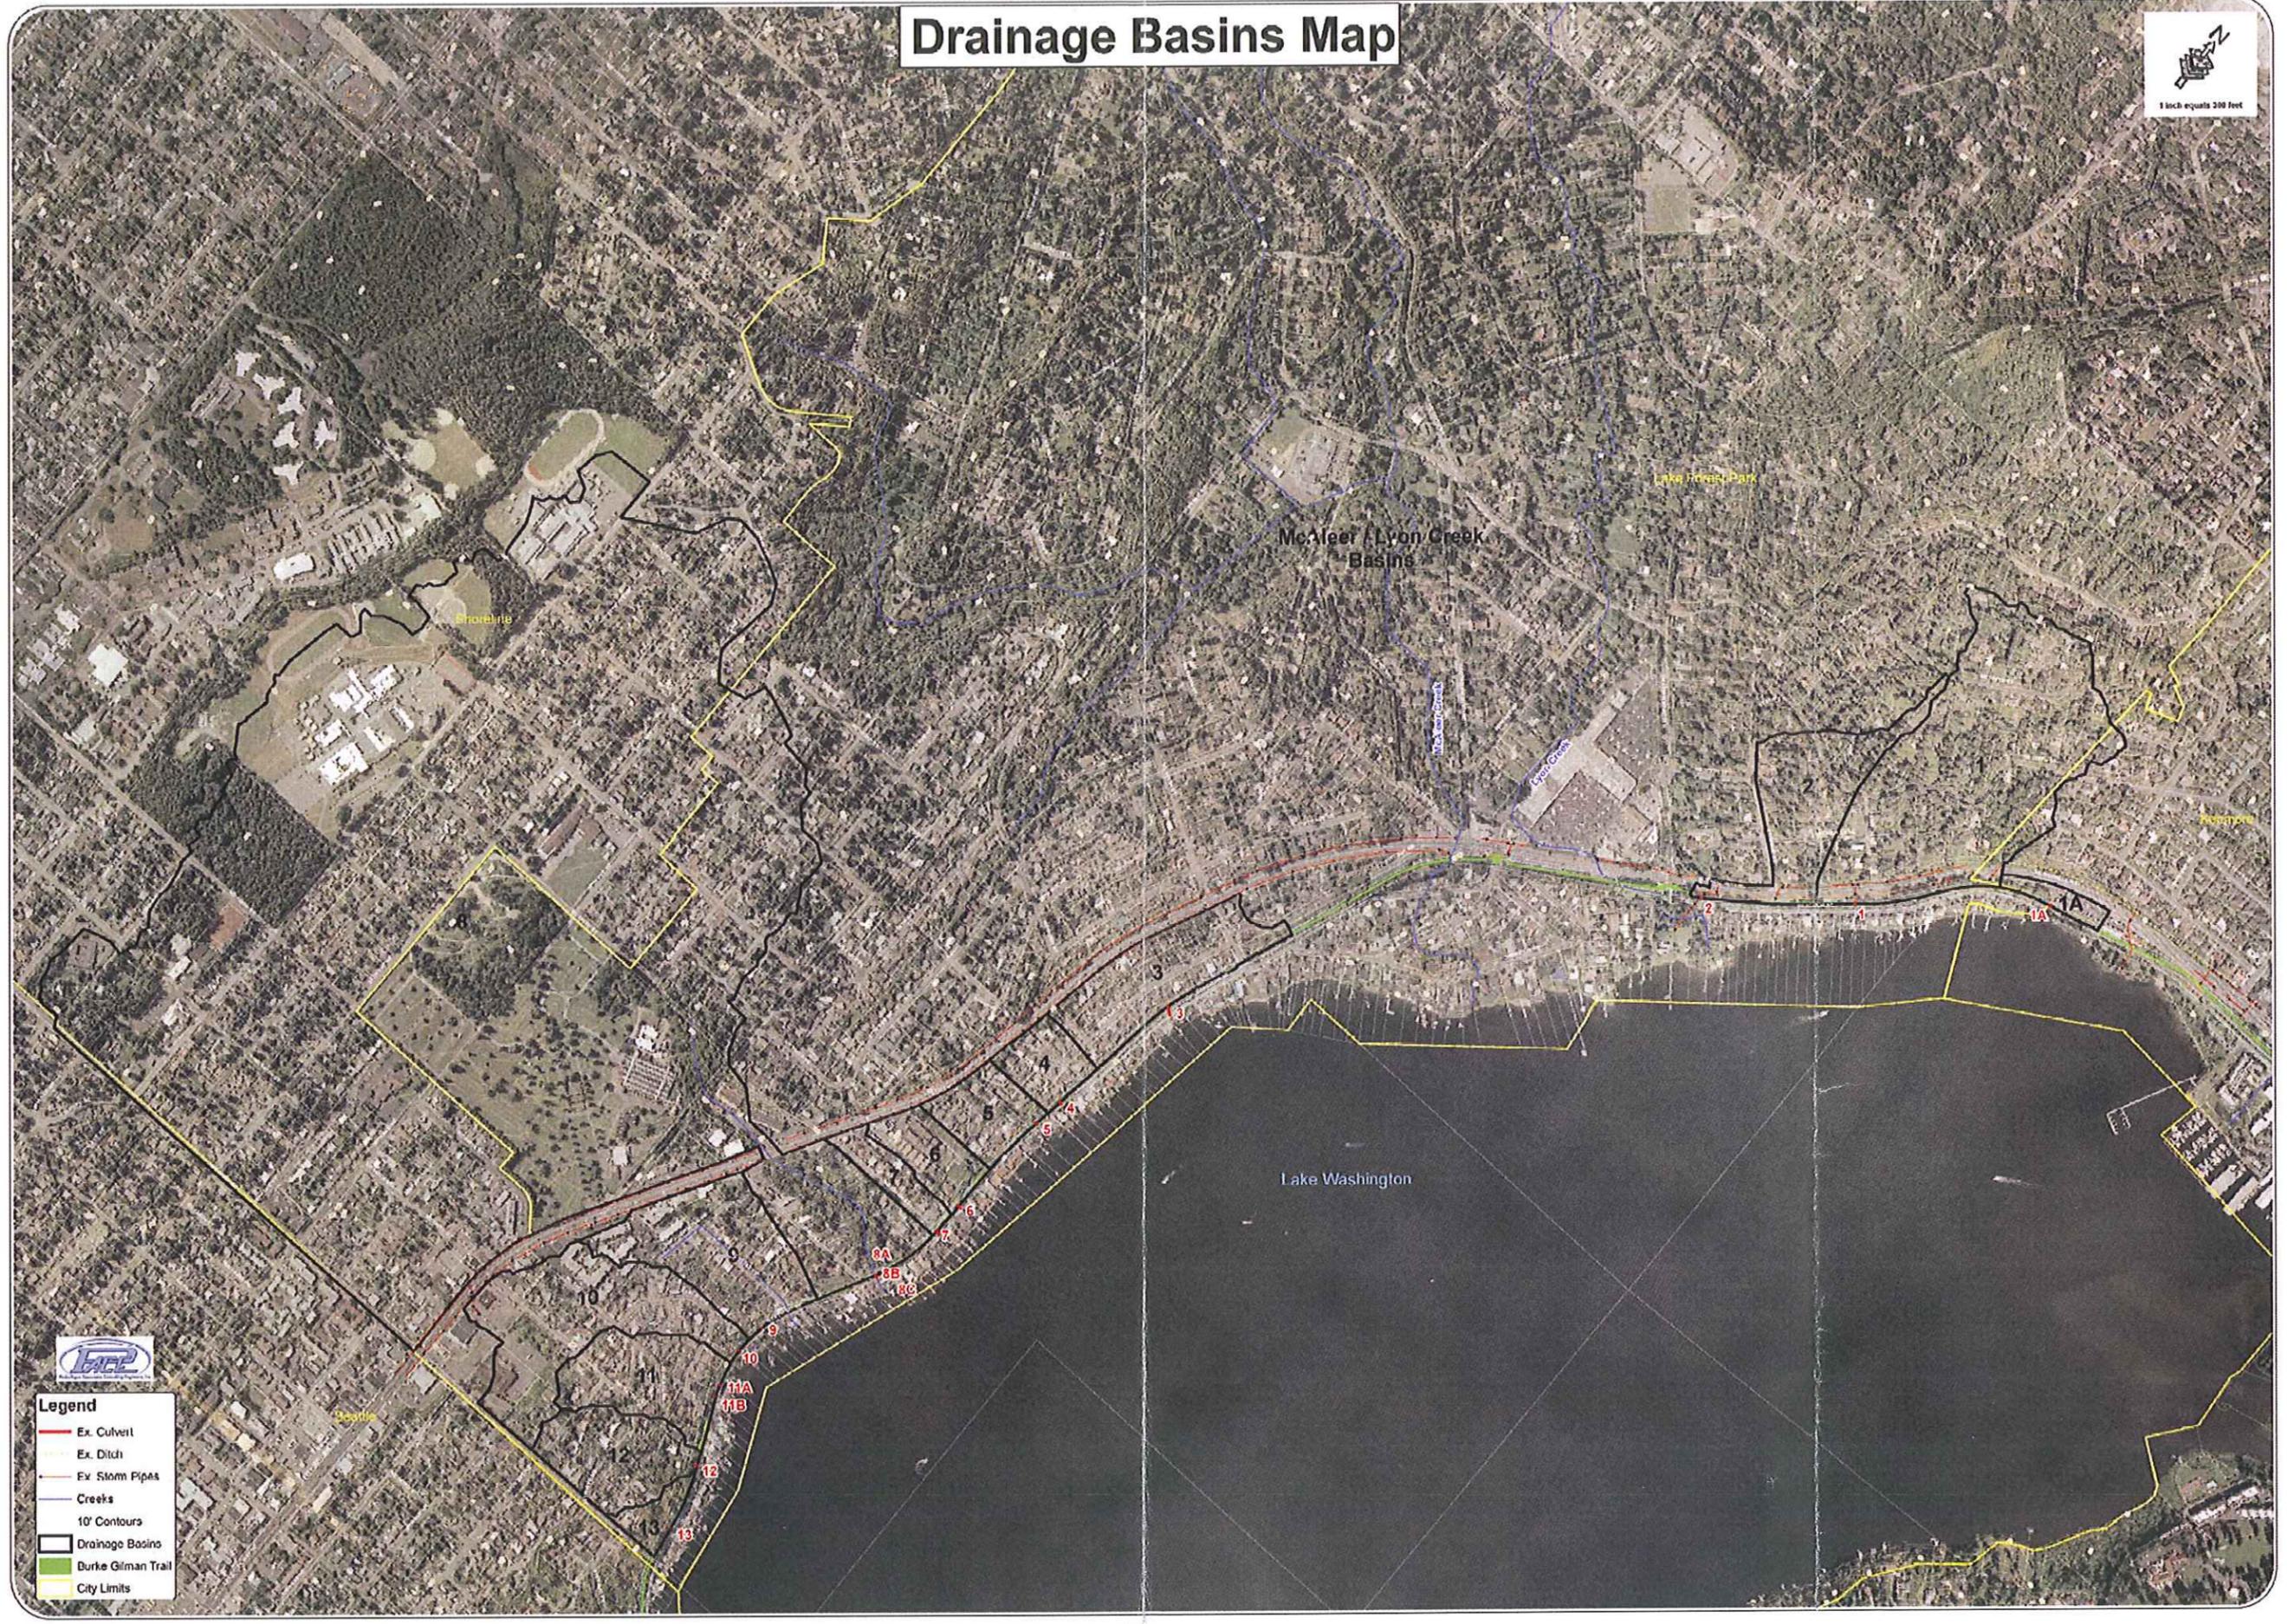
Drainage Basins Map

Based on the results shown above, culvert number 1 may be undersized, and may need to be upgraded as part of the redevelopment of the trail. This will need to be analyzed in more detail during the final design. Also, the capacity of culverts draining basin 8 will need a more detailed evaluation during the final design phase since there is insufficient data based on the survey to determine the capacity of the existing culvert crossings for the drainage basin.

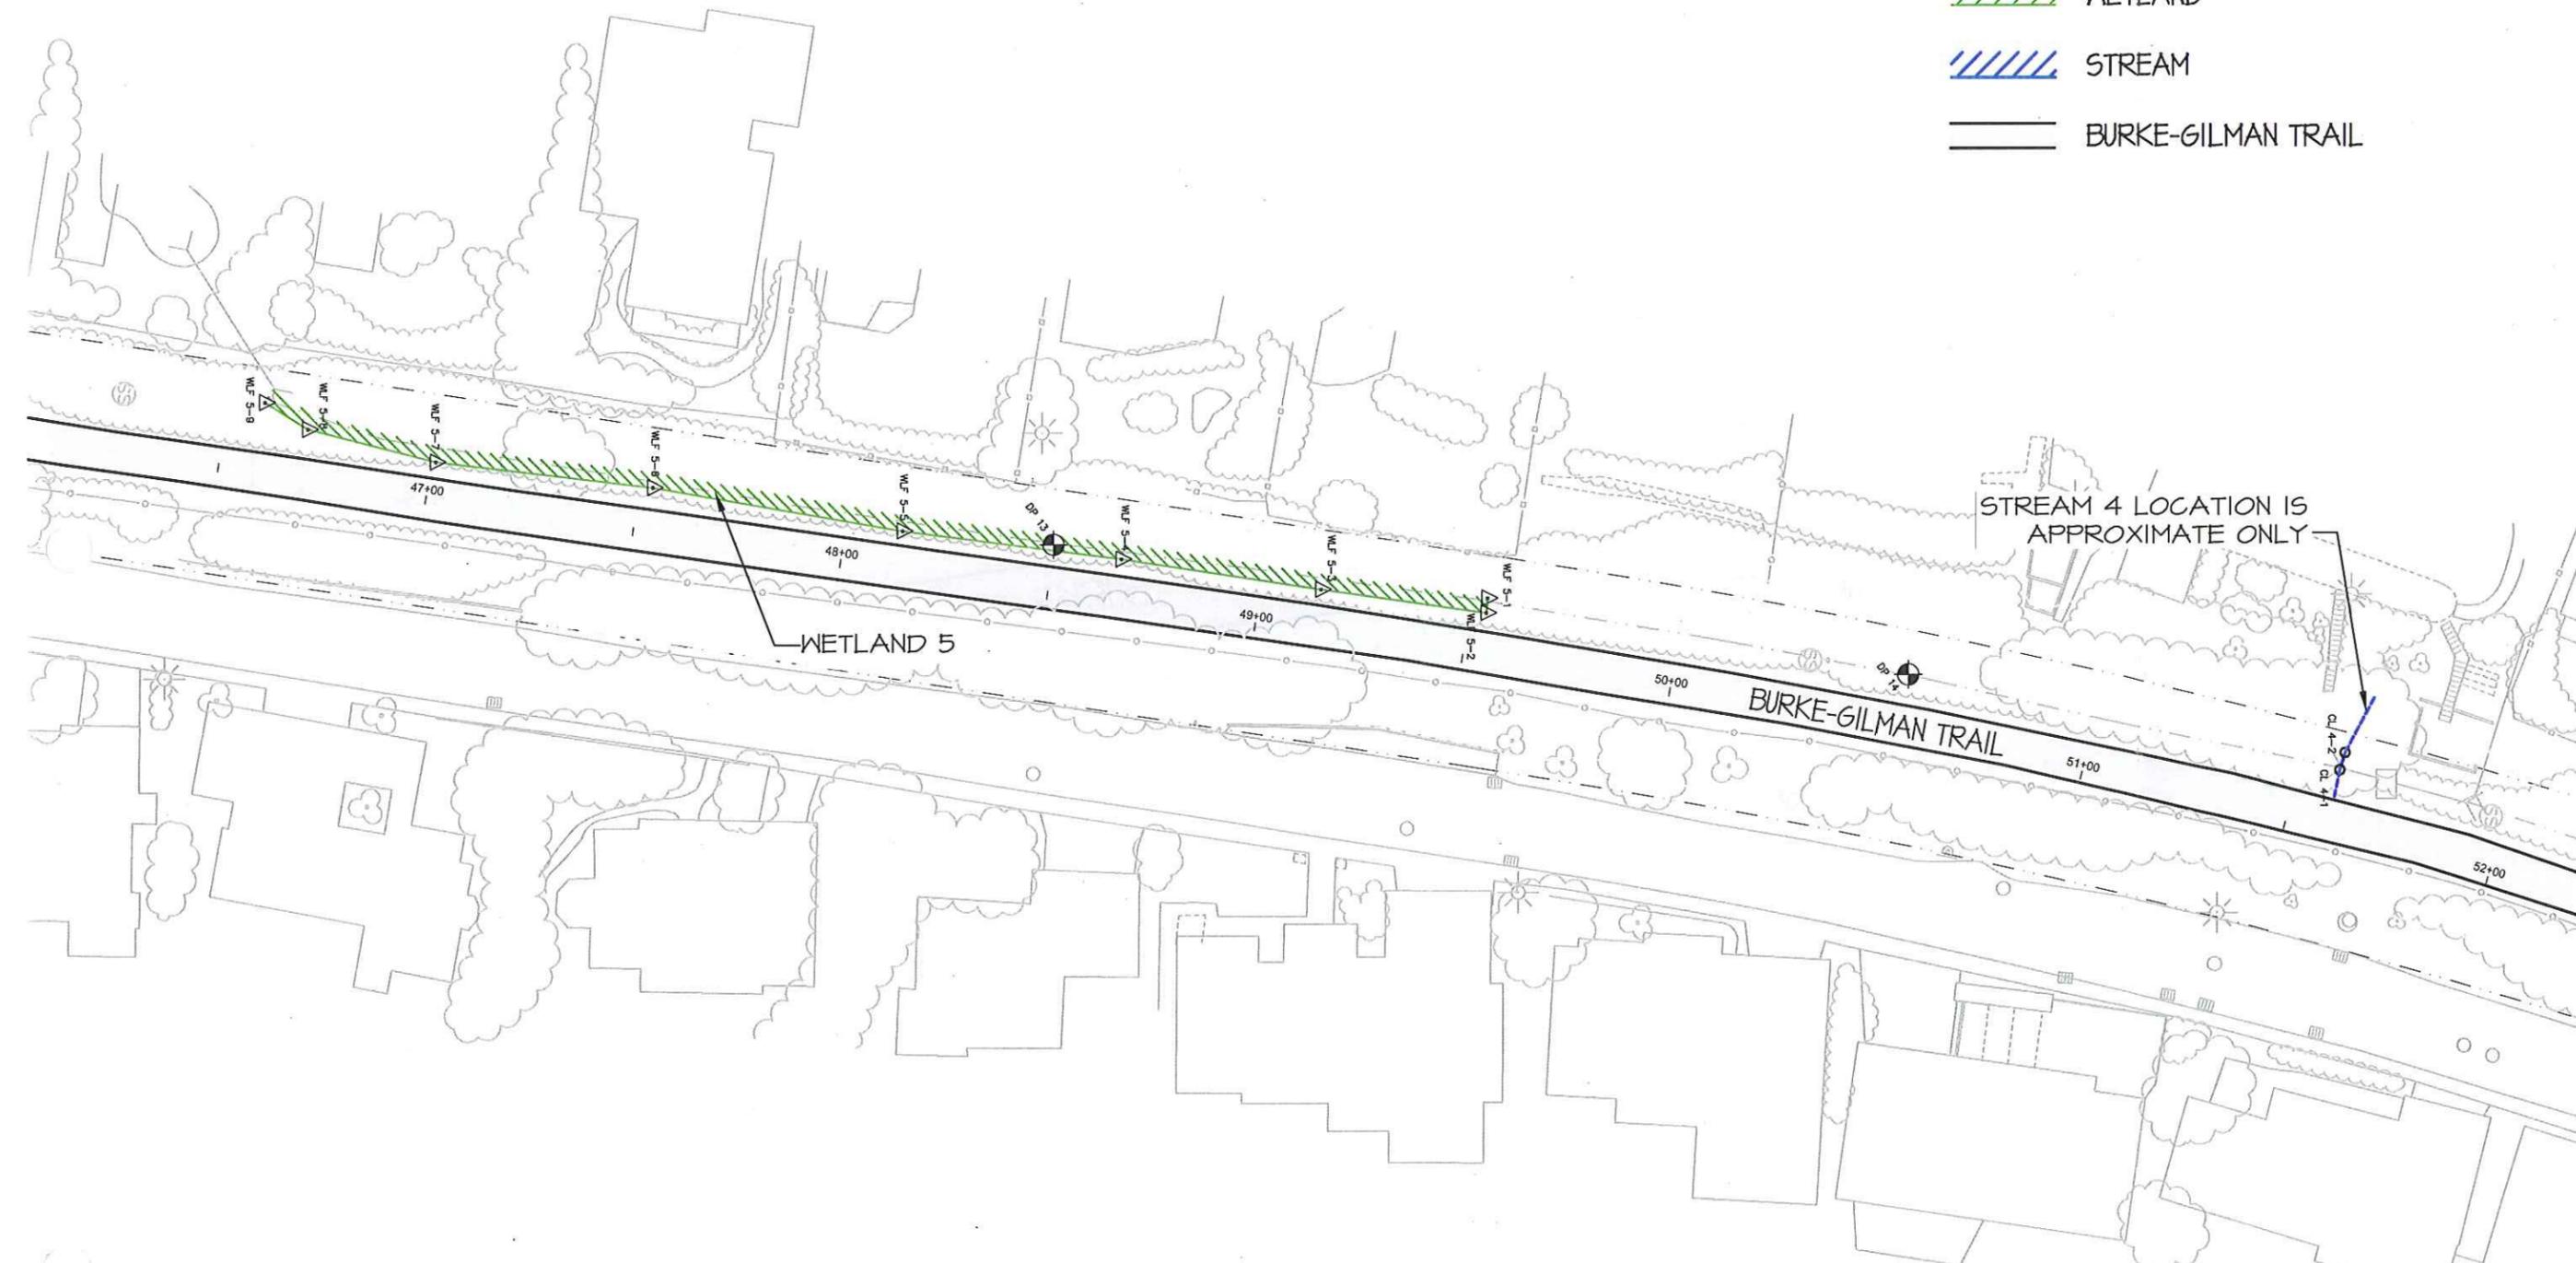
STREAM 4 LOCATION IS APPROXIMATE ONLY

WETLAND 5

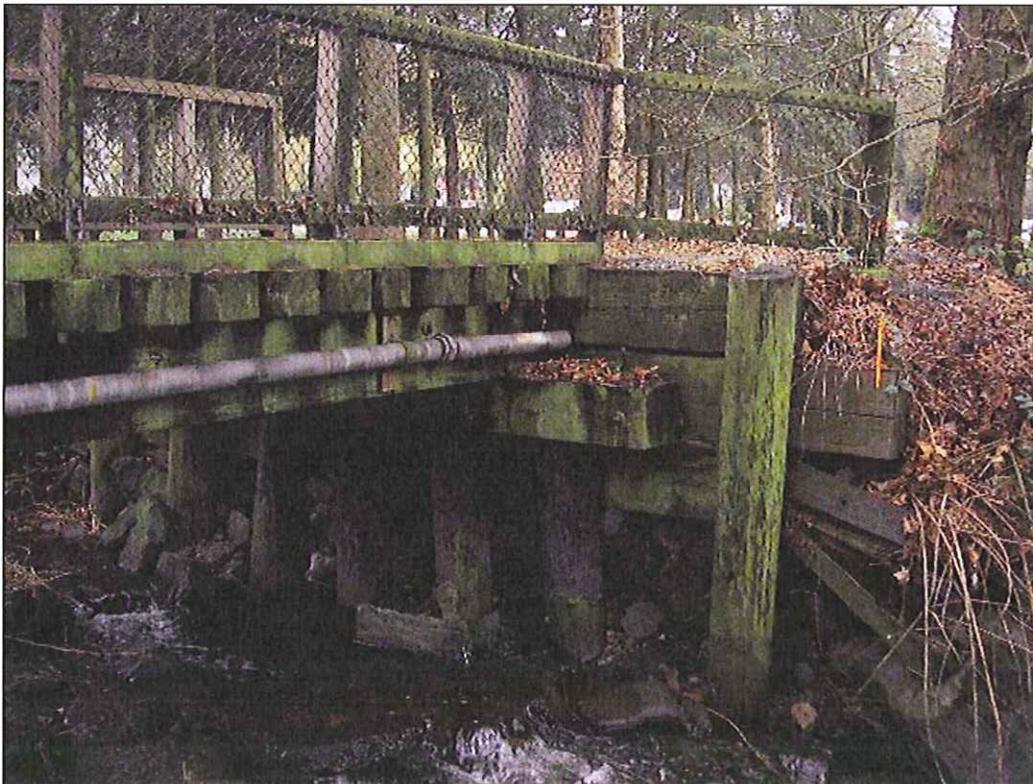
Lyon Creek bridge – 7 March 2006.

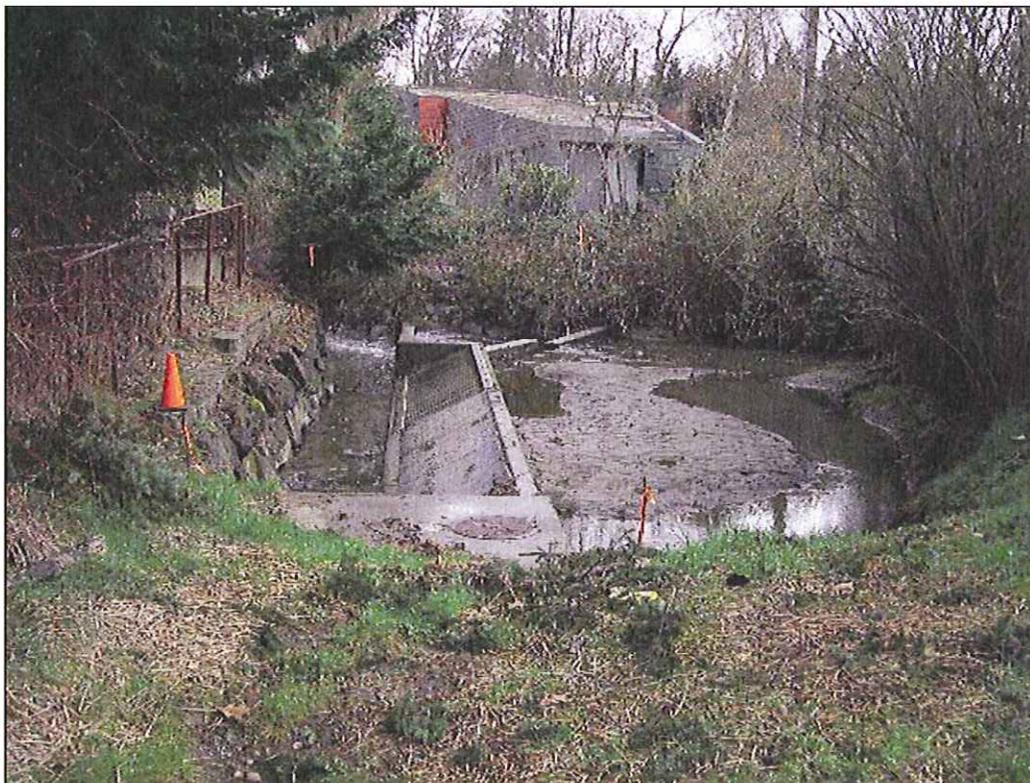
McAleer Creek sediment trap facility – 7 March 2006.
