# **Public Safety Management Plan Countyline Levee Setback Project**

**Date:**

September 10, 2015

**King County**

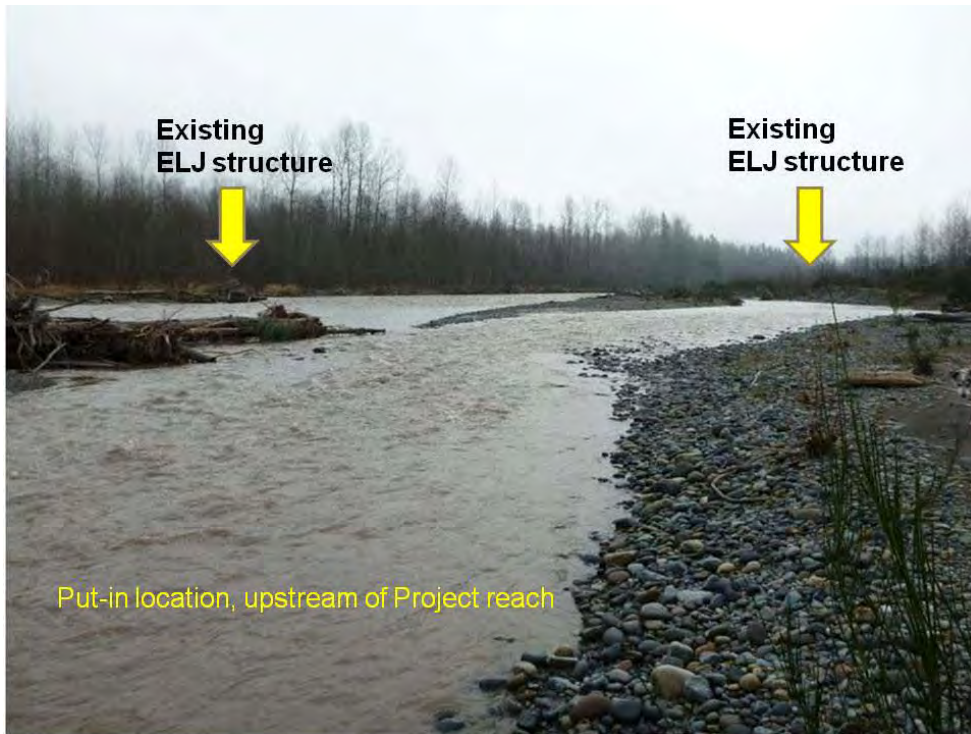
**Photo 1:** Put-in location near RM 10.6, looking upstream at established ELJs on both banks.

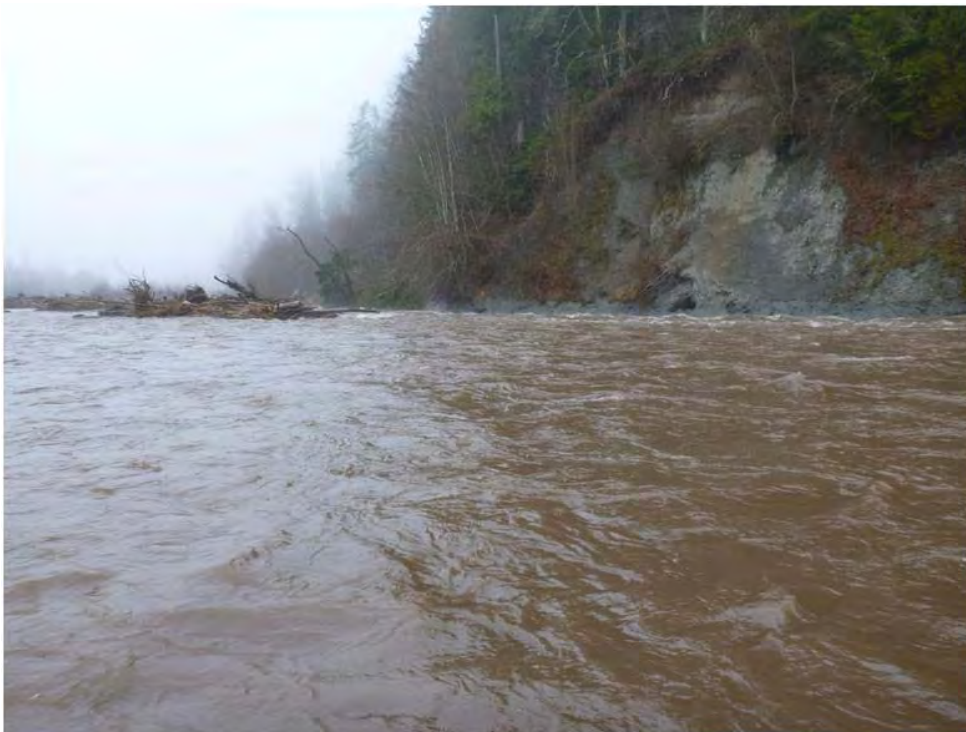
**Photo 2:** “C”-rated LW in channel near RM 10.0, looking downstream.

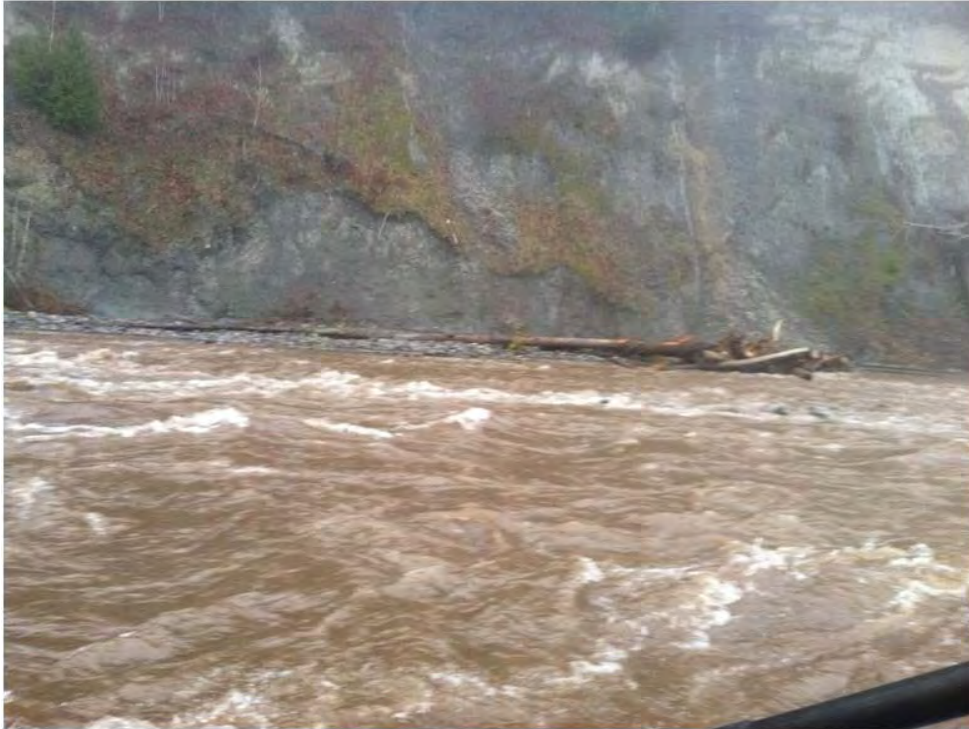
**Photo 3:** “B”-rated LW along the channel near RM 9.5, upstream of the Project reach.

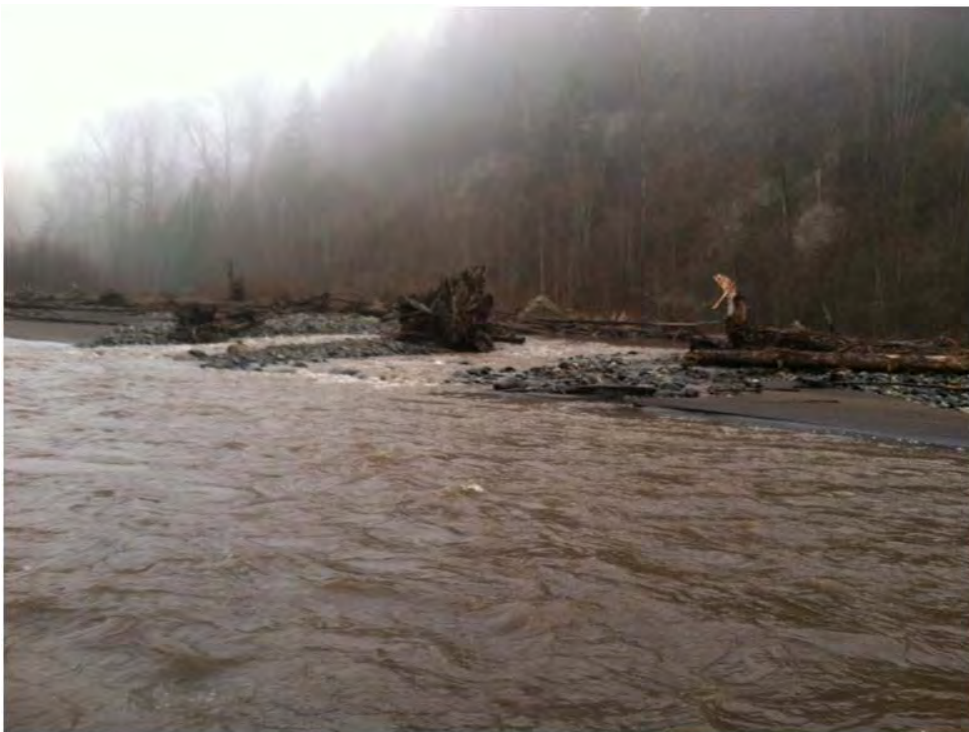
**Photo 4:** LW on gravel bars near RM 9.0, looking downstream. These accumulations would be “A”-rated since they are not in the boatable channel.

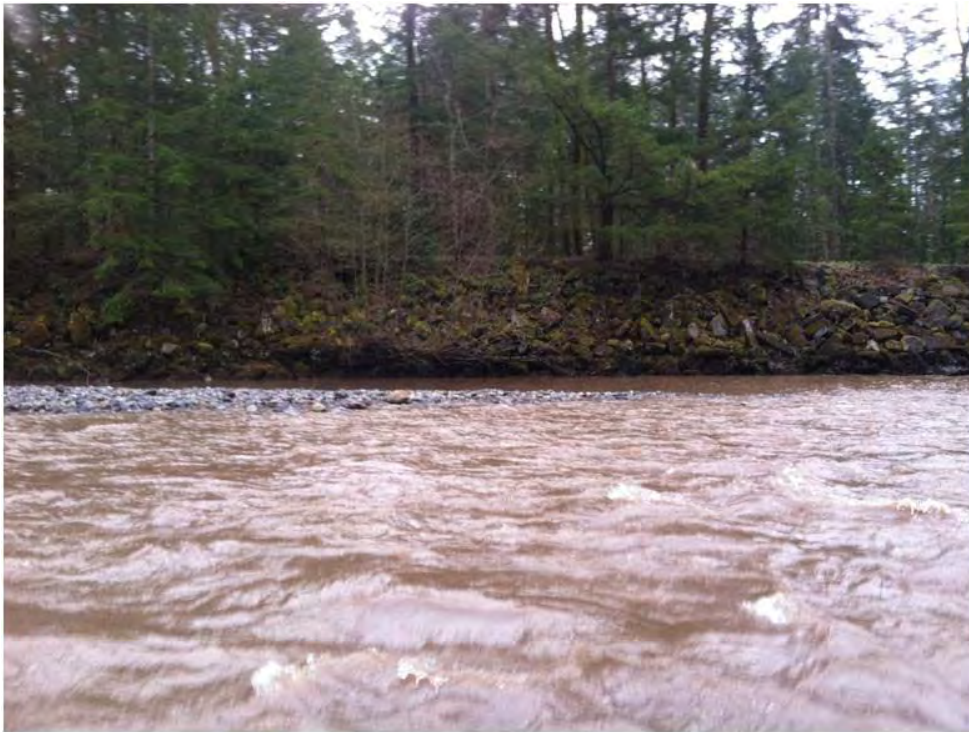
**Photo 5:** Left bank levee with riprap, near RM 8.5, upstream of the project reach.

The team observed the existing levee along the left bank within the project reach and upstream and downstream of the project reach. Upstream of the project reach, the river level was observed to be several feet below the top of the left bank levee (Photo 5). Within the project reach, portions of the left bank (existing Countyline) levee were at approximately the same elevation as the tops of gravel bars. No exposed rebar or in-channel weirs were observed outside or within the project reach. A concrete revetment was observed within the project reach on the right bank downstream of the BNSF Railway bridge. Large wood was observed on the upstream side of the single, in-water pier of the A Street bridge and on the two in-water piers of the Stewart Road bridge (Photo 6). Due to riverbed aggradation, the water surface elevation of the river at RM 6.0 during the relatively low flow level was within approximately two feet of the top of the left bank levee.

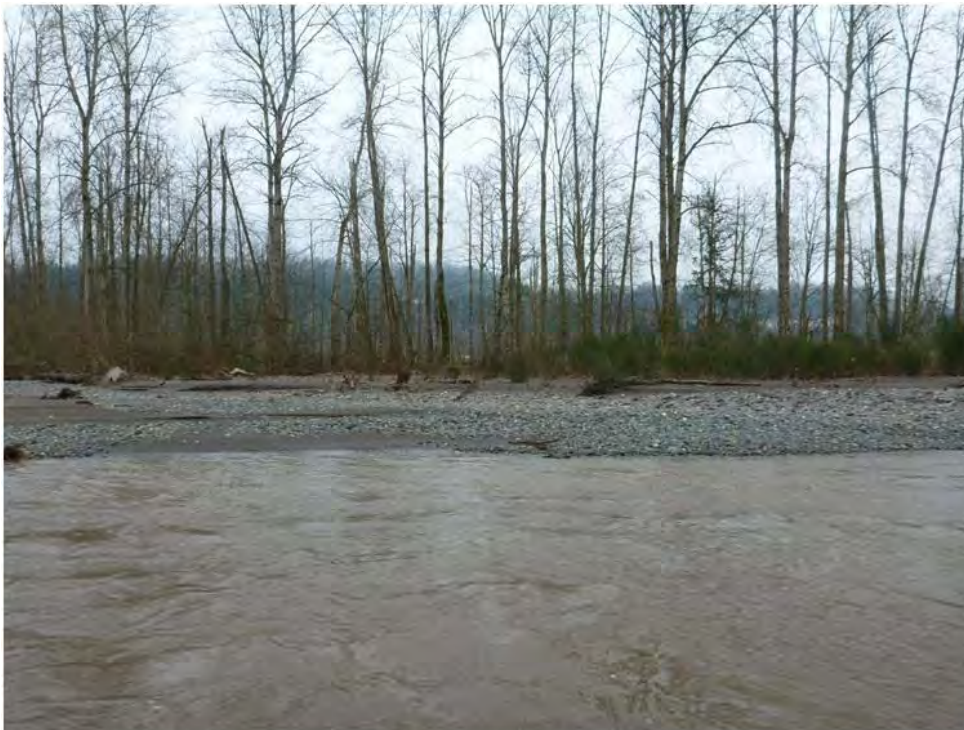
**Photo 6:** River level at the top of the left bank levee, near RM 5.8, within the project reach.

The biorevetment units proposed along the east side of the wetland to protect the new setback levee from channel migration may also pose a hazard to boaters and tubers as they attempt to negotiate the right turn, where the channel changes direction to the south. Throughout the setback area, the flow is likely to split into several channels. The shallow flow in these channels could make navigation more difficult, and could result in boaters becoming stranded as a result of encountering shallow water, gravel bars, and substantial accumulations of LW. Boaters and tubers may also need to portage to find a passable channel. Due to the presence of numerous dead and dying trees, the wetland area (Photo 6) will provide good opportunities for natural LW recruitment into the new channel(s). As a

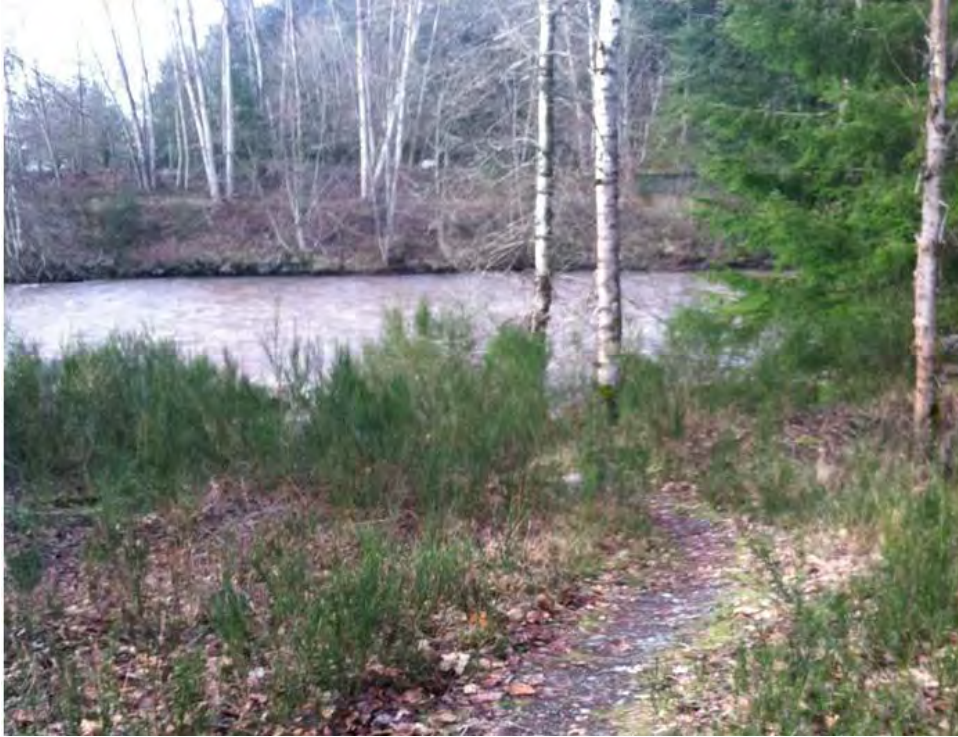
**Photo 7:** Potential signage and take-out or put-in location at Game Farm Park, near RM 8.2.

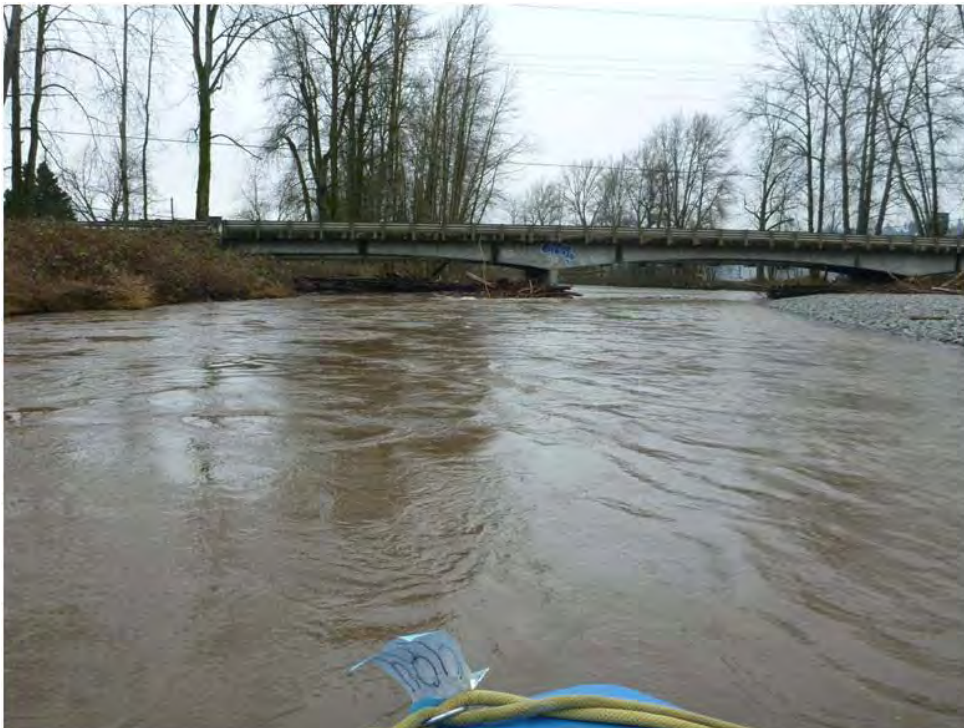
**Photo 8:** Potential take-out location at the Stewart Road bridge near RM 5.0, with accumulated LW. This LW complex would rate a “D” or “E” based on criteria in Table 1.

The take-out at the Stewart Road bridge was determined to be unsafe due to the amount of accumulated LW on both in-water piers (Photo 8). Using the criteria from Table 1, this LW complex would rate a “D” or “E”, indicating a relatively high hazard. As a result, the team used the right bank immediately downstream of the 24th Street bridge (Photo 9) for take-out. This area was somewhat constrained, and is limited to taking out a single raft at a time. However, if this location was ever considered as a take-out for casual inner tube use, this would probably not be an issue. An alternative take-out is located on the right bank, upstream of the end of 16th Street, but is only accessible by walking several hundred feet along a pedestrian trail.

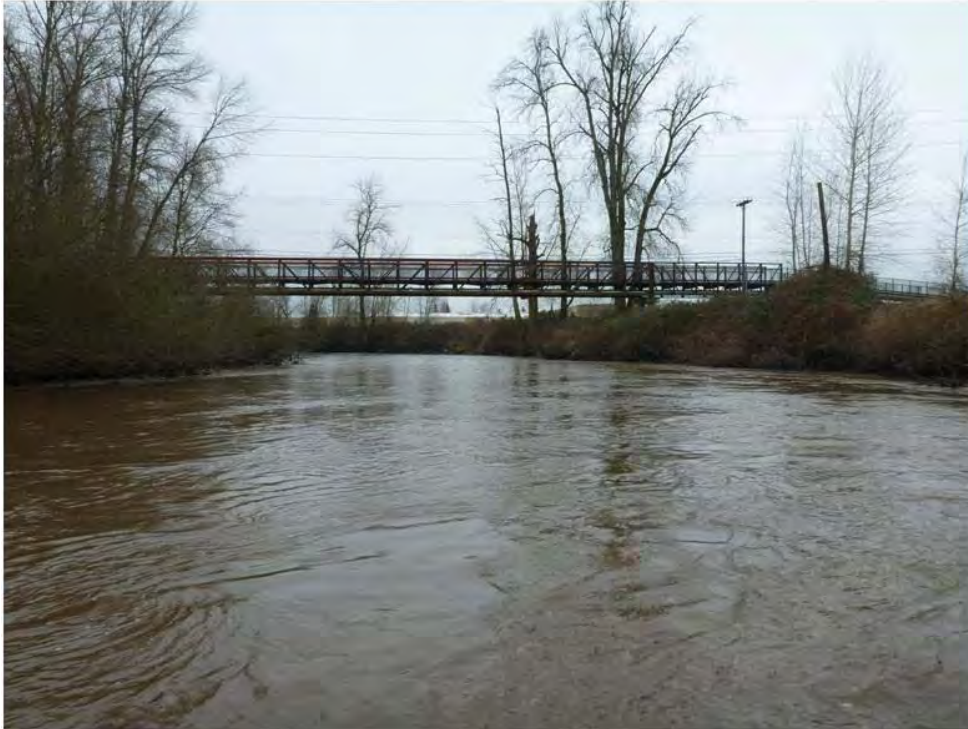
**Photo 9:** 24<sup>th</sup> Street bridge near RM 3.5, looking downstream. Take-out is on the right bank, immediately south of the bridge.

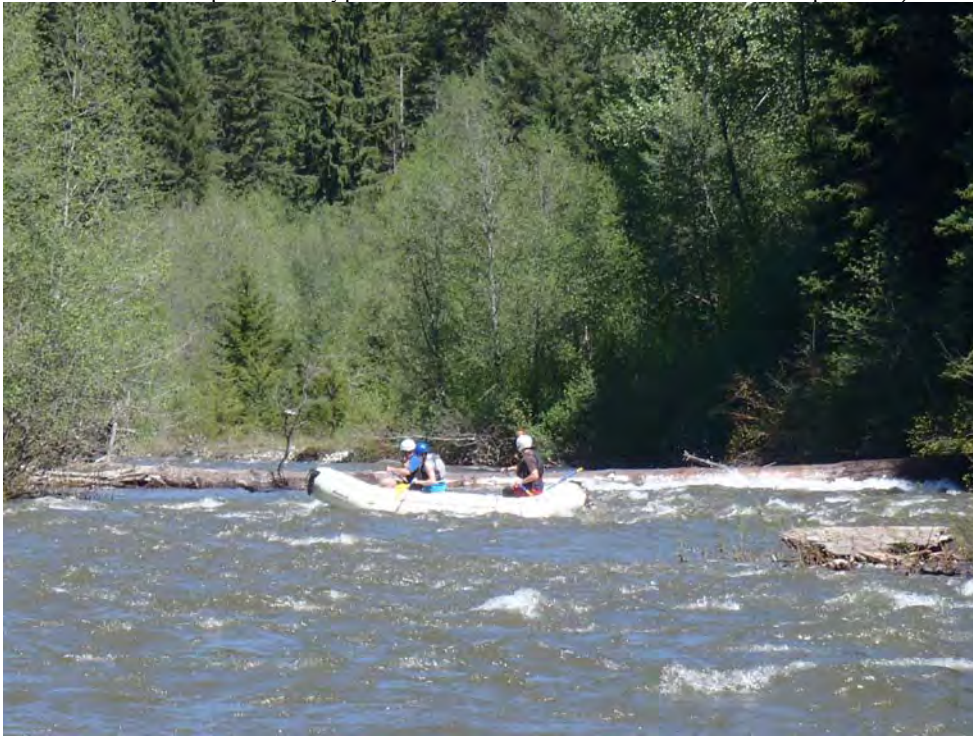
**Photo 10:** Example of a Type “F” LW accumulation on the Twisp River).
