# GEOTECHNICAL DESIGN REPORT

## Jan Road Neighborhood Improvements Design Project

Prepared for: Tetra Tech, Inc. and King County  
Department of Natural Resources and Parks, Water,  
and Land Resources Division, River and Floodplain  
Management Section

Project No. 190175-2000 • February 7, 2022 DRAFT

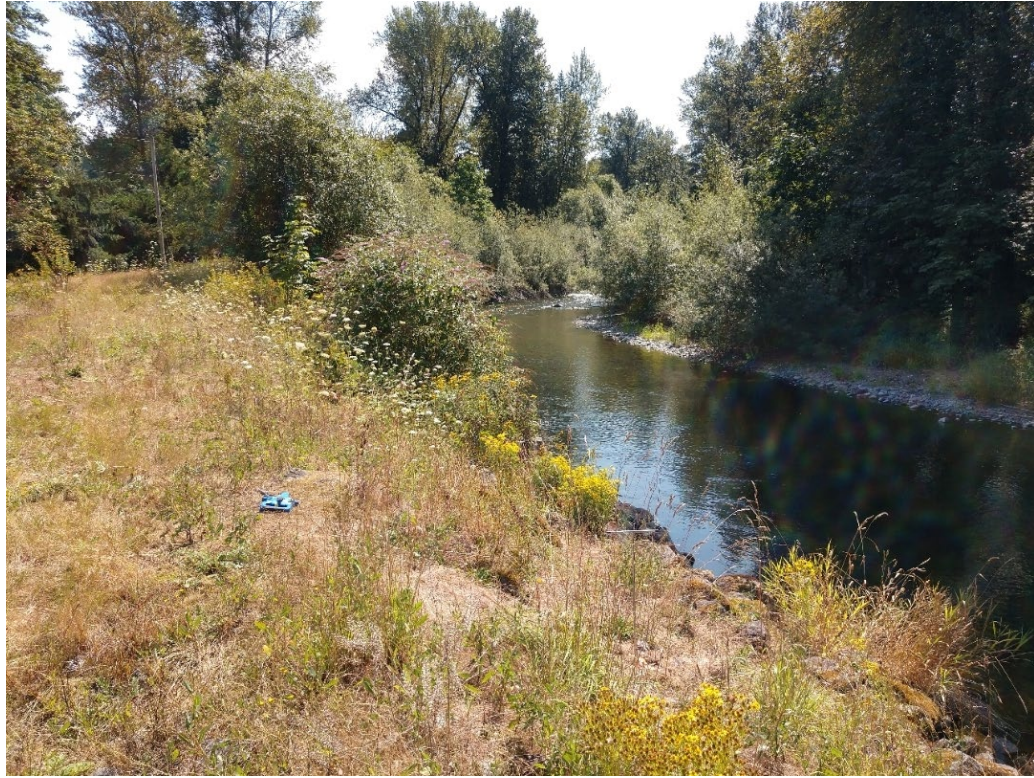
- **Jan Road Levee** (levee): The facility is located along the right bank of the Cedar River (right bank) and is approximately 1,400 feet in length (Photo 1 below). The levee is not designed to contain a 100-year flood event and is not tied to high ground at either end. It has been overtopped and/or circumvented in moderate flood events in recent history, resulting in flooding of the SE 19th Pl/221st Ave SE/228th Ave SE (access road), and isolation of up to 16 single-family homes in the neighborhood behind the levee.

*Photo 1: Jan Road Levee at RM 13.3, Looking Southeast*

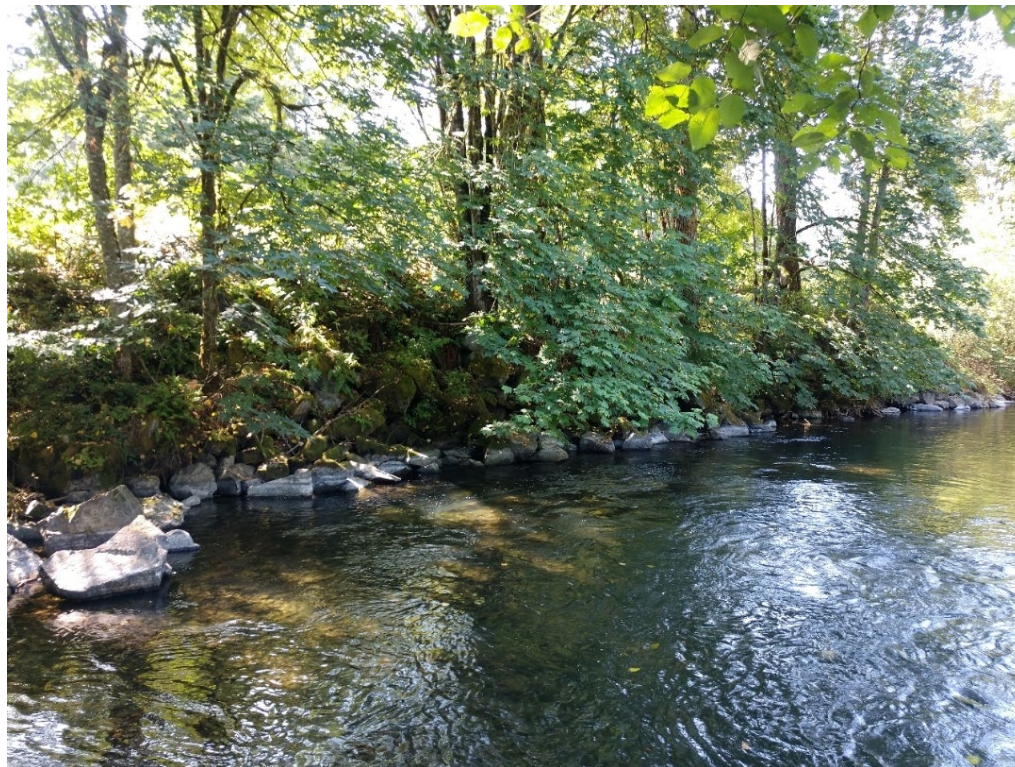
- **Cedar River Trail Site 7 Revetment** (CRT 7 revetment): This facility is located along the left bank of the Cedar River (left bank; Photo 2 below), and protects the Cedar River Trail (trail) and, further west, SR 169. The facility is approximately 500 feet in length. County records and observation have confirmed that this facility has experienced erosion and scour effects from the river.

*Photo 2: CRT 7 Revetment at RM 13.15, Looking Northwest*

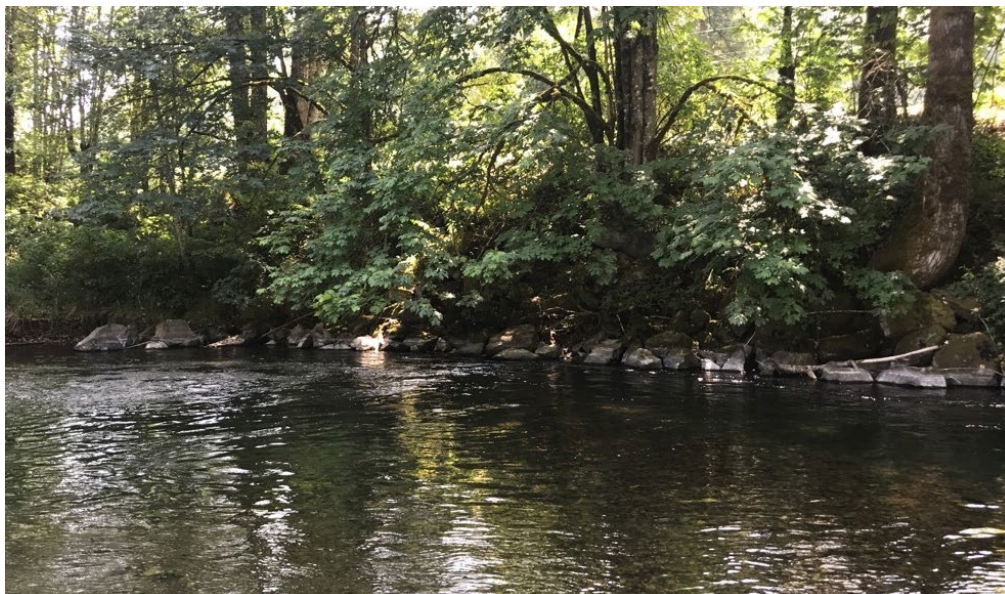
*Photo 3: CRT 7 Revetment at RM 13.1, Oversteepened Soil Along Revetment Toe (Looking Southwest)*

The CRT 7 revetment typically slopes up from the river channel at a 1.5H:1V slope to a height of 20 to 25 feet. During a site recon on August 15, 2019, Aspect observed some oversteepened areas at the toe of the revetment where its slope approaches vertical (Photo 3). The revetment slopes up toward the CRT, which is approximately 20 feet wide. East of the trail surface is a small drainage swale and, beyond that, the SR 169 roadway.

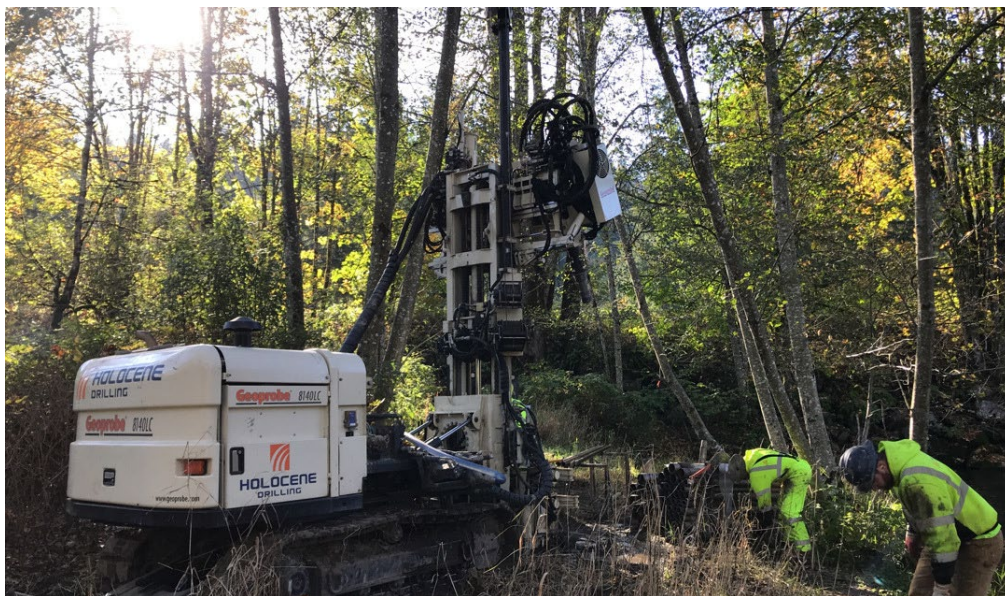
*Photo 4: Sonic drill positioned at AB-05*

The locations of Aspect's explorations are shown on Figure 2. Exploration logs created by Aspect for the Site and more detailed descriptions of the exploration methodologies are provided in Appendix A. Representative photographs of the subsurface exploration program are shown below in Photographs 4 and 5 below.

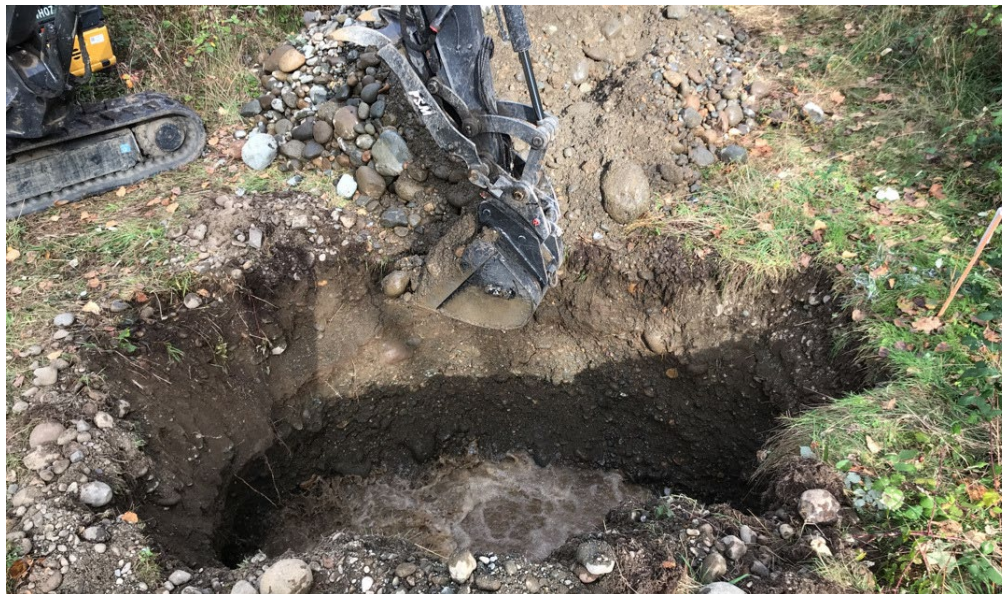
*Photo 5: Excavation of test pit at ATP-02*

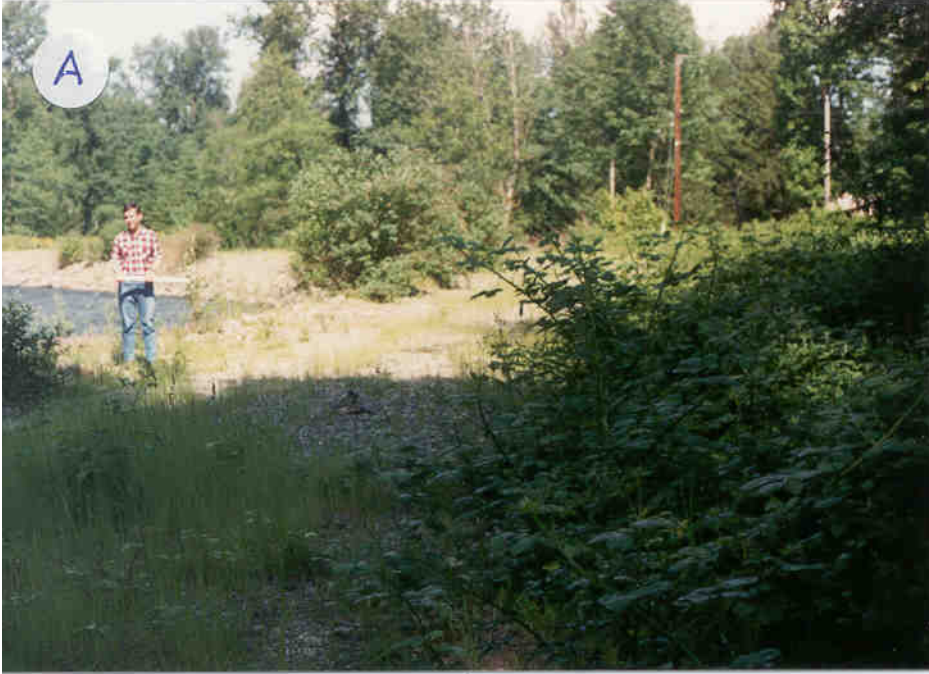
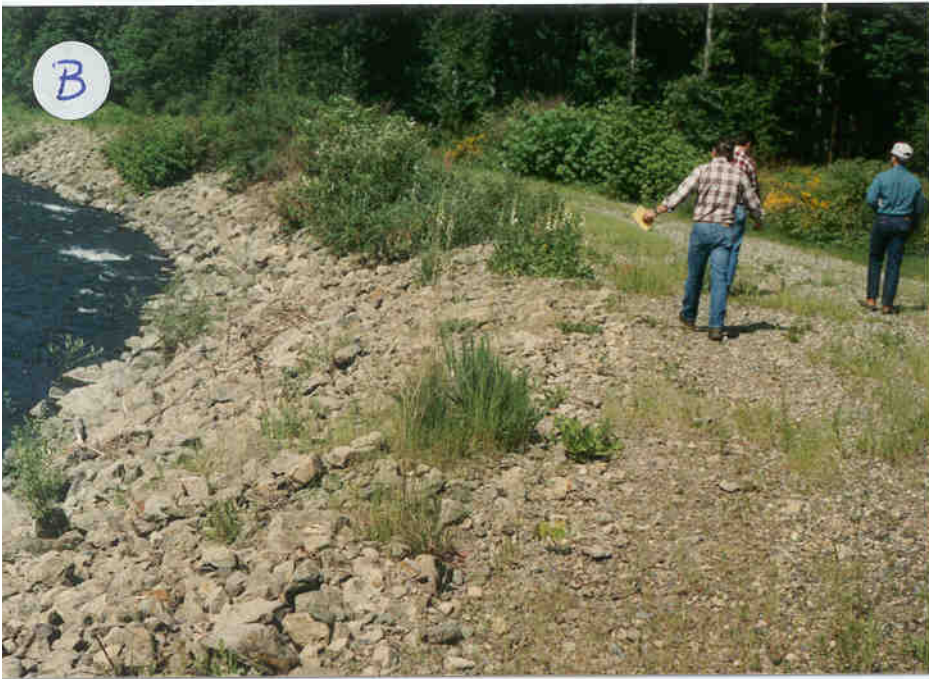
A – At upstream end looking downstream. Brush and small trees on the landward slope of the levee.

B – At station 11+00 looking downstream. Riprap bank protection.

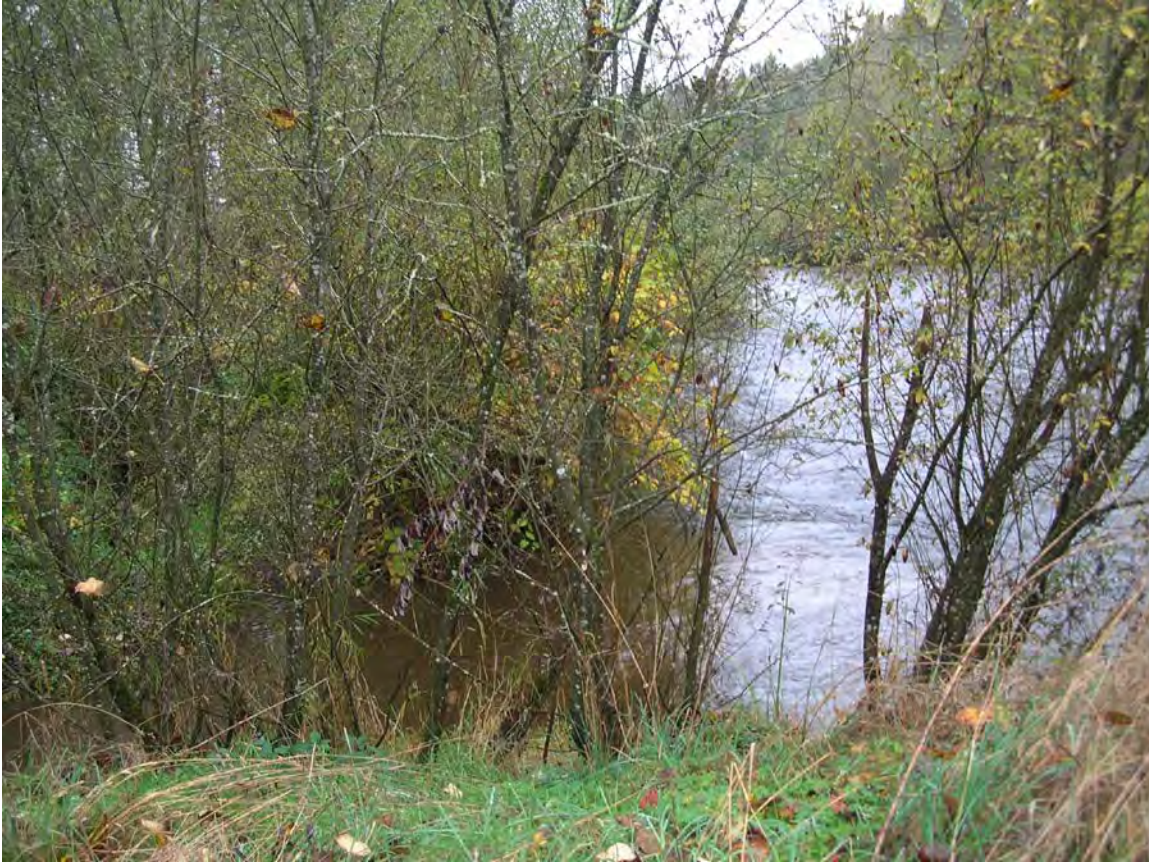
**Photo 1** – Jan's Curve Levee – At the curve, looking downstream. The levee face and toe require brushing and tree removal.

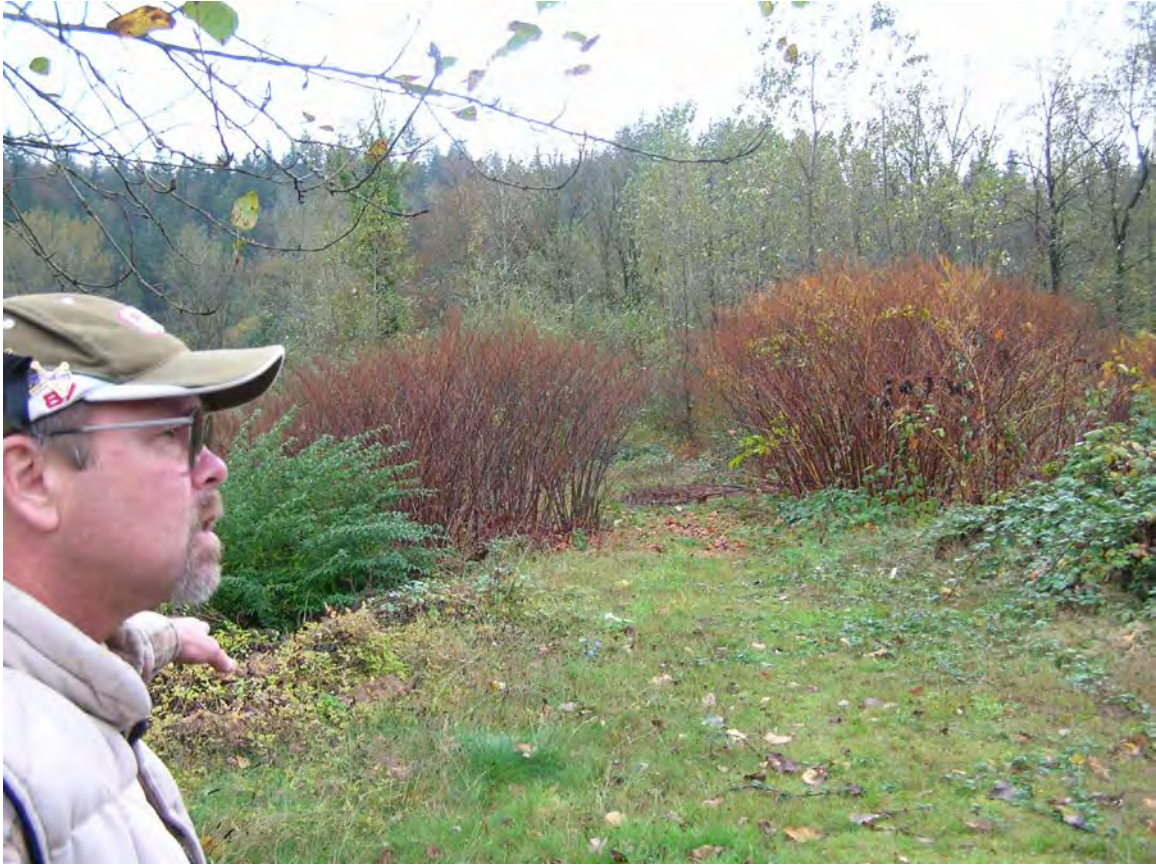
**Photo 3** – Jan's Curve Levee –Looking downstream near the downstream end. The knotweed was recently injected with herbicide.

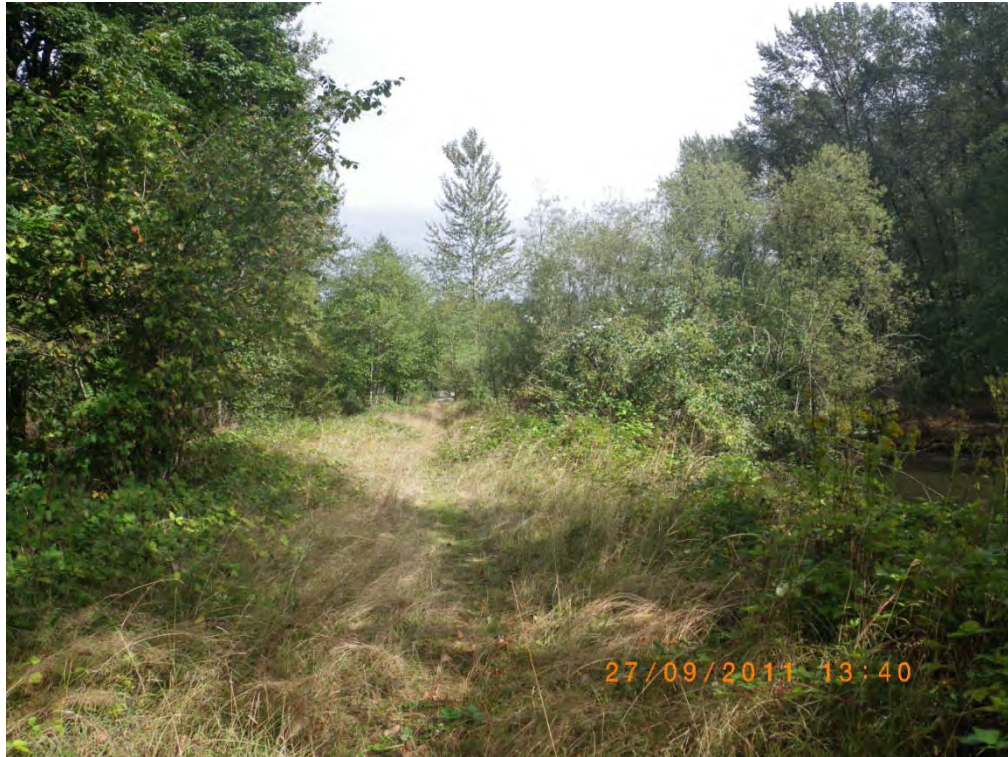
**Figure 2** – View of levee from downstream end looking upstream.

The inspection began at the upstream end of the levee. The entire length of levee is in desperate need of vegetation maintenance. A majority of the levee length has very dense brush and overgrown grass covering both the landward and riverward slopes and the crown (see Figure 2). There are also a number of trees on both the riverward and landward slopes that exceed the maximum allowable size of 4" diameter at breast height (DBH). Near the middle section of the levee, a local homeowner has maintained the levee crown and it appears that it sees a reasonable amount of recreational use. Near a picnic table on the crown, the crown shoulder appears to be losing material (see Figure 3). The inspection team is assuming this is caused by foot traffic displacing the riprap blanket near the top of the slope and subsequent damage to the material underneath. The heavy brush covering the levee slopes made inspection of the rock blanket, and landward slope, impossible resulting in a "Not Rated" rating for the related categories.

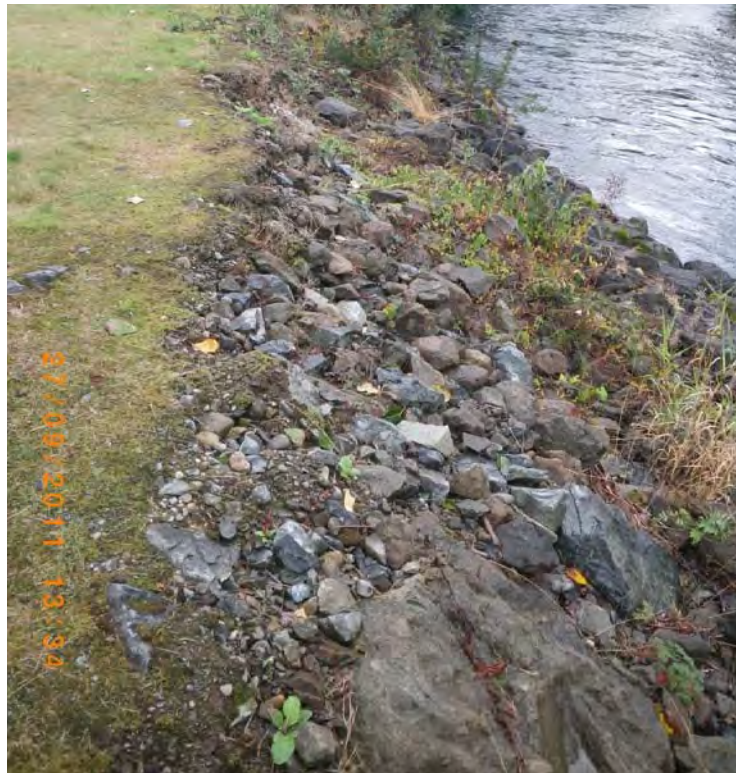
**Figure 3** – Shoulder of crown deterioration appears to be from homeowners walking on and displacing slope rock.

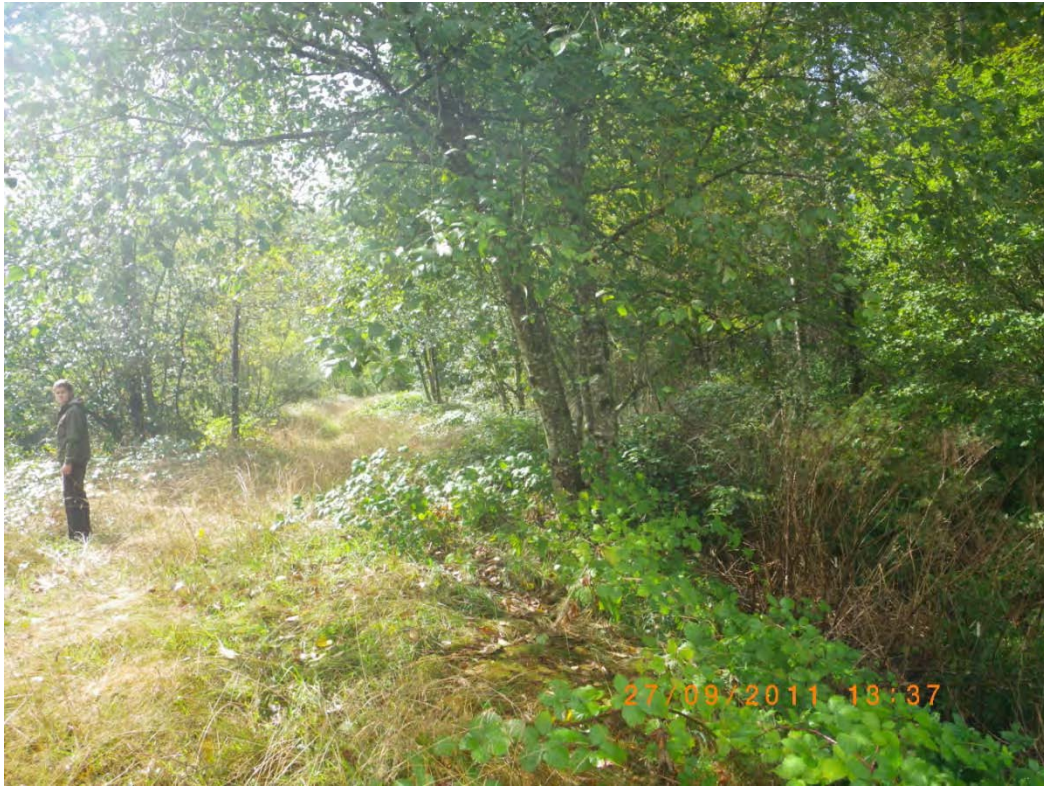
**Figure 4** – Trees larger than 4" DBH on both riverward and landward slopes.

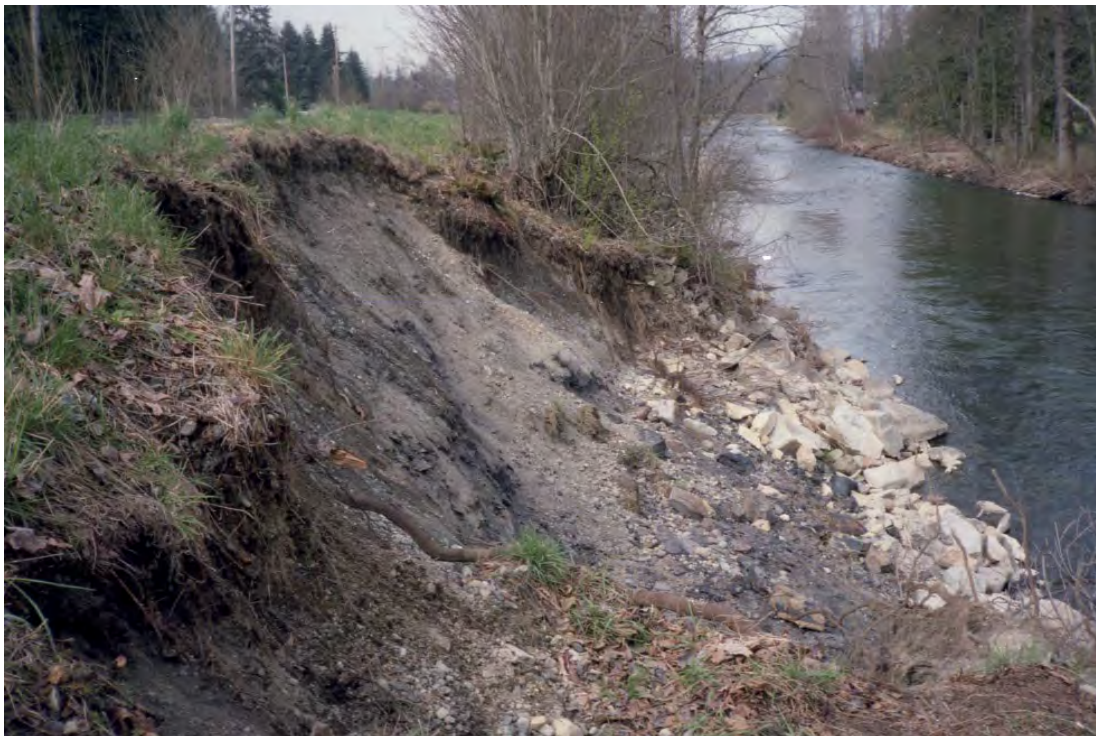
Figure 3. Revetment Damage (1996)

Extensive damage of the revetment at approximately RM 12.95 was observed following flood events in November 1995 and February 1996. The damage included slumping of the revetment and riverbank adjacent to the trail. The high flows of the flood events almost completely washed away the revetment armor rock resulting in a nearly vertical slope of bare and exposed soil extending along approximately 125 linear feet of the revetment surface. Photographs from the damage appear to indicate the revetment armoring prior to the flood damage included angular rocks on the surface of the slope between 3 and 5 feet thick.

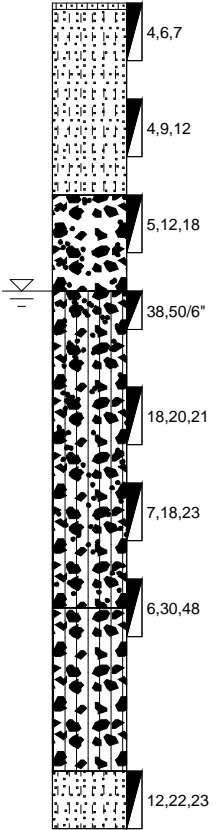
SM	Dark Brown, Medium Dense, Fine to			
		SP-SM	Medium Grain Silty Sand with Gravel, Moist.			8" Recovery.
			Tan, Medium Dense, Fine to Medium			
5		GW	Grain Poorly Graded Sand with Silt and Gravel, Moist.			9" Recovery.
			Tan, Medium Dense, Sandy Well Graded			Gravel in Sampler
		GW- GM	Gravel, Moist.			Tip.
			Tan/Brown, Dense to Very Dense, Well			6" Recovery.
10			Graded Gravel with Silt, Sand and			Gravel in Sampler
			Cobbles, Wet.			Tip.
						10" Recovery.
		SP	Tan, Dense, Gravelly Fine to Medium			
			Grain Poorly Graded Sand with			13" Recovery.
			Occasional Cobbles, Moist.			
15						17" Recovery.
		GM	Reddish Brown, Very Dense, Silty Gravel			
			with Sand, Moist.			
20						
		SP-SM	Reddish Brown, Dense, Fine to Medium			18" Recovery.
			Grain Poorly Graded Sand with Silt and

Gravel, Wet.			
			Boring Terminated at 21.5 Feet BGS.			
25						
30						
35

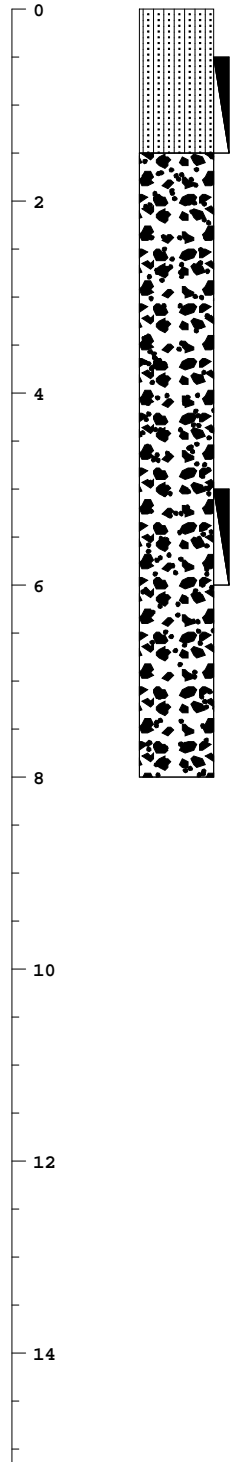
SM	Dark Brown, Fine to Medium Grain Silty Sand with Gravel and Occasional Cobbles, Moist, Fine Roots to About 18". (Fill?)		21.8	Debris Noted in Upper 1.5 Feet.
2		GW	Light Brown/Tan, Well Graded Sandy Gravel with Cobbles and Occasional Small Boulders, Moist (Moisture Content Increasing with Depth).			Increased Cobble Content at 4' to 8'.
4						
6						
8			Test Pit Terminated at 8' BGS.			
10						
12						
14

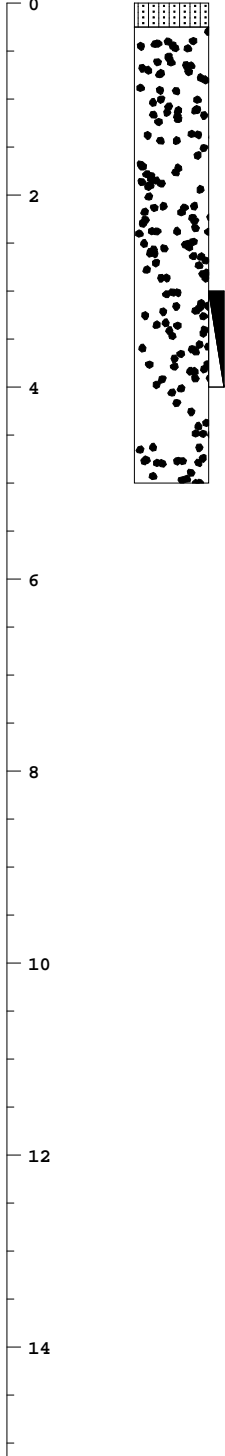
SM GP	Brown, Silty Sand with Gravel, Non-Plastic, Moist, Fine Roots to Approximately 18". (Topsoil)		2.5	
2			Light Brown/Tan, Sandy Poorly Graded Gravel with Occasional Cobbles, Moist. (Fill)			
4						
6			Test Pit Terminated at 5' BGS.			
8						
10						
12						
14

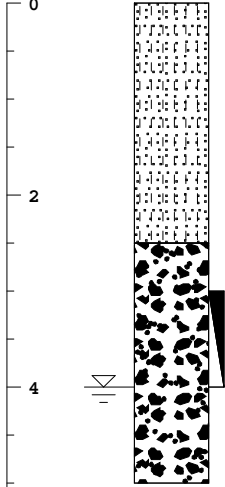
SP-SM	Brown, Fine to Medium Grain Poorly Graded Sand with Gravel and Silt, Abundant Cobbles, Moist, Fine Roots to Approximately 2'.			
2		GW	Light/Reddish Brown, Well Graded Gravel with Sand and Cobbles, Moist becoming Saturated at 4'BGS.			
4			Test Pit Terminated at 5' BGS.			
6						
8						
10						
12						
14

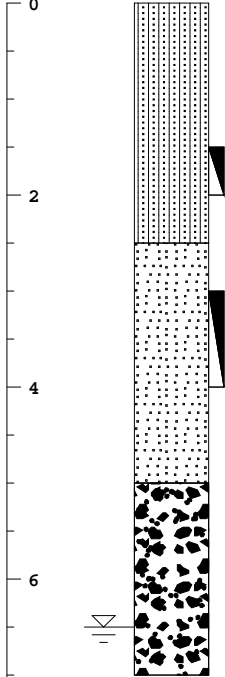
SM	Brown, Silty Fine to Medium Grained Sand, Trace of Gravel, Non-Plastic, Moist. (Abundant Roots 1/2" to 3" Diameter to a Depth of 2.5")			
2		SP	Tan, Fine to Medium Grain Poorly Graded Sand with Gravel and Cobbles, Moist.			Fill - Brick Encountered about 2.5' BGS.
4		GW	Tan/Reddish Brown, Well Graded Sandy Gravel with Cobbles, Moist Becoming Wet at 6.5' BGS.			
6			Test Pit Terminated at 7' BGS.			
8						
10						
12						
14

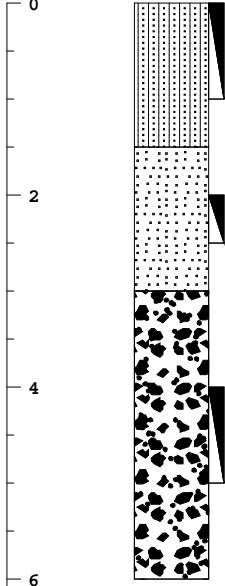
SM	Brown, Silty Fine Grain Sand with Gravel, Non-Plastic, Moist, Fine to 1-Inch Diameter Roots to 18".			
2		SP	Tan, Gravelly, Fine to Medium Grain Poorly Graded Sand with Cobbles and Occasional Small Boulders, Moist.			
4		GW	Tan/Reddish Brown, Well Graded Gravel with Sand, Cobbles and Occasional Boulders, Moist.		1.5	
6			Test Pit Terminated at 6' BGS.			
8						
10						
12						
14

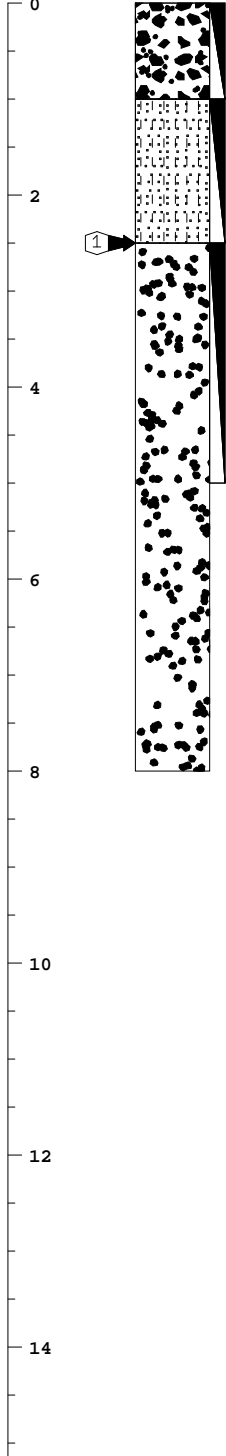
GW	Brown, Well Graded Gravel with Sand, 5% Cobbles, Non-Plastic, Moist, Fine Roots.	7.1	4.3	Possible Subgrade From Access Road.
2		SP-SM	Tan, Fine Sand with Silt, Non-Plastic, Moist.	22.8		
4		GP	Gray/Light Brown, Poorly Graded Gravel with Sand, 20% to 30% Cobbles, Moist.	2.9	0.7	
8			Test Pit Terminated at 8 Feet Due to Caving and Equipment Capability.			
10						
12						
14

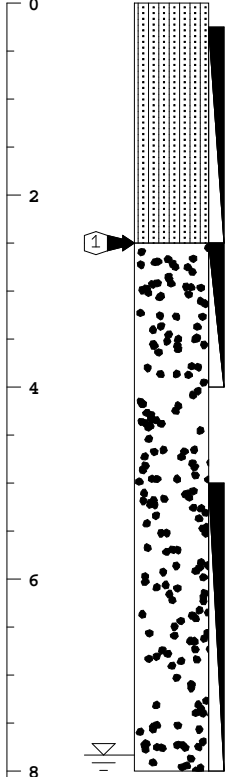
SM	Dark Brown, Fine Grain Silty Sand, Non-Plastic, Moist to Near Saturated, Fine Roots near Surface and 1/4" to 1" Diameter Roots to 2.5' Depth.	26.7	43.3	
2		GP	Gray, Poorly Graded Gravel with Sand, 20% Cobbles, Moist becoming Saturated at Bottom of Test Pit.	3.4		
4				7.5	2.8	
6						
8			Test Pit Terminated at 8 Feet Due to Water and Caving.			
10						
12						
14

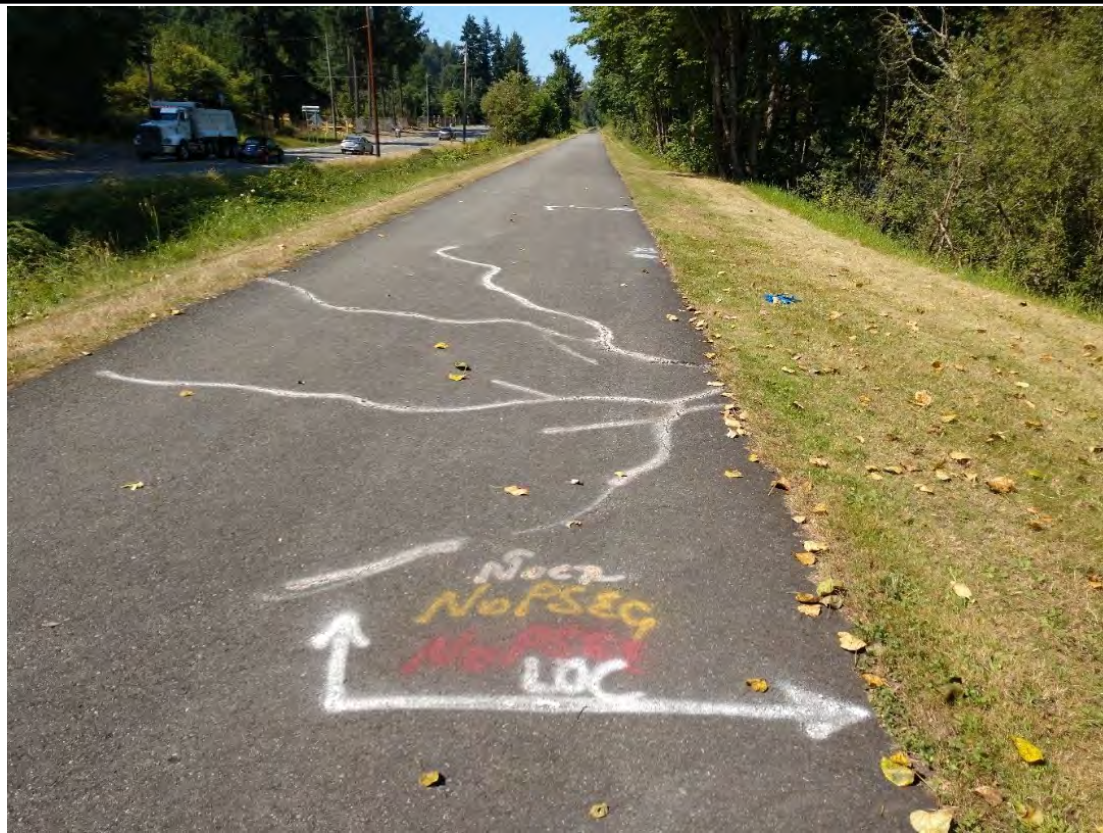
PHOTO 1: Cedar River Trail 7, Near B-2, looking north, pavement cracks in white

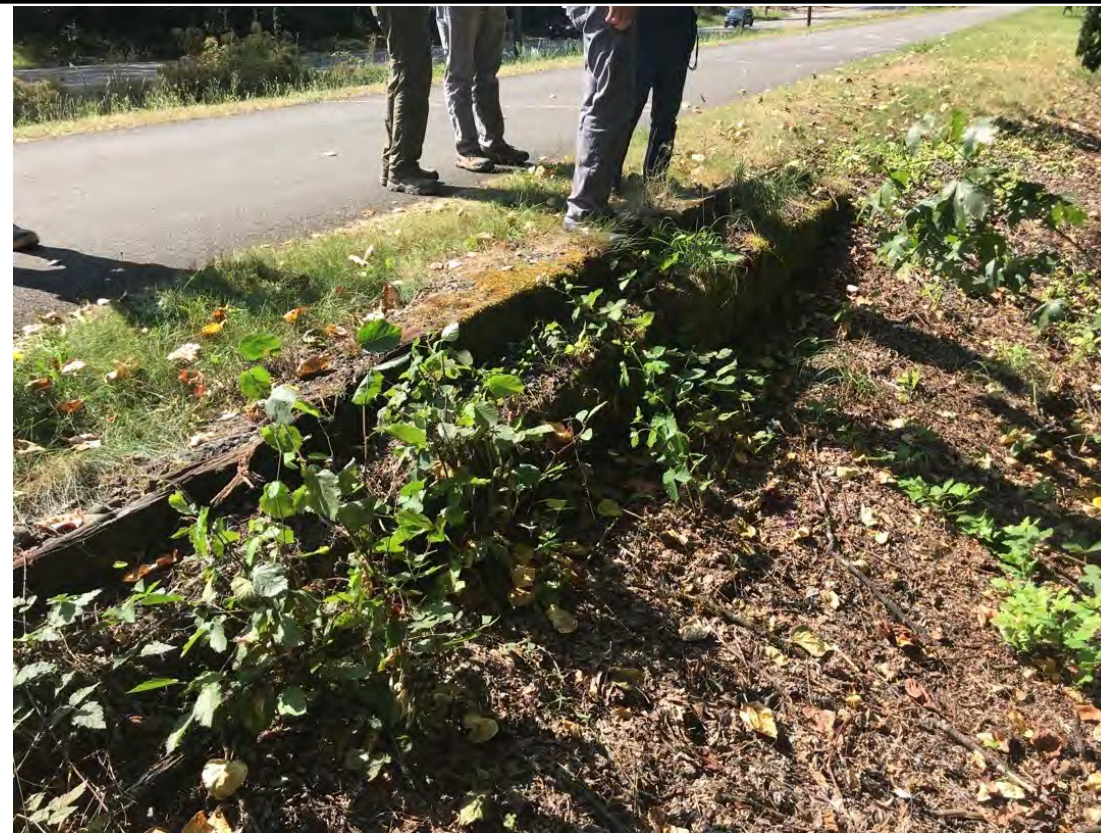
PHOTO 2: Cedar River Trail 7, Between B-1 and B-2, looking northwest, area of Trail settlement and vertical offset

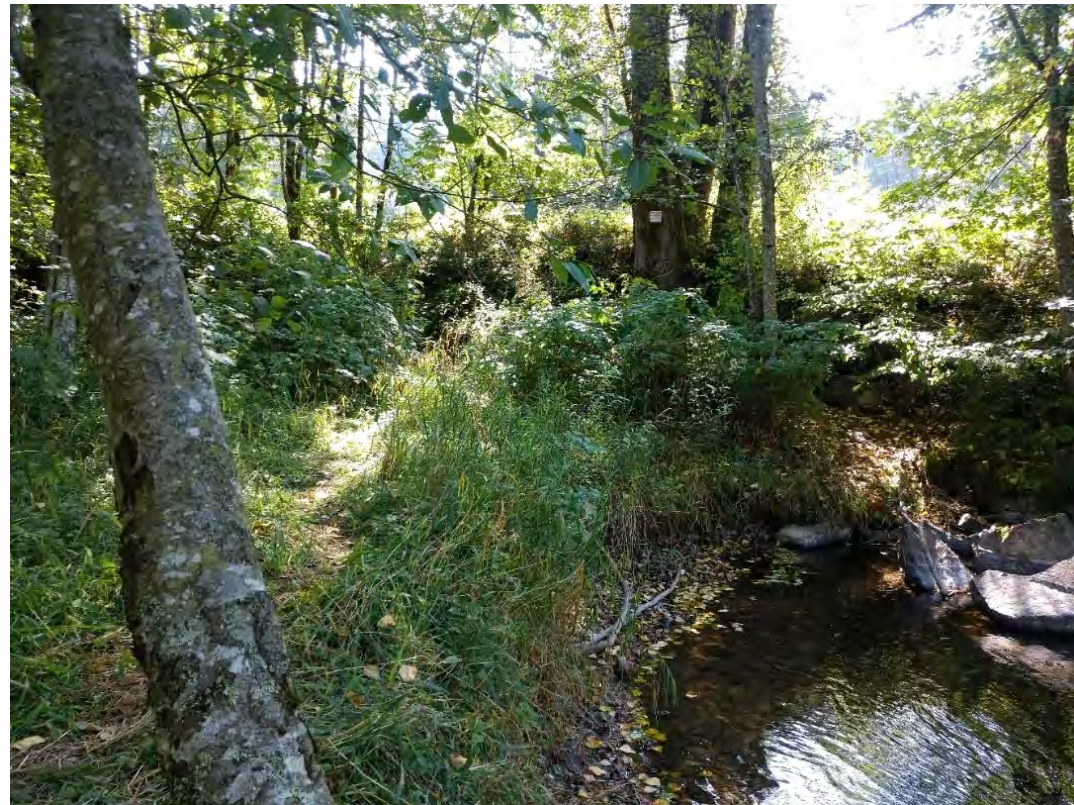
PHOTO 5: River Left Bank, approximately River Mile 13.17, looking west at toe of Revetment

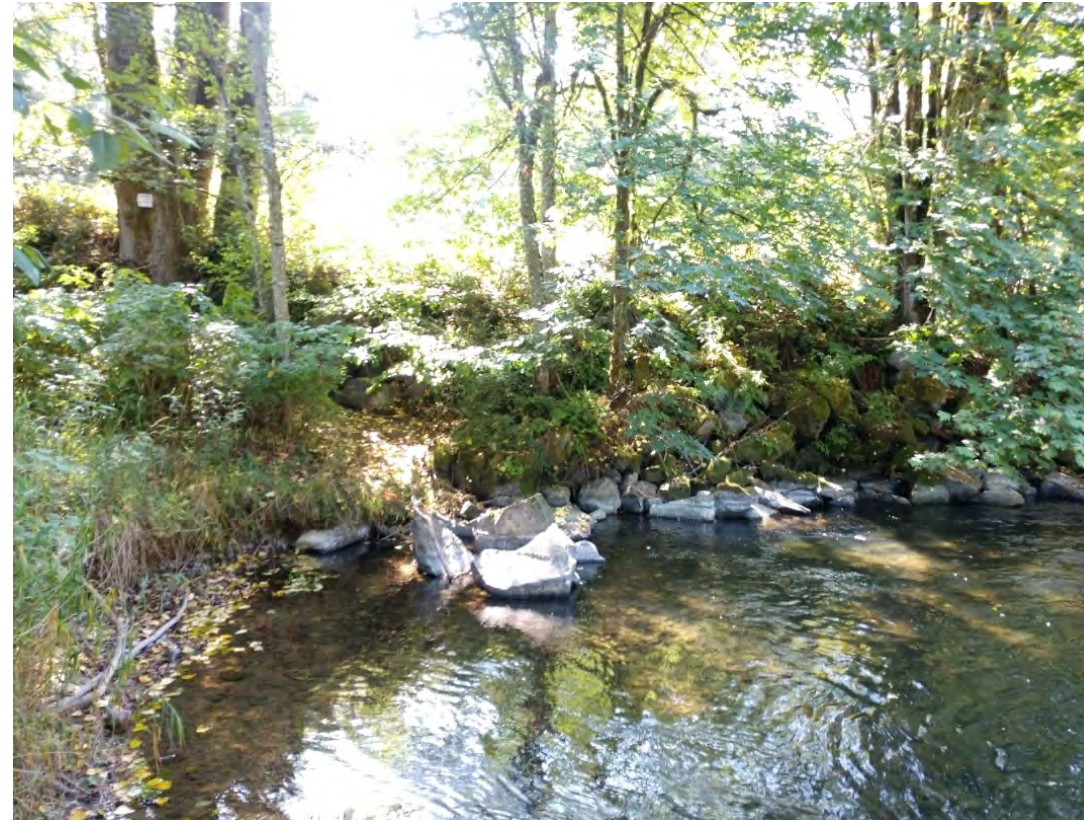
PHOTO 6: River Left Bank, approximately River Mile 13.17, looking west at toe of Revetment (2)

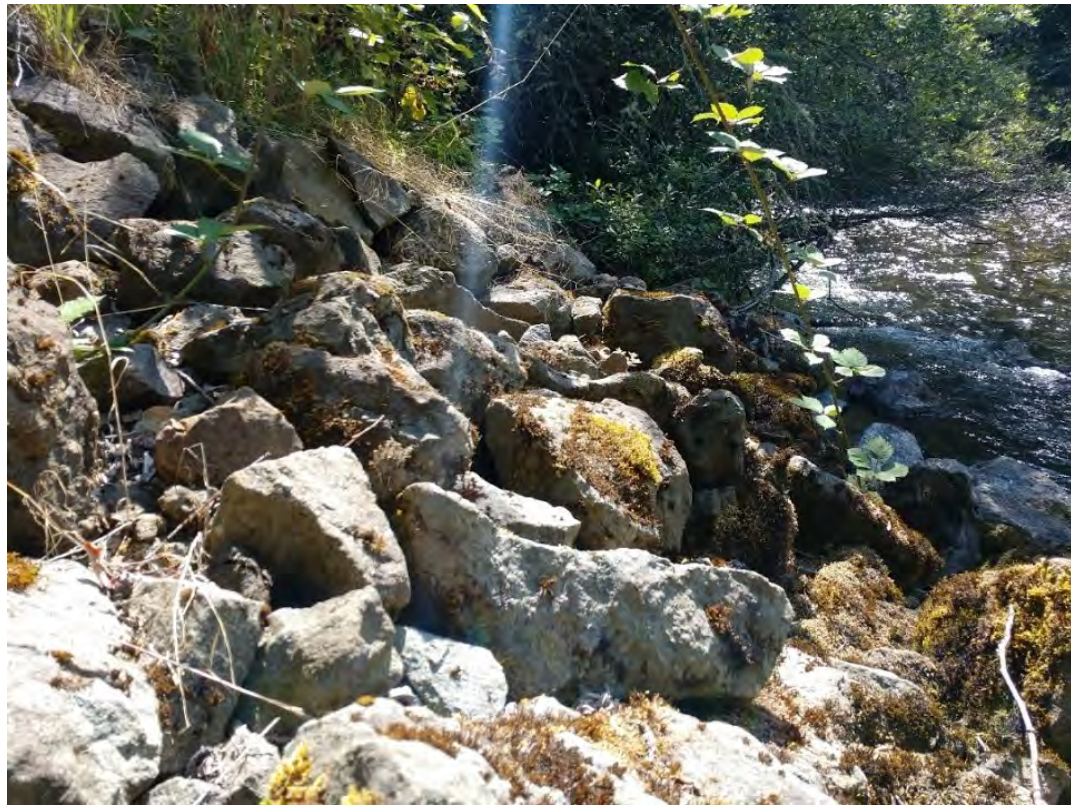
PHOTO 15: Revetment Rock (typical)
