Materials Laboratory

RSD-TR-0100

RE: **Fairwood 11 Culvert Replacement 2: Project #1117559**

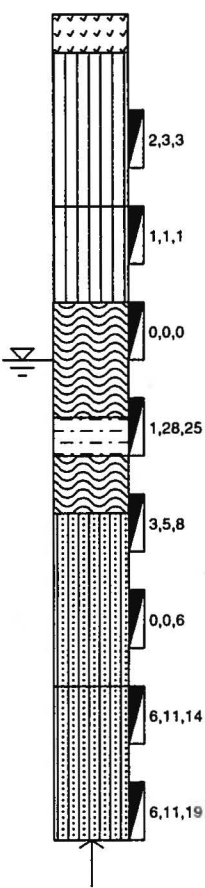
PROJECT: Fairwood 11 Culvert Replacement  
 BORING LOCATION: Fairwood Division 11 (see location map)  
 BORING METHOD: Hollow Stem Auger  
 DRILLER: Holocene Drilling  
 DEPTH TO - Water: 9'

ELEVATION/ DEPTH	SOIL SYMBOLS SAMPLER SYMBOLS AND FIELD TEST DATA	USCS	Description	Moist (%)	-200 (%)	Remarks
100 0

Dark brown silty sand to sandy silt, scattered organics and roots, wet, loose.			
	2,3,3	ML	Brown to gray sandy silt, scattered organics, mottled, wet, loose. (fill)			
95 5	1,1,1	ML	Brown sandy silt, scattered organics, mottled, wet, very loose. (fill)			
	0,0,0	OL	Dark brown organic silt intermixed with fibrous peat, wet, very loose.			
90 10	1,28,25		Wood debris			Sampler driven on log.
	3,5,8	OL	Dark brown organic silt intermixed with fibrous peat, wet, very loose. (fill?)			
	0,0,6	SM	Gray silty sand, trace gravel, wet, loose to medium dense. (fill?)			
85 15	6,11,14	SM	Gray silty sand to sandy silt, trace gravel, wet, medium dense to dense.			
80 20	6,11,19					
75 25						
70 30						
65 35

Groundwater was encountered at 9 feet below the ground surface during drilling.

In B-1, very loose to loose sandy silt fill was encountered to a depth of approximately 9 feet. Below the sandy silt, very loose organic silt intermixed with fibrous peat fill was observed to 13 feet. From 13 feet, loose to dense silty sand was found to the termination depth of the boring at 21.5 feet. Groundwater was observed in the boring at 9 feet below the ground surface at the time of drilling.
