Feasibility Study Report

Molasses Creek Fish Barrier and Habitat Improvement Project

August 2, 2023

Herrera Environmental Consultants, Inc.

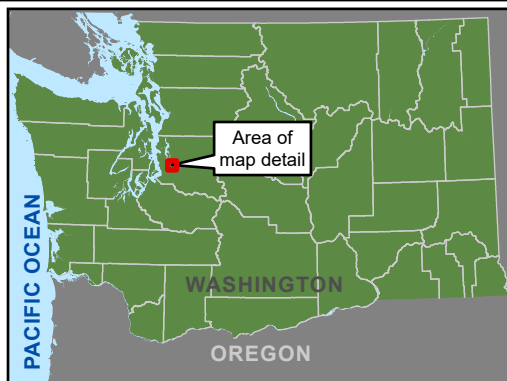
Figure 1.
Vicinity Map for the Molasses Creek Fish Barrier and Habitat Improvement Study.

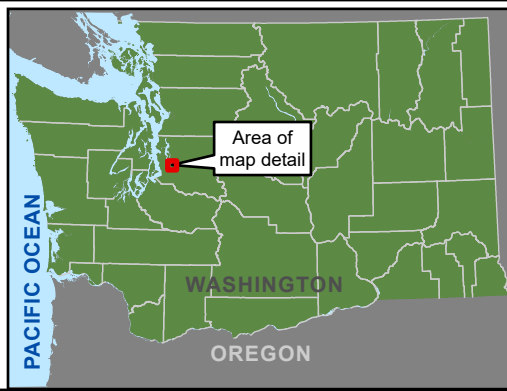
Figure 1.
Vicinity Map for the Molasses Creek Fish Passage Feasibility Study.

Molasses Creek is a tributary of the lower Cedar River, in Water Resource Inventory Area (WRIA) 8: Cedar-Sammamish. The project area focuses on the culverted section of Molasses Creek from approximately river mile (RM) 0.9 to RM 1.15 (King County 2022a). It is located in unincorporated King County near the southeastern limits of the city of Renton, in Section 27, Township 23 North, Range 05E of the Willamette Meridian (Figure 1).
