# Habitat Inventory and Assessment of Three Sammamish River Tributaries: **North, Swamp and Little Bear Creeks**

**May 2001**

**Sammamish Washington  
Assessment and Modeling Program**  
**Water and Land Resources Division**  
201 South Jackson St, Suite 600  
Seattle, Washington 98104

# **1999 Habitat Inventory and Assessment of Three Tributaries to the Sammamish River: North, Swamp, and Little Bear Creeks**

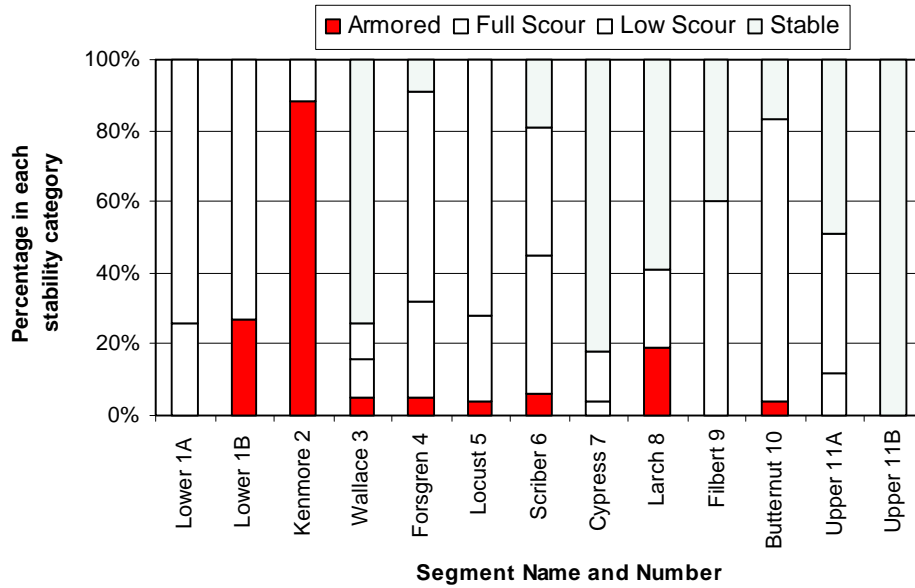
**Figure 6. Streambank stability ratings of Swamp Creek segments. A higher percentage of streambanks were rated armored and high scour in the lower segments.**

- The lower 6 segments had the highest percentage of reaches rated “armored” or “full scour.”
- Forty percent or greater of the upper segments 7-11 were rated “stable”, with the exception of segment 10, which had banks that were rated 79 percent low scour and 17 percent full scour.

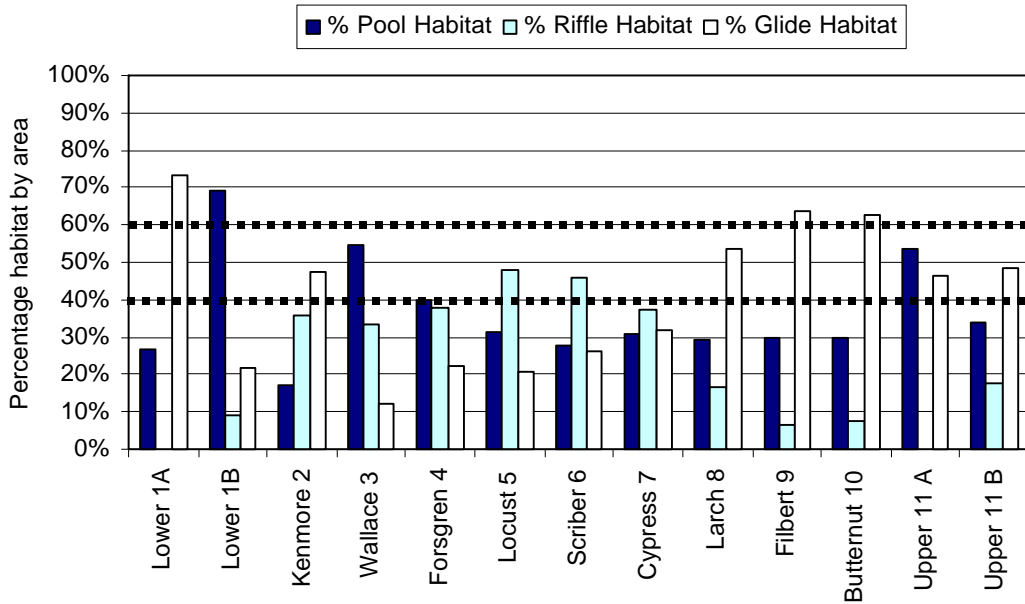
**Figure 7. The percent habitat composition by area of Swamp Creek segments. Optimal habitat distribution is 1:1 pool to riffle ratio; the percentage of each should be between 40 and 60 percent (Peterson et al. 1992). The percent pool habitat by area decreased from the mouth of Swamp Creek to the middle segments and increased slightly in segments 11A and 11B.**

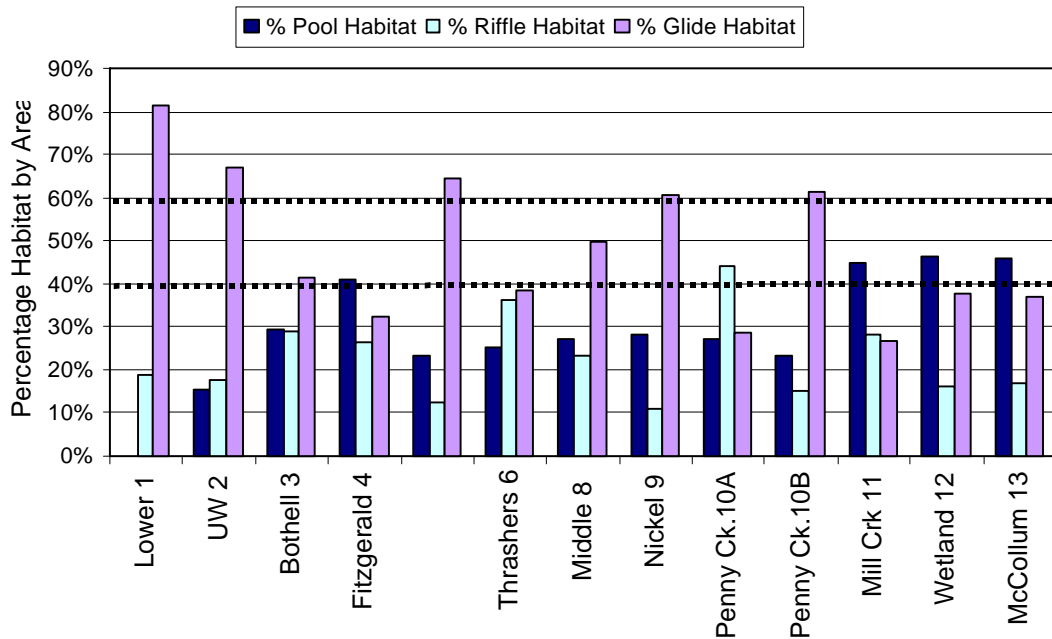
**Figure 13. Percentage habitat composition of North Creek segments. Optimal pool to riffle habitat ratio is 1:1; the percentage of each should be between 40 and 60 percent (Peterson et al. 1992). Only four segment had more than 40 percent pool habitat by area, and only one had greater than 40 percent riffle habitat by area.**

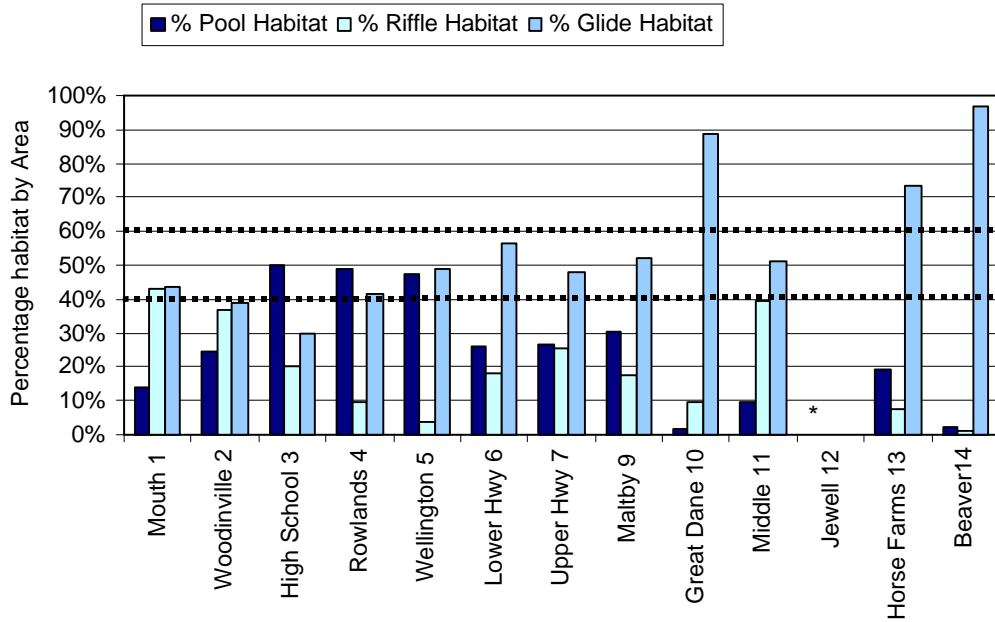
**Figure 19. Percent habitat composition by area in Little Bear Creek. Optimal pool to riffle habitat ratio is 1:1; the percentage of each should be between 40 and 60 percent (Peterson et al. 1992). Only four segments had more than 40 percent pool habitat by area, and only one had greater than 40 percent riffle habitat by area. \* Segment 12 was visually assessed and estimated to be similar to the adjacent segments 11 and 13.**

Pools comprised 10 percent or less of the stream habitat in mainstem segments 11 and 14, and Great Dane tributary segment 10.

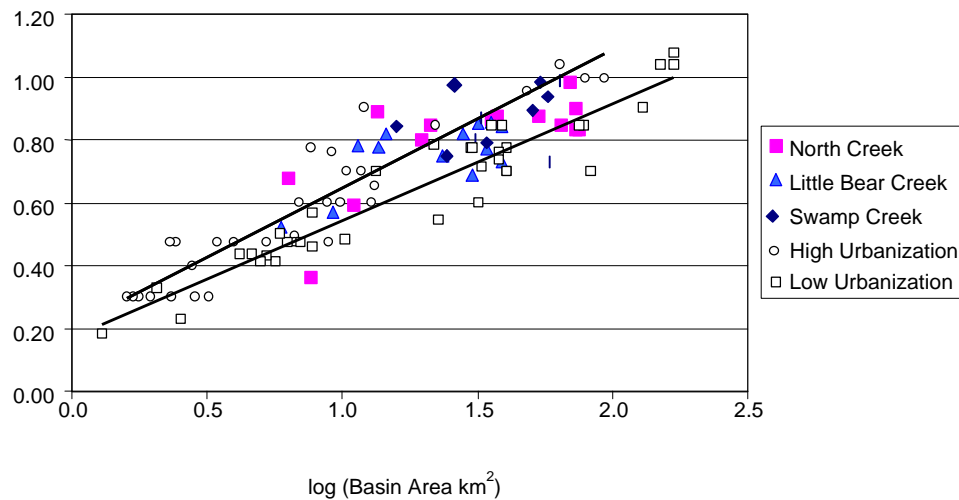
**Figure 22. The bankfull width of urbanized streams are larger relative to the basin size than streams with low levels of urbanization. The data from the three study streams: Swamp, North and Little Bear Creeks fall in the highly urbanized category (Henshaw 1999).**

Urbanizing streams tend to “over-widen” and incise as a result of more frequent bankfull flow conditions (Dunne and Leopold 1978). When BFW measurements are plotted against sub-basin area, regional curves can be developed showing the characteristic relationship for natural and urban streams. Using regional data compiled by the University of Washington, Center for Urban Water Resources Management (Henshaw 1999), BFW measurements from the three assessed streams were compared to regional curves for low-urbanization and urbanized (high urbanization) streams (Figure 22). The data for North, Swamp, and Little Bear Creeks generally correspond with the regional data for urbanized streams, and confirm the conclusion that a modified hydrologic regime has negatively impacted stream channel morphology.

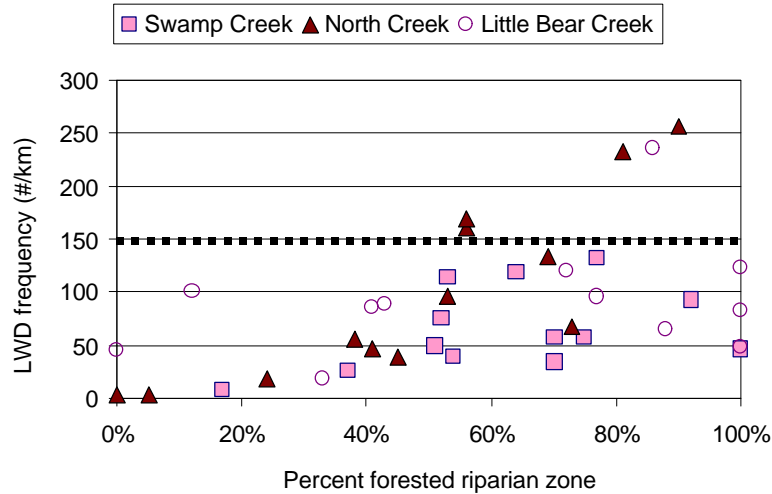
**Figure 23. LWD frequency and the percent of the riparian corridor that is forested. Instream large woody debris frequency is only high when a significant portion of the riparian zone is forested.  $R^2 = 0.23$ ,  $p < 0.01$ . Dashed line is the low end of the natural frequency range (Murphy and Koski 1989).**

Substantial frequency and volume of LWD were only found in assessed stream-segments that had a considerable forested component within their riparian zone, which may function as a source of LWD and a buffer to LWD removal by area residents. Having a fully forested riparian corridor did not, however, ensure natural levels of instream LWD (Figure 23). Isolated areas where mature, coniferous dominated forest corridors still occur in these urbanizing watersheds (see segment 10) of Swamp Creek, the upper mainstem segments (11-14) of Little Bear Creek, and segment 13 (McCollum) on the upper mainstem of North Creek). These areas in North and Swamp Creeks but not in Little Bear Creek, had relatively high LWD frequencies. High percentages of riparian forest cover do not necessarily guarantee high LWD frequencies due to multiple loss mechanisms and possible limiting recruitment potential.

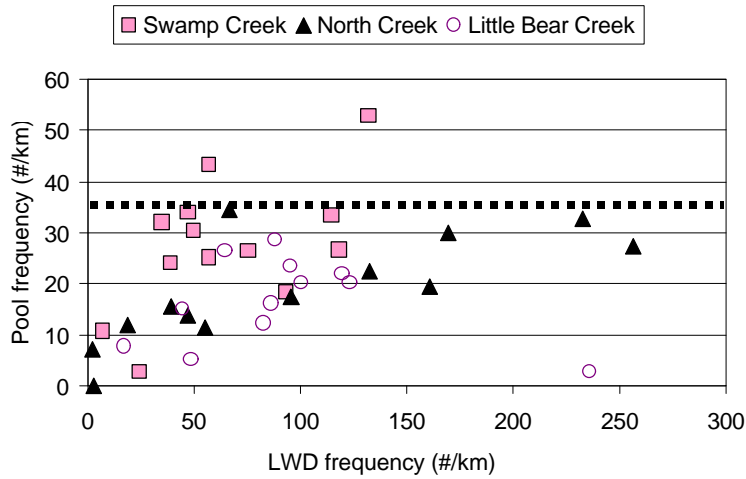
**Figure 24. Pool frequencies relationship to LWD frequencies. Pool frequencies were lowest where instream LWD frequencies were also low. Pool frequencies were mostly higher where LWD frequencies were high.  $R^2 = 0.21$ ,  $p < 0.01$ . Dashed line is the lowest frequency of pools that indicates properly functioning conditions (NOAA 1996).**

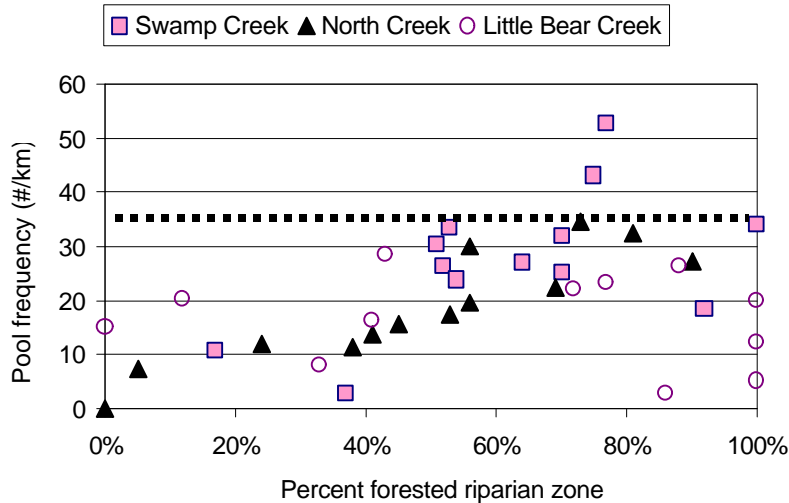
**Figure 25. The relationship between pool frequency and percentage of forested riparian zone. The relationship is relatively strong on Swamp and North Creeks ( $R^2=0.55$ ,  $p < 0.001$ ); but less so on Little Bear Creek (all data:  $R^2=0.21$ ,  $p < 0.01$ ). Dashed line is the lowest frequency of pools that indicates properly functioning conditions (NOAA 1996).**

Only reaches above the city of Mill Creek in North Creek, scattered middle segments of Swamp Creek and a few segments in lower middle Little Bear Creek appear to have pool quantities approaching to natural conditions. Pool quantity (surface area fraction and frequency) was positively influenced by LWD (Figure 24) and the maintenance of a mature, forested riparian corridor with few breaks (Figure 25).
