# East Lake Sammamish Master Plan Trail, South Sammamish Segment A Critical Areas Study

Prepared for  
**King County**  
Facilities Management Division

December 2014

Prepared by  
**Parametrix**

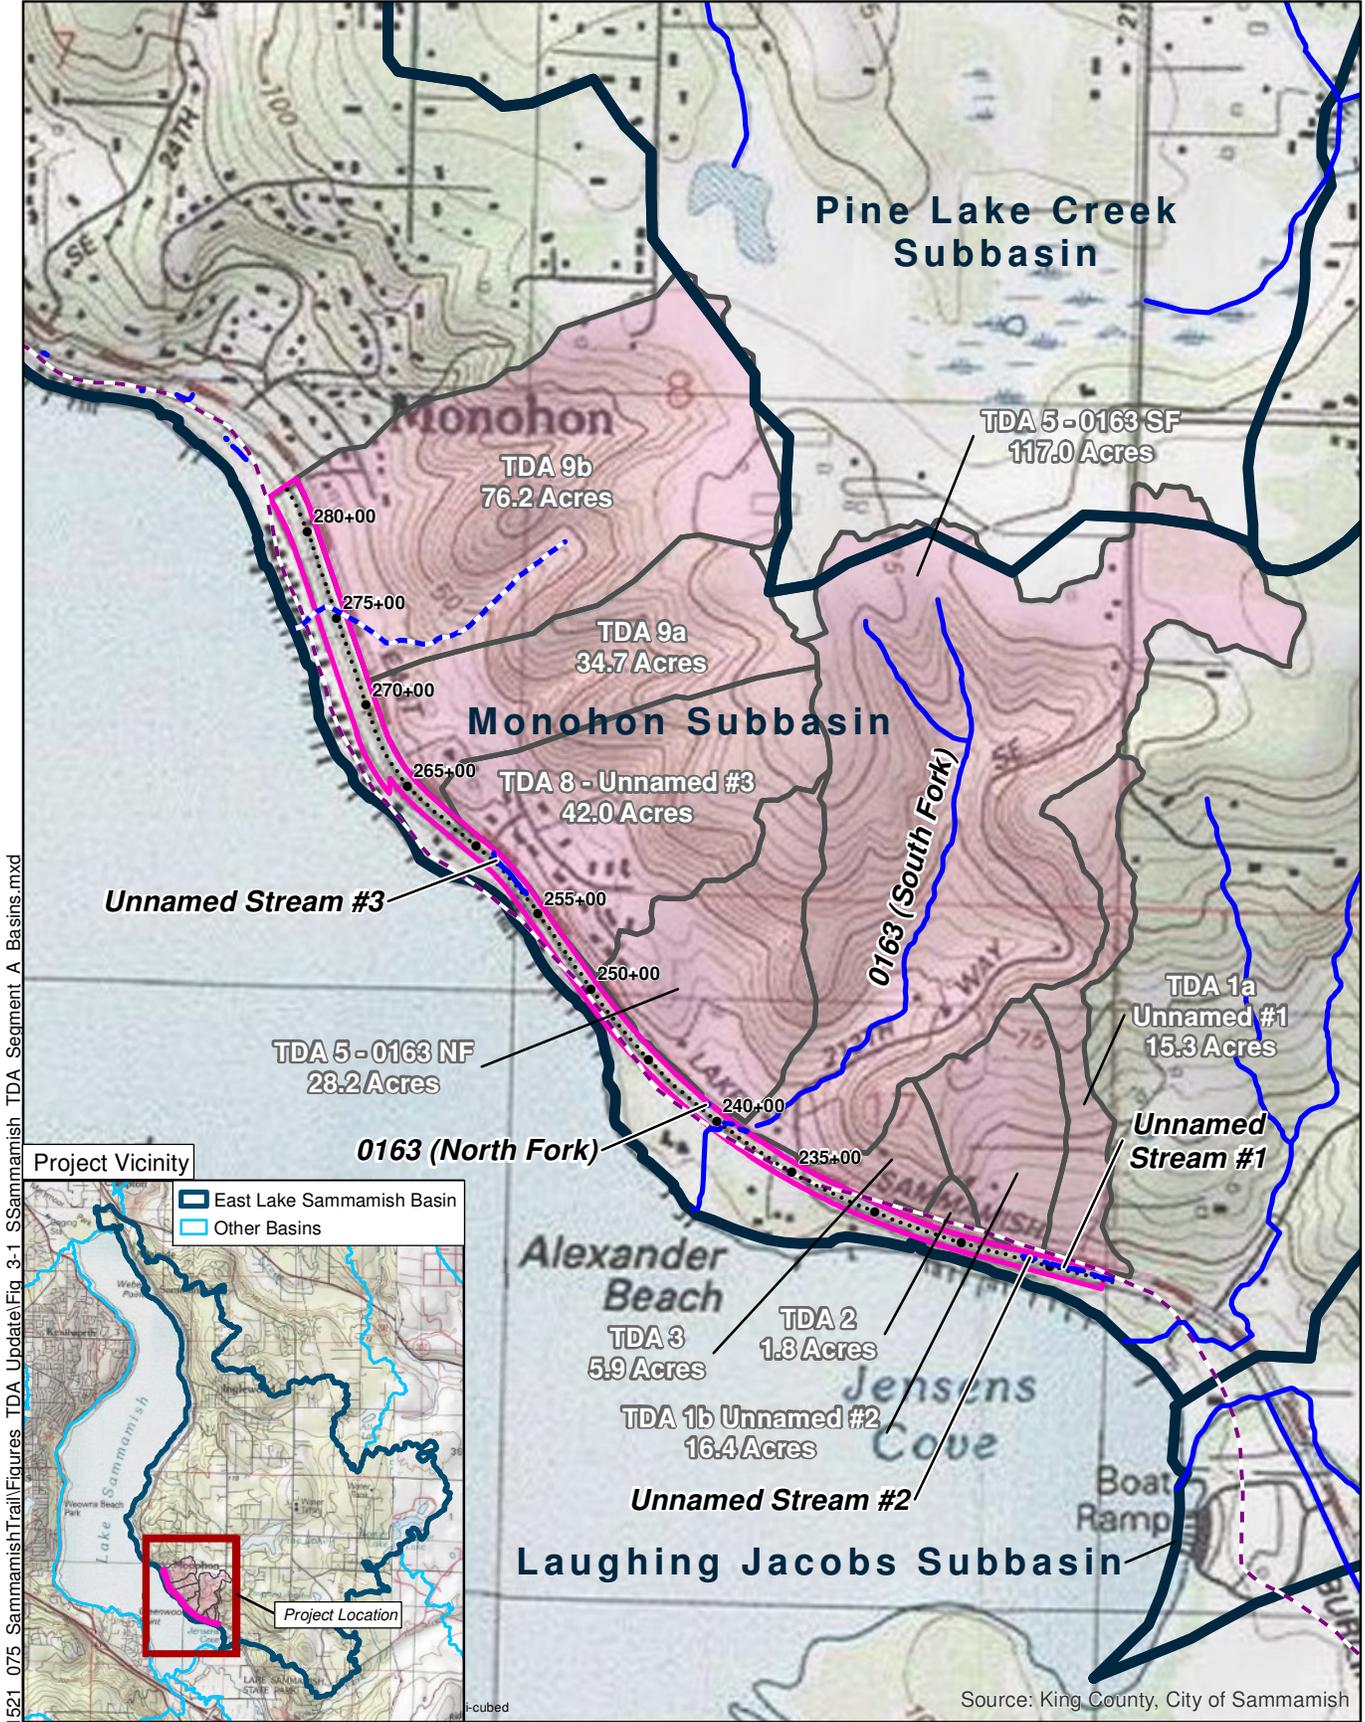
**Figure 3-1  
Drainage Basins,  
Subbasins and  
Site Characteristics**

- ▬ South Sammamish Segment A Project Location
- ▬ Stream Crossing Field-verified by Parametrix
- - - Stream Crossing Not Found within Trail Corridor
- - - 100-year Floodplain Boundary
- Drainage Subbasin Boundary
- Catchment Area

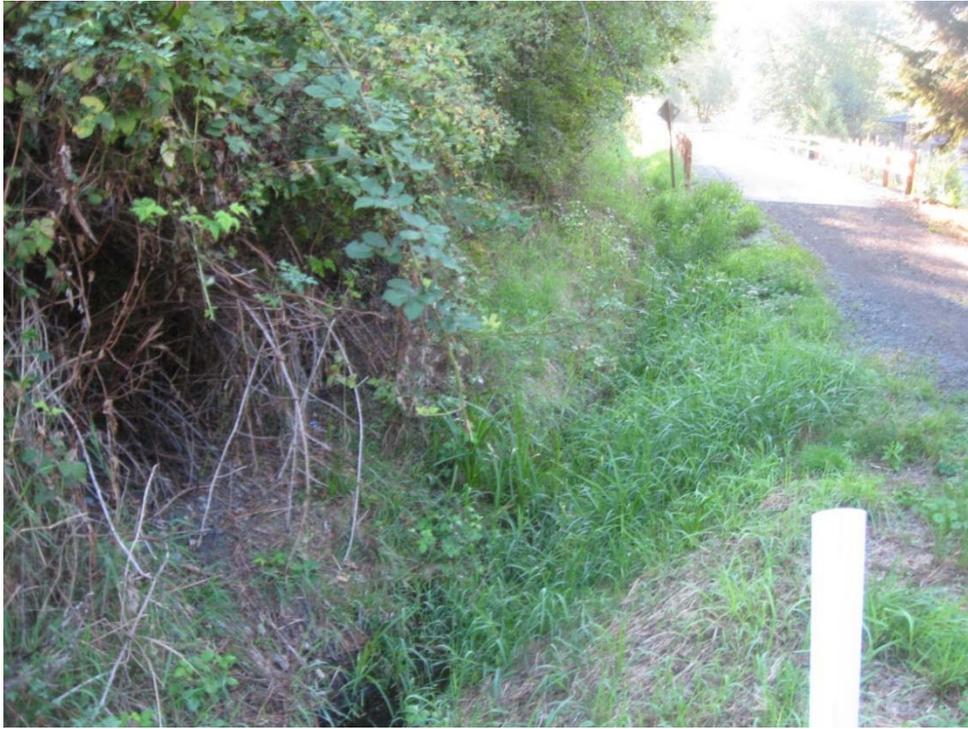
**Photo 1.** Wetland 3E (looking south from north end).

Wetland hydrology is maintained by local area runoff and overbank flow from Many Springs Creek. Many Springs Creek discharges into the south end of the wetland from a culvert that passes under East Lake Sammamish Parkway. Surface water from the stream drains to the south crossing under the trail to its outlet in Lake Sammamish. Surface water also flows north via a ditch in the wetland to a pipe under a driveway, connecting to Wetland 14A. Soils were saturated to the surface with standing water during the October 2007 and September 2013 field investigation. Surface water was observed throughout the ditch and flowing water was present in Many Springs Creek. Wetland 3E has permanently inundated and saturated only water regimes.

Wetland 3E has an emergent vegetation community with an overhanging tree canopy rooted outside of the wetland. Dominant vegetation in the wetland includes small-fruited bulrush (*Scirpus microcarpus*) and reed canarygrass (*Phalaris arundinacea*). Other species observed include broadleaf cattail (*Typha latifolia*), softstem bulrush (*Scirpus tabernaemontani*), watercress (*Nasturtium officinale*), ladyfern (*Athyrium filix-femina*), giant horsetail (*Equisetum telmateia*), ovate spikerush (*Eleocharis ovata*), American vetch (*Vicia americana*), fowl mannagrass (*Glyceria striata*), bluegrass (*Poa* spp.), and a few black cottonwood (*Populus balsamifera*) saplings. Common duckweed (*Lemna minor*) was present in deeper stagnant water.

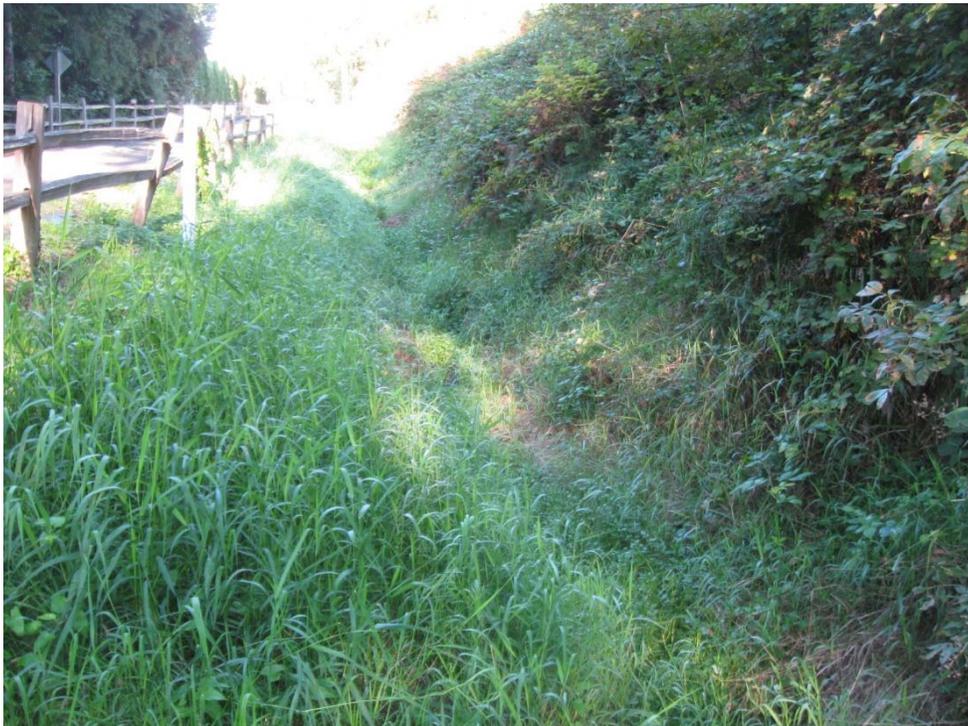
**Photo 4.** Wetland 14A and Unnamed Stream #1 (looking north from south end).

Wetland 14A is an emergent vegetation community dominated by reed canarygrass and watercress. Other species observed during the field investigation include reed canarygrass, American speedwell, watercress, giant horsetail, small-fruited bulrush, common duckweed, hedge false bindweed, and Himalayan blackberry.

Wetland 14A is situated between the trail and East Lake Sammamish Parkway SE. Driveways are found at the wetland boundary to the west and the east. The wetland buffer is limited to an area upslope between the wetland and the parkway. Vegetation in the buffer is dominated by Himalayan blackberry. Other species include black cottonwood, Oregon ash, salmonberry (*Rubus spectabilis*), Scotch broom (*Cytisus scoparius*), Japanese knotweed (*Polygonum cuspidatum*), giant horsetail, reed canarygrass, and bracken fern. The surrounding area is characterized by single-family residential development. Lake Sammamish is located beyond a row of houses to the west. The buffer between the trail and the wetland is a narrow band of maintained herbaceous vegetation.

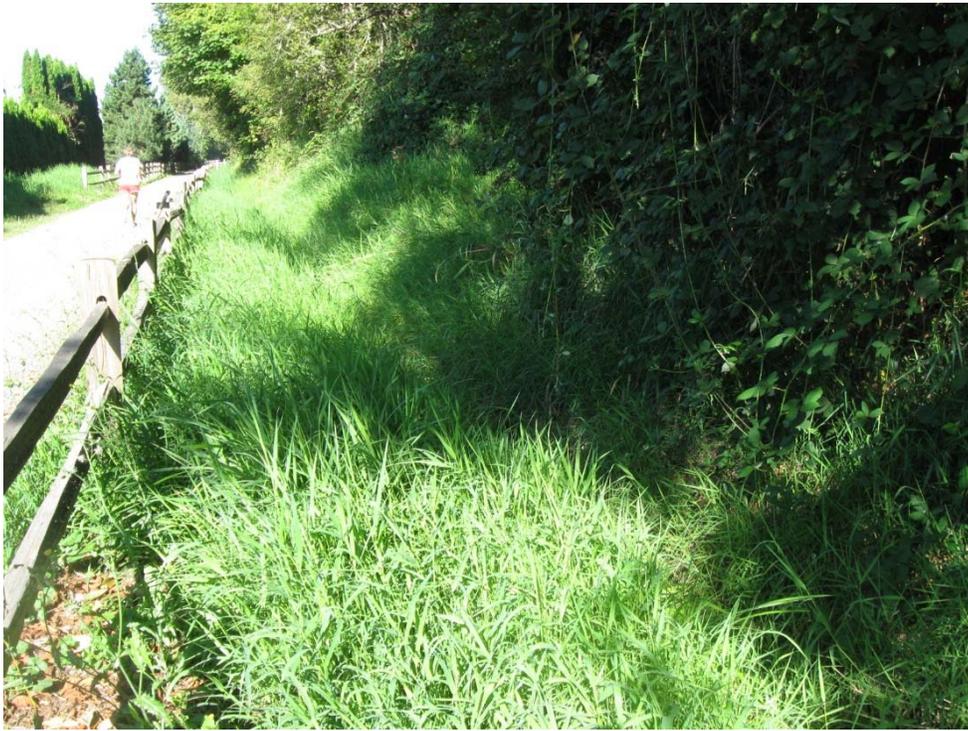
**Photo 5.** Wetland 14C (looking north from south end).

Wetland hydrology is maintained by seasonally high groundwater, seeps, surface water from a pipe under East Lake Sammamish Parkway SE, and local area runoff. The wetland drains through a ditch that runs parallel to the trail. Most of the water flows east to a culvert under a driveway and discharges into Wetland 14A. Water also flows seasonally north to a culvert under the trail. Inundation (up to 6 inches) and soil saturation to the surface was observed in the ditch during site visits conducted in October 2007 and September 2013. This wetland has permanently flooded, seasonally flooded, and saturated only water regimes.

Wetland 14C has an emergent vegetation community dominated by reed canarygrass. The ditch contains small-fruited bulrush, American speedwell, and common duckweed. Other species observed include red alder saplings, Himalayan blackberry, common rush, softstem bulrush, fringed willowherb, giant horsetail, and climbing nightshade.

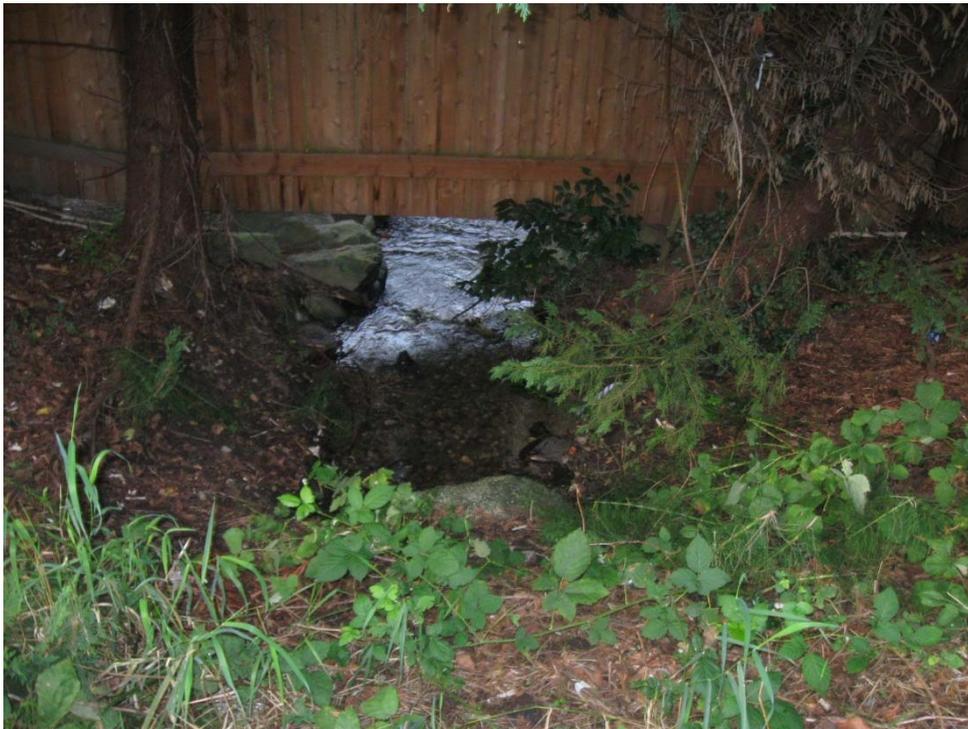
**Photo 6.** South Fork Stream 0163 (looking west from trail).

it is not accessible to fish because of piping below the trail. Only trace flow was observed in this fork by Parametrix biologists on April 24 and August 9, 2000. The South Fork is 0.7 mile in length with only about 0.1 mile accessible to non-resident fish (King County 1990b). There are no impassable barriers at or downstream of East Lake Sammamish Parkway SE, but a culvert just upstream of the parkway may be a velocity barrier at times. Prior to the creation of the fish barrier(s) near the East Lake Sammamish Parkway SE, this stream likely supported sockeye salmon and/or the landlocked form of the species, kokanee salmon. It may still support some cutthroat and kokanee below East Lake Sammamish Parkway SE. No fish were visually observed by project biologists during field investigations.

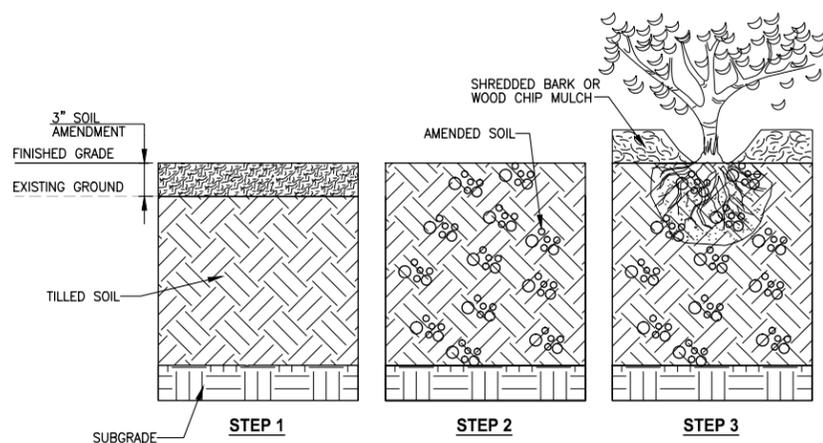
**PLANTING AREA SOIL AMENDMENT- SEQUENCE OF WORK DETAIL**  
 NO SCALE

- STEP 1**  
 TILL, DISC OR RIP SOIL IN PLANTING AREAS TO 10" DEPTH. PLACE 3" OF SOIL AMENDMENT OVER SOIL SURFACE.
- STEP 2**  
 TILL SOIL AMENDMENT INTO TOP 10" OF ENTIRE PLANTING ZONES NATIVE SOIL AFTER CLEARING AND GRUBBING.
- STEP 3**  
 INSTALL PLANTS FOLLOWED BY 3" WOOD CHIP MULCH.
