**CSO Sampling and Monitoring Data Inventory  
Task 5 Report  
Sediment Management Plan**

Prepared by the  
**Sediment Management Plan Project Team  
King County Department of Natural Resources**

**Final Draft 08/04/98**

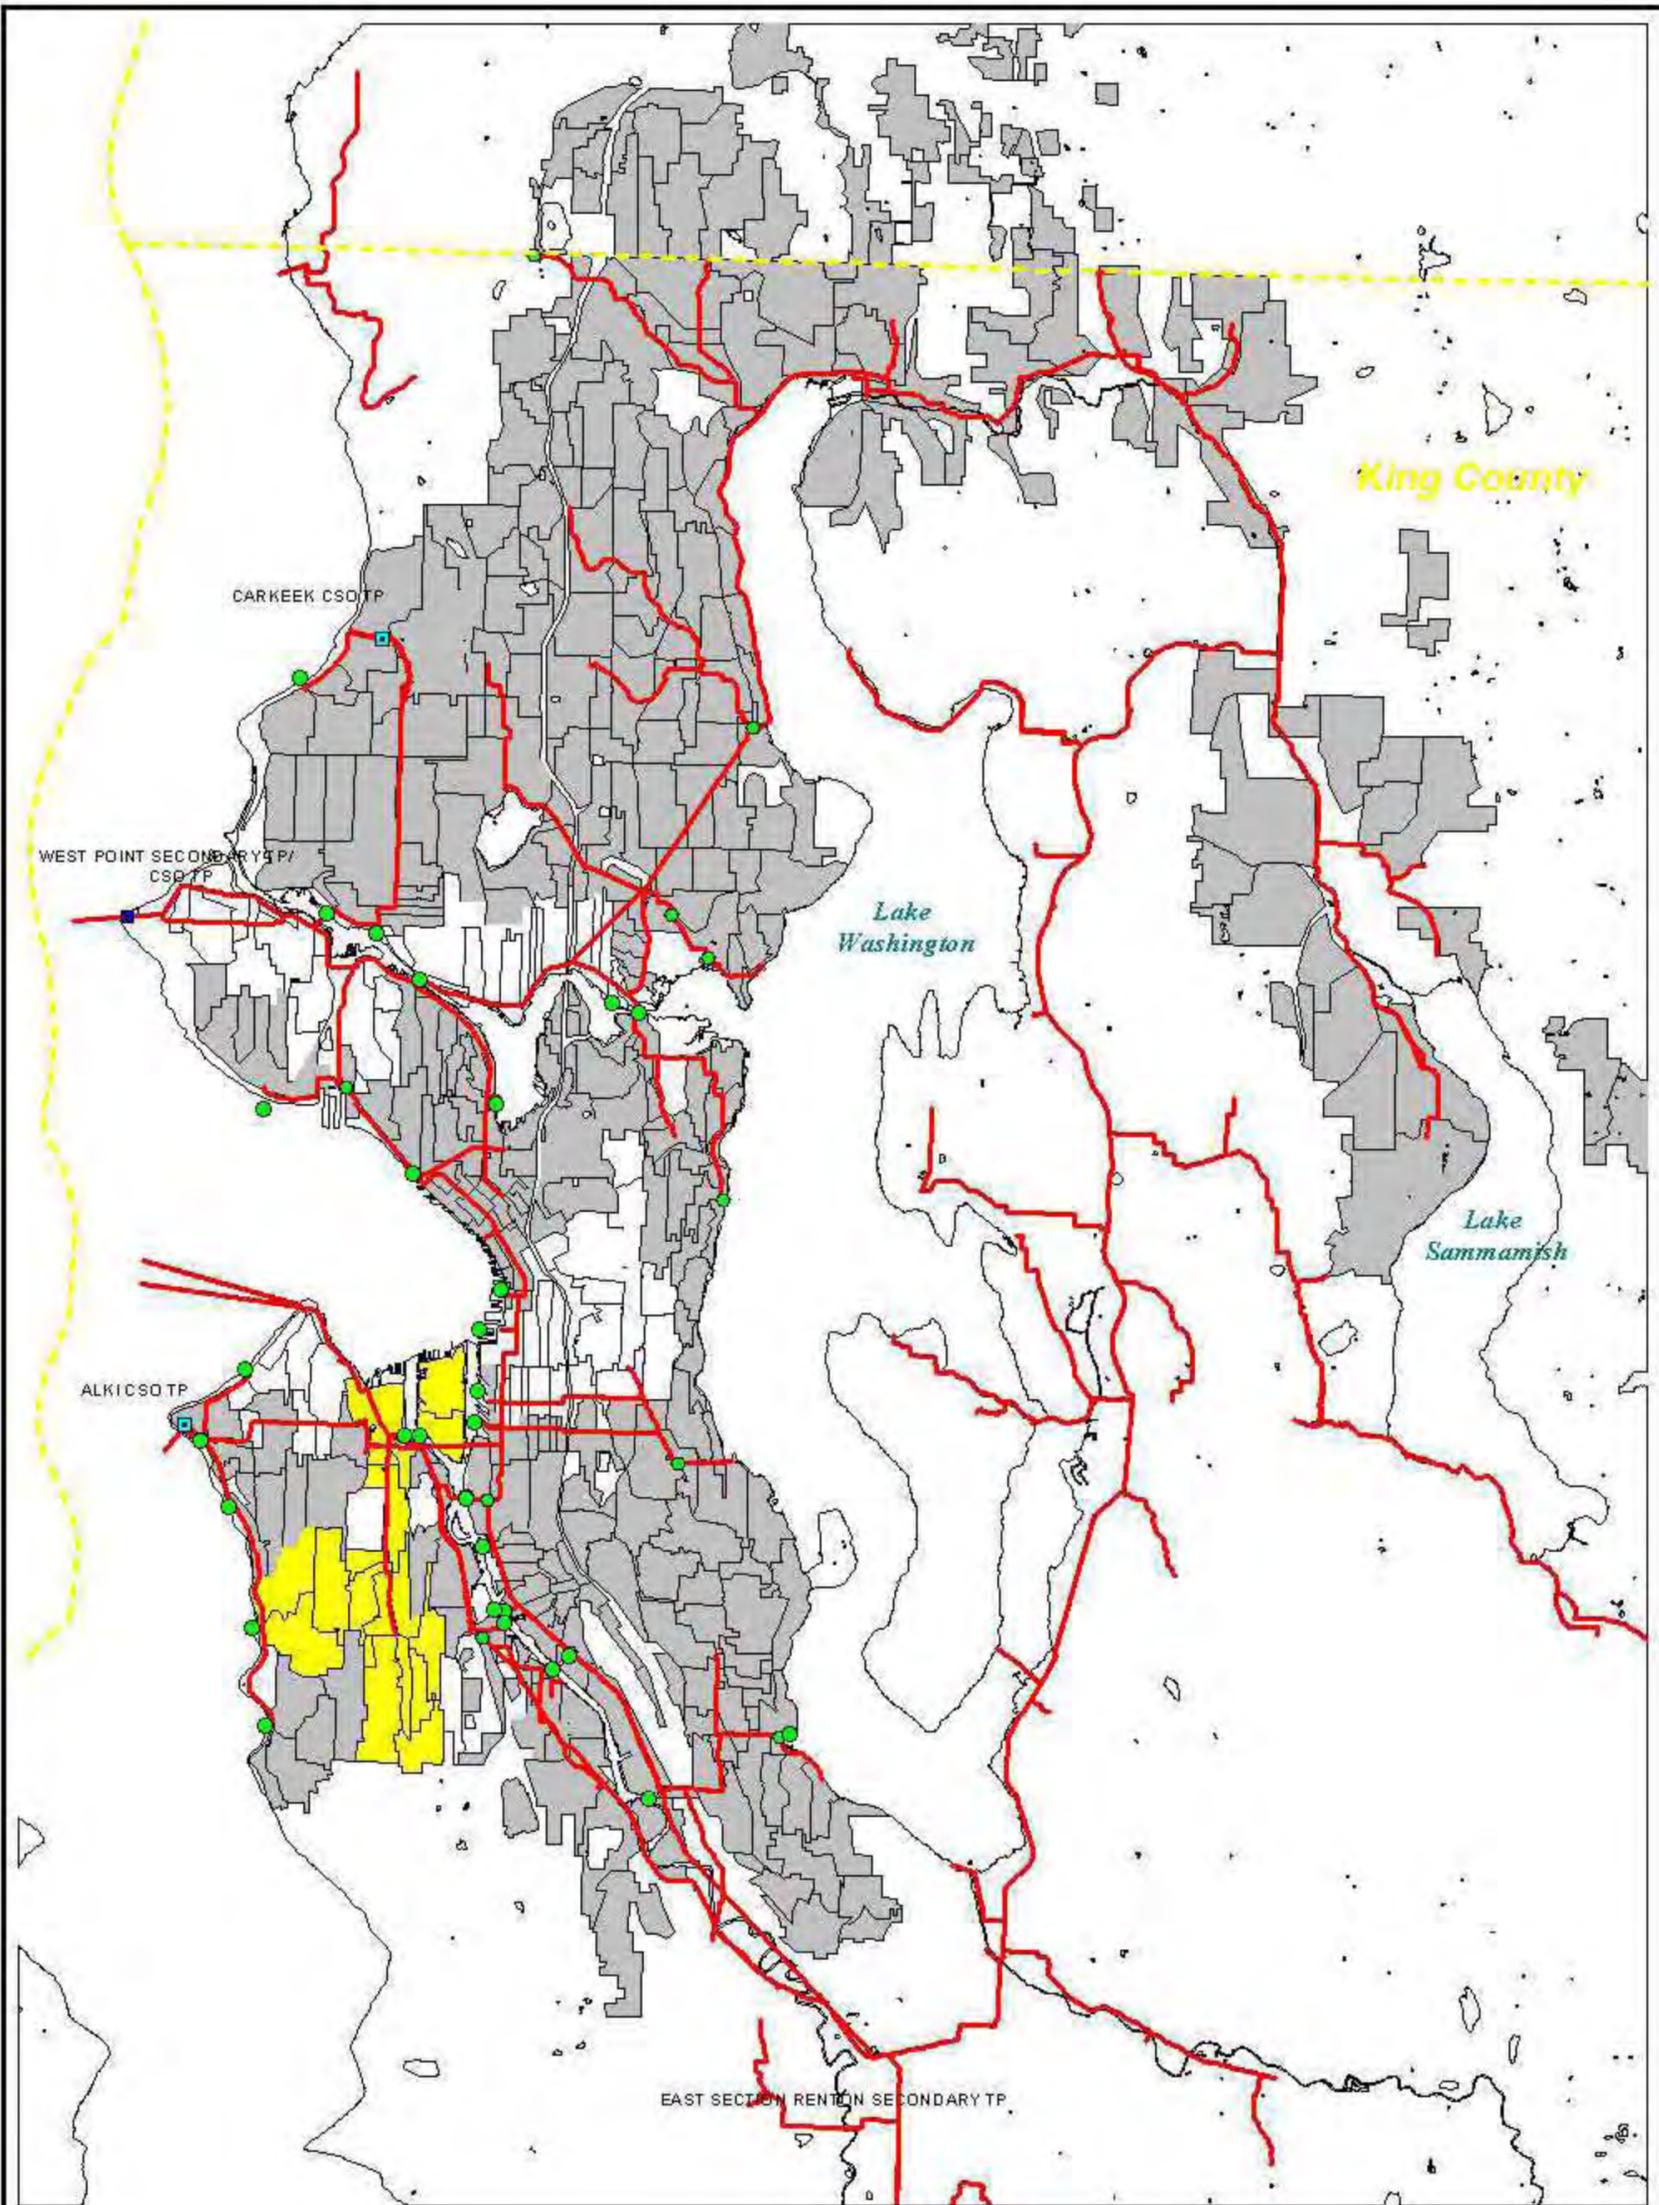
Figure 1-1

A map of King County CSO locations is presented in Figure 1-1, on the following page.

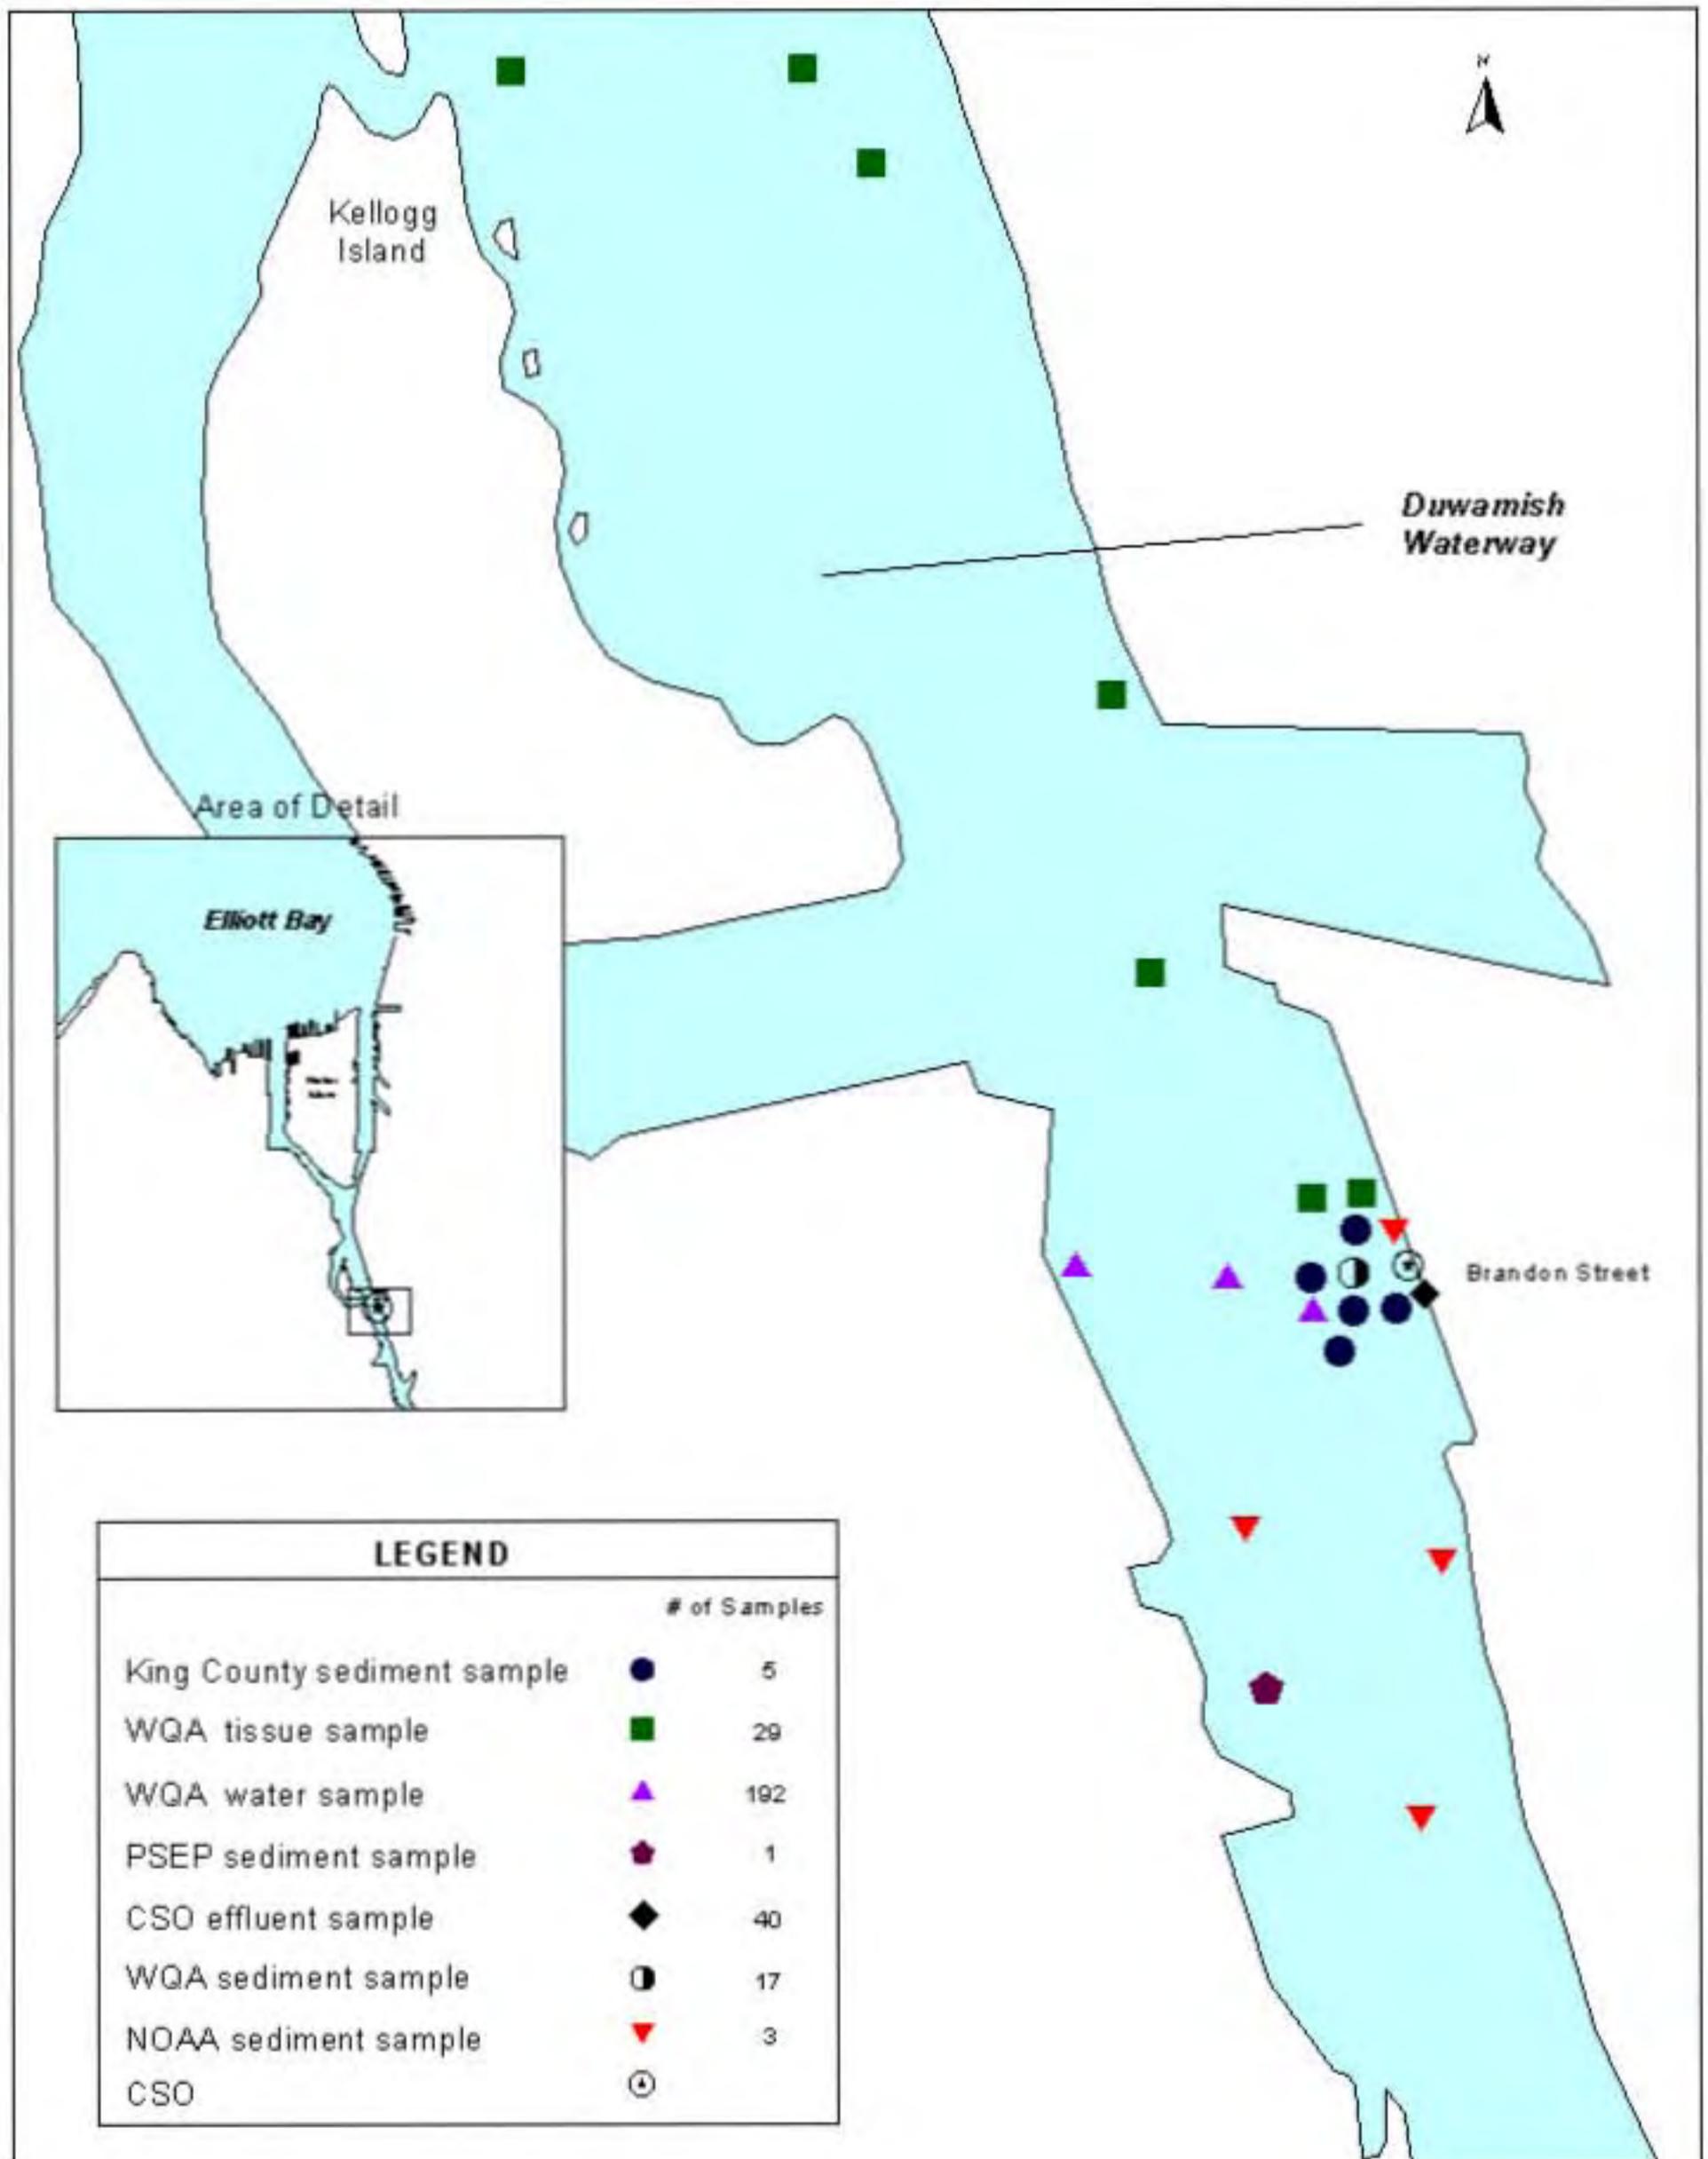
Figure 2-1

The Brandon Street CSO regulator and outfall stations are located at 5241 East Marginal Way South. The outfall for this CSO discharges along the eastern shoreline of the main channel of the Duwamish River. This outfall is exposed during normal low tides and, during extremely low tides, can discharge directly across exposed intertidal sediment. Sampling locations in the vicinity of the Brandon Street CSO outfall are shown in Figure 2-1.

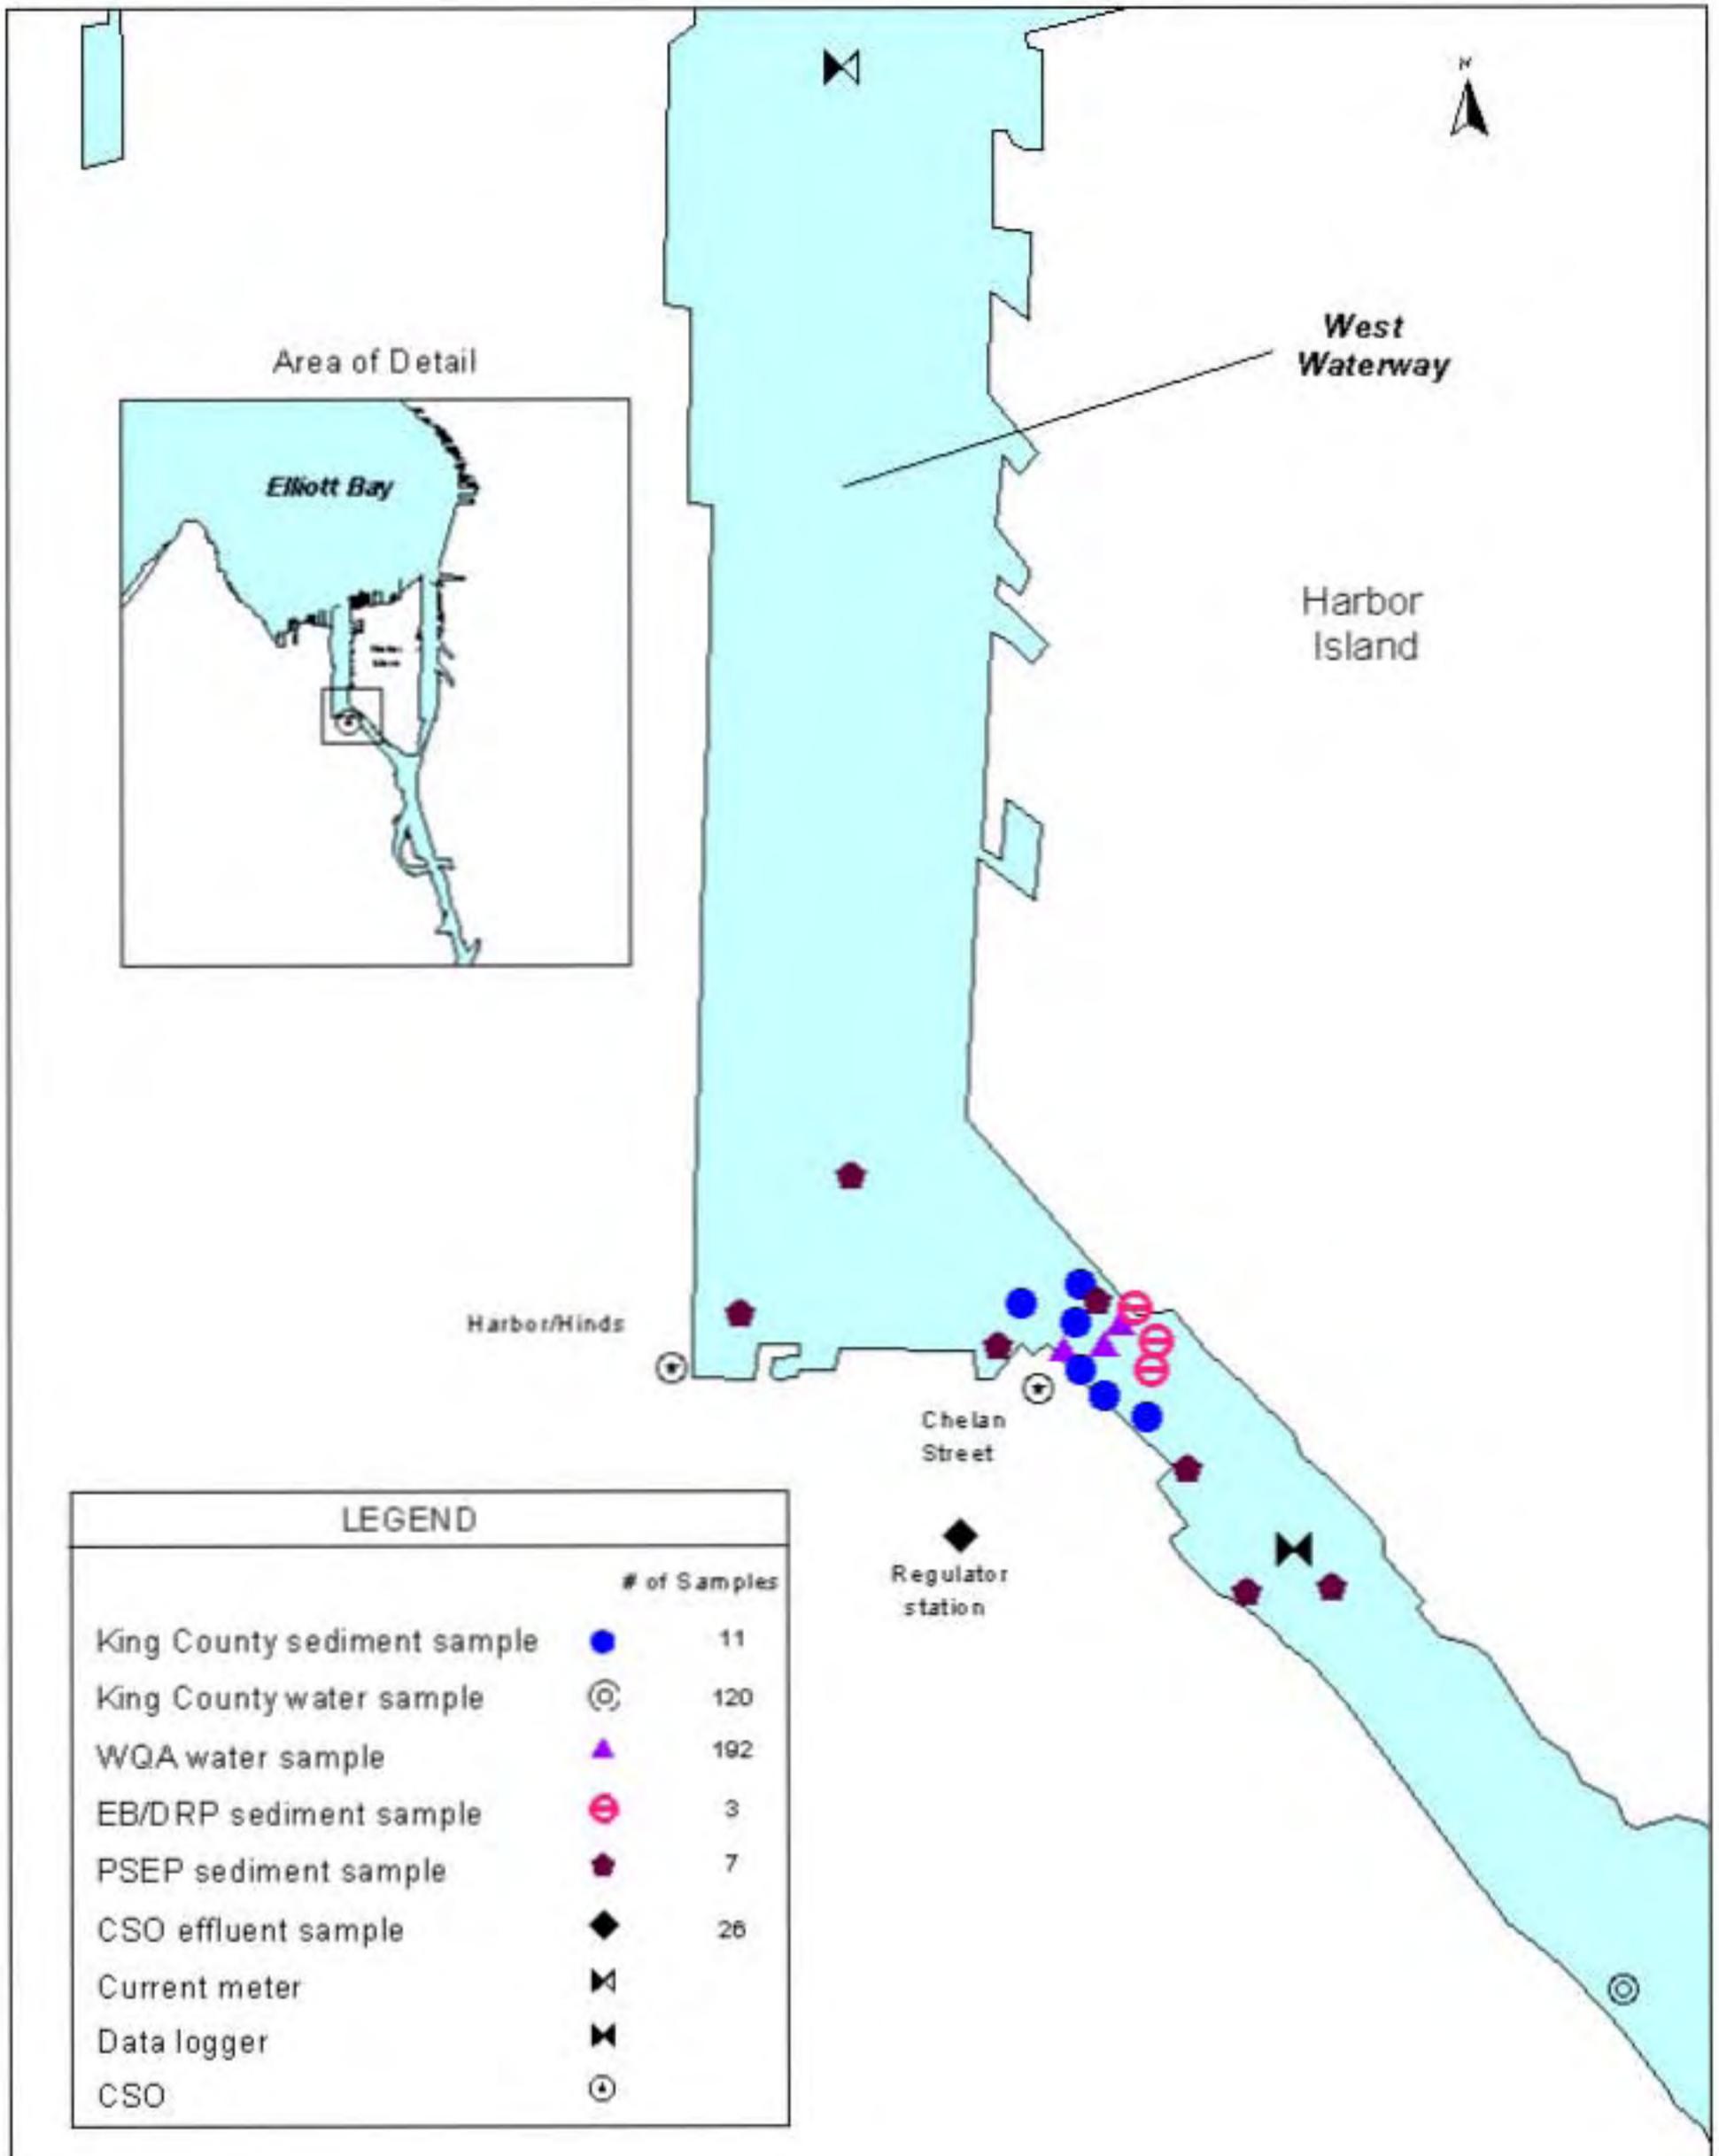
Figure 3-1

The Chelan Avenue CSO regulator station is located at 3455 Chelan Avenue Southwest. The outfall for this CSO discharges into the West Waterway of the Duwamish River approximately 40 yards offshore of the west bank. This outfall is submerged at a depth of about 30 feet and is never exposed. Sampling locations in the vicinity of the Chelan Avenue CSO outfall are shown in Figure 3-1.

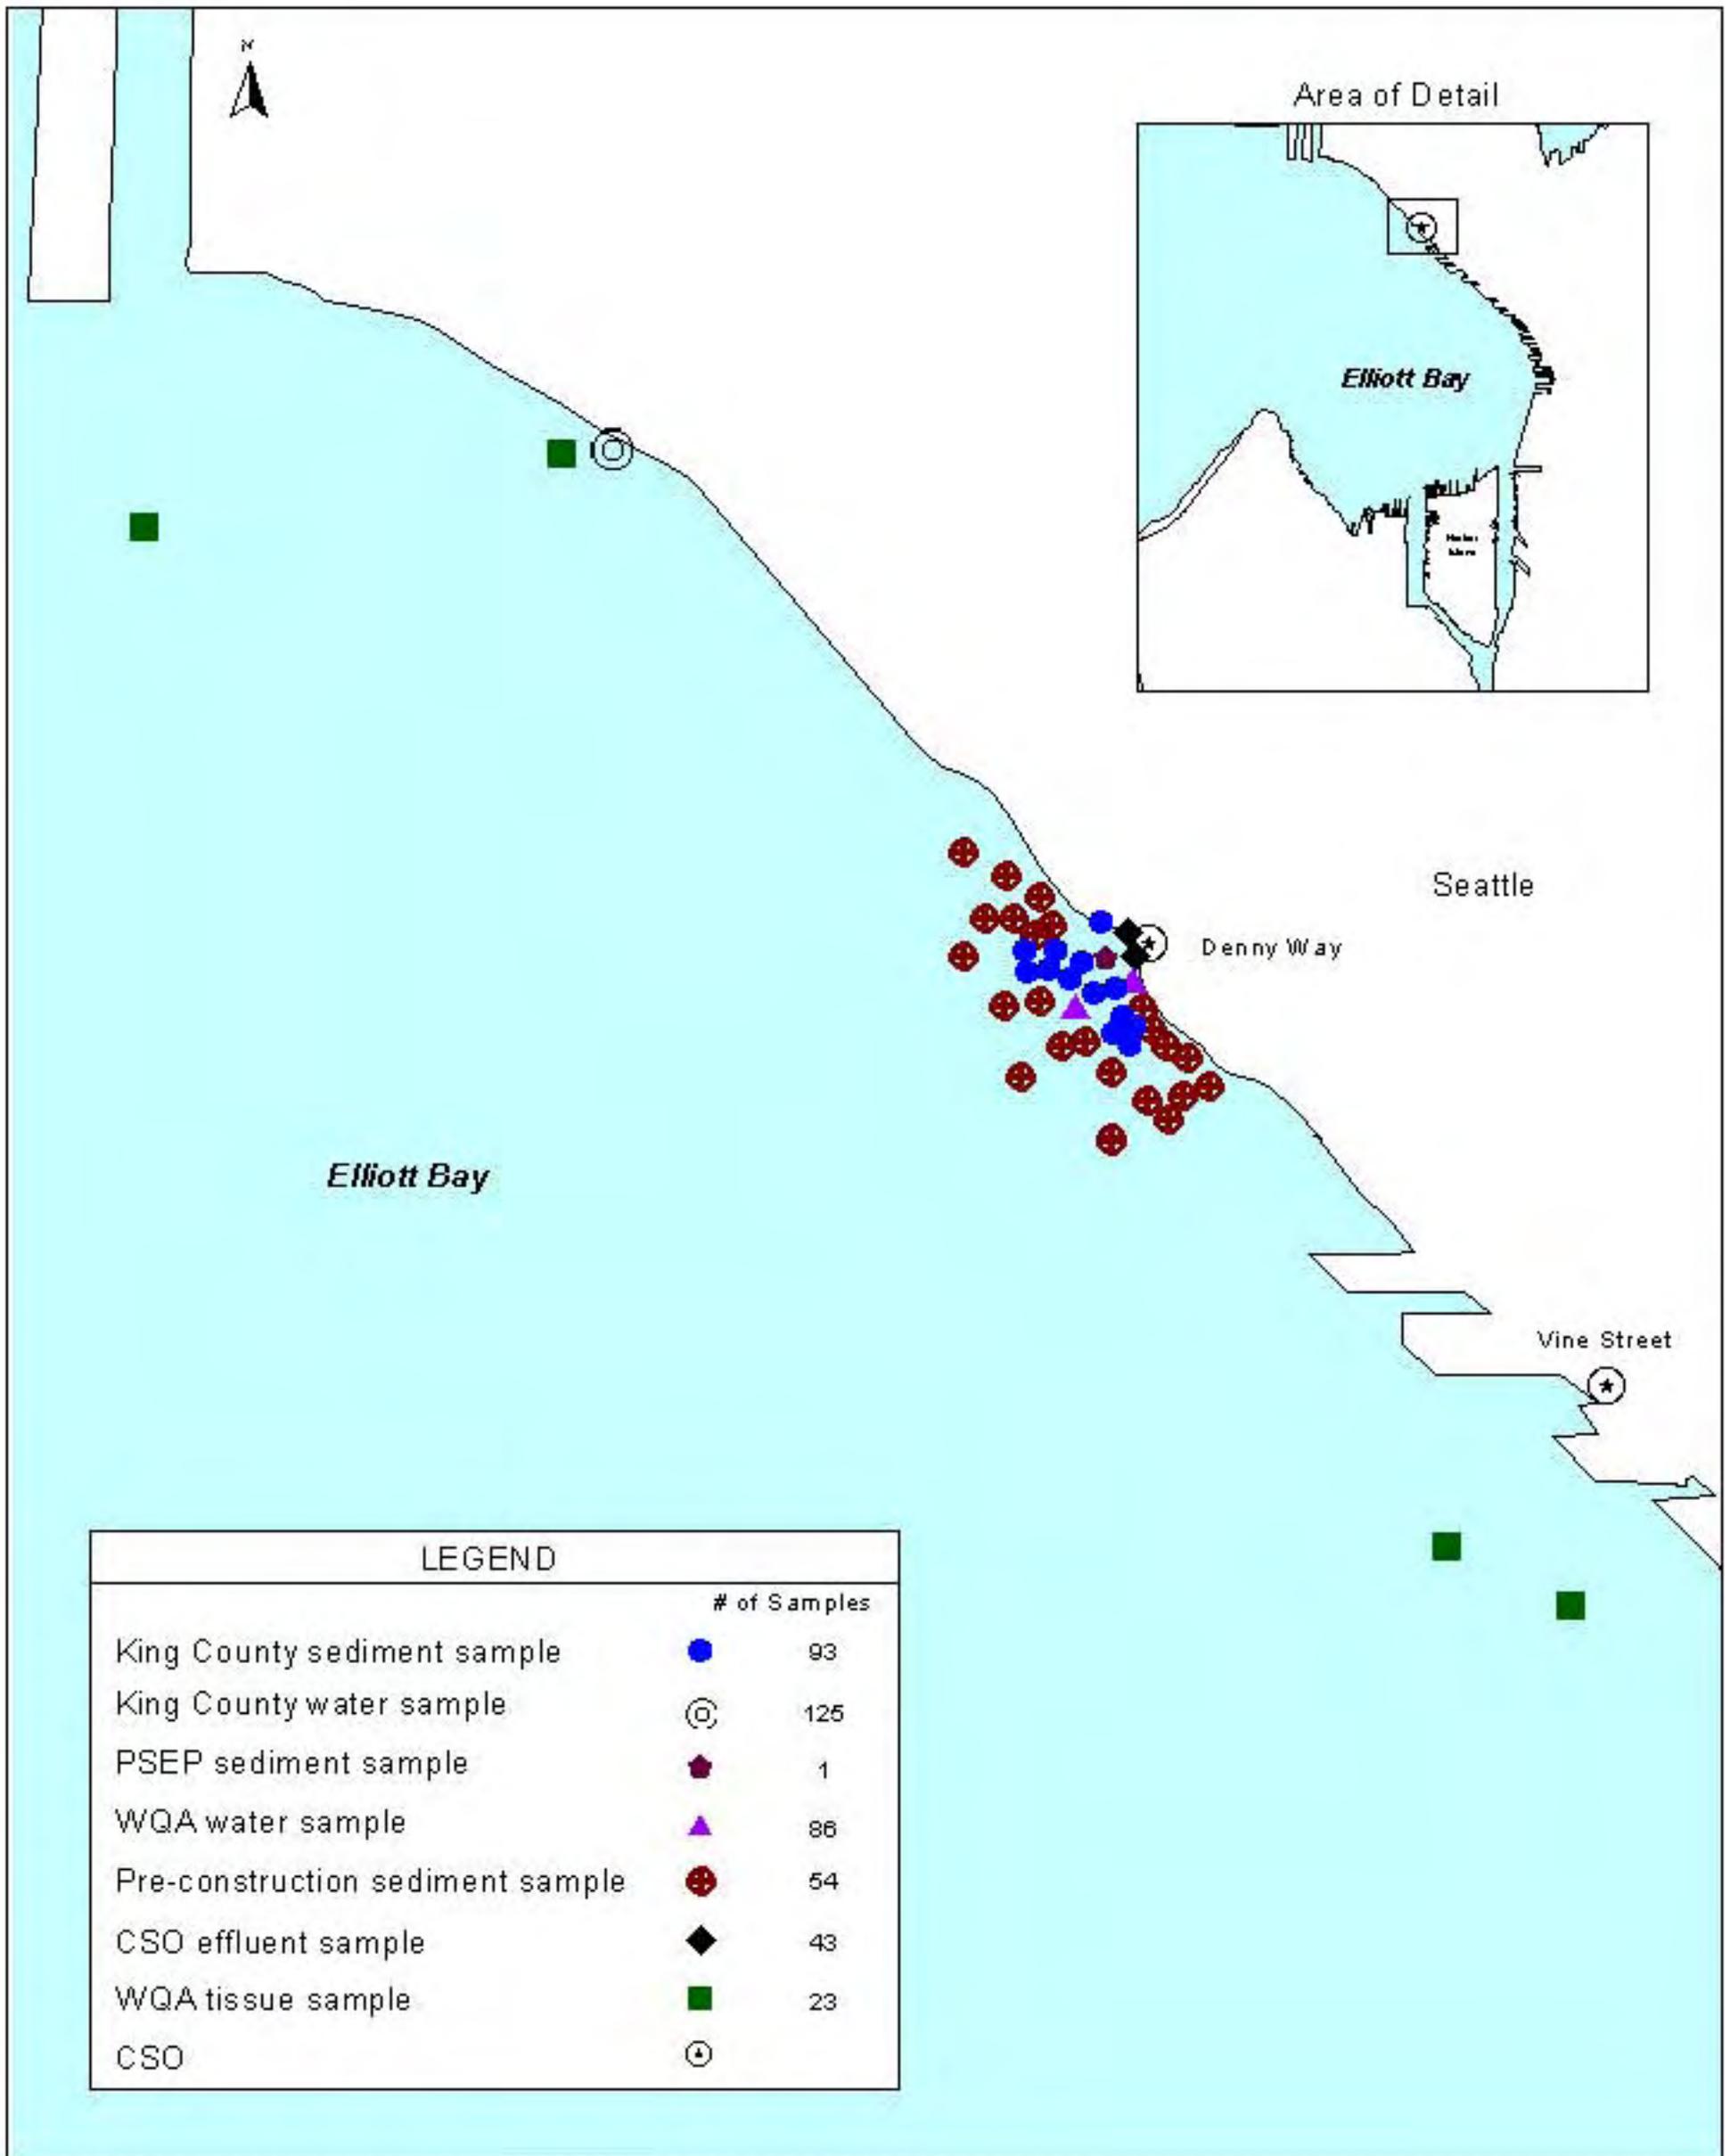
Figure 4-1

The Denny Way CSO regulator station is located at 3165 Alaskan Way. The outfall for this CSO discharges into Elliott Bay along the northeastern shoreline in Myrtle Edwards Park. This outfall is exposed during normal low tides and frequently discharges directly across exposed intertidal sediment. Sampling locations in the vicinity of the Denny Way CSO outfall are shown in Figure 4-1.

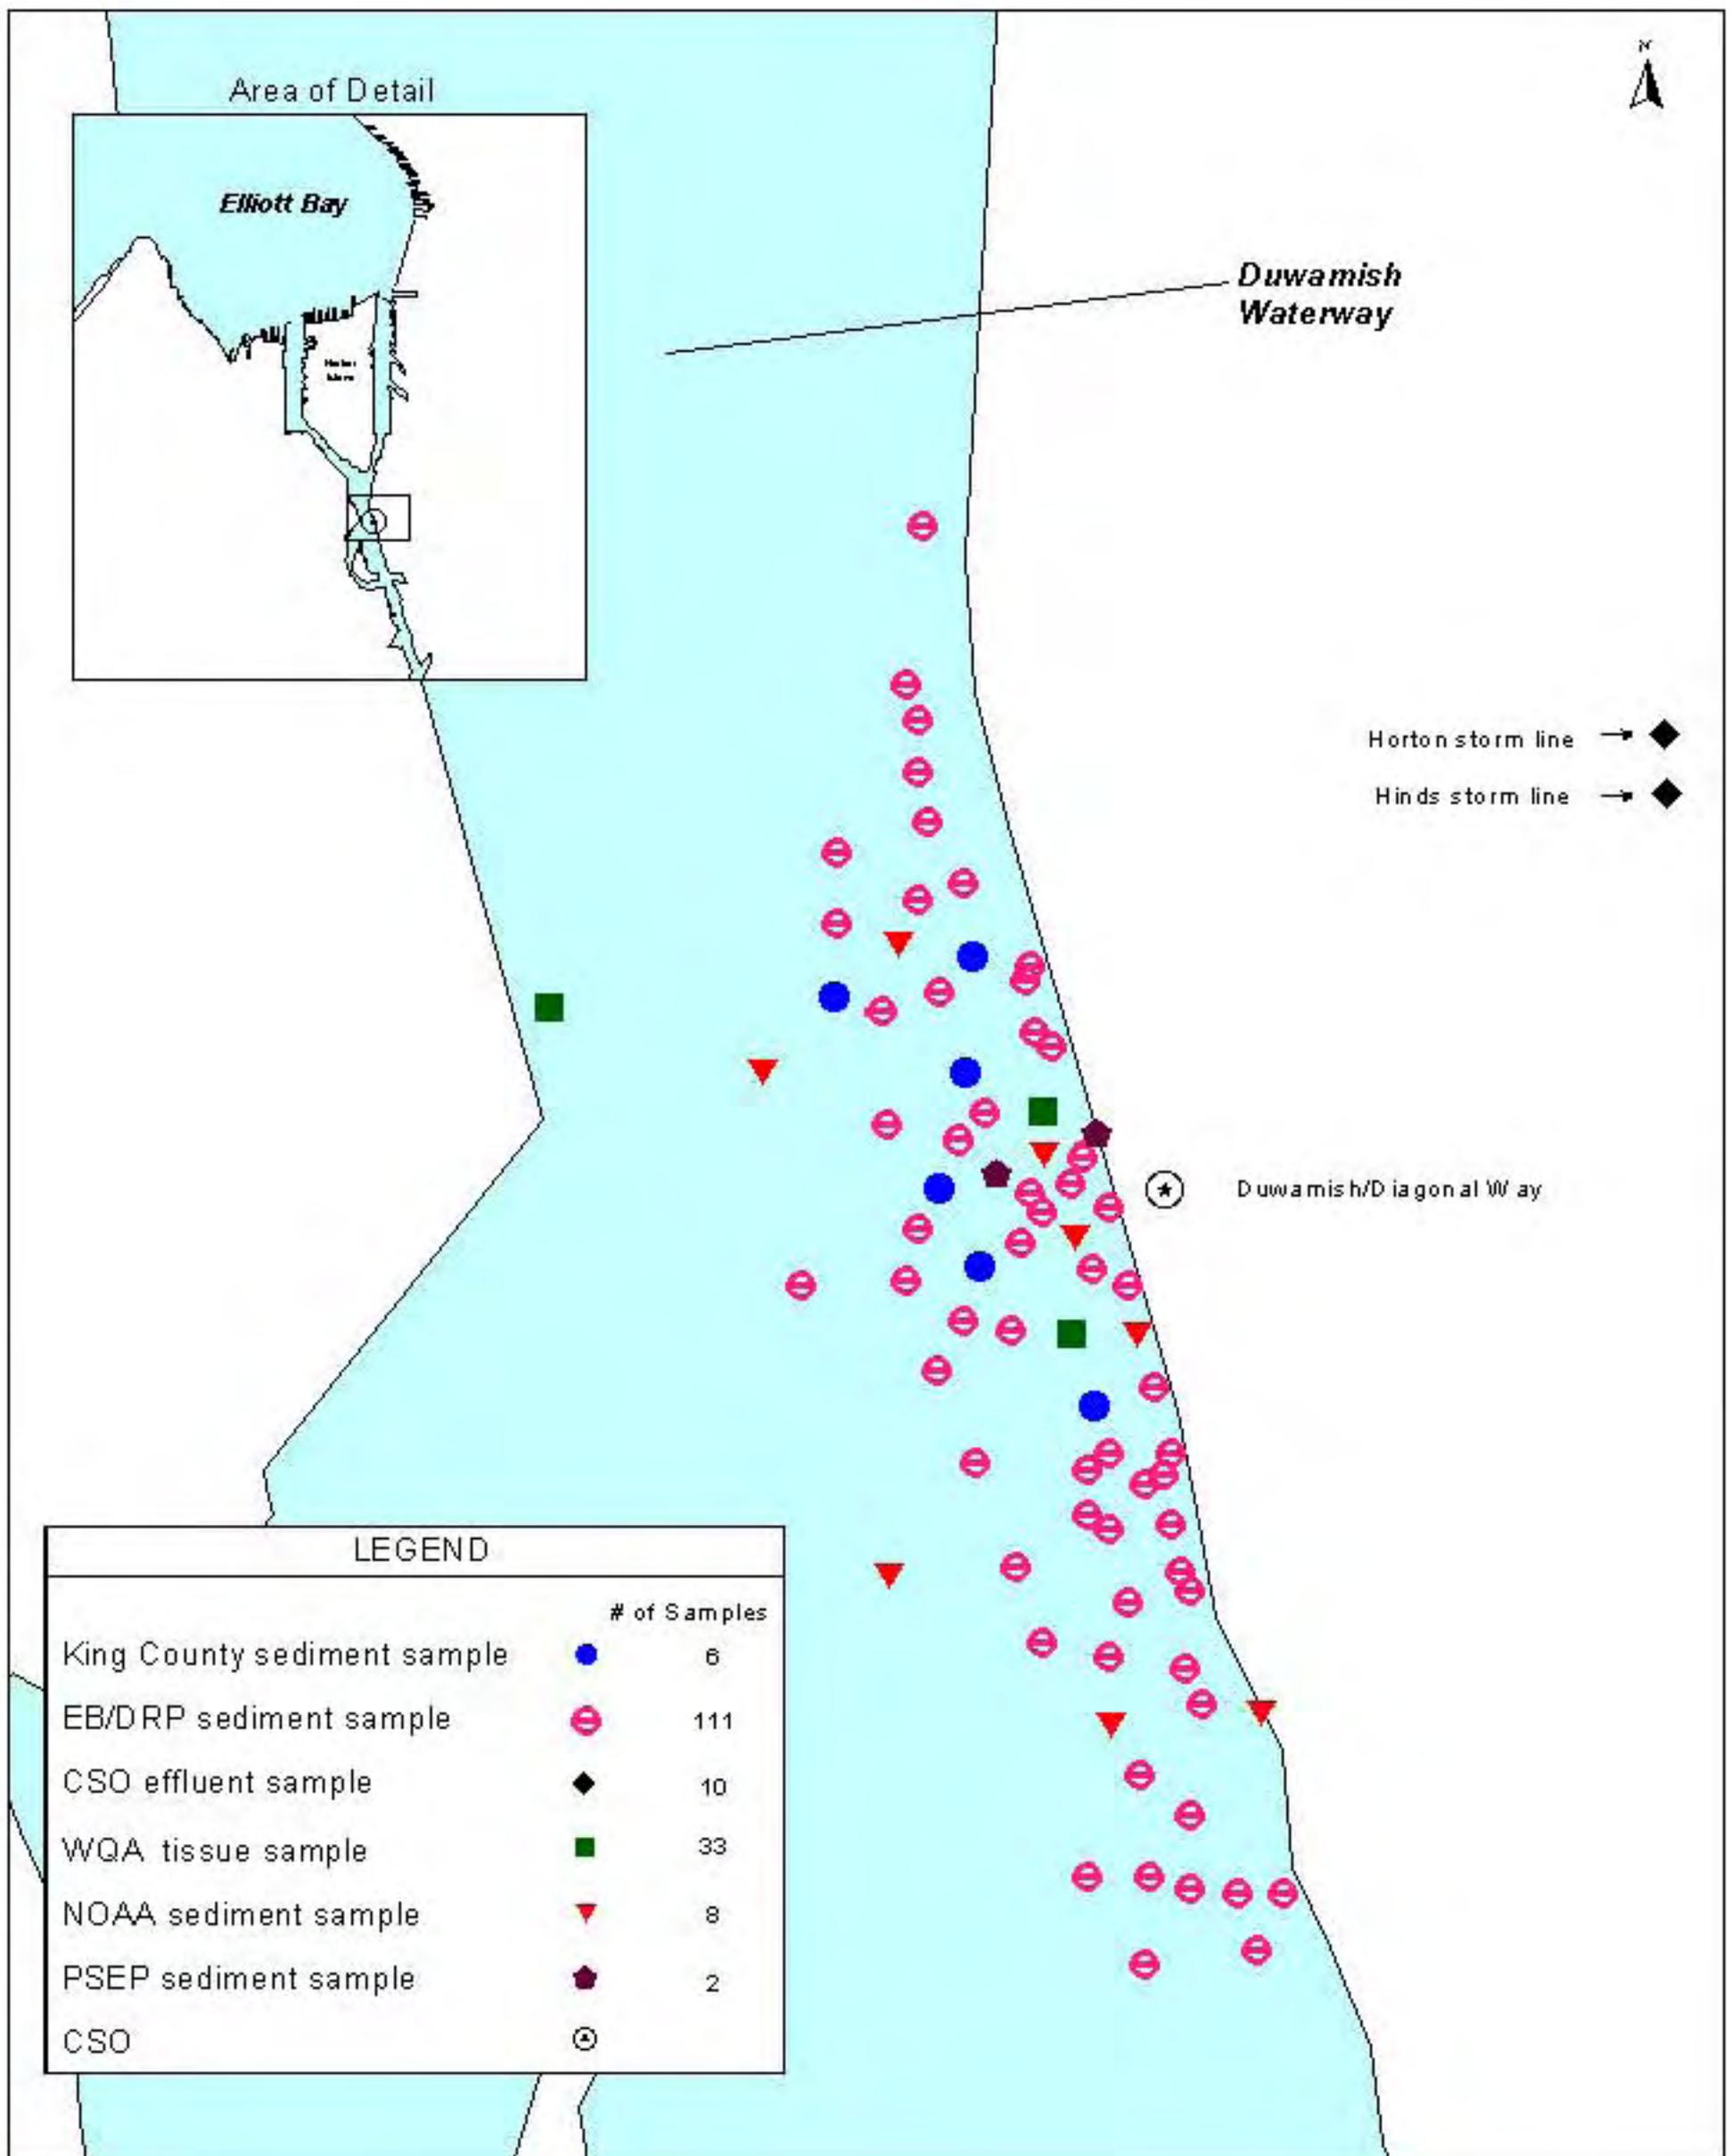
Figure 5-1

The Duwamish Pump Station is located at 4501 East Marginal Way South, receiving flows from both the Elliott Bay Interceptor and the Duwamish Siphon. This location would only overflow in the event of an extremely large flow or during a power outage. The outfall for the pump station overflow structure is co-located with the City of Seattle Diagonal Way CSO and storm drain (SD) outfall. The CSO/SD outfall is totally exposed at low tide and can discharge directly onto exposed intertidal sediment. Sampling locations in the vicinity of the Duwamish Pump Station and Diagonal Avenue CSO/SD outfalls are shown in Figure 5-1.

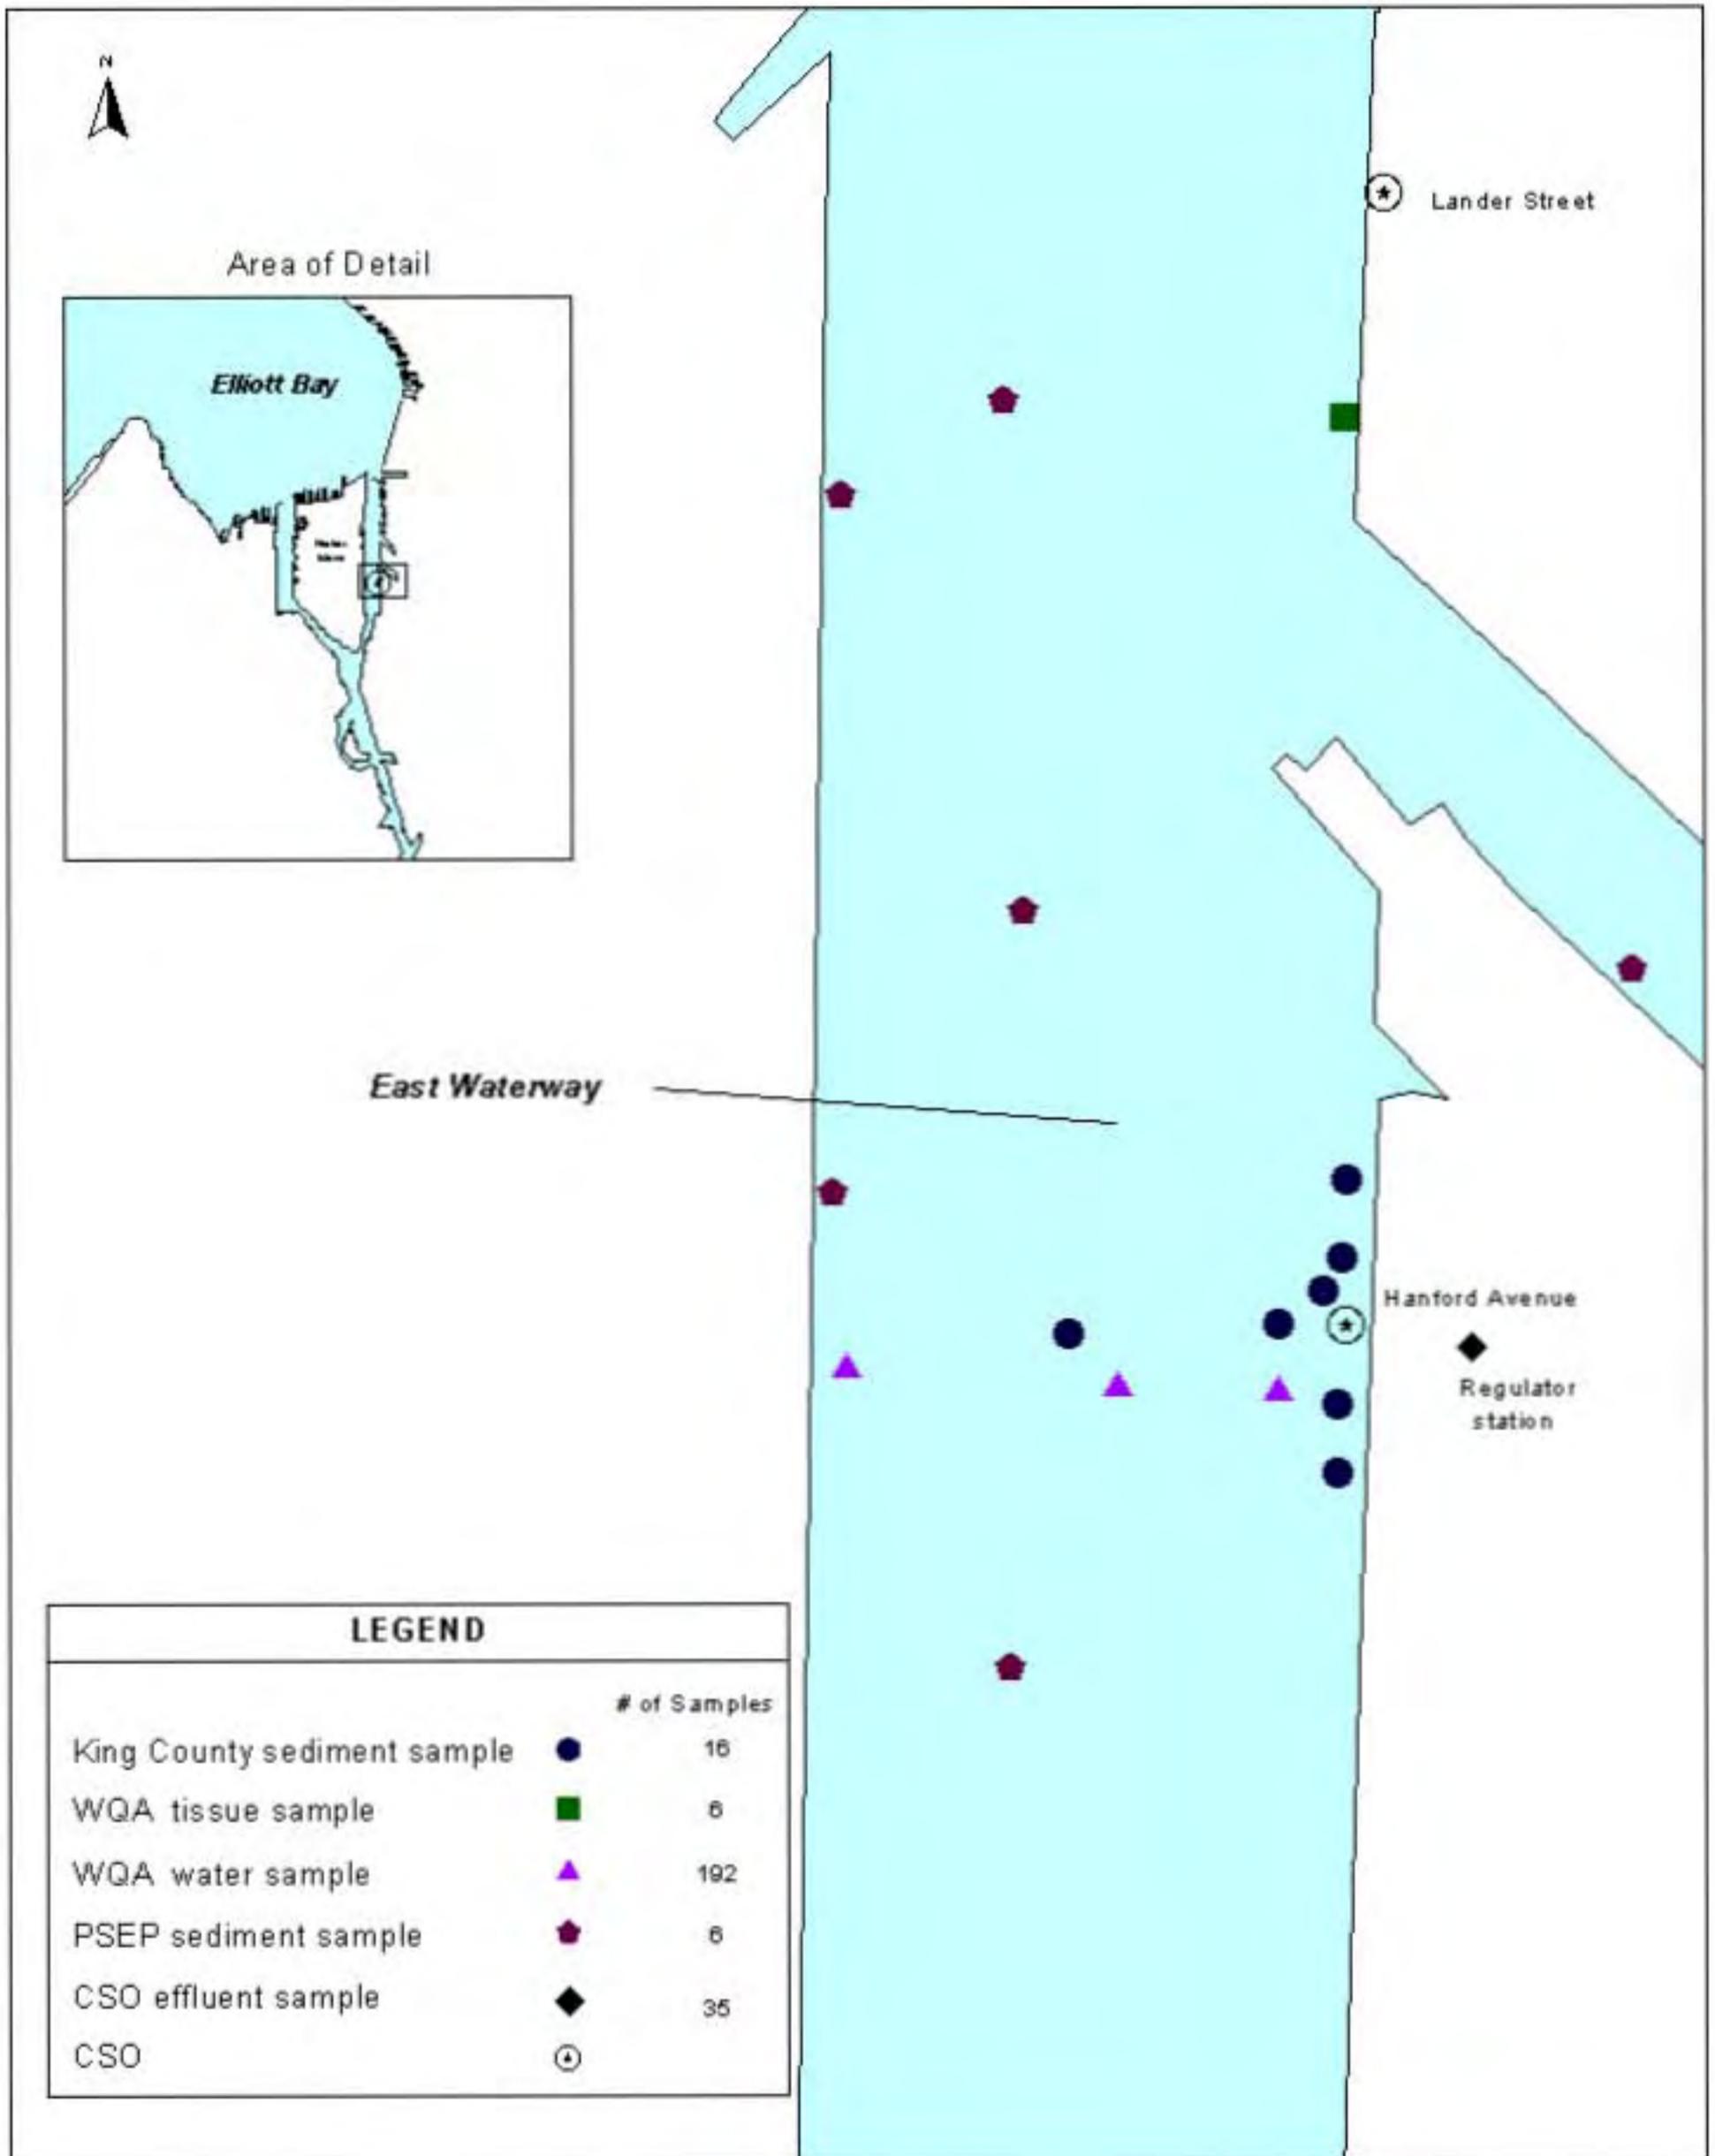
Figure 6-1

The Hanford Street CSO regulator and outfall stations are located at 2999 East Marginal Way South, within the trailer yard of the Port of Seattle Terminal 25. The outfall for this CSO discharges into the East Waterway of the Duwamish River, underneath the container pier. The outfall is located in a rip-rapped wall on the east bank and is exposed during very low tides. The original outfall extended to the middle of the East Waterway but, in the late 1970's, the outfall was shortened to the current location on the east bank. Sampling locations in the vicinity of the Hanford Street CSO outfall are shown in Figure 6-1.
